ISSUE 2/2020

AVIATION SAFETY LETTER

TP 185E

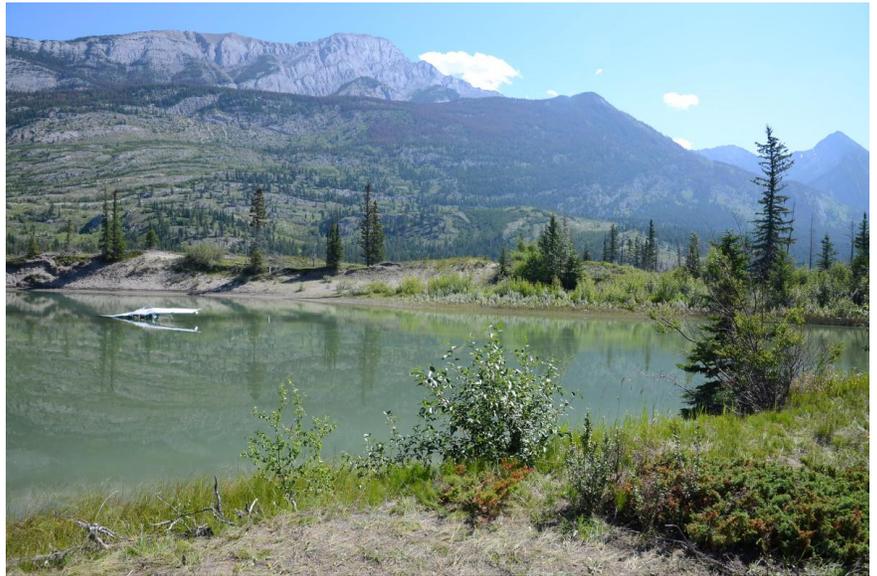
Cessna 150J wreckage involved in the July 2019 accident in Jasper, Alberta.

All of the major components of the aircraft were accounted for at the accident site. The wing flaps were found in the retracted position. The aircraft was within the certified weight and balance limits. Based on examination of the wreckage and the photo and video information collected, it was determined that the engine and flight controls had been operating normally prior to impact.

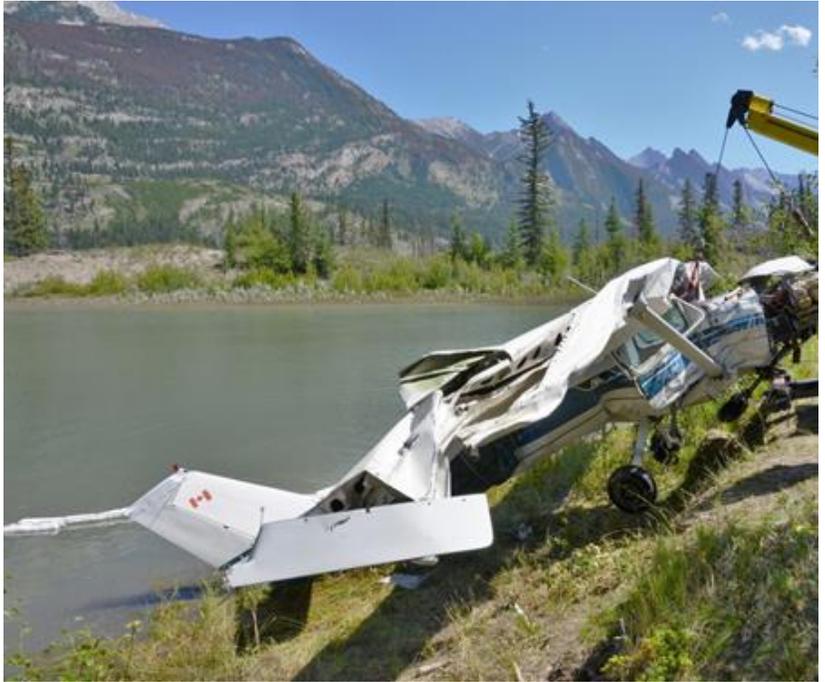
Cessna 150J wreckage upon recovery from the Athabasca River in Jasper, Alberta.

The aircraft was equipped with a Garmin GPSMAP 196. It was recovered at the accident site and was sent to the TSB Engineering Laboratory for analysis. Just before the loss of control, the GPS (global positioning system) recorded a reduction in ground speed from 83 mph to 64 mph and a course change approximately 30 degrees to the left of the runway track. During the reduction in airspeed, the altitude remained constant at about 150 ft AGL for almost 5 seconds before the aircraft departed controlled flight and entered the aerodynamic stall and left-hand spin.

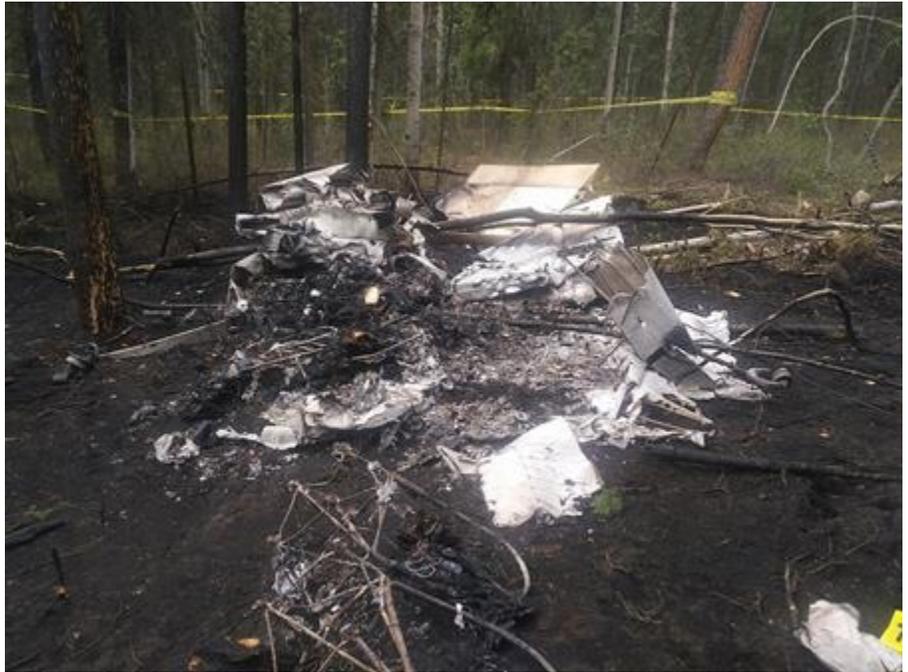
Accident site approximately 2000 ft south of Runway 14R at the Erik Nielsen Whitehorse International Airport (CYXY), Yukon

At 17:30:25, the aircraft crashed into a wooded area and was severely damaged. An on-board video recorder continued to record both audio and video after the aircraft had come to rest. Based on the audio, electric power was still on after the crash because a beeping sound could be heard. A fire erupted 10 seconds after impact and eventually consumed the aircraft. Both occupants were fatally injured. The emergency locator transmitter was activated during the crash sequence.

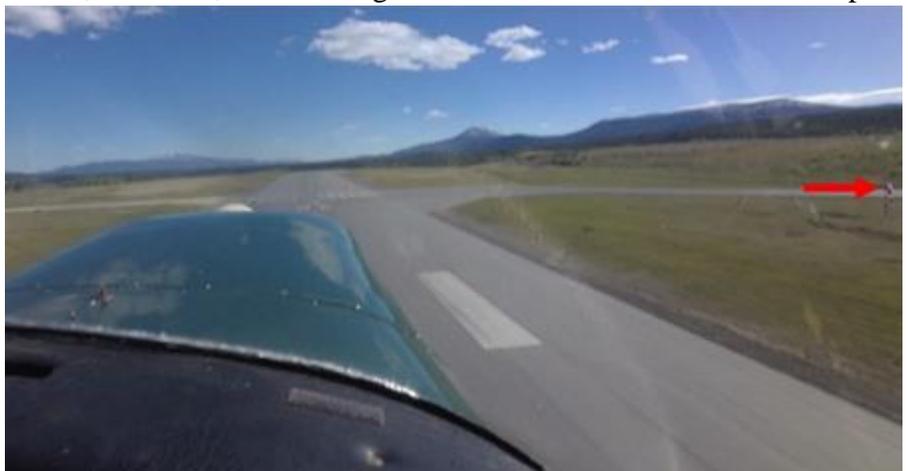
Image capture of the takeoff (at 17:29:38). The red arrow points to the windsock at the far end of Runway 14R, indicating calm winds. (Source: Video recorder installed on the aircraft involved in the occurrence, with TSB annotation)

In this occurrence, after becoming airborne, the aircraft did not climb above 50 ft, and a right-wing-low attitude was maintained on the departure climb. As well, the flaps were set to 40° and then to either 30° or 20°, which would have increased drag. The Cessna 170B owner's manual clearly states that the use of flaps at higher-density altitudes is not recommended. It is important to follow aircraft manufacturers' recommendations to ensure the aircraft performs as designed.

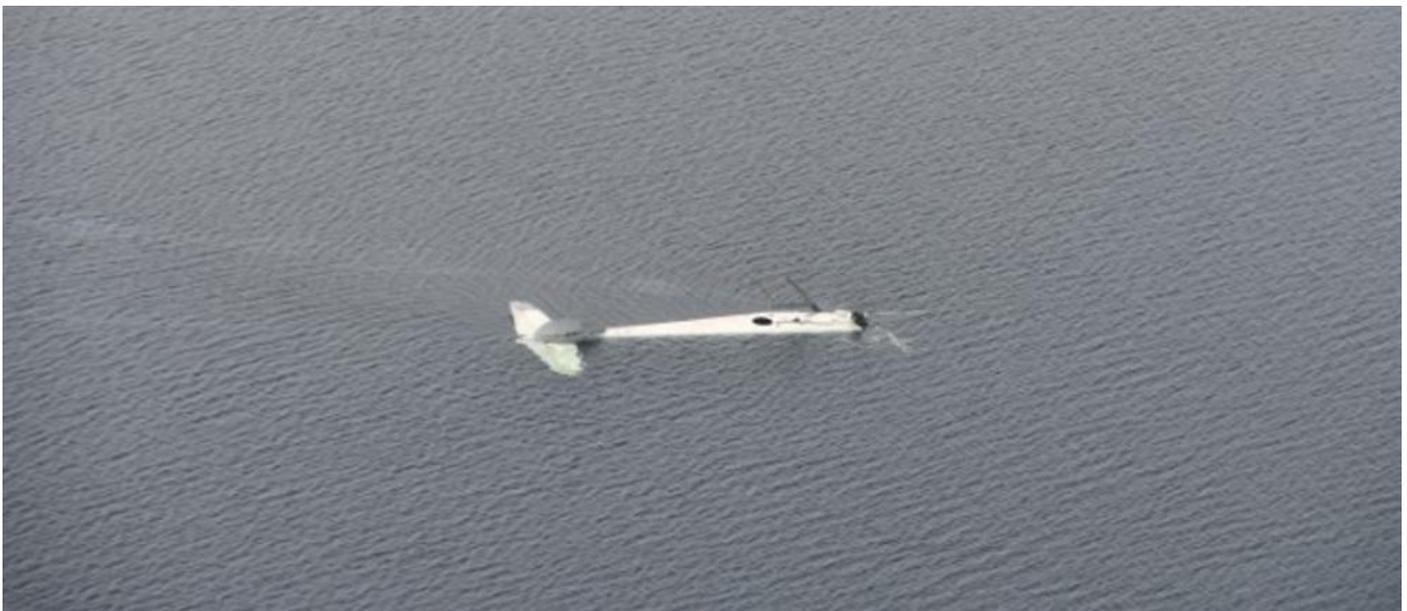
The wreckage observed floating on the water during the first day of recovery consisted of the fuselage and empennage of the aircraft. When first discovered, the fuselage was inverted and partially submerged. The engine, wings, and floats had detached from the fuselage and were not visible.

Figure 2. Wreckage of occurrence aircraft (Source: RCMP)

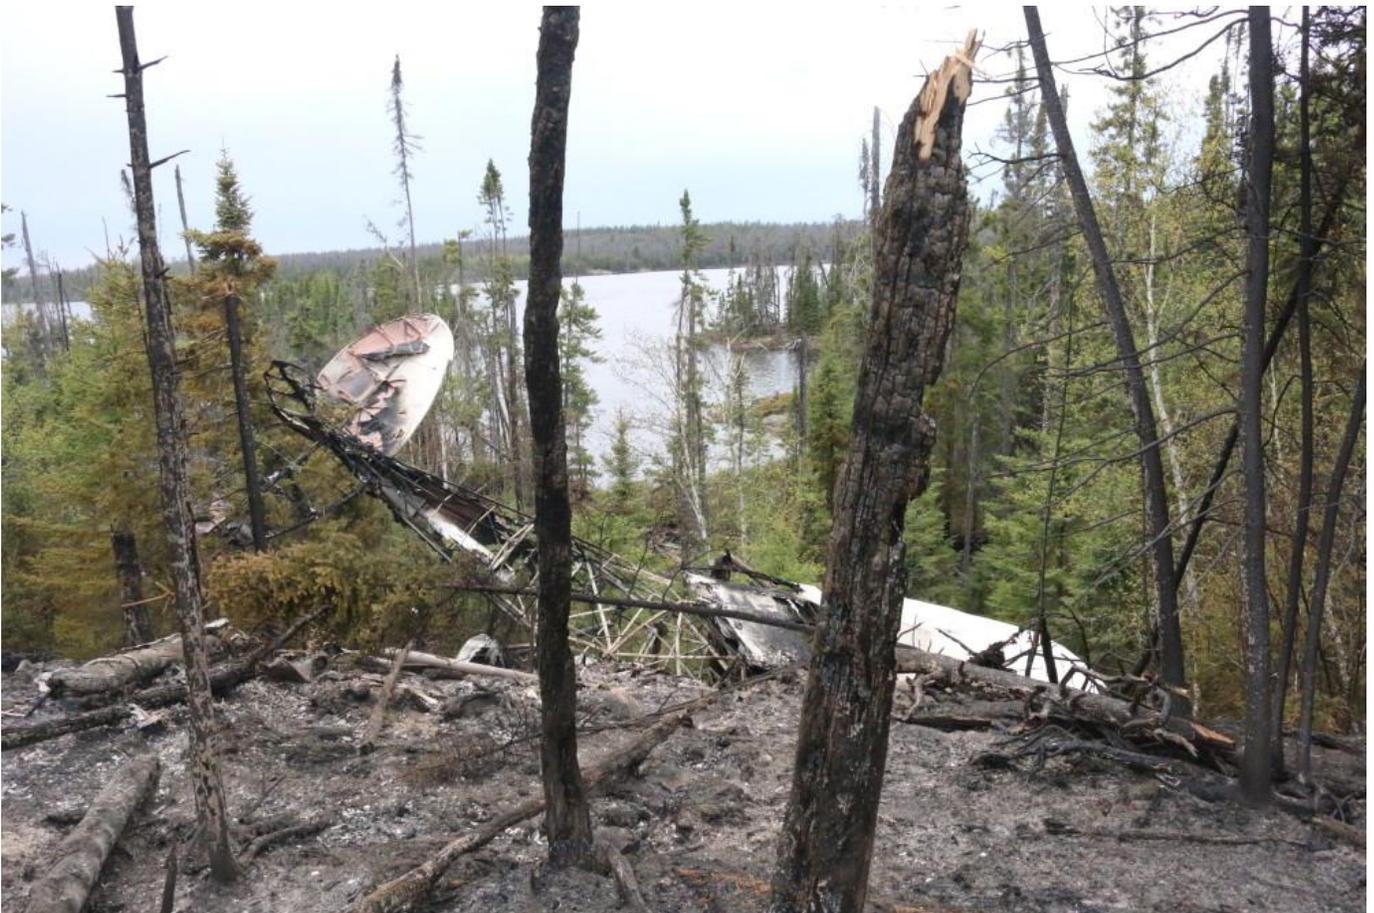
Figure 3. Accident site

An inspection of the airframe for any pre-impact anomalies was inconclusive due to the damage sustained on impact and in the post-impact fire.

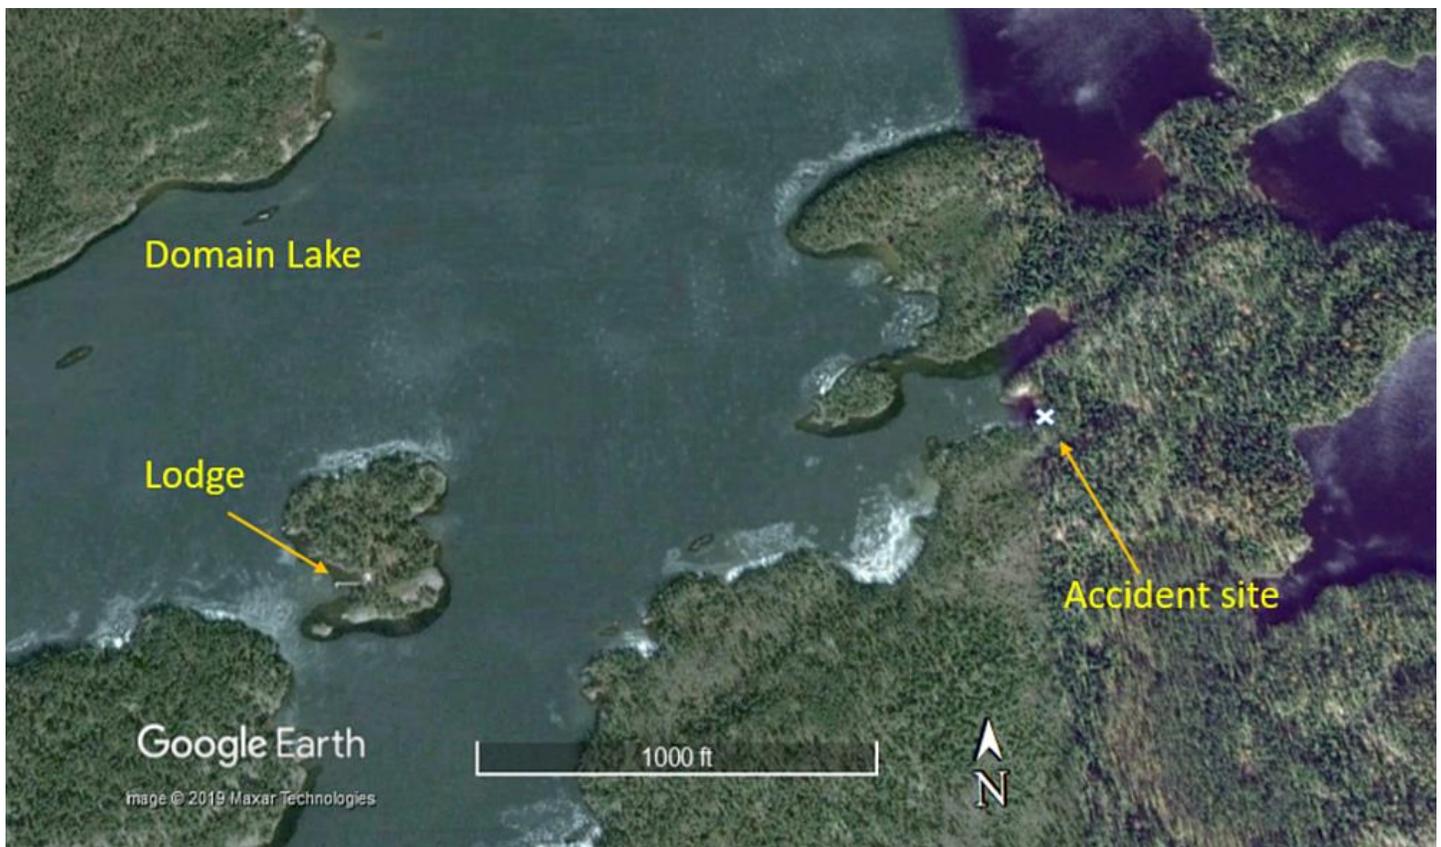
Figure 4. Accident site near the shore of Domain Lake, Ontario

Pilots should consider their abilities, experience, and the aircraft’s capabilities when planning and conducting flights, especially when gusty surface winds and moderate turbulence are forecast along the route of flight.
