Transport
Canada

ISSUE 4/2020

AVIATION **S**AFETY **L**ETTER

TP 185E

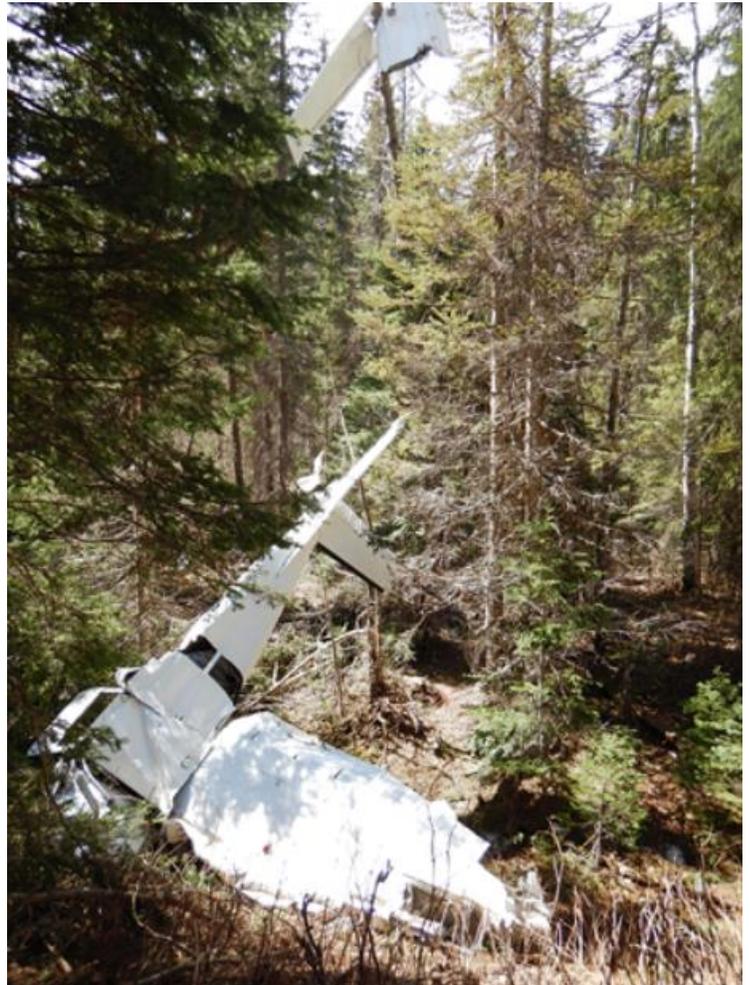
Figure 3. The occurrence aircraft at the accident site, with the right wing atop a tree (Source: TSB)

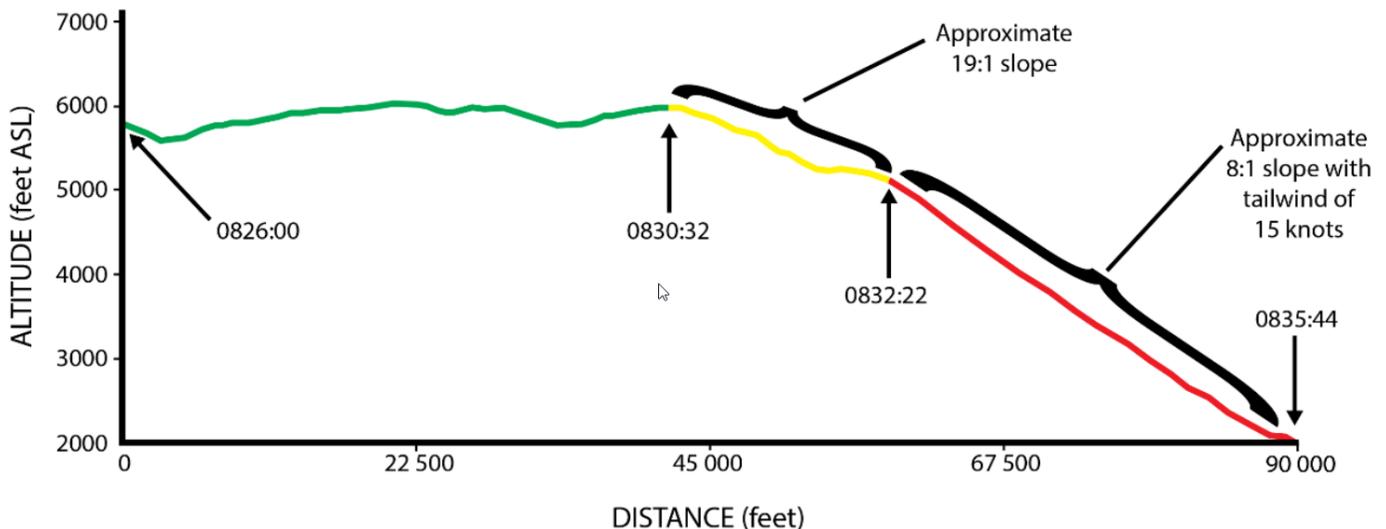
Figure 4. Occurrence aircraft altitude profile for the last 10 min of the flight

The flight was conducted under visual flight rules and in daylight visual meteorological conditions. The aircraft was equipped with a GPS. Data from this GPS were recovered and are presented in Figure 4.

The GPS (global positioning system) data shows that when the aircraft's performance started degrading, the aircraft started a shallow descent (about 19:1 glide ratio) that lasted for almost 2 min, consistent with partial engine power. This was followed by a steeper descent (about 8:1 glide ratio) that lasted for over 3 min, consistent with a complete engine power loss. The ice that likely formed in the carburetor would have initially reduced the engine's ability to produce enough power to maintain altitude and eventually led to a complete loss of power.

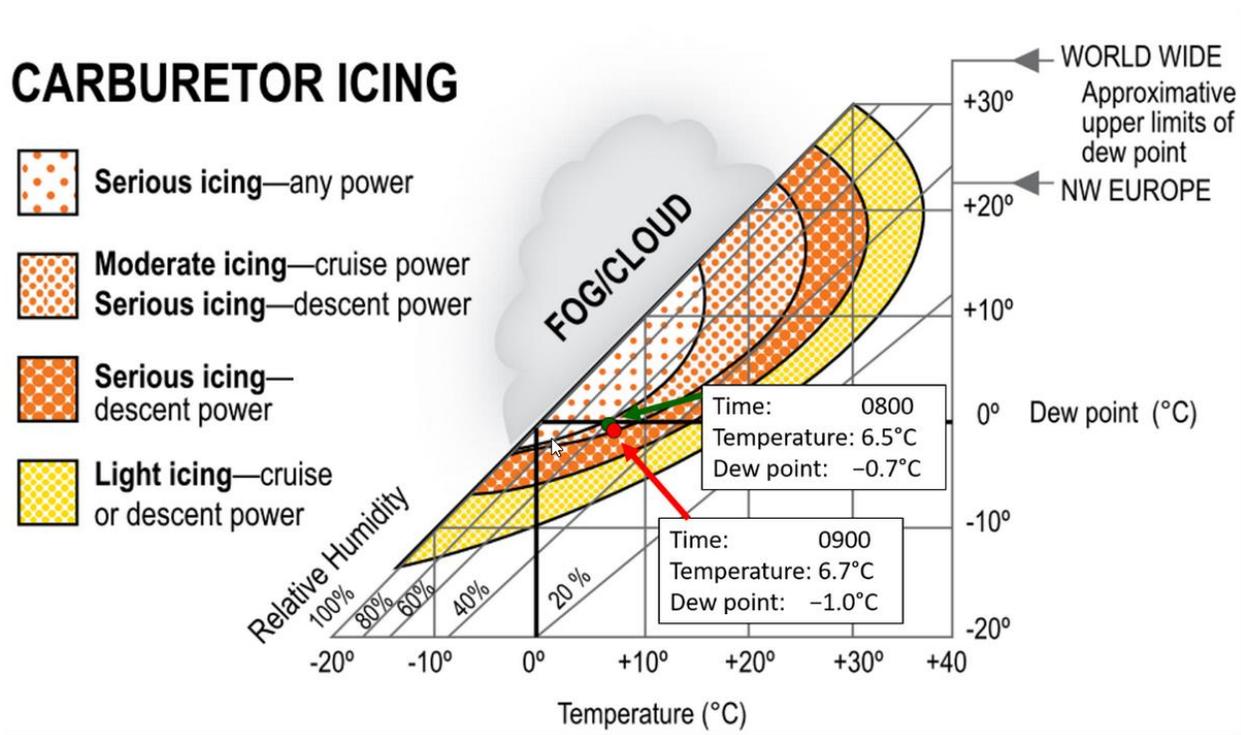
Figure 5. Carburetor icing potential based on ground-level weather conditions at Nilkitkwa, BC (Source: Transport Canada, TP 14371, Transport Canada Aeronautical Information Manual [TC AIM], AIR – Airmanship [10 October 2019], subpart 2.3, with TSB annotations)

Use of partial power increases the likelihood of ice buildup on the throttle valve and decreases the exhaust system heat available for the anti-ice system. Use of richer mixtures increases the cooling effect of fuel vaporization. As ice forms, this increases the Venturi cooling effect due to narrowing of the carburetor throat and this narrowing reduces power output. If significant ice is allowed to develop within the carburetor and full heat is applied to melt it, the resultant water flow through the engine causes the engine to run rough and to lose further power and may even cause the engine to quit. Unchecked, the ice can quickly lead to a complete engine failure. To overcome carburetor icing, aircraft manufacturers provide a system to heat the incoming air and prevent ice accumulation. To help determine whether atmospheric conditions are likely to produce carburetor ice, charts that compare outside temperature and dew point have been produced (Figure 5).

The chart indicates that, based on the temperature and dew point at the weather station 14 NM from the accident site at the time of the occurrence, the conditions were conducive to serious carburetor icing even at cruise power. Although the dew point at the aircraft’s location is not known, nearby rain showers indicate humidity at least as high as that at the weather station. When a dew point is not precisely known, the presence of precipitation should

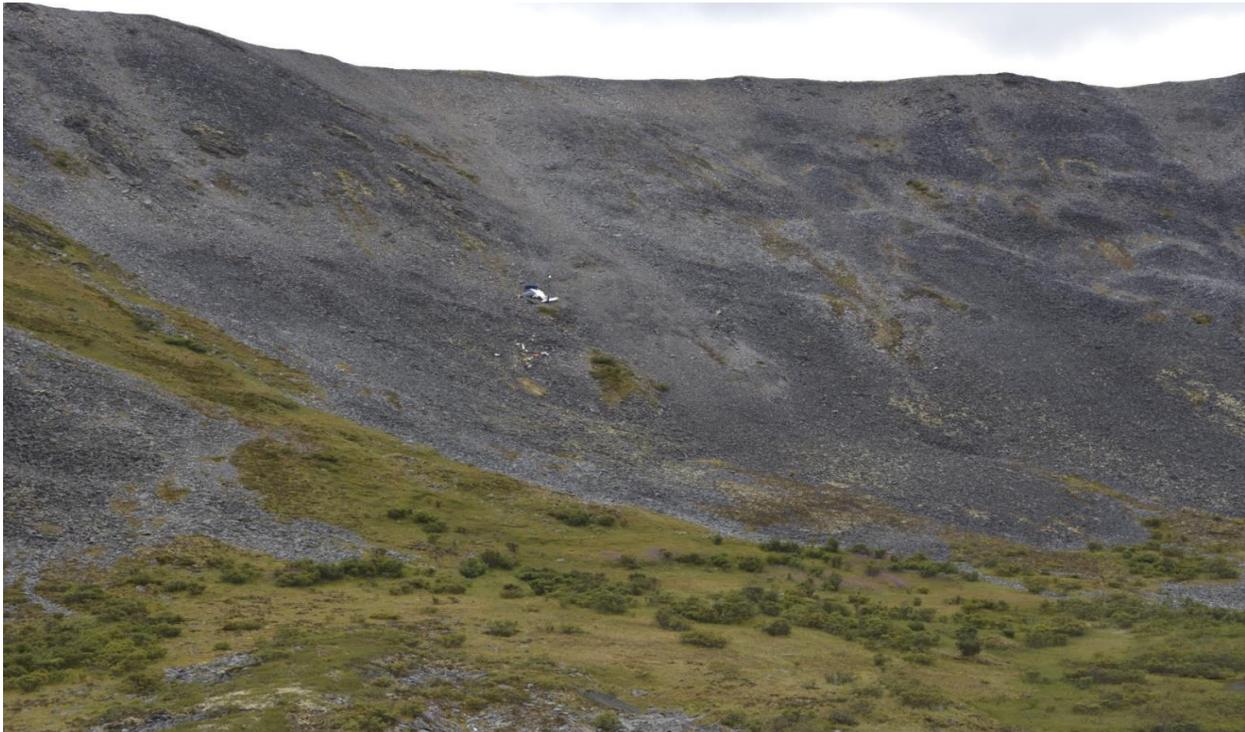
Both wings partially detached from the fuselage and the left elevator separated from the horizontal stabilizer. The engine separated from the firewall and all four propeller blades were broken free from the propeller hub. There were signs of a small post-impact fire on the outboard portion of the left wing.

Figure 5. Aircraft wreckage, looking south (Source: TSB)

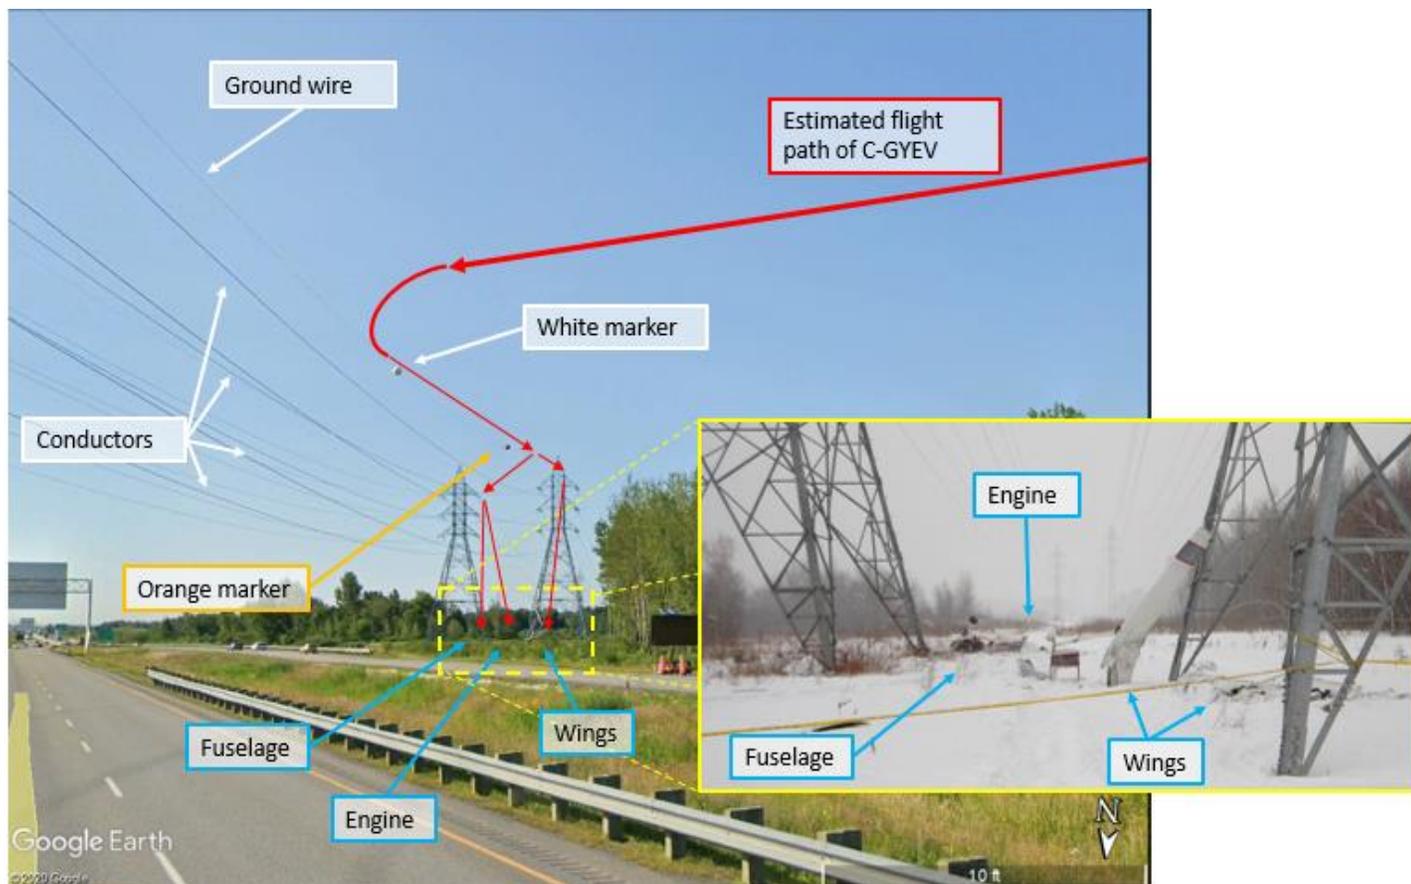
Figure 3. Estimated path of the occurrence aircraft and inset picture of the crash site
(Source of main image: Google Earth, with TSB annotations. Source of inset image: TSB)
