ISSUE 2/2022

AVIATION **S**AFETY **L**ETTER

TP 185E

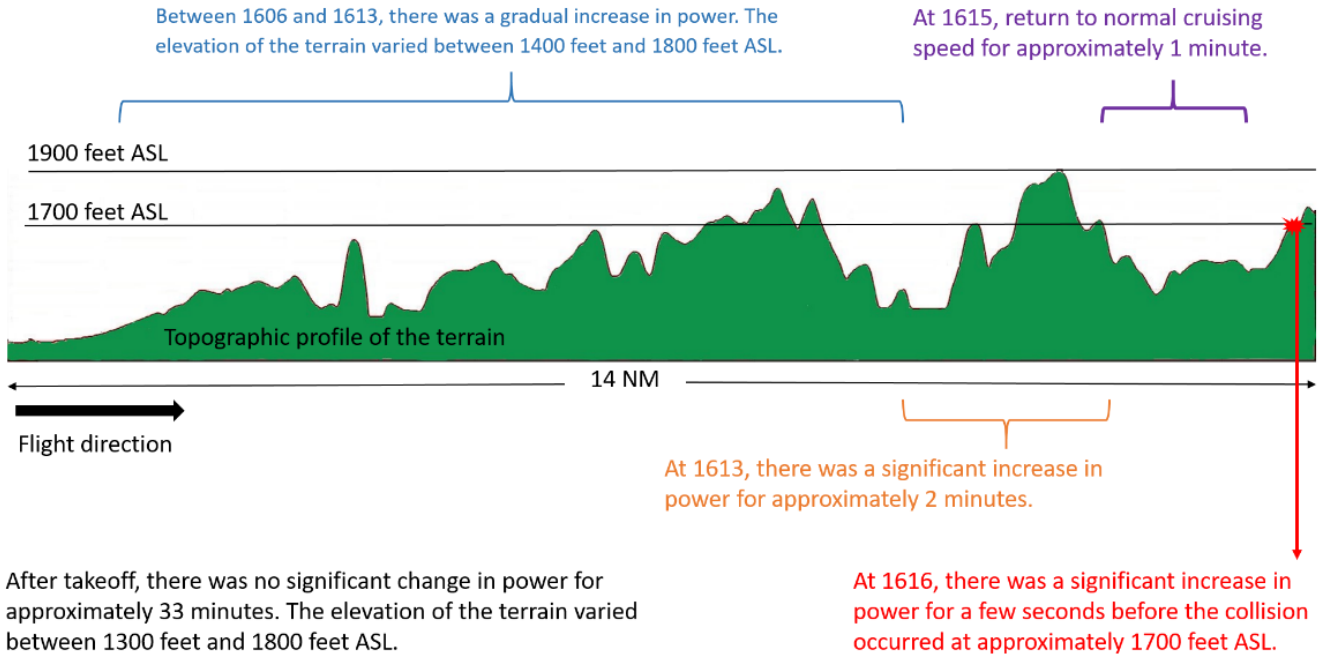
Figure 2. Correlation between the topographic profile of the terrain and power parameters (Source: TSB)

Using the aircraft’s estimated straight path and comparing the data from the engine data recording and monitoring system, the estimated ground speeds, and the topography, a correlation was found between the use of the power lever and the topography of the terrain (Figure 2). It was also found that the aircraft’s altitude in relation to the terrain lessened as the flight progressed.

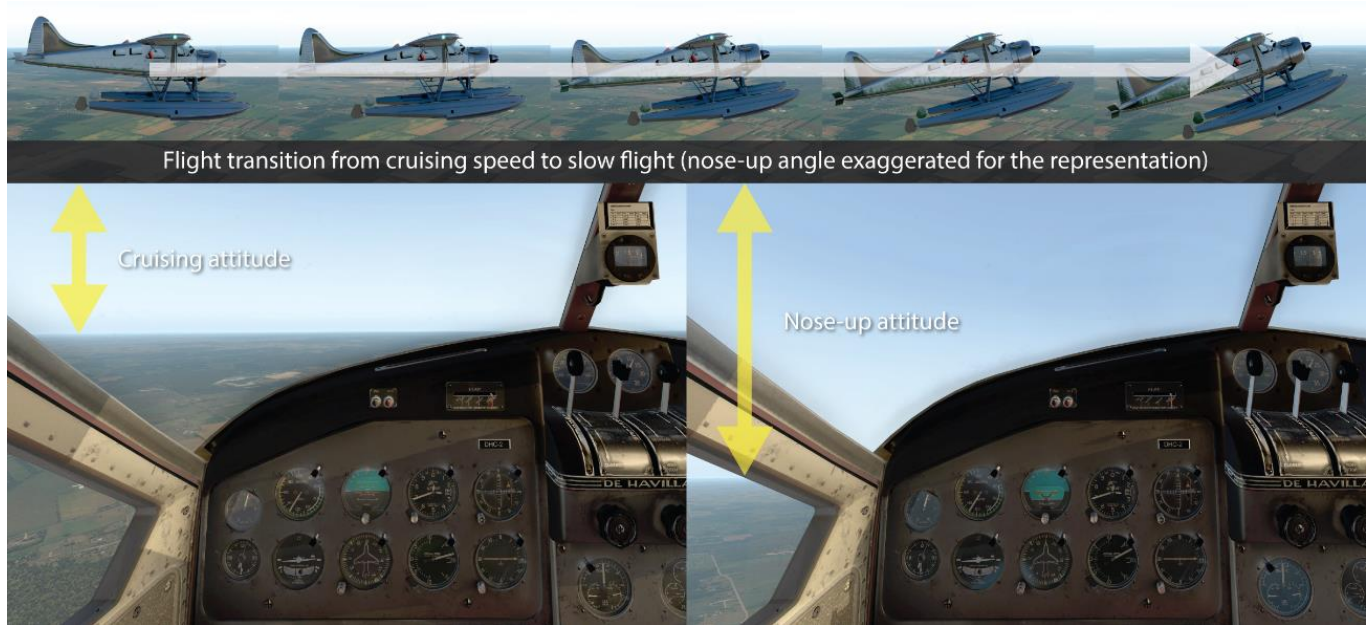
Figure 3. Visual references of the attitude from the cockpit (Source: TSB)

In slow flight, the aircraft is more nose-up than it is at cruising speed. The nose-up position changes the position of the horizon visible from the cockpit as well as the earth's surface that is visible (Figure 3). The horizon and the earth's surface are therefore the main visual cues used by a pilot to determine the aircraft's attitude. If a pilot sees the horizon move to the lower part of the windshield and the earth's surface that is visible diminish above the instrument panel, the pilot can recognize the aircraft's nose-up position.

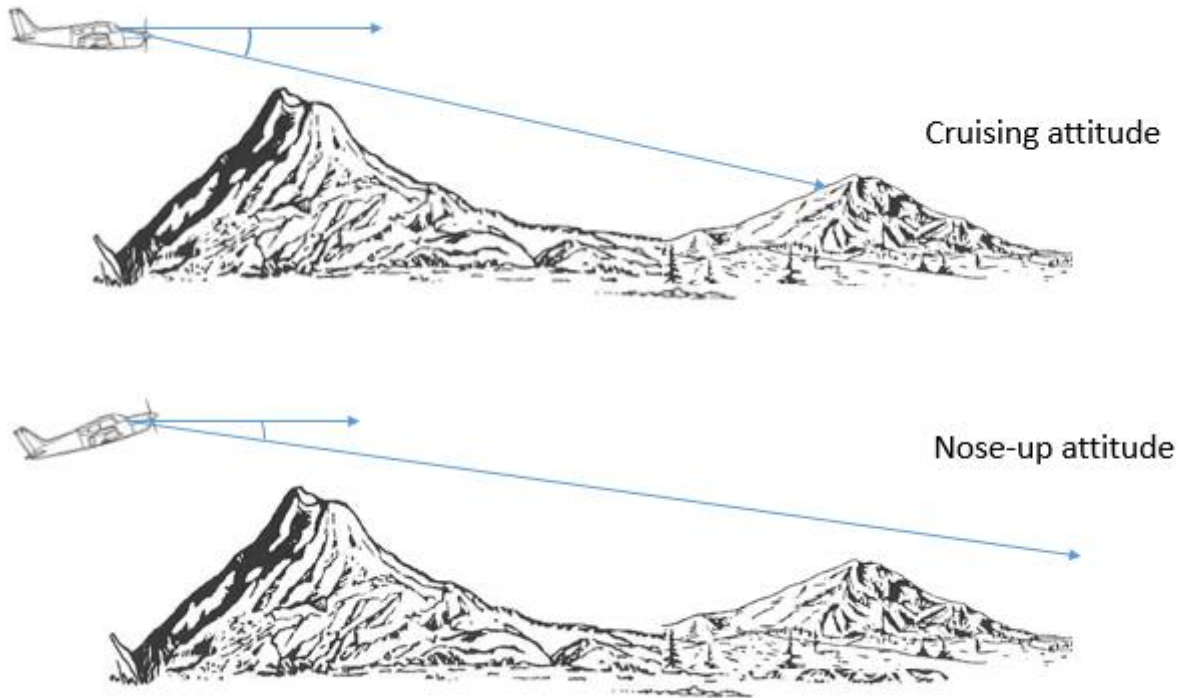
Figure 4. Pilot's viewing angle depending on the flight attitude (Source: TSB, using figures in Transport Canada's Air Command Weather Manual [TP 9352E] and Flight Training Manual [TP 1102E])

In slow flight, the pilot's front viewing angle is reduced (Figure 4). Also, when the aircraft has a high instrument panel, as is the case in the DHC-2, the reference line for the actual horizon and the terrain may be completely hidden by the instrument panel. Hence, the visual cues needed to detect obstacles straight ahead are greatly reduced, which hinders the pilot's ability to maintain a safe altitude when flying at low altitude, and even more so when visibility is reduced.

In this occurrence, the fact that there was a sudden increase in power a few seconds before the collision with the trees, while the aircraft was possibly descending toward a rising terrain, suggests that the pilot saw the trees too late. The reduced speed, excess weight and proximity of the trees prevented the aircraft from regaining sufficient altitude to avoid the impact.

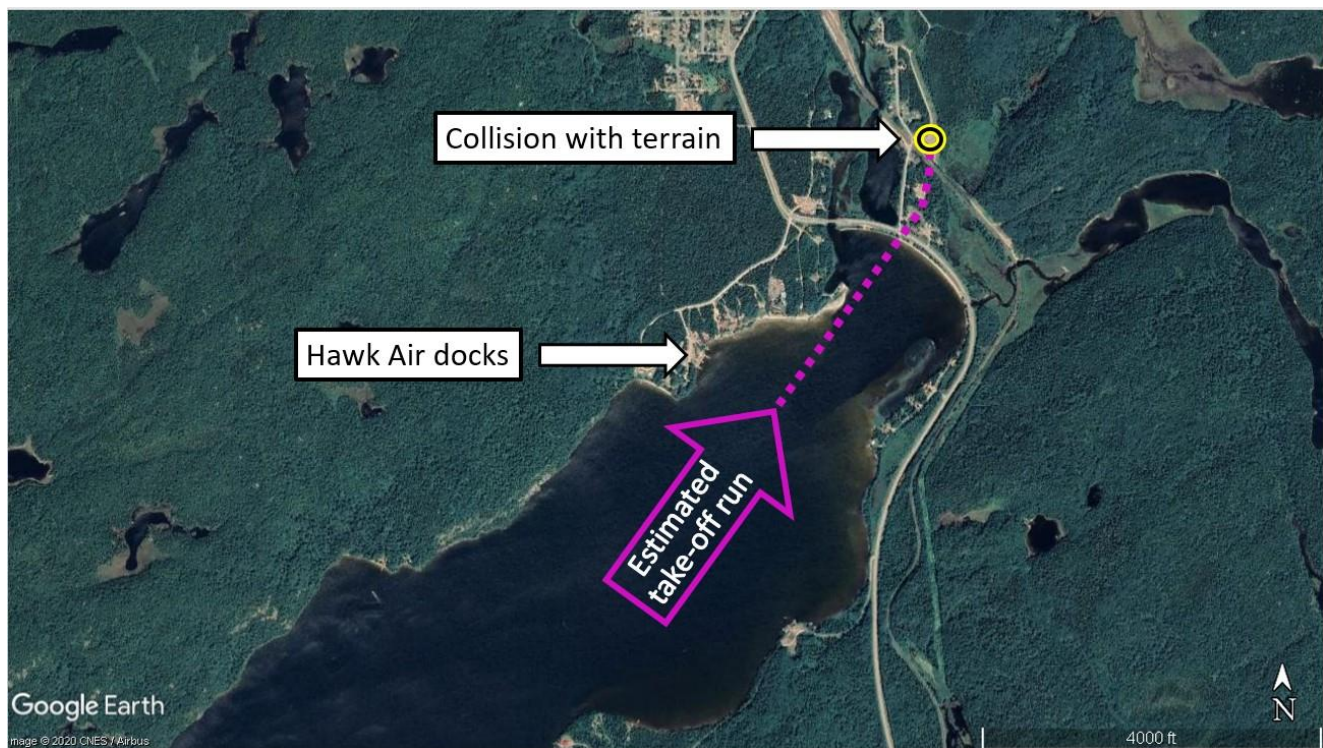
Figure 1. View of occurrence site, with dashed magenta line showing estimated flight path
(Source: Google Earth, with TSB annotations)

At approximately 0852, the aircraft began its take-off run. It became airborne approximately abeam the dock (Figure 1) and climbed to an estimated height of 300 to 400 ft above ground level (AGL). The aircraft was observed to be climbing normally before entering a sudden left bank and an extreme nose-down attitude.

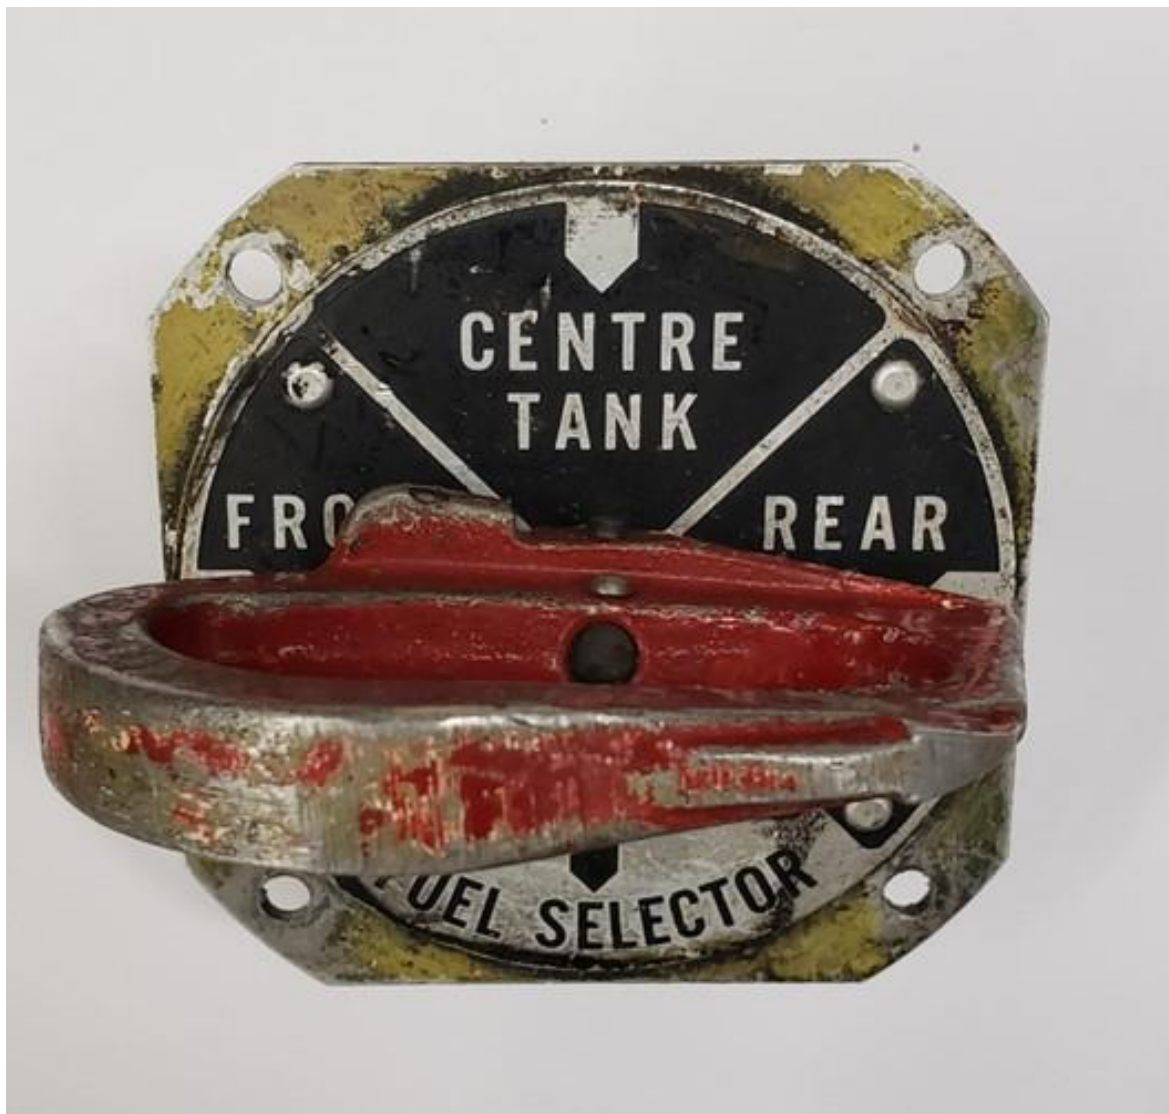
Figure 2. Fuel selector from the occurrence aircraft, with the rear tank selected (Source: TSB)

The fuel selector was found to be set to the REAR TANK position at the occurrence site, as shown in Figure 2. The cable-actuated selector valve was also found to be positioned for the rear fuel tank to be the fuel source.

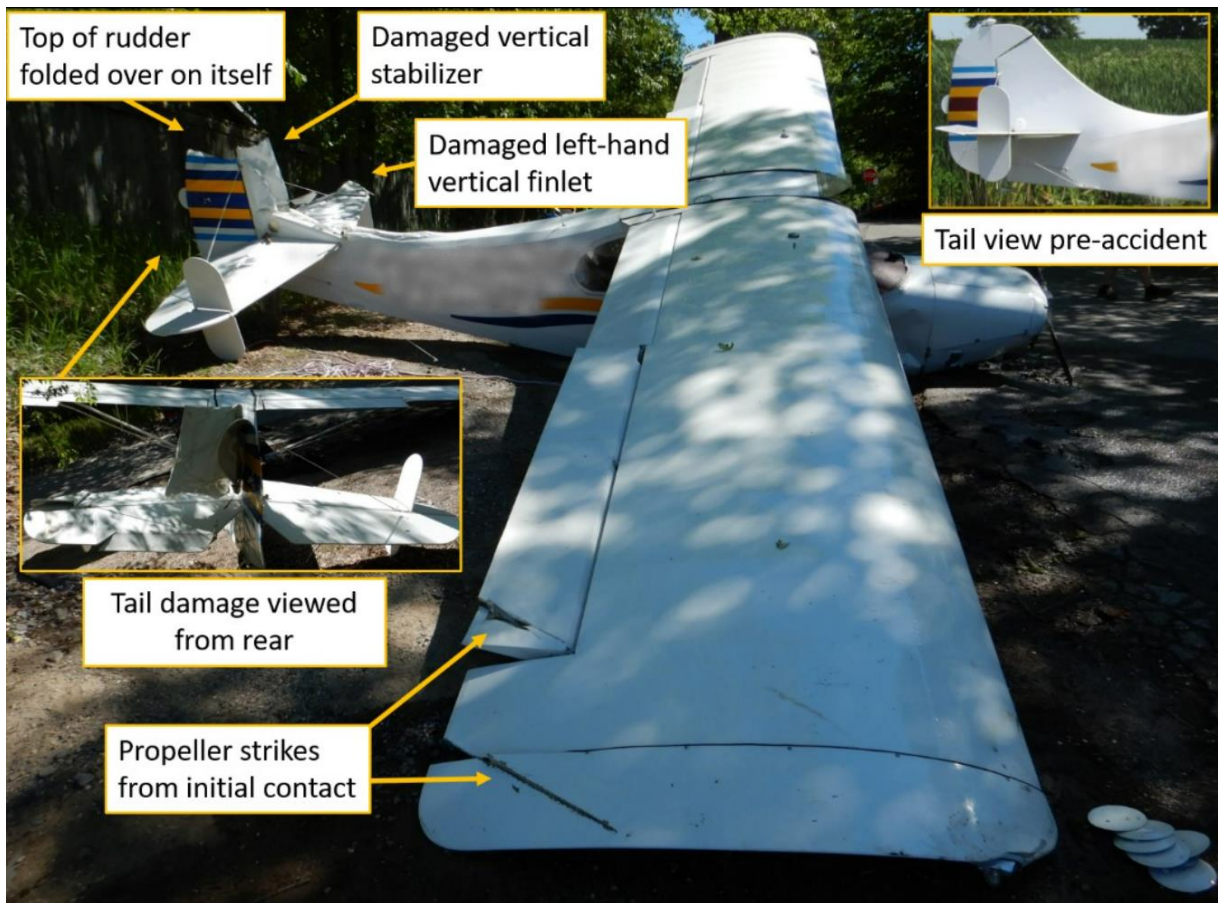
Figure 2. Damage to the Champion (Source of main image and tail damage inset image: TSB. Source of tail view pre-accident inset image: third party, with permission)

During the collision sequence, the Champion sustained two propeller strikes on the top of the right wing: one close to the wing tip, along the trailing edge of the wing, and the other on the right aileron. The tail was extensively damaged in the collision (Figure 2). The damage caused the pilot to lose the ability to control the aircraft using the ailerons, horizontal stabilizer, or the rudder. He was, however, able to control the pitch of the aircraft using engine power. Increasing the engine power would pitch the nose of the aircraft up, while decreasing it would pitch the nose down.

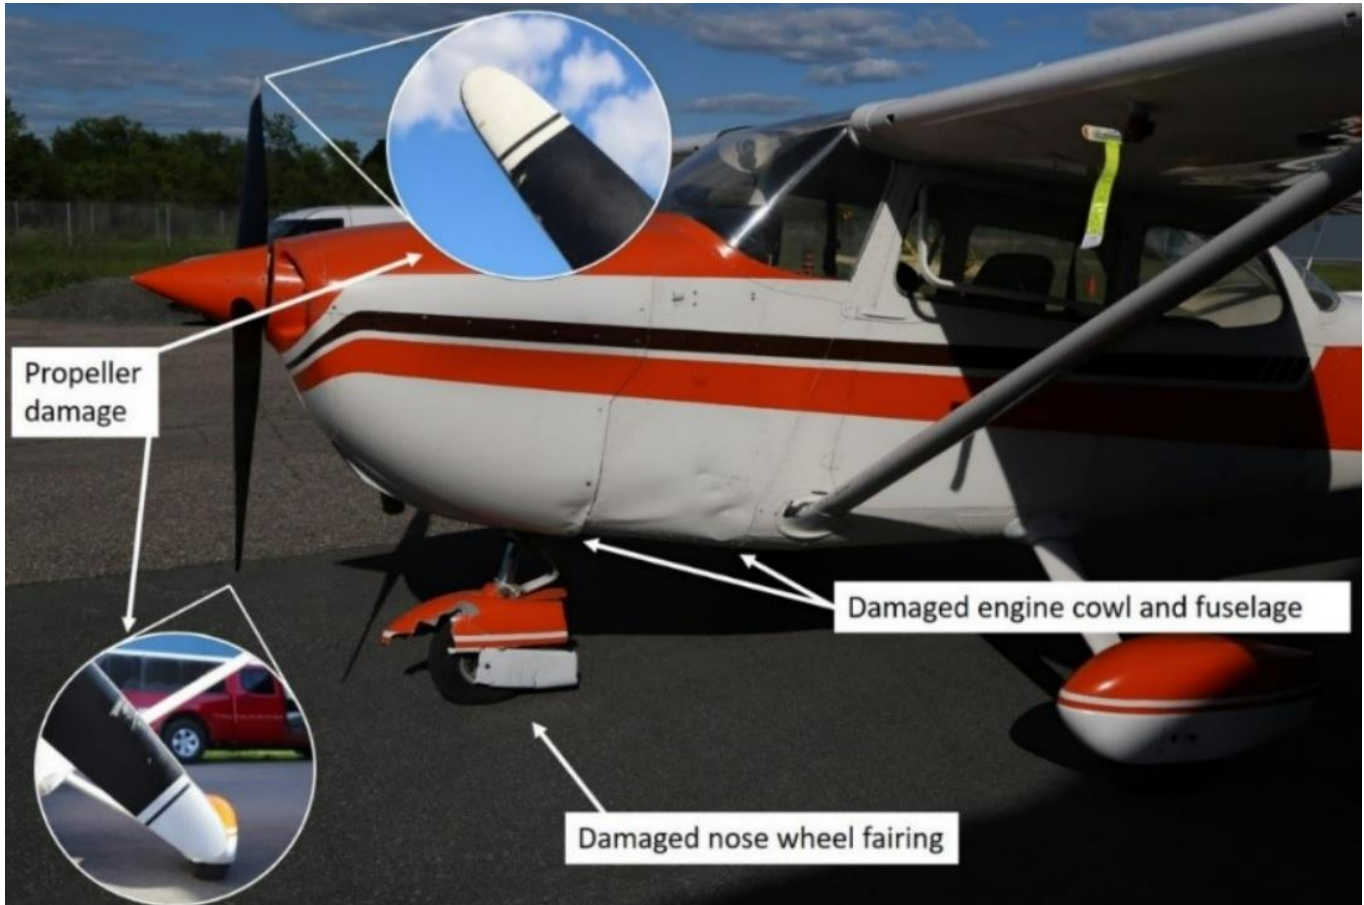
Figure 3. Damage to the Cessna (Source: Ottawa Police Service, with TSB annotations)

The damage to the Cessna consisted of some scraping and paint marks on both propeller blades, a damaged front wheel fairing, and some damage to the left-hand engine cowl and lower left-hand portion of the fuselage immediately aft of the firewall (Figure 3). The damage did not lead to any control issues for the pilot.
