Issue 4/2011

# Feedback

Canadian Aviation Service Difficulty Reports

TP 6980E  
(12/2011)

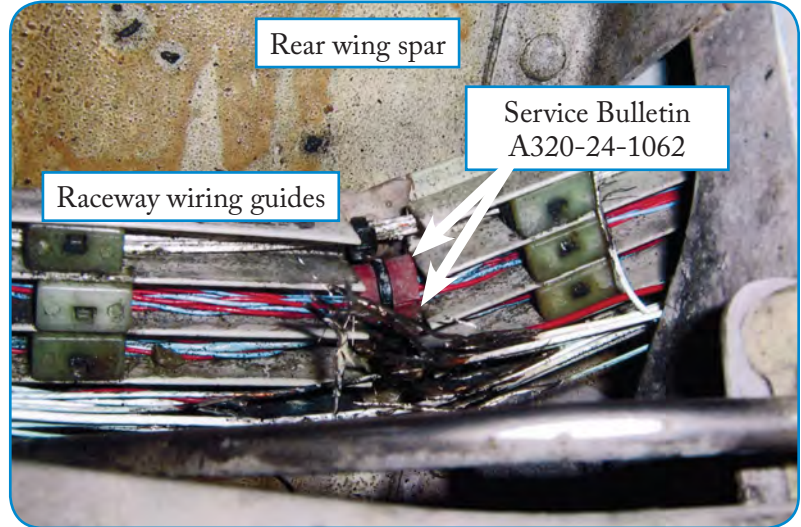
The aeroplane arrived with a no-go snag for a left wing tip brake solenoid fault. While maintenance was troubleshooting this defect, it was discovered that several wires were chaffed and burnt on the left wing aft spar raceway just outboard of the #1 engine pylon area.

Other systems affected due to the wiring fault included the #1 engine low pressure fuel valve and the left-hand nav/strobe light.

The wiring was repaired and the aeroplane was made serviceable.

*European Aviation Safety Agency (EASA) Airworthiness Directive (AD) 2008-0051R1 mandated the incorporation of Airbus Service Bulletin (SB) A320-24-1062 which installed insulation for the "S" or inner harness runs.*

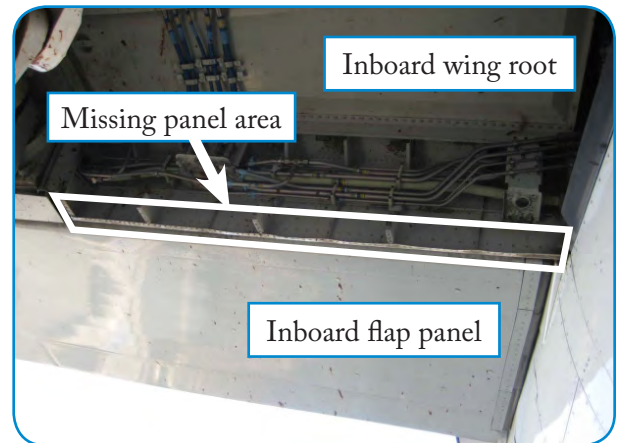
During a maintenance walk-around, it was discovered that a riveted panel, forward of inboard flap on right wing, was missing.

The aeroplane was repaired as per the Structural Repair Manual (SRM). A new wing panel was installed and the aeroplane was made serviceable.

*European Aviation Safety Agency Airworthiness Directive 2006-0107 was issued which mandated the one-time inspection of the supporting fasteners and surrounding structure of this discrepant wing panel. Following this and due to the occurrence of more events of this nature, European Aviation Safety Agency Airworthiness Directive 2008-0002 was issued mandating the incorporation of Service Bulletin A330-57-3100, which replaces the existing blind rivets with bolted fasteners.*

*Transport Canada Civil Aviation (TCCA) would like to advise all A330-200/300 and also applicable 340-300 operators of this possible scenario and available documentation. The accomplishment of the latest Service Bulletin is recommended to be done at the soonest possible opportunity. ✖*

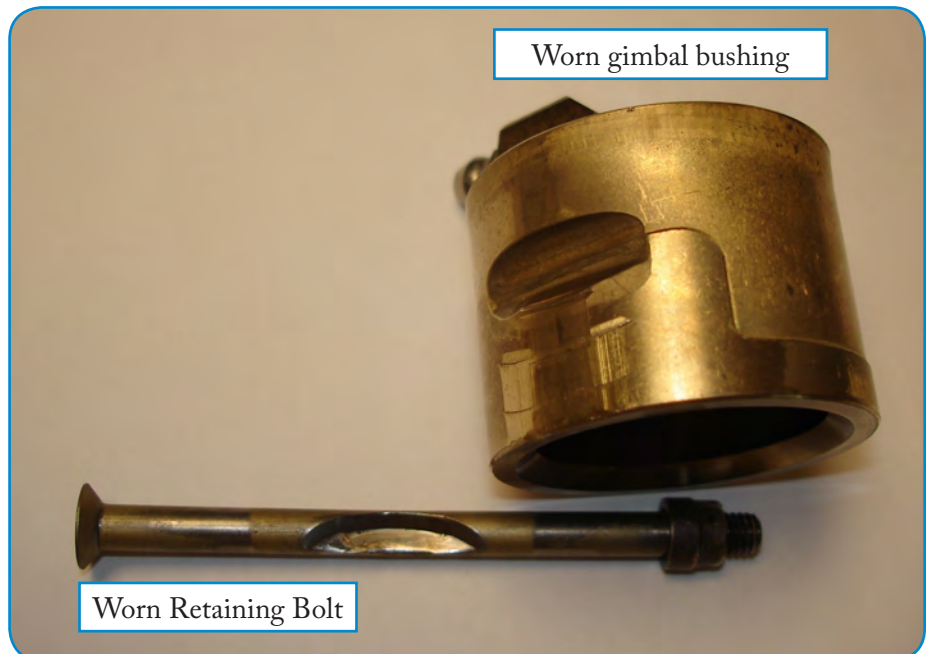
During a scheduled performance of Boeing task cards 27-144-00-01/02 to lubricate the left and right inboard flap outboard ballscrew and gimbals, it was found that the lower gimbal bushing assembly on both the left and the right inboard flaps had migrated out from their respective gimbal seats.

The results of these migrated bushings were excessively worn attachment bolts, which are used to retain the bushings within the gimbal.

The photo to the right shows the abnormal wear of a retaining bolt and gimbal bushing. Both gimbal bushing assemblies and retaining bolts were replaced and the aeroplane was released back to service.

*Boeing Fleet Team Digest (FTD) 737NG-FTD-27-03006 defines in detail this possible scenario which is rooted to the application of excessive high grease-gun pressures that can apply undue pressure on the gimbal bushing, forcing it to migrate out and wear into its retaining bolt.*

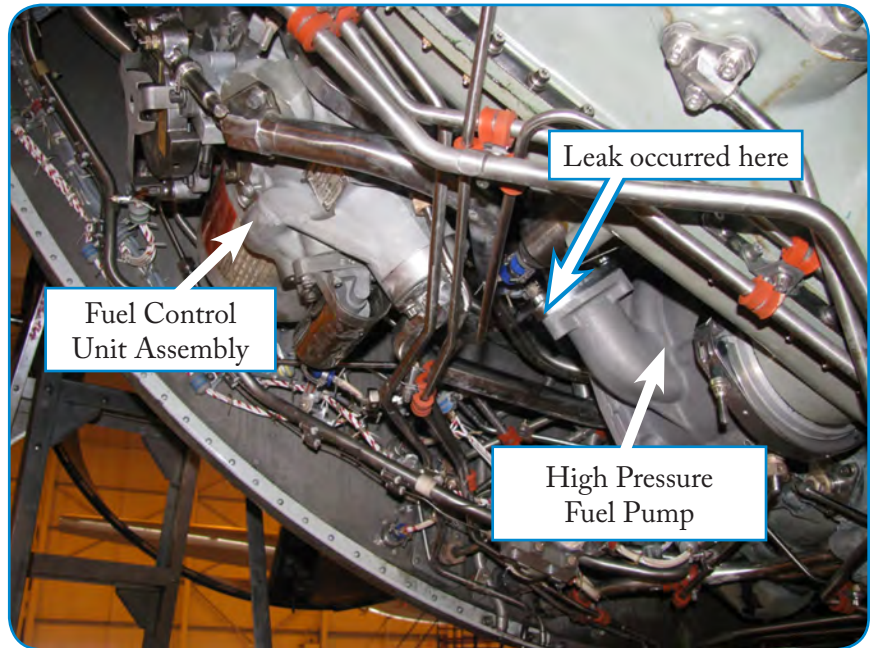
During cruise, the aeroplane experienced a large fuel imbalance due to a fuel leak at the right hand engine. The aeroplane declared an emergency and diverted where upon arrival the right hand tank fuel quantity was 1500 kilogram (kg) less than the left hand tank.

Maintenance personnel found an o-ring that was leaking at the right engine high-pressure fuel pump feed line. The o-ring was replaced and the aeroplane was returned to service.

Six flight legs previous to this event, the right engine high-pressure fuel pump had been replaced where new o-rings were used and leak checks carried out.

*The reason behind the failure of the o-ring has not been determined but is suspected that possible damage or improper installation of the new o-ring was incurred during the pumps replacement.*

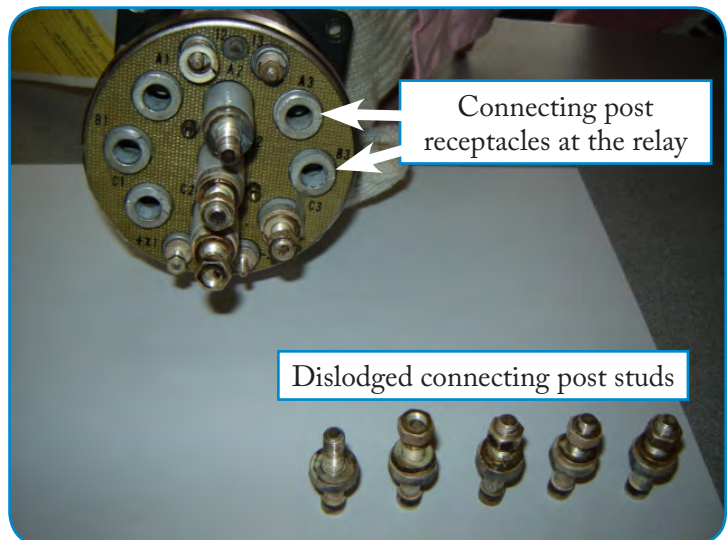
During flight, several system failure messages were posted where maintenance troubleshot the fault to a failing relay.

It was noted that several of the connecting post studs were loose within the relay body receptacles, breaking the posts electrical continuity capability.

The relay was replaced and the aeroplane was made serviceable.

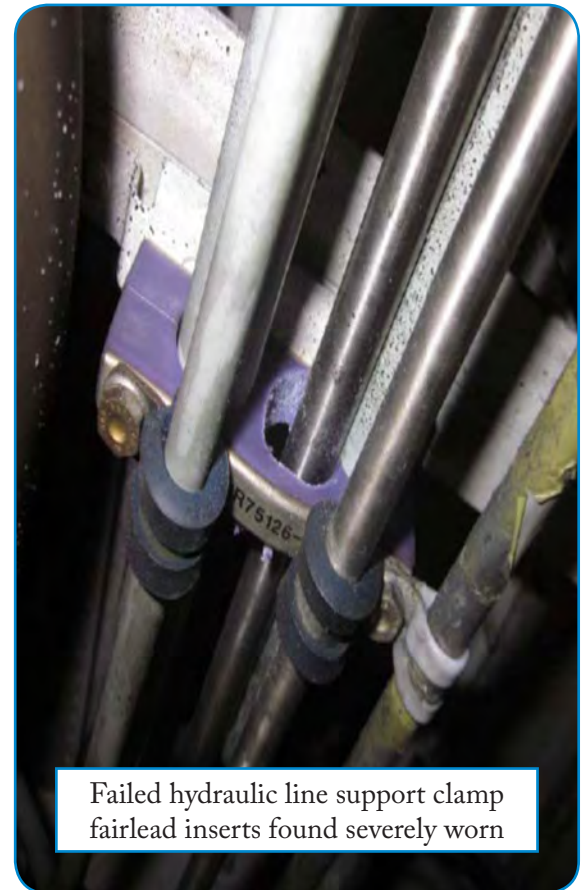
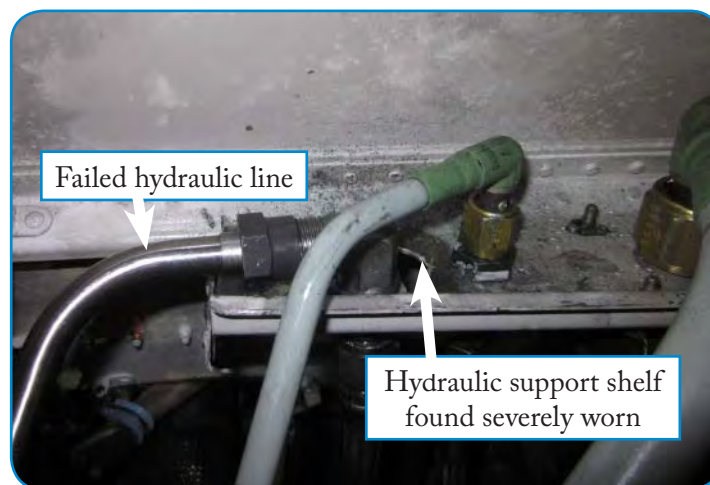
Upon maintenance investigation, it was found that the #1 hydraulic pressure line in the aft equipment bay was chaffed through, causing the complete loss of the fluid. The chaffing was a result of the hydraulic line jam-nuts at the top of the hydraulic support shelf coming loose, allowing significant movement and vibration.

The hydraulic support shelf was severely worn along with several support bracket fairleads downstream the line.

*This scenario demonstrates that the worn fairlead inserts were an indicator of a more significant failure else-where in the system.*

The hydraulic support shelf was repaired, the hydraulic line and fairlead inserts for the support brackets were replaced and the aircraft was made serviceable.

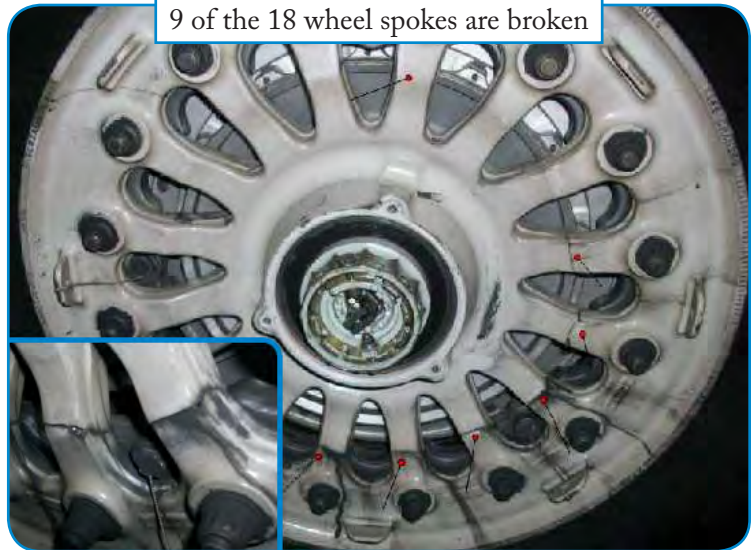
During a standard service check it was found that several rim spokes of the main landing gear wheel number 2 (left-hand inboard) were found cracked.

The wheel assembly was replaced as per the aircraft maintenance manual and the aeroplane was made serviceable.

*The close visual inspection of all wheel assembly landing gear items is an essential task to accomplish for all pre-departure walk-around and service checks. ✖*

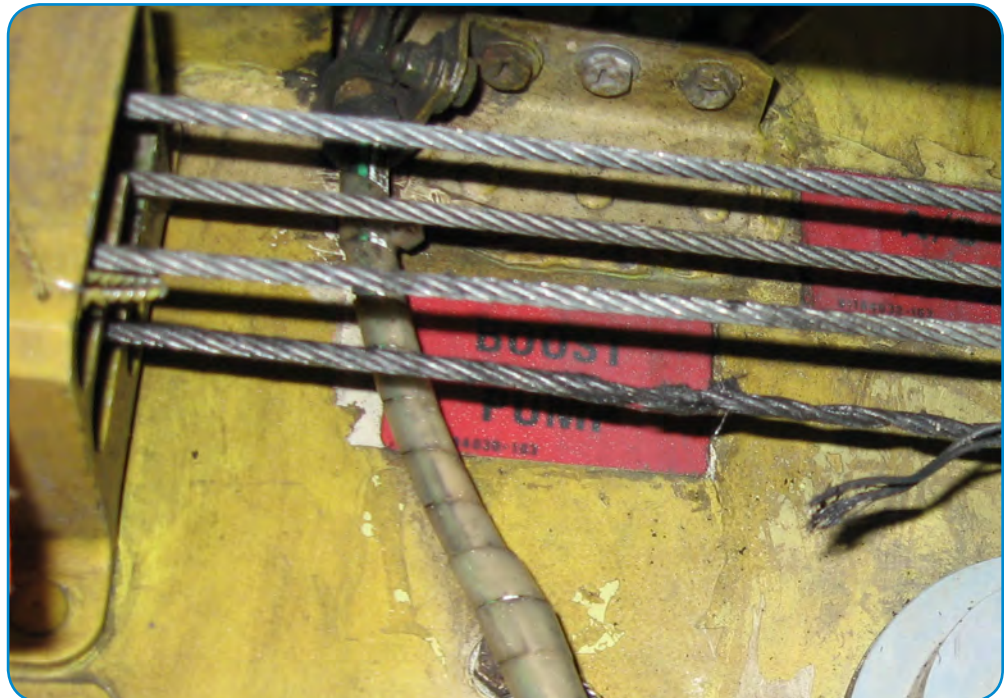
During inspection, the right-hand aileron cable was found to be significantly frayed and beginning to unravel. The area of the failing cable (Wing Station (WS) 181) is located in a cable block on the aft spar where aluminum guide rollers part number FL4C6-2. This particular area of the cable is almost impossible to see when the gust lock is engaged and/or the aileron is in a neutral position because of the cable block.

*The SDR database reveals several previous reports of this nature in this general area.*

*A reminder for personnel that during flight control cable inspection that the entire cable run must be inspected to detect these types of failures. ✖*

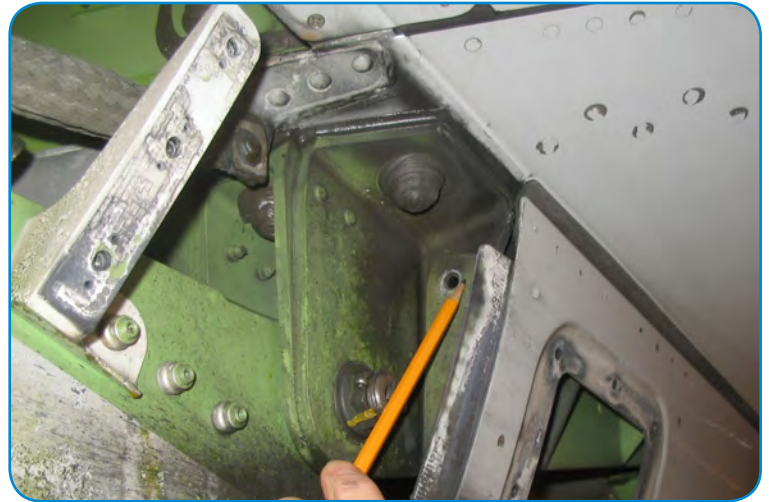
During a heavy maintenance “N1” check visit on the aeroplane, a left-hand pylon inspection found that the aft lower fixed fairing assembly was missing several items of attaching hardware. Within the pylon fixed fairing, both forward quick release pins had fallen out, as had one of four mid-point attach bolts. The missing hardware was found in the bottom of the fairing. The right-hand pylon was found to have the two forward quick release pins and three of four mid-point bolts also missing. The pins and two of the three missing bolts were found inside the fairing. In both cases, the four aft mounting bolts were found installed and properly torqued.

*This operator obtained the required engineering Original Equipment Manufacturer (OEM) and company approval to install a single dash length longer attaching bolt and reinstalled new quick release “pip” pins.*

*Transport Canada Civil Aviation (TCCA) would like to advise all Embraer 170 operators of this Service Newsletter (SNL) and its intent to replace the discrepant hardware to increase its bolt length, final torque and to introduce a new countersunk washer. ✖*

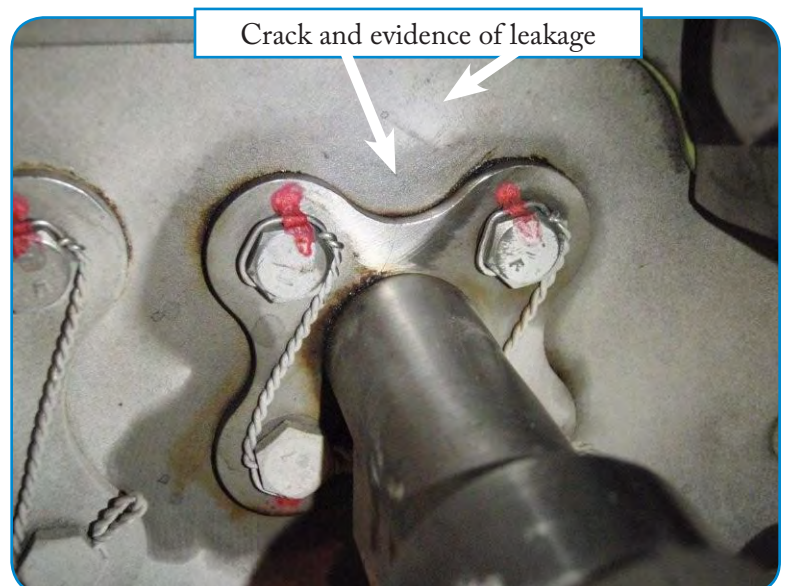
During a heavy maintenance “C-check” visit, maintenance found the #1 & #2 pylon engine driven hydraulic pump pressure line T-fittings cracked and with evidence of hydraulic fluid leakage.

Both pressure line T-fittings were replaced to correct the fault.

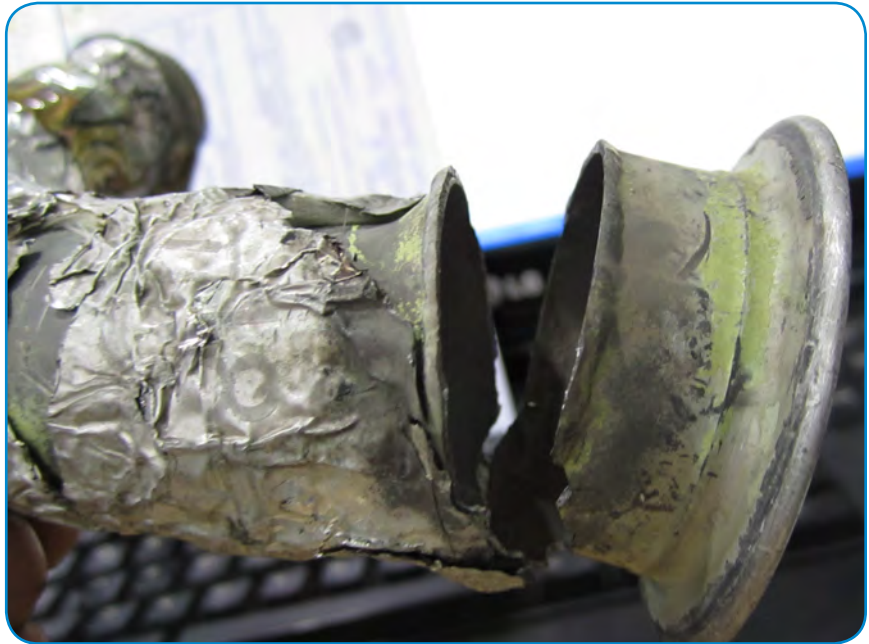
The pressurization was snagged as inoperative by the flight crew. During maintenance trouble-shooting it was noted that the engine bleed pressure would fluctuate uncontrollably and when turned to “high” only function for approximately 30 seconds. Then the eyeball vents would drop off with almost no air-flow output available.

During subsequent inspection of the right-hand wing bleed air duct plumbing, maintenance found the tube assembly from the right-hand modulating valve to right-hand cooling turbine cracked in half. The tube was replaced, ground run accomplished and the aircraft returned to service.

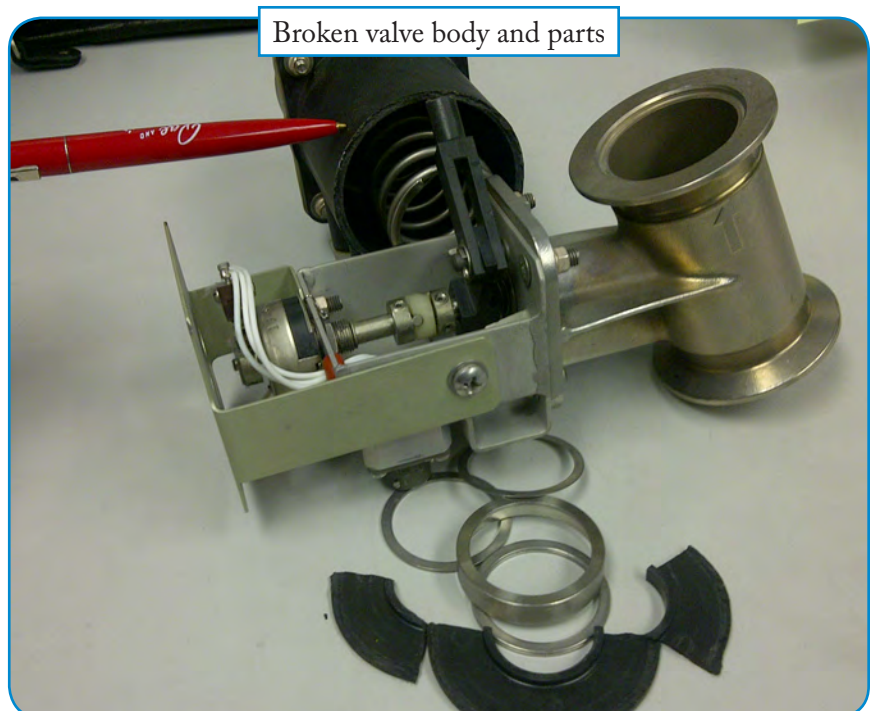
During cruise, the cabin temperature was uncontrollable, leaving the cabin in a very warm and uncomfortable condition.

Upon maintenance investigation, the cabin temperature control valve plunger body was found cracked off, shearing the plastic link arm which opens and closes the butterfly valve and rendering it uncontrollable.

The valve was replaced and the aircraft made serviceable.

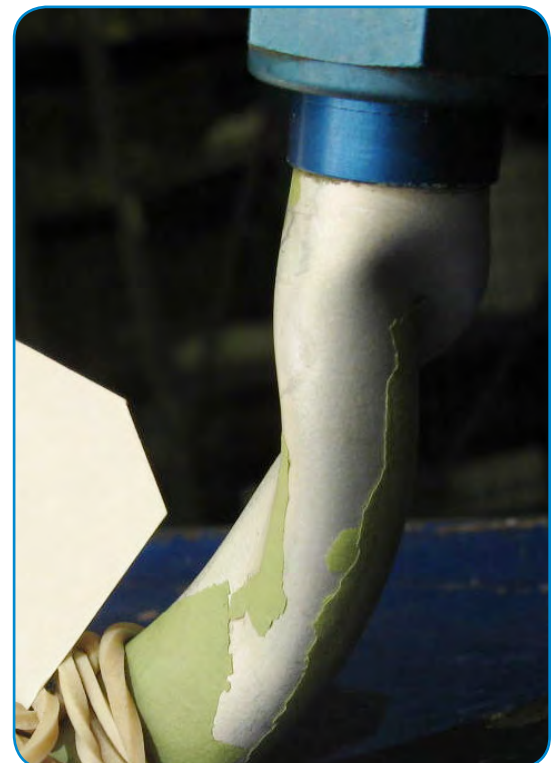
During a scheduled inspection on a SAAB 340A, maintenance found a fuel line twisted on the left-hand engine lower nacelle.

*Correct fuel line installation is essential to support the full range of engine operation.*

The line was removed, replaced and the aeroplane was made serviceable.

*When installing fuel lines of any type and in particular aluminum, proper aircraft maintenance manual torque values must be followed. ✖*

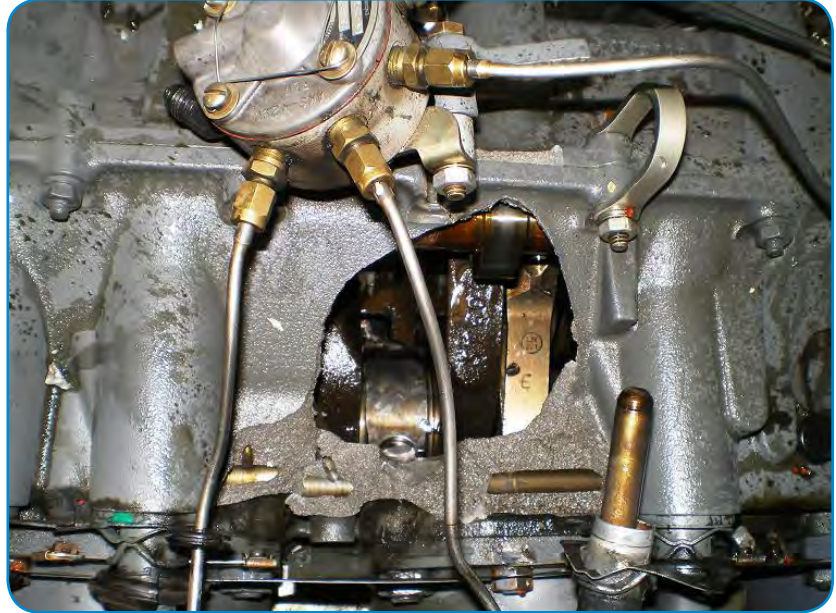
The pilot reported a loud bang and subsequent engine failure. The pilot auto-rotated to an open field with no damage to the airframe during the landing. The aeroplane was removed from the field and transported to a repair facility for further investigation. Aeroplane panels were removed and a large hole in the crankcase was observed near the #3 cylinder intake lifter bore. Large pieces of crankcase debris were found on top of the engine case above the #2 cylinder area. Lycoming was advised and a field service rep came to investigate the failure on location.

Initial indications were the #4 connecting rod failed just below the piston pin area and this caused the breach in the crankcase between the #3 & #4 cylinders.

*The cause of this connecting rod failure was the result of a missing wrist Pin Plug. Maintainers are reminded that all manufacturers' instructions must be followed. ✖*

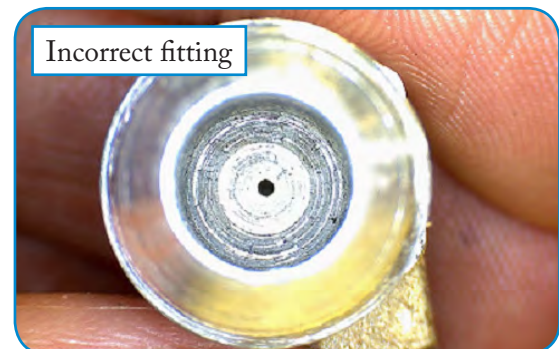
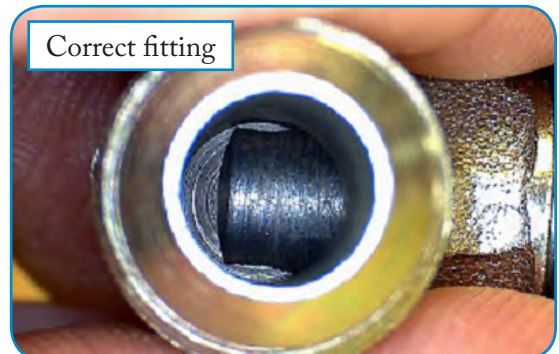
The engine was received fresh from the overhaul facility with the engine driven fuel pump and associated fittings assembled. Post install ground runs were unable to achieve take off power. After 2300 revolutions per minute (rpm) further power lever advancement resulted in loss of revolutions per minute (rpm) and increase in manifold pressure, indicating fuel starvation. Upon inspection it was found that the inlet fitting to the fuel pump was restricted (just a pin hole) either the part was not manufactured properly (not fully drilled through) or it is an incorrect part (a restrictor fitting). In either case it does not belong on the engine. The fitting was replaced with the correct part and engine runs completed.

*Inventory control is of utmost importance. When receiving parts from stock or from a supplier, it is important to inspect for defects and that the part ordered is the part received. ✖*

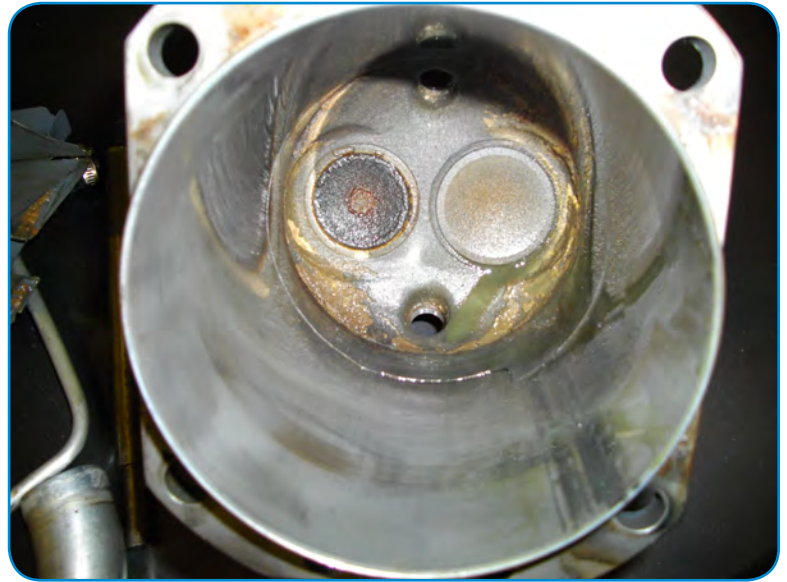
The engine experienced a sudden stoppage in flight. Aircraft was landed and the engine was removed and shipped for inspection. Upon disassembly, it was found that the #4 cylinder failed due to a crack that progressed from near the top of the barrel almost all the way around the circumference. This failure seized the engine. This cylinder appears to be a field overhauled unit and has been sent to Transport Safety Board (TSB) for inspection. The last engine logbook entry has 488.9 hours since overhaul. The engine was last overhauled June 19, 2009 and was installed October 23, 2009.

*It is likely that this crack was almost undetectable using visual inspection technique before the catastrophic failure. Field overhauls must be completed in accordance with the manufacturer's instruction and include any required Non-Destructive inspections carried out by an appropriately rated facility. ✖*

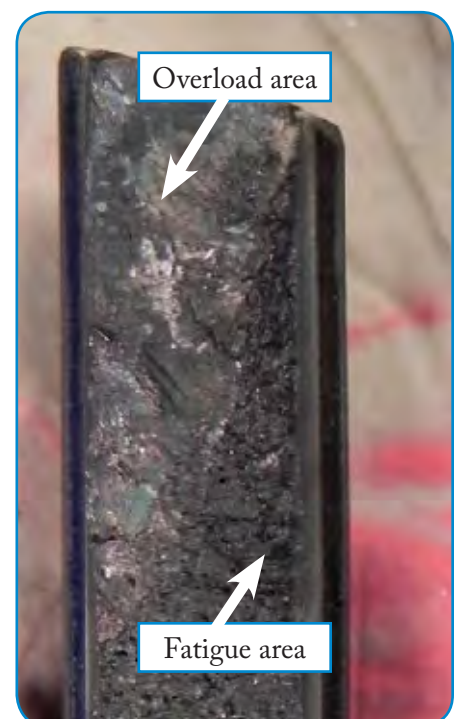
The engine was removed subsequent to a catastrophic failure during takeoff roll. The pilot reported, "engine failed on takeoff roll, audible noise, metal exiting exhaust duct, engine went to minimum flow and takeoff aborted".

During a dismantle investigation, the power section was found excessively damaged and it appeared that the failure occurred in the power turbine area. The 1st stage power turbine blades were found broken close to the platform areas. The fracture surface exhibited rough appearance with textures of brittle overloading fracture. The 2nd stage power turbine blades were found broken; the breakage varying from below shrouded the blade tip to above the blade platform.

Service Bulletin (SB) 14369 was released to address a premature failure issue and Service Bulletin (SB) 14003 provides relevant life limit recommendations for pre-service bulletin 14369 2nd stage power turbine blades. ✖
