Issue 1/2012

Canadian Aviation Service Difficulty Reports

TP 6980E
(3/2012)

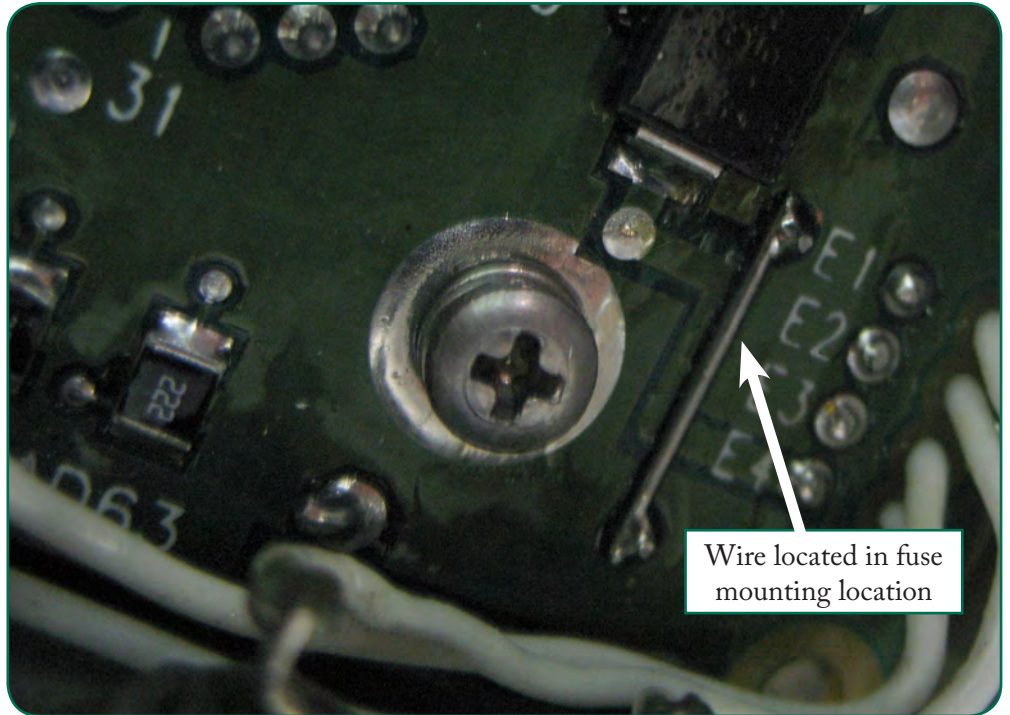
"We recently received a Multi-Function Control Display Unit (MCDU) (part number 100-601702-002) for repair from a European Operator. While conducting maintenance on the product, we noted that during a previous repair, a fuse (F1 on the 28 volt input line of the lightning protection circuit board) had been replaced with a solid wire.

The technician saw that the power supply fuse F1 was unserviceable. He tried with an ammeter to see if the power was ok. The power was correct, and he has installed the wire to continue with "comfort" the troubleshooting[sic]. When it was discovered that the repair could not be done at home, the MCDU was assembled but the "comfort" wire was forgotten. The wire was used only for troubleshooting purposes."

Wire located in fuse mounting location

Maintenance, overhaul and standard practice manuals give detailed instruction on trouble shooting and repair of the products they support. They also list approved tools for specific tasks. Deviation from them puts the maintainer in a dangerous area where simple mistakes could end up creating major problems. In the above example, a latent condition could have been created resulting in serious failure or fire. ✘

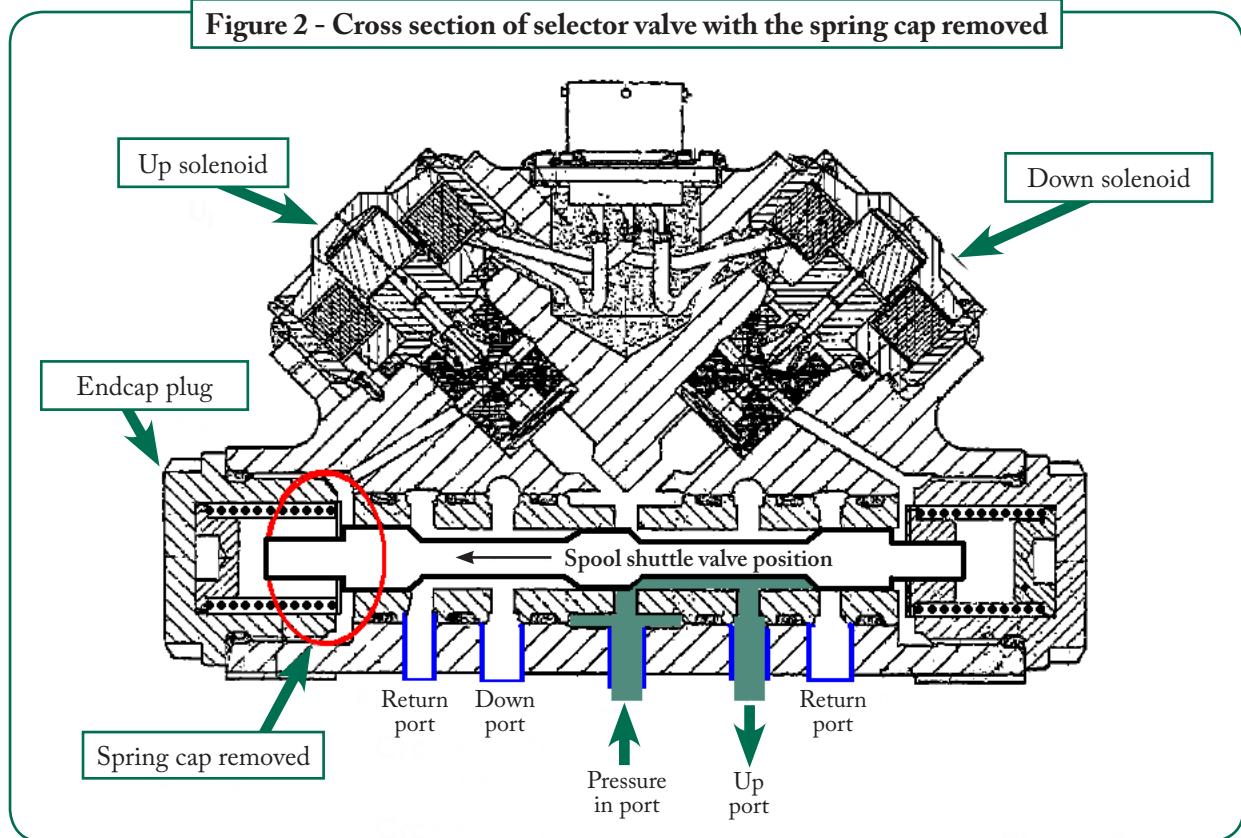
Figure 2 - Cross section of selector valve with the spring cap removed

- the unit failed an internal pressure drop test
- the unit used an unknown type of lockwire for the end-cap plugs
- the lockwire installation was "sloppy" with long pigtailed
- upon the valves disassembly, the spring cap for the spool shuttle valve of the "UP" solenoid side was found missing

It is believed that due to the missing spring cap, the spool shuttle valves last set position was such as to allow the inadvertent direction of hydraulic pressure to the “UP port” or retract side of the three gear retract actuators, portrayed in figure 2.

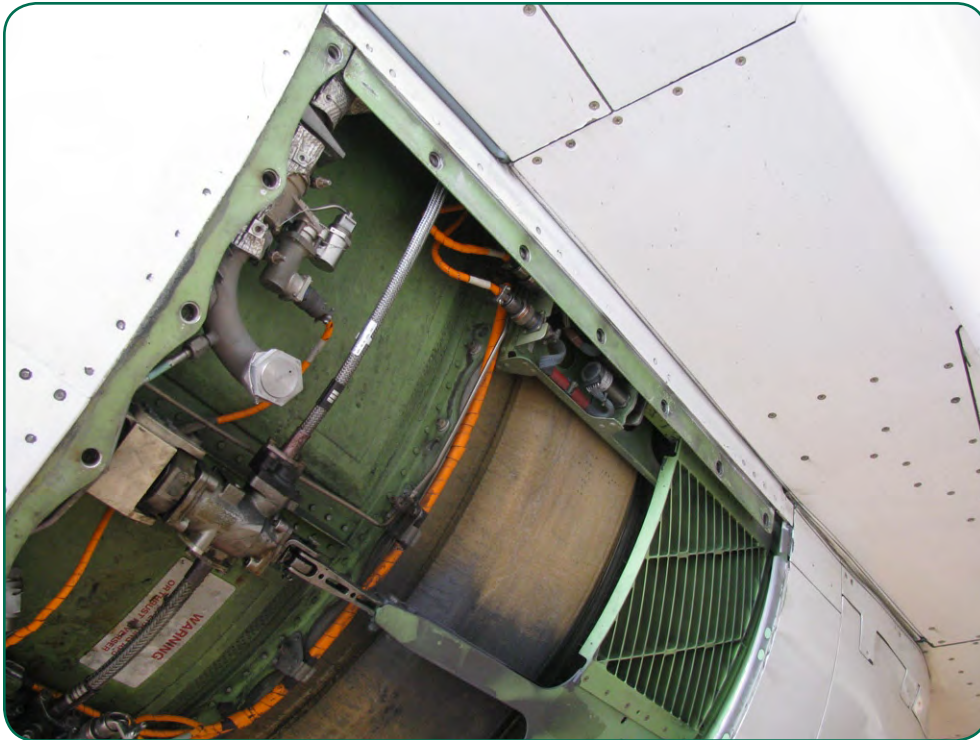
Upon landing, the right-hand engine lower fan cowl fell off the aeroplane and onto the runway. The aeroplane then taxied to the gate without incident. A maintenance investigation revealed that an 'A'-check had been accomplished the night before where the cowls were removed. This was the second landing of the day when the cowl departed the aeroplane. Inspection of the cowl and nacelle shows evidence that not all of the fasteners were secured, specifically, the inboard fasteners appeared to be unlocked. The damaged cowls were replaced and the aeroplane returned to service.

This is not the first instance of an engine fan cowl departing an aeroplane in flight. If certain fasteners are not properly secured, air loads in flight are sufficient to deform the cowl and overcome the remaining fasteners. The critical area appears to be in the forward inboard location. The issue seems to be the fastener design and location. As the spring in the fastener and cams in the receptacle wear, its locking ability is compromised. Even with an apparently full rotation, one can get the impression of a fully engaged device. Compounding this problem is the proximity of the fastener row to the pylon structure. As seen in the photograph, there is little room to get a straight push on the tool. A short screwdriver is required making it even more difficult to apply adequate torque and pressure.

Extra vigilance is required when installing these units. Special attention should be paid to fastener wear including the receptacles, cross pins and springs. ✖

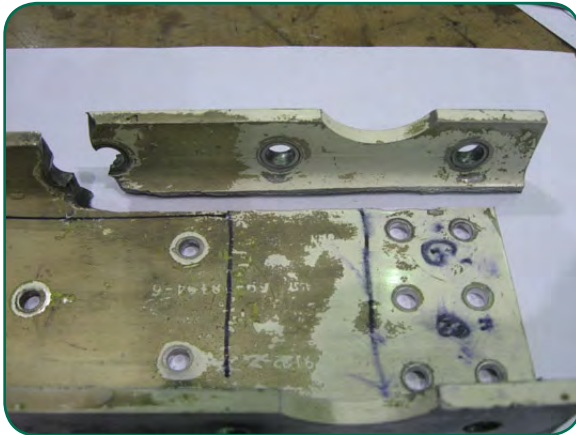
Maintenance was alerted and the aeroplane was towed back to the ramp. Hydraulic fluid was found coming from the belly drains aft of the Nose Landing Gear (NLG) bay. Further maintenance investigation found the NLG lock actuator leaking due to the lock actuator support bracket being cracked.

The bracket, actuator, hydraulic pump case drain filters and pressure filter were replaced, gear swing functional accomplished, leak checks and engine runs carried out and the aeroplane was made serviceable.

Transport Canada Civil Aviation would like to advise all Boeing 727 operators of possible NLG lock actuator support bracket fatigue cracks. ✖

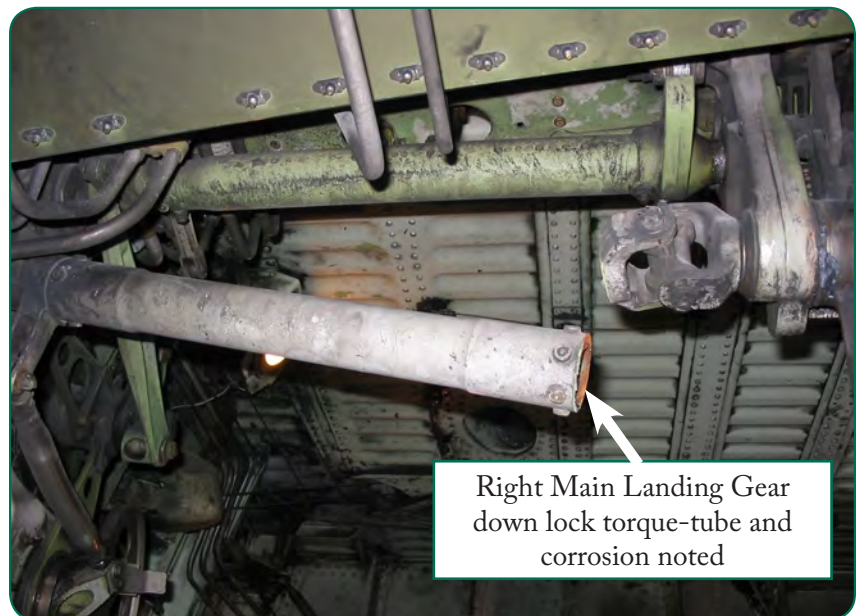
The operator noted that the torque-tube universal joint attachment end was corroded, causing its failure.

The torque tube was replaced, no further discrepancies were identified, and the aeroplane was returned to service.

Transport Canada Civil Aviation is advising all Boeing 727 operators and maintainers to pay close attention to this torque-tube assembly for any indication of possible corrosion. ✖

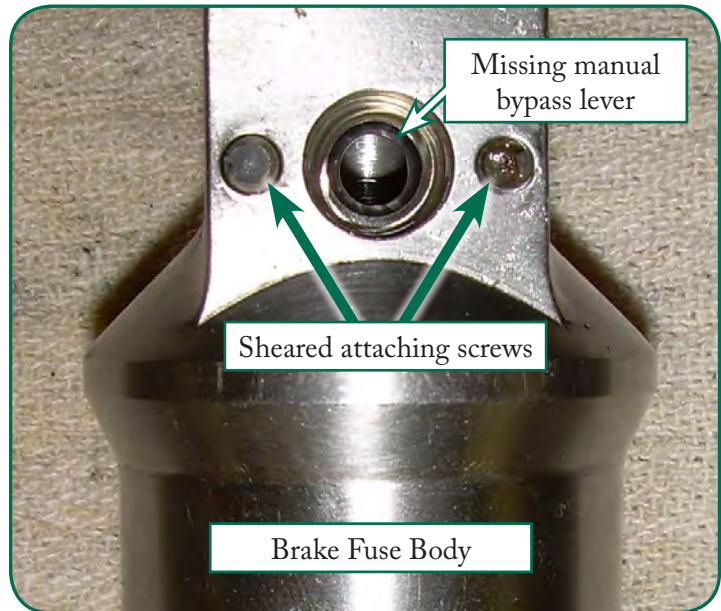
Maintenance discovered a hydraulic fluid leak in the right-hand wheel well. The right-hand normal brake hydraulic fuse was found to be leaking fluid where the fuse was subsequently replaced as per the Aircraft Maintenance Manual (AMM) 32-41-72, making the aeroplane serviceable.

It was noted by maintenance that the manual bypass lever and its hold down plate were missing. Also the attachment screws which secure the hold down plate were both fractured.

Transport Canada Civil Aviation would like to advise all Boeing 737 operators and maintainers of this possible brake fuse failure scenario. ✖

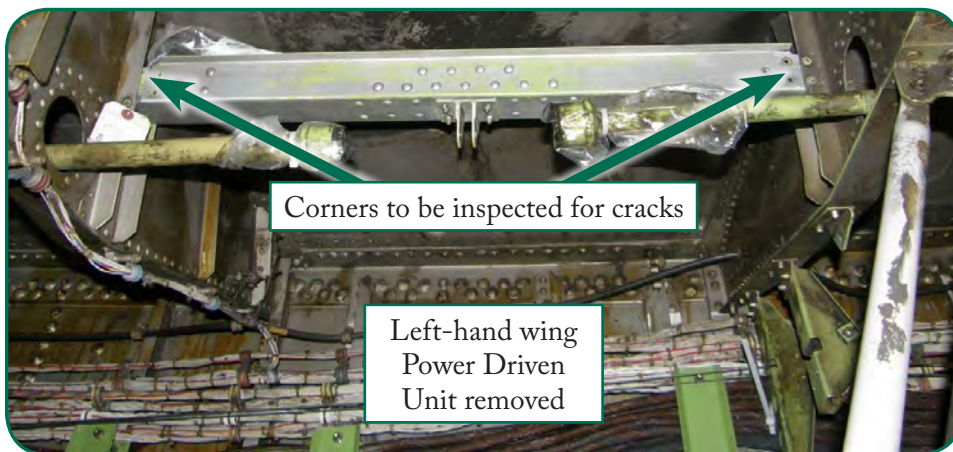
Upon removing the flap Power Drive Unit (PDU) for access, maintenance found the support beam channel of the PDU cracked. The part was removed for repair per Structural Repair Manual 51-40-03 and the aeroplane was made serviceable.

An inspection was called by the operator for all leading edge flap PDU support beam channels on the remaining fleet.

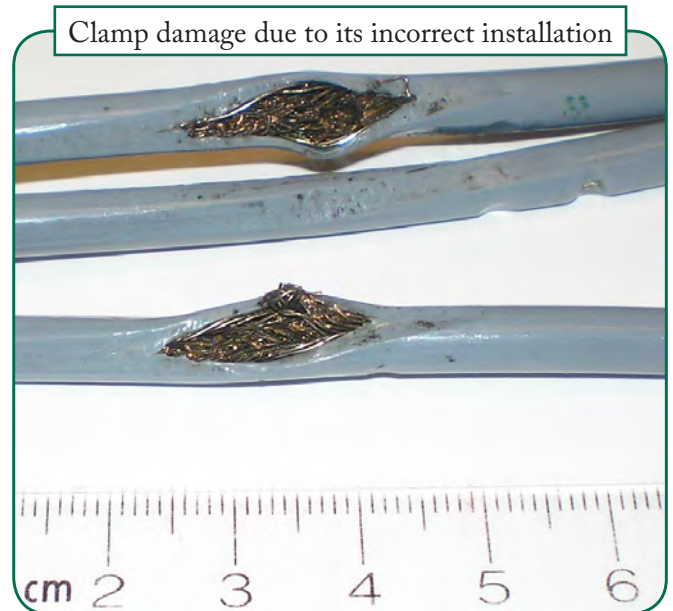
During the operational check of the hydraulic Power Transfer Unit (PTU) system, arcing was observed at a wiring harness clamp approximately 60 centimeters (cm) (2 feet) from the right hand electric hydraulic pump power connector.

The wiring was repaired; its associated clamp properly reinstalled and the aeroplane was made serviceable.

When a harness is clamped, there should be enough compression to gently support the wiring but enough slack to allow for sideways movement. ✖

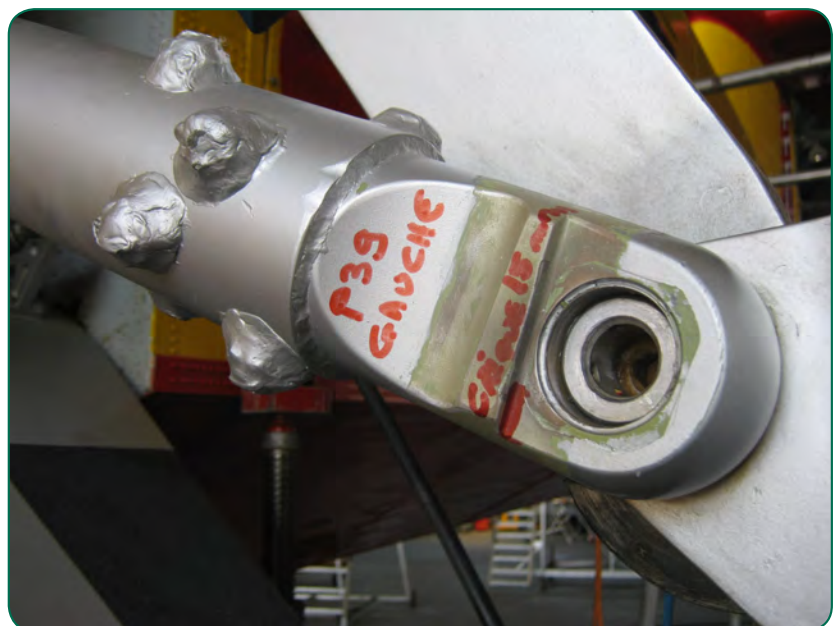
During a scheduled gear inspection, maintenance found a 36 millimeter (mm) long by 5.5 mm deep crack on the forward left-hand lug of the upper member.

Further investigation by the operator has found other similar cracks in their fleet. Canadair has been involved in ongoing corrective action and has released an Alert Service Bulletins (ASB) detailing the Liquid Penetrant Inspection (LPI) as well as Eddy Current (EC) inspection procedures. The LPI is detailed in Service Bulletin (SB) 215-A4450 and SB 215-A547. The EC inspection is detailed in SB 215-A4451 and SB 215-A548.

Transport Canada has recently issued Airworthiness Directive CF-2011-35 mandating these inspections. ✖

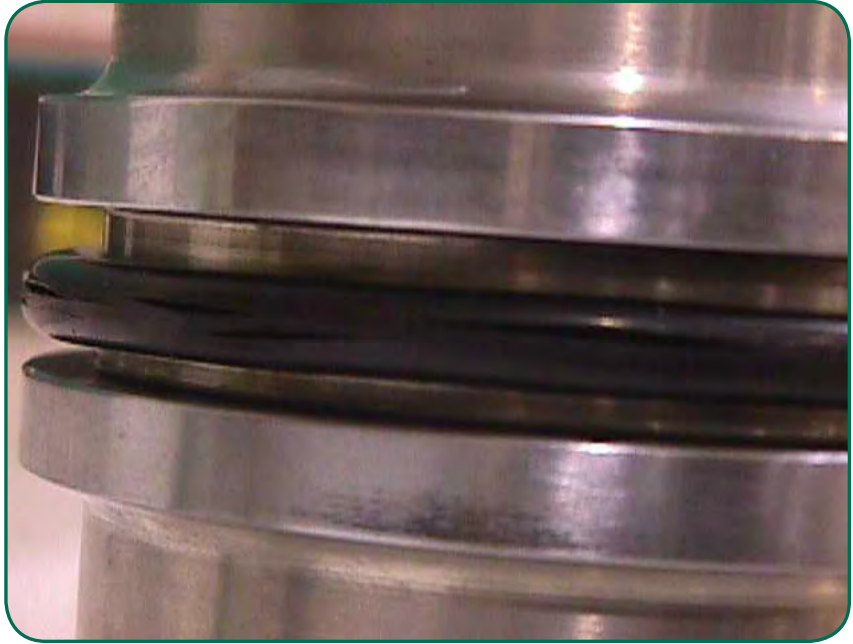
Maintenance had been adding a litre of hydraulic oil after every water bombing mission. They found the nose landing gear actuator relief valve, part number 150-323, assembly had been spraying hydraulic oil under pressure out of the valve's air vent hole when the nose landing gear was selected down. The actuator was removed and disassembled. Inspection found 2 O-rings severely damaged. Piston O-ring, part number MS28775-334, was split radially along the outside surface. The second O-ring, part number MS28775-225, had been rolled, cut and damaged. Any leakage out of the vent hole of the relief valve is a major cause for concern and the actuator should be removed for repair. Finding leaking oil in the nose wheel well area can be difficult as some water scooping operations may wash out the well.

it is an indication of a problem. In the above example, the washing of the nose compartment in scooping operations was likely masking the condition. Good job by the engineer who remained vigilant and discovered this snag. ✖

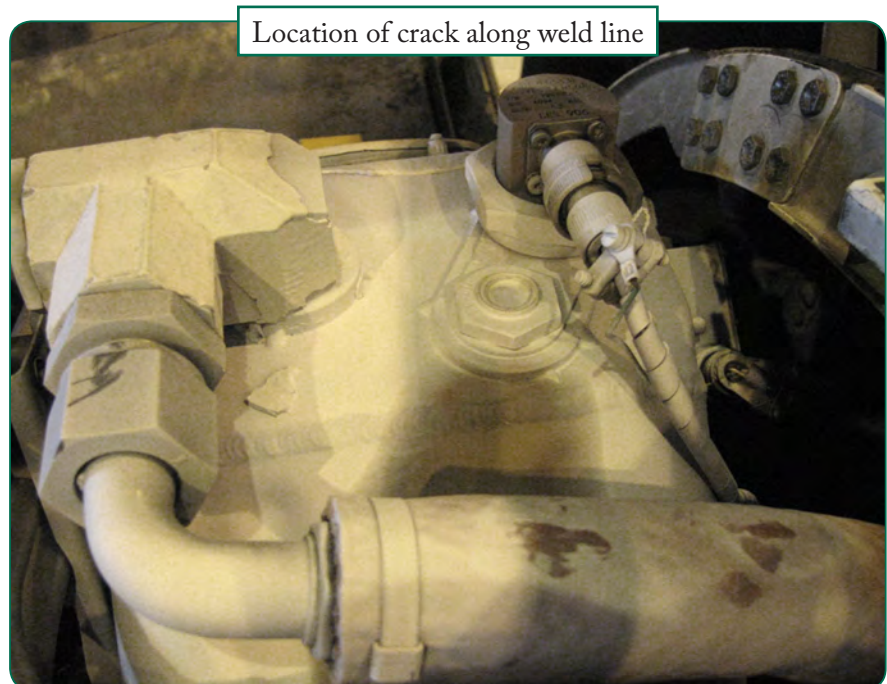
During a routine maintenance, high oil consumption was noted on the right-hand engine. The initial investigation indicated an oil leak on the engine. The engine was cleaned and ground runs were carried out. A crack in the top weld of the oil tank was found. The right-hand engine oil tank, part number 5079T05G01, was replaced and the aeroplane was returned to service.

While the use of dye penetrant developer is a great tool for locating leaks, precaution must be taken to ensure that the developer is not applied to any surface that it might be incompatible with. ✖

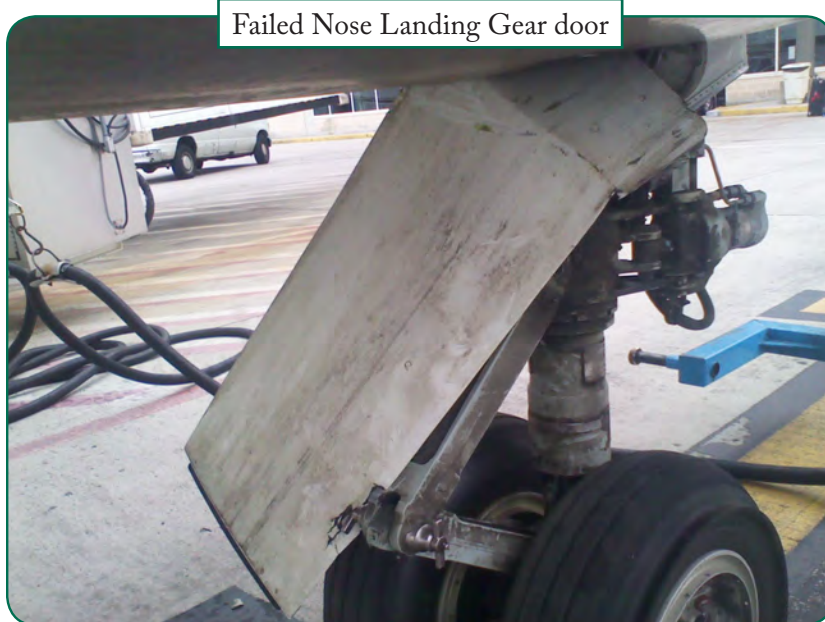
During a post flight walk around, the flight crew noticed damage to the aft Nose Landing Gear (NLG) door assembly. The aeroplane was grounded and a maintenance team dispatched.

After evaluation of the damages, the door assembly was removed and the aeroplane ferried to a maintenance base for repair. Visual inspection of the NLG area revealed that the aft door had sustained significant damage and needed replacement including both actuating rods. Also replaced was the NLG aft door drive bracket being bent and the steering control module.

The failure likely occurred during the gear extension of the flight as there was no abnormal noise or condition reported by the flight crew during flight.

All operators and maintainers need to pay close attention to this area for condition and integrity. ✖

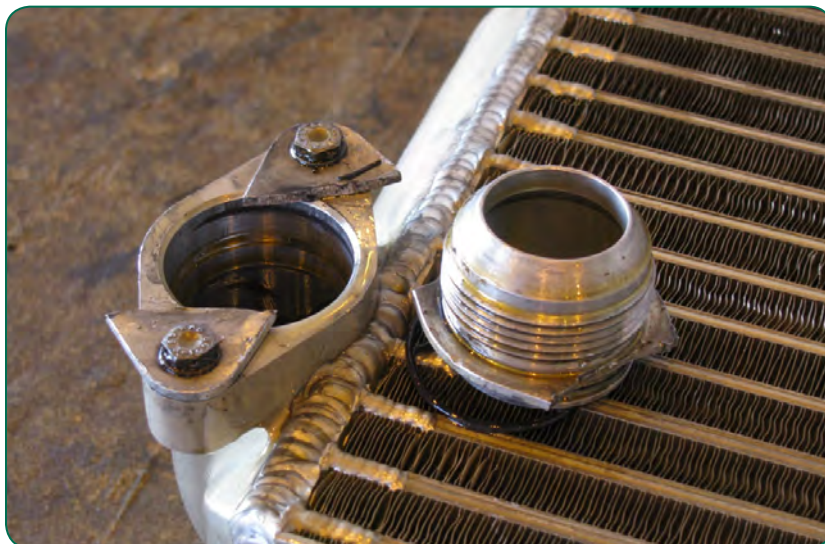
Maintenance soon discovered that the right-hand oil inlet tube adaptor fitting that connects to the left-hand oil cooler was broken and disconnected. This resulted in the loss of a substantial amount of oil in a very short period of time.

The oil cooler and the inlet fitting were replaced and the aeroplane returned to service. The oil cooler (part number 28E99-8) was only recently installed. It is suspected that the adaptor fitting may have had a hairline crack during the last installation. Please note that the adaptor fitting remains with the aeroplane when the oil cooler is replaced.

Although fittings can suddenly fail without warning, it is important to always check for signs of oil leaks around the engine area. ✖

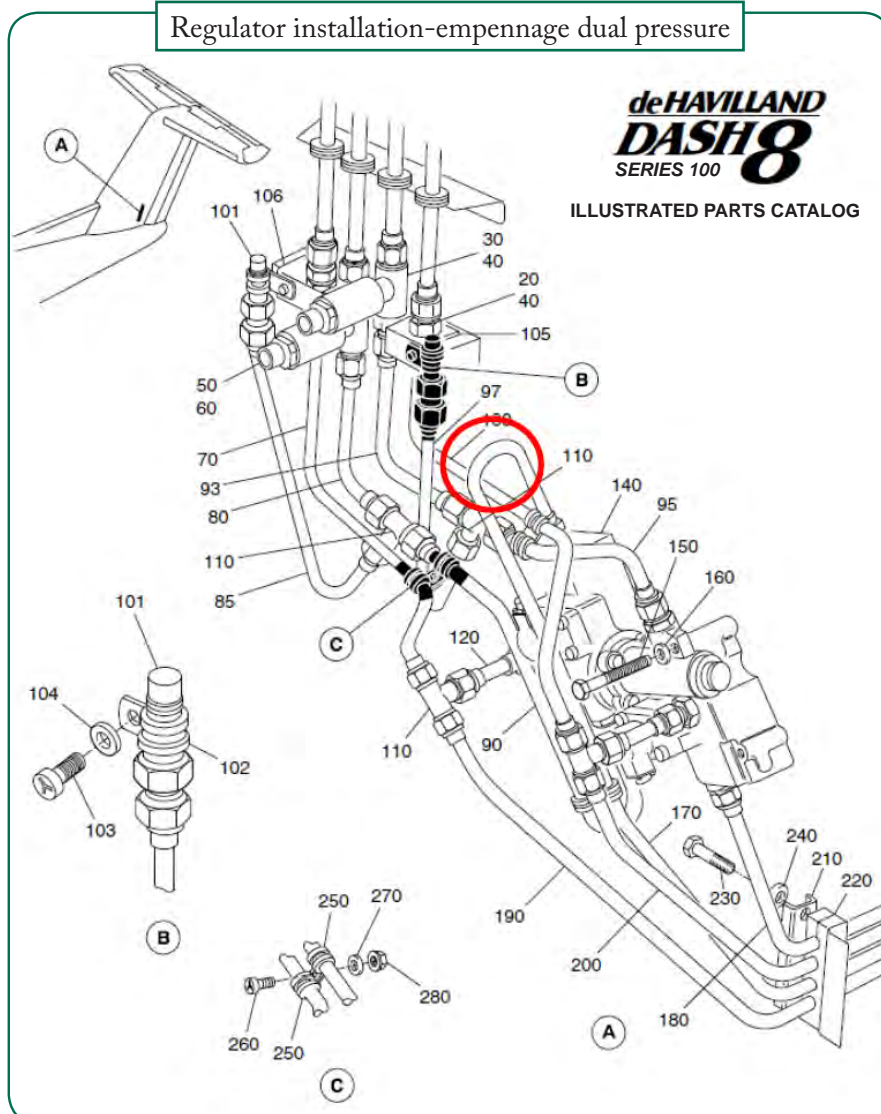
Maintenance personnel found that the leak originated somewhere in the tail section area. Further investigation revealed 3 pin holes on the pressure supply hydraulic tube

that connects to the rudder dual pressure regulator. The holes are located on the outside of a 180-degree elbow. The defective hydraulic line and engine driven hydraulic pump were replaced and the aeroplane returned to service.

Any bends in hydraulic tubing can result in stresses that can fail without notice. It is important to ensure bends do not exceed manufacturers’ recommendations.

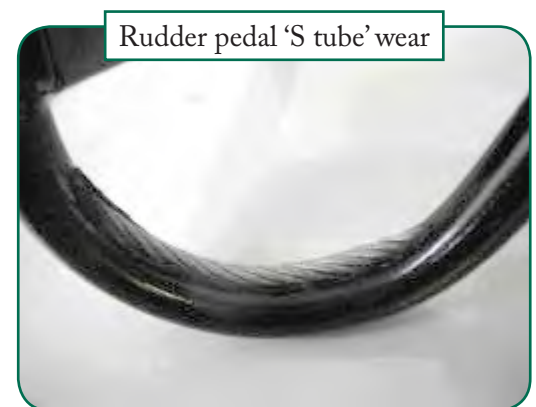
Prior to start-up, the pilot noticed that he wasn't able to adjust the rudder pedals. After a visual inspection, the Aircraft Maintenance Engineer (AME) noticed that the left pilot side rudder pedals 'S-tube' had the rudder cable protruding from one of the bends. Both pilot side rudder pedals were replaced and further inspection revealed that the right side had significant wear.

According to the manufacturer, the only time the cables move through these tubes is during pedal adjustment. In a situation where an individual pilot is operating the aeroplane and little or no pedal adjustments are made, this should never be an issue. In a flight-training environment where many pilots are operating the machine, extra care must be taken by the maintainer to inspect this area carefully.

The manufacturer is looking into alternate lubricants that may help reduce wear. ✖

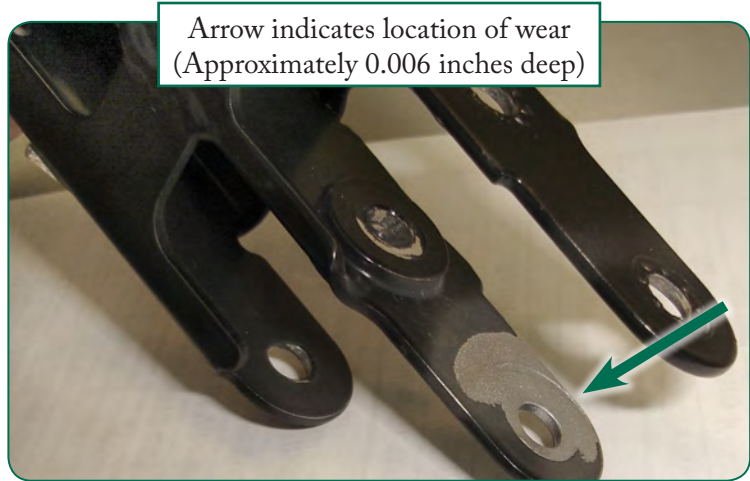
The split flap bellcrank has a 0.1524 millimeters (mm) (0.006 inches) deep wear mark on the flap actuator lower arm. The material thickness in this area is 1.651 millimeters (mm) (0.065 inches). The wear was caused by interference with the flap actuator rod end. The combination of both the rod end alignment and bushing location can cause wear.

This appears to be an area that could be difficult to detect any anomalies. Operators should be aware of this potential wear spot. ✂

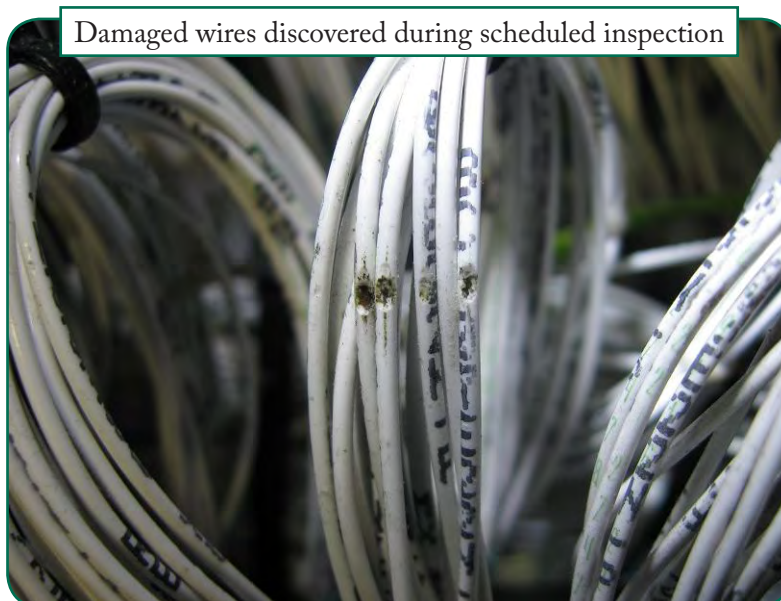
Multiple wires on ground block module VN220, behind the right-hand instrument panel, were found with abrasion damage caused by chaffing on the engine instrument display. Several wires were found with the insulation damaged through to the conductor.

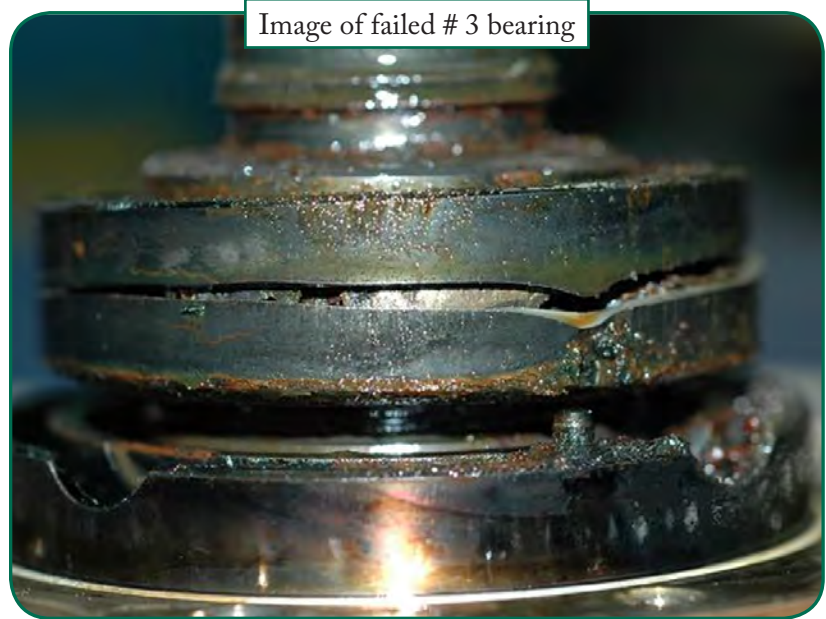
Image of failed # 3 bearing

The number two bearing was examined visually and localized areas of corrosion were noted. Rub marks were found in the corrosion and the pit edges on the rollers. Inner ring was burnished and plastically deformed, indicating that the number two bearing was operated for some time subsequent to the formation of the corrosion pits. The number three bearing was destroyed.

The corrosion had to occur when the engine was idle for a period of time and was not stored in accordance with the manufacturer's procedures. Because both bearings were installed in the engine and as there are no records indicating that the engine had been preserved in accordance with the maintenance manual from 28 May 2004 to 06 June 2007, the corrosion likely occurred during this period”

Regardless of how insignificant a maintenance action or procedure may seem it could have major consequences at a future point in time. In the above example, procedures were not followed resulting in a latent condition that led to a catastrophic failure.

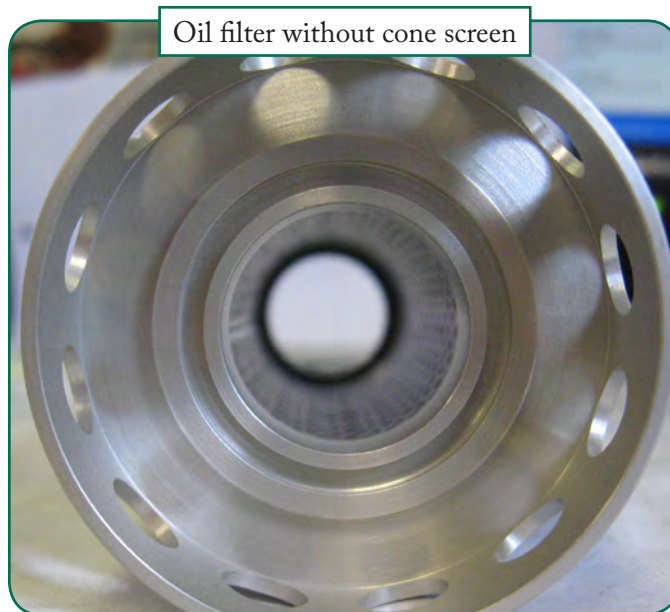
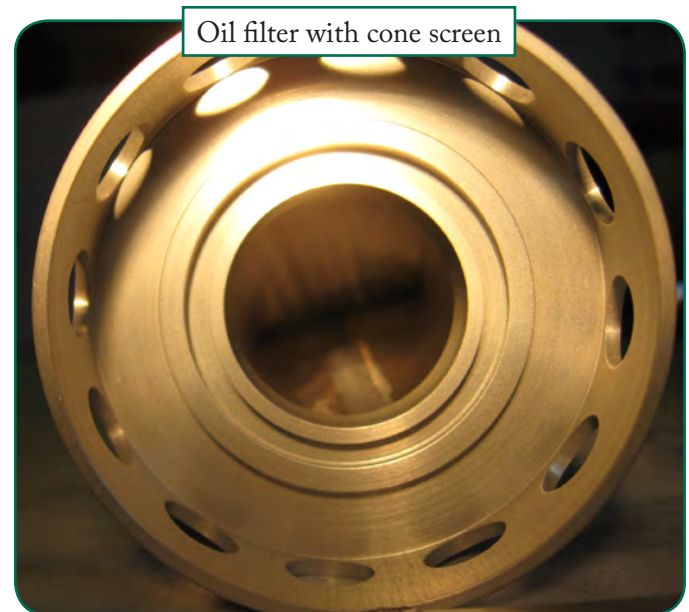
When an apprentice engineer received an oil filter Parts Manufacturer Approval (PMA) part number 7579522AM, equivalent to Pratt & Whitney Canada part number 3024084 or 3033315, from the company's store department, he noticed that the fine cone shaped screen was missing from the end of the filter, that is first inserted into the oil filter housing. This is the first filter that the company has found with the cone screen missing from that type of oil filter. The remaining stock
