Issue 2/2011

Canadian Aviation Service Difficulty Reports

TP 6980E
(6/2011)

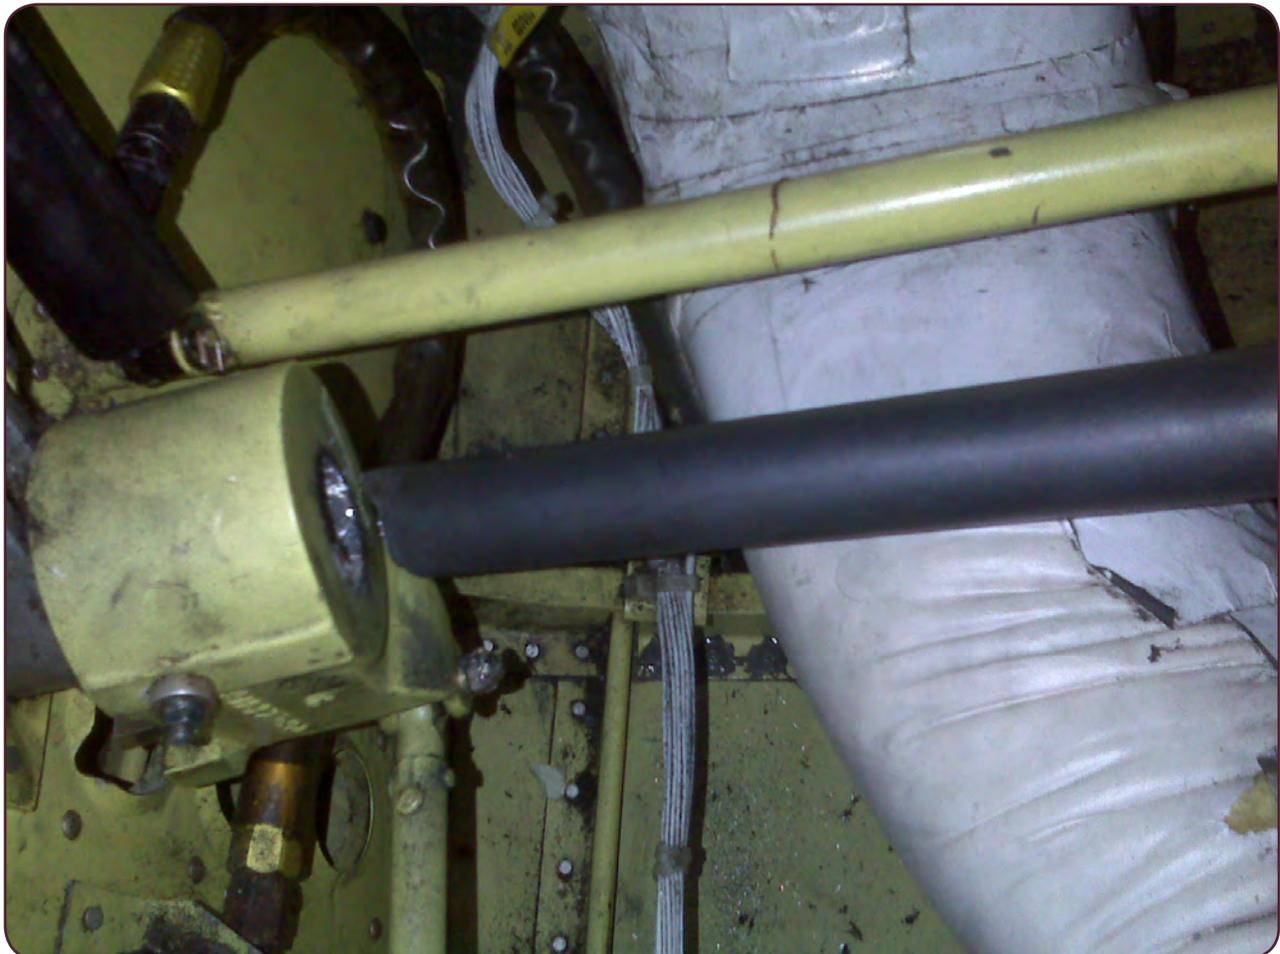
Rudder Torque Tube – Failure

During a functional check, the Aircraft Maintenance Engineer found that the L/H torque tube was broken just inboard of the left rudder pedal block. Disassembly revealed that the rudder torque tube failure started at the taper pin hole that is used to secure the rudder pedal assembly block to the shaft. Further inspection revealed a secondary crack at about 90 degrees. A third crack was found parallel to the initial crack. The failure appears to be from an overload condition.

It is difficult to detect a failure of this type as the initial failure takes place in an area not visible unless the pedal assembly block is dismantled. Once the crack gets large enough to compromise the torsional ability of the shaft, complete failure would likely occur. The entire

rudder and steering system was inspected to determine if other related systems were a factor in this event. No fault found.

Because the pedal block is not disassembled unless necessary, it is recommended that this area be closely examined for defects around the pedal block/torque tube interface. A physical check for any “rotational play” of the torque tube may give an indication of impending failure. ✖

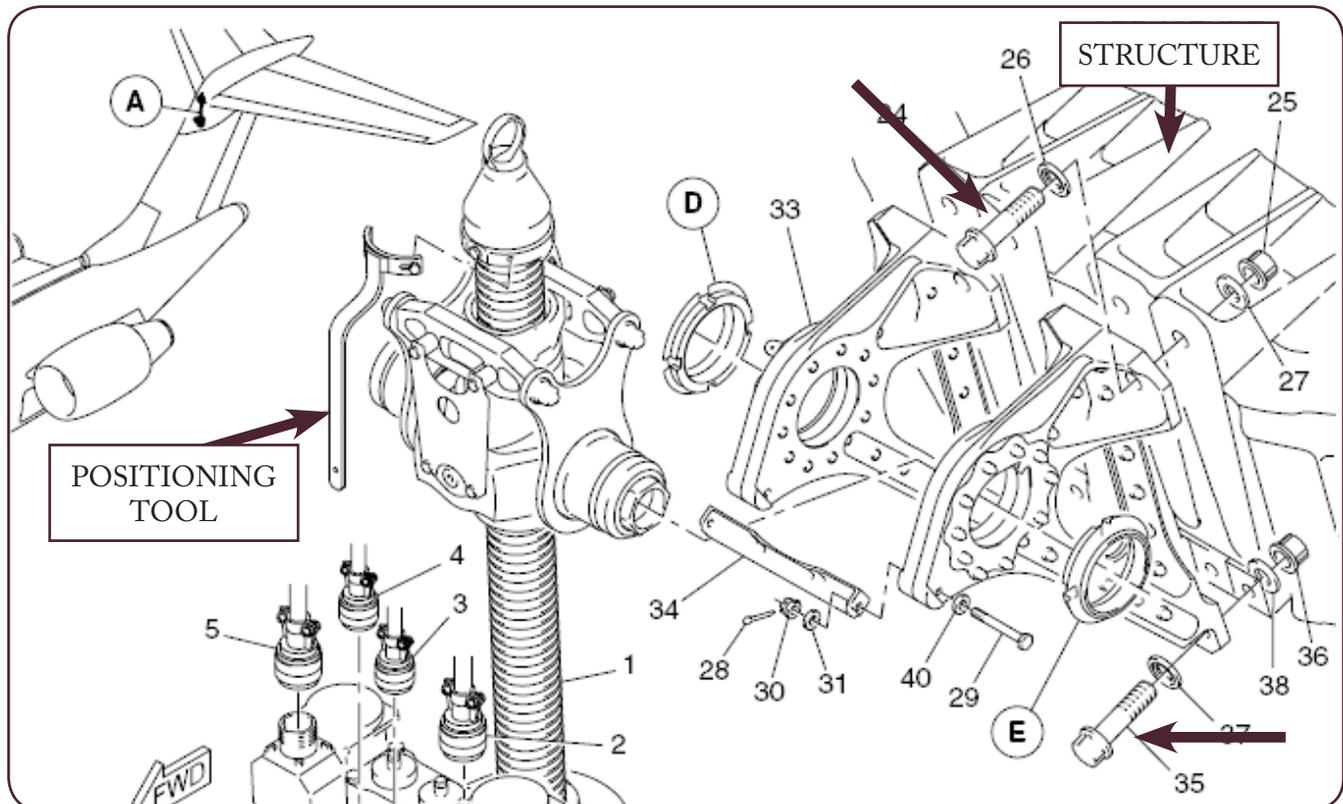
Pitch Trim Actuator - Upper Attachment Loose Bolts

During a routine maintenance check in the translating nut area of the horizontal stab trim actuator (HSTA), two bolts were found loose. These bolts, which are positioned at the upper L/H & lower R/H bolt location, connect the upper half of the pitch trim actuator assembly (Item 33) to the aeroplanes structure. See pictorial below. (Reference CRJ700/900 AMM Figure 27-42-01, Items 24 & 35)

a revision was made to the AMM TR 27-0345 and TR 27-0346 to address the installation of the trim actuator. Manual Change Requirement (MCR) Chapter 20 will now require paint strip marks on the bolt and the nut. The TCH now advises replacement of the nuts after each use.

The 2000 Flight Hour oil level check on the HSTA may be an opportune time to do a precautionary one-time nut torque check. ✖

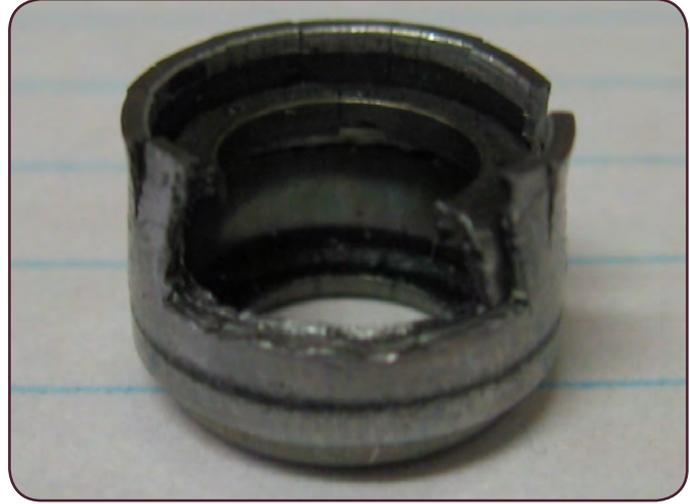
Assymetrical (Split) Flap Condition – Flap Rollers

Shortly after take-off, the R/H flap retract flap cable failed. This was visually confirmed by the pilot. The consequences of the cable failure caused the L/H flap (slave flap) to fall into the fully extended position with the R/H flap (master flap) proceeding to go to the selected flap retracted position. Fortunately, the pilot was able to gain control of the aeroplane.

Initial investigation revealed that the R/H cable was completely severed in the area where the cable rolls over the central flap pulley cluster located in the middle of the cabin behind the headliner (FS 65.33). The subject flap cable was also found frayed in several other areas along the complete flap cable run.

Further inspection found that the L/H aft outboard flap roller (Part Number 0523921) failed due to a “flat spot” on the roller and would not roll thus locking the flap during the retraction cycle. With the slave flap locked in the flap track, the flap motor continued to tension the flap retract cable until the cable failed. The flap motor and transmission can create extremely high torque/tension, which exceeds the tensile strength of the flap cable, if the flap is in a “jammed” condition. The root cause of this event appears to be due to the failure of the flap roller with the flap cable failure as a subsequent event.

Transport Canada Civil Aviation wishes to advise owners/operators to closely inspect the flap rollers for cracks or flat spots. Premature fraying of flap cables may also be an indication of an impending flap roller failure. ✖

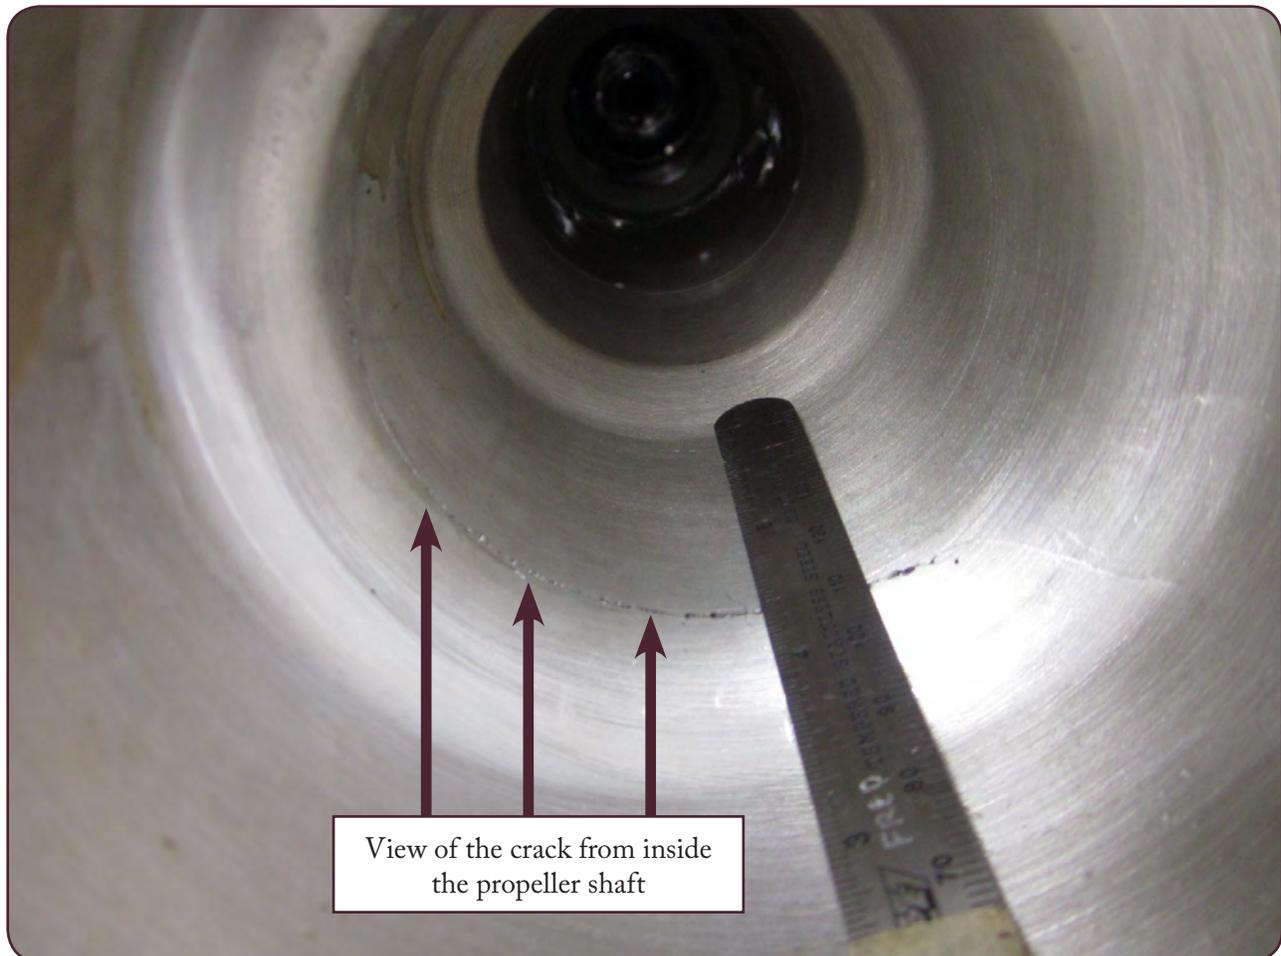
Engine Propeller Shaft Crack

During a pre-flight walk around, the pilot noticed an external oil leak from the propeller shaft area. A more detailed inspection revealed a crack almost half way around the circumference of the shaft at approximately 10 to 11.5 cm (4 to 4.5 inches) from the front flange.

visual inspection and metal testing have confirmed that the crack was caused by hydrogen embrittlement.

View of the crack from inside the propeller shaft

The engine was removed and replaced and the aeroplane was made serviceable.

PWC are progressing with a more in-depth investigation and have issued Service Information Letter PW100-139 as well as Service Bulletin 21798 advising all PW100 Series engine operators of this possible scenario.

Transport Canada Civil Aviation would like to emphasize to all affected operators the importance for thorough flight crew and maintenance awareness when addressing propeller shaft oil leaks. ✖
