Transport
Canada

Issue 2/2012

Canadian Aviation Service Difficulty Reports

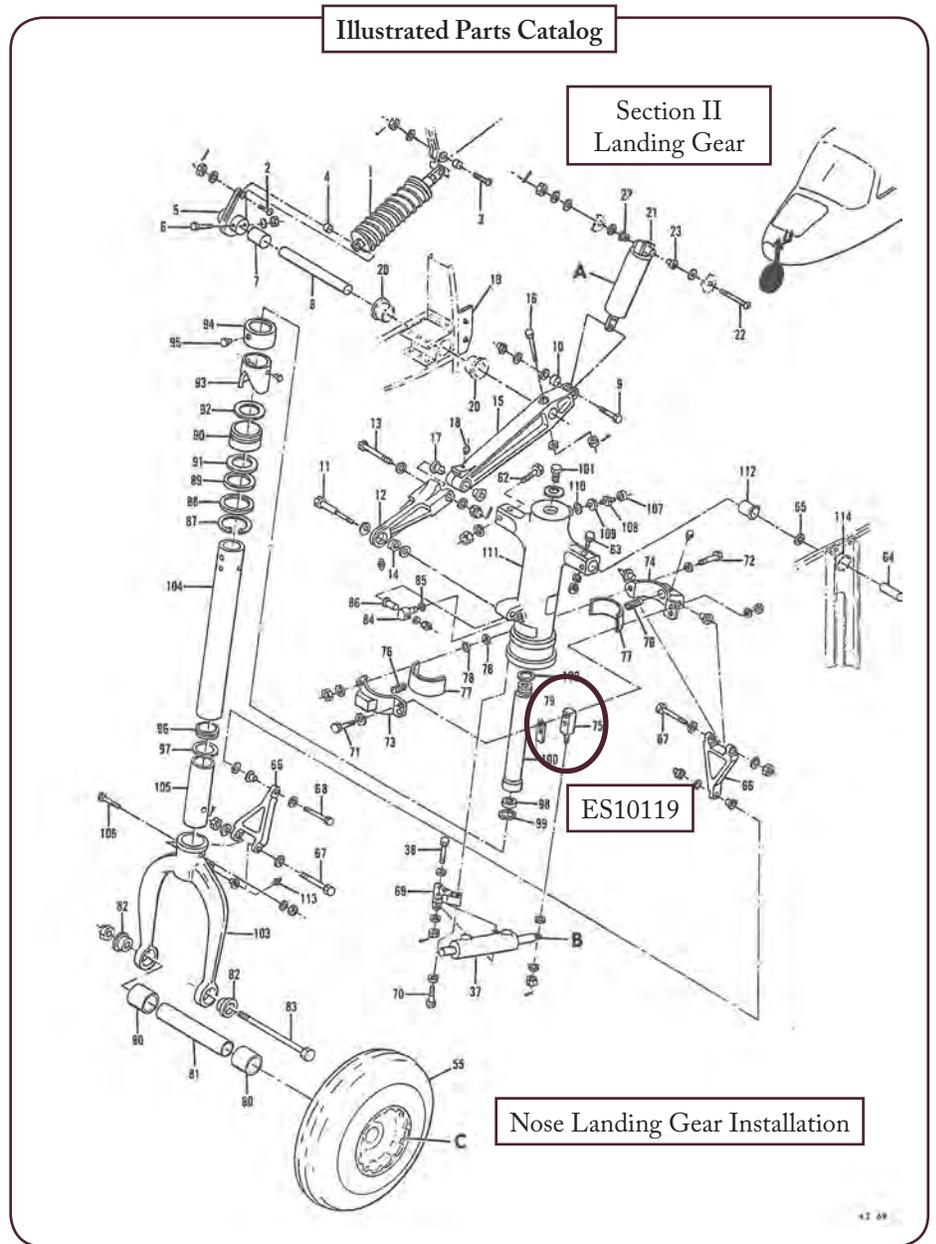
The maintenance investigation revealed that a bolt that connects to the nose wheel steering actuator to the nose gear was missing. The actuator end spacer shaft (IPC Page 2-81, Fig 2-19, Item 75) was missing. The shaft is held into the spacer with a roll pin which was found sheared and had fallen out thereby leaving the nose wheel free and uncontrolled.

It appears that an incorrect installation was the root cause factor in this event, which endangered the crew and occupants of this aeroplane.

The operator has taken the appropriate internal action to ensure that maintenance personnel strictly adhere to the manufacturers aircraft manuals. ✖

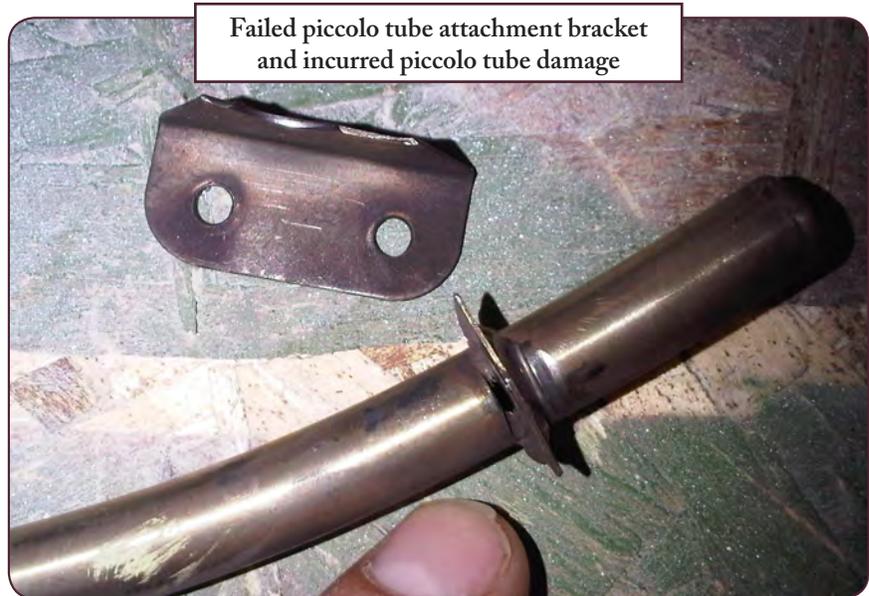
Nose Cowl Piccolo Tube Damage

During a heavy maintenance visit, the right hand engine intake cowl was removed, where upon further inspection of the cowl; loose rivets were noticed behind the intake lip. The technician proceeded to remove the intake lip to further assess the pulled rivets. It was discovered that the attachment brackets had cracked and chaffed through the piccolo tube.

Through research with the operator and BAE engineering, the cracking of the intake piccolo tube support brackets is a known issue and resulted in the release of an optional service bulletin 71-JA 930240 in 1993, which replaced the welded supports with new, flexible mounts.

The piccolo tube and attaching brackets were replaced and the aeroplane was made serviceable.

Transport Canada Civil Aviation would like to advise all owners, operators and maintainers of the availability of this service bulletin and the importance of its embodiment. ✂

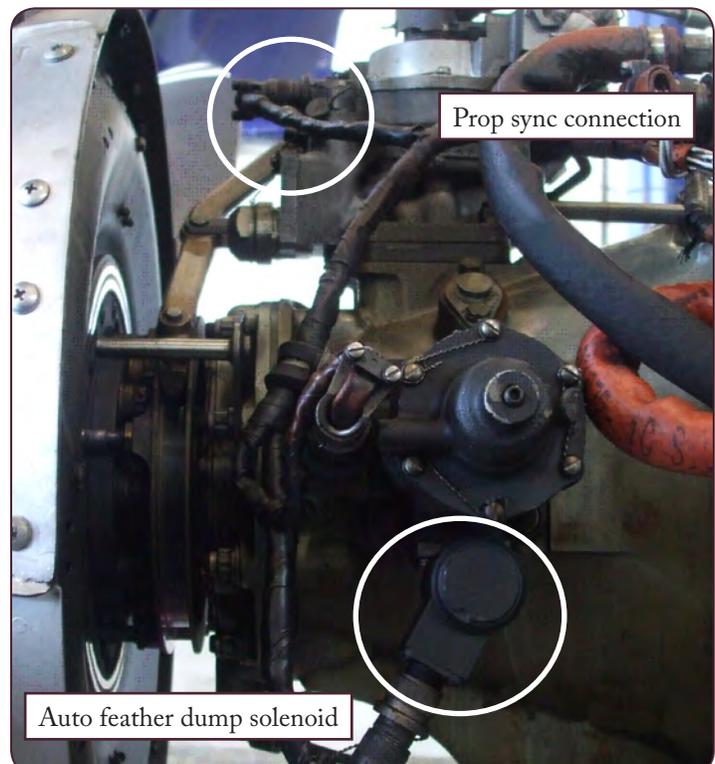
Shortly after departure, the aeroplane experienced an uncontrolled propeller pitch change from coarse to feather. Following an uneventful landing, maintenance personnel found that the cause of the problem was that the canon plugs for the propeller synchrophaser solenoid for the propeller governor and the auto-feather solenoid for the overspeed governor were found in reverse positions. These two canon plugs are within close proximity and identical in appearance, thus the mechanic must be very attentive when reconnecting these canon plugs. The Service Difficulty Report (SDR) submitter also stated that maintenance personnel had completed an engine change the previous day. It seems apparent that this is when these 2 canon plugs had been reversed. The subject aeroplane is powered with twin PT6A-65B engines and Hartzell HC-B4MP-3A propellers.

In normal operation, the propeller synchrophaser sends a pulse voltage to the propeller synchrophaser solenoid located on the propeller governor to ensure both propellers are at the same Revolutions per

Minute (RPM). When these canon plugs are incorrectly reversed; the propeller synchrophaser control box sends a pulse voltage to the auto feather dump solenoid causing the propeller to momentarily feather.

The submitter also stated that the incorrect connection of these canon plugs could lead to a serious in-flight problem and even more perilously, if a dual engine change was carried out simultaneously.

Transport Canada Civil Aviation recommends strict adherence to Canadian Aviation Regulation (CAR) Part V - Standard 571.10 – Types of Work. Additionally, Transport Canada Airworthiness Notice C-010 publication “Inspection of Control Systems” provides necessary guidelines regarding maintenance releases. ✖

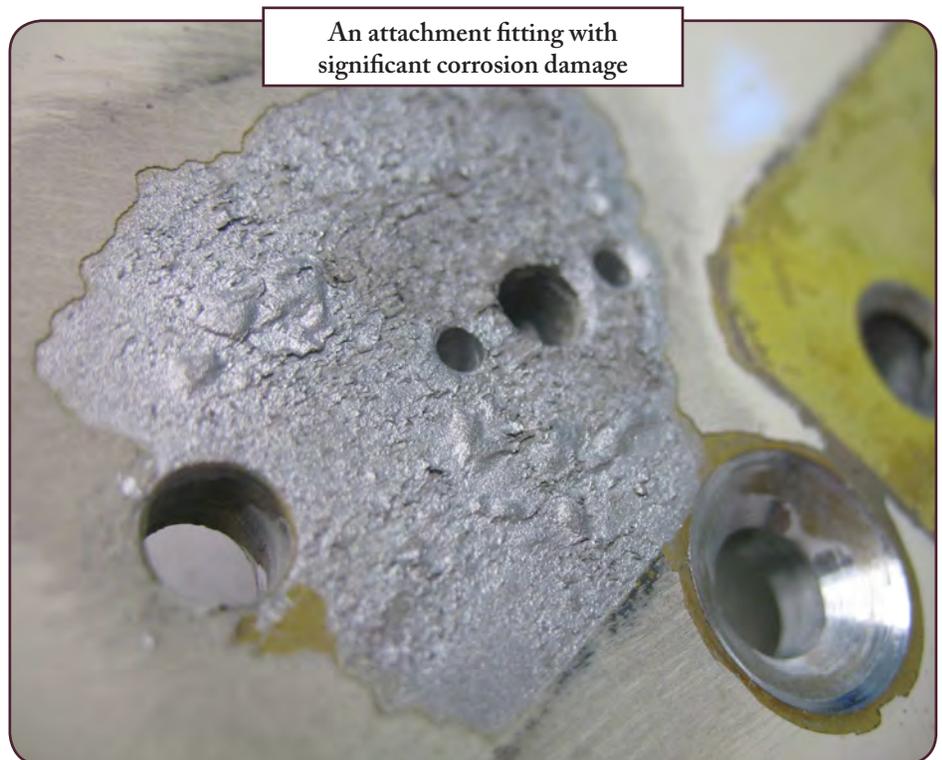
Horizontal Stabilizer Fittings – Level III Corrosion

Maintenance personnel found Level III corrosion at both the upper and lower stabilizer attachment fittings.

The left-hand upper surface of the upper attachment fitting had chaffing and significant corrosion damage at the anchor nut location. Additionally, extensive corrosion damage was found at the lower fitting and at the anchor nut locations.

A previous SDR reported severe intergranular corrosion and crack fitting in this same area. Always be attentive to the early signs of corrosion such as white/gray powdery deposits and pitting/etching damage, which can eventually lead to crack development. ✖

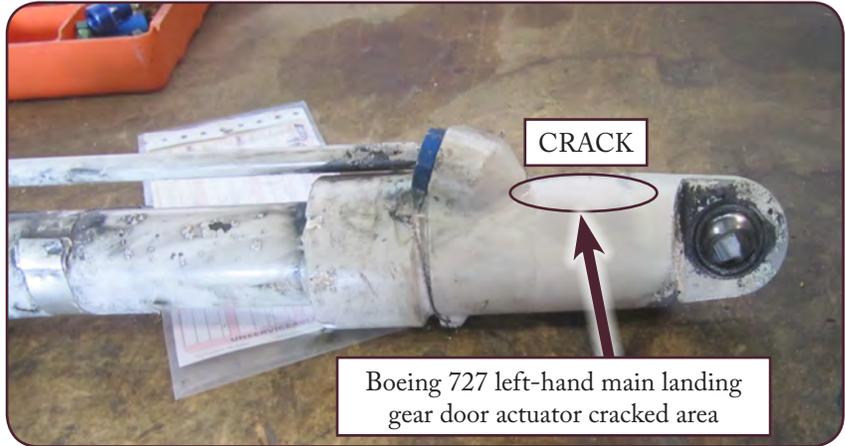
Hydraulic Fluid Loss

Maintenance inspection revealed that the left hand gear door actuator was cracked, allowing the loss of the hydraulic fluid.

It is suspected that there was prior evidence for the propagation of the crack on the door actuator through minor hydraulic fluid weeping in the area.

The actuator was replaced and the aeroplane was returned to service.

Transport Canada Civil Aviation would like to advise all owners, operators and maintainers to be adamant and thorough when trouble-shooting fluid leaks. ✖

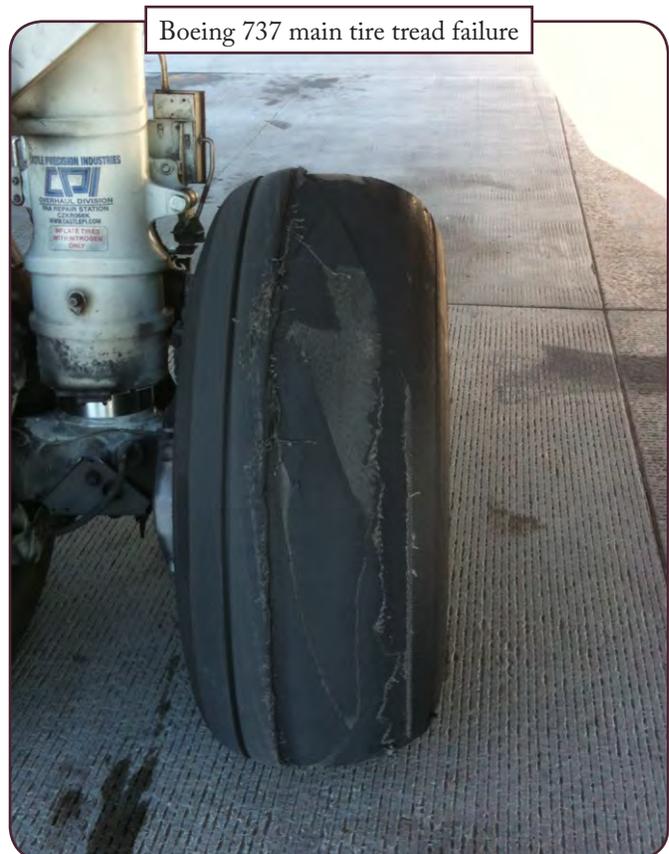
Tire Tread Separation

On take-off, what was described as a bang was reported to the captain by the cabin crew. No other issues were reported by the flight crew in cruise. Upon landing it was discovered that #2 main wheel received substantial tread separation on its previous takeoff. This caused damage to the inboard flap as well as the inboard spoiler.

Due to the importance for the correct operation of all aeroplane tires and the seriousness of this event, through the operators internal safety management system, it was determined that the possible frequency of retread could have been the cause of failure.

Both the #1 & #2 main wheels were replaced and all necessary repairs done to the flap and spoiler making the aeroplane serviceable.

Therefore a maximum limit of 3 retreads was put in-place for the overhaul of all main tires.

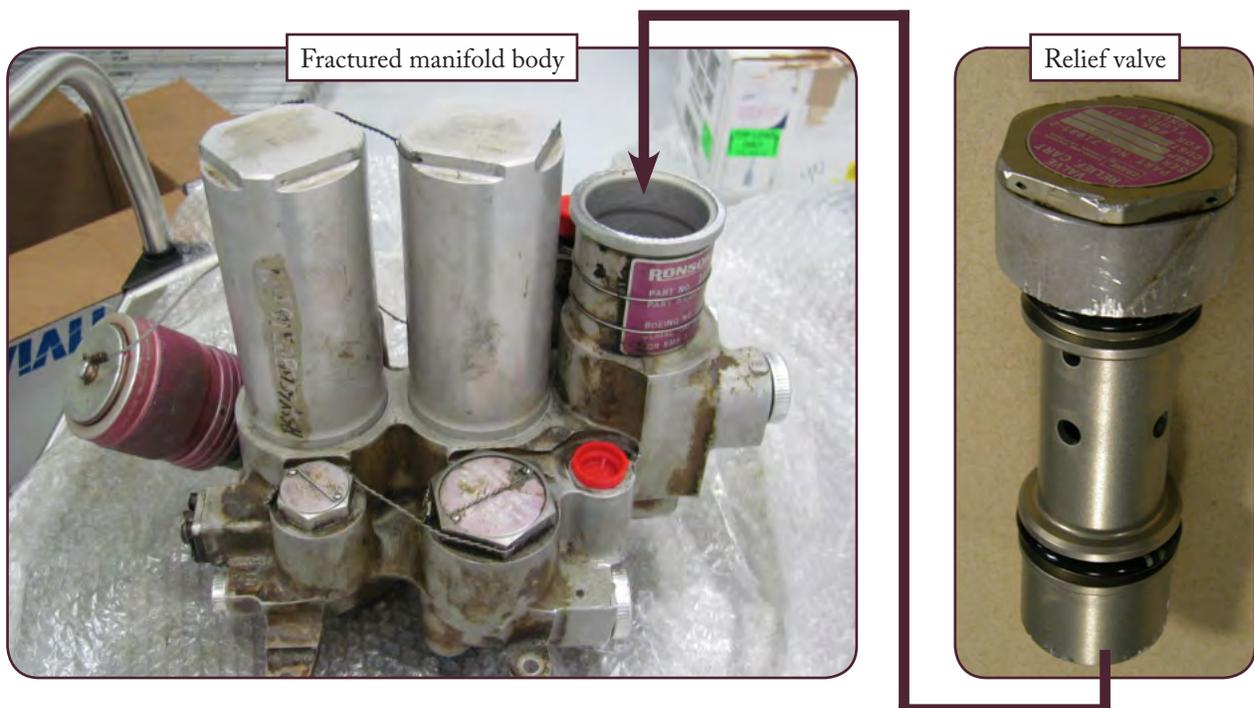
Hydraulic Failure

It is suspected that the failure of the hydraulic module body was due to the possibly imposed over-torque stress of the relief valve during its last installation, causing metal fatigue.

The failed hydraulic manifold was replaced, the hydraulic system serviced and the aeroplane was made serviceable.

Transport Canada Civil Aviation would like to advise all maintainers and AMO shop overhaul facilities of the importance to follow all Aircraft Maintenance Manual (AMM) and Component Maintenance Manual (CMM) installation torque values. ✖

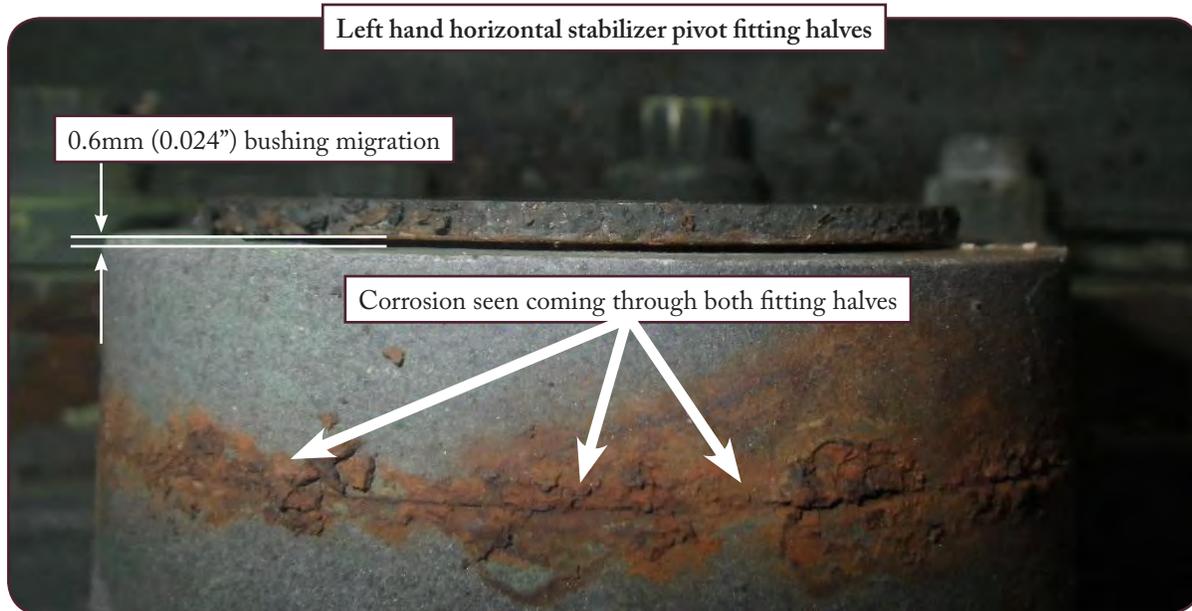
Horizontal Stabilizer Attachment Corrosion

While completing a detailed inspection of the horizontal stabilizer pivot fittings per task 55-320-502, iron oxide colored corrosion was observed coming through the fitting halves on both the left-hand and right-hand sides. Upon further inspection, the bushing in the left-hand horizontal stabilizer pivot fitting was found migrated 0.6 millimeters (mm) (0.024 inches).

Both fittings were replaced to correct the fault.

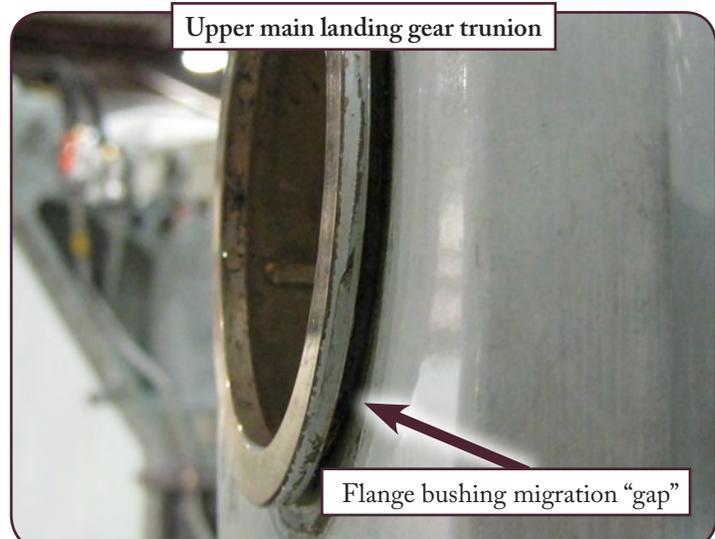
Main Landing Gear Trunion Bushing Migration

During a heavy maintenance check, the forward Main Landing Gear (MLG) trunion bushings were found to be migrated on both the left and right MLGs.

All operators and maintainers are asked to pay close attention to this area of the MLG trunion. ✖

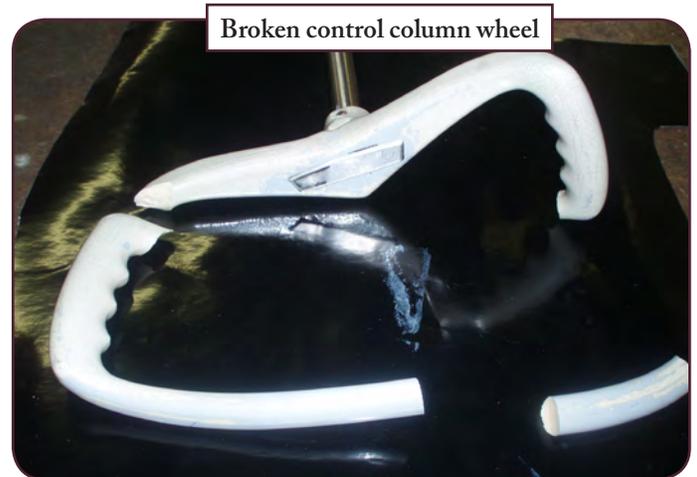
Control Column Wheel - Broken

During stall practice with very little yoke aft pressure being applied by the co-pilot (as the pilot was already applying most of the pressure); the control column wheel fractured. Following an uneventful landing, a technician applied a small amount of force on the control column wheel and another portion of the wheel broke off. It was found that the co-pilot control column was made from plastic and had broken in the upper left and lower right corners.

Cessna Service Letter (SL) 62-44 has been superseded by SL 64-8 that calls for a “pull test” inspection and specifies that the critical area is located at the bottom left corner. The SDR submitter stated that this particular aeroplane was out of service for 8 years, thus effects of sun-soaking may have been a factor in this failure.

Transport Canada Civil Aviation highly recommends compliance with Cessna SL 64-8. In particular, pay close attention to the inside upper corners of control wheels. Any control wheel that has a crack or fails the pull-test should be replaced before further flight with a metallic control-wheel. ✖

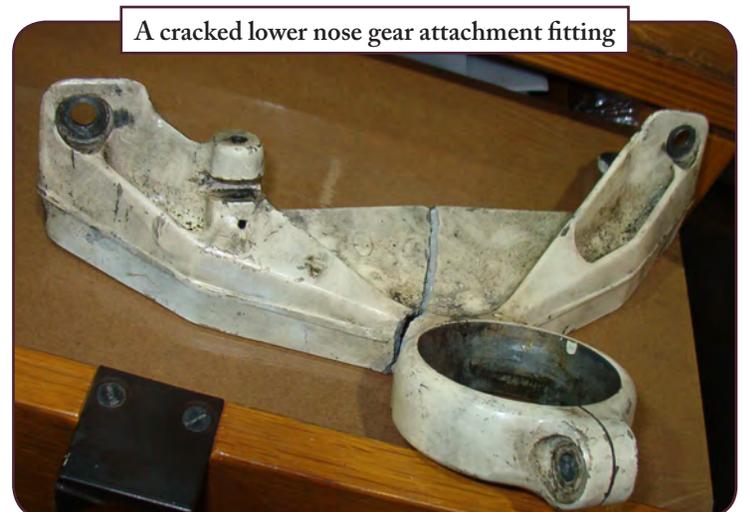
During routine inspection, the lower nose gear attachment fitting was found cracked behind the nose oleo attachment support.

This aeroplane had previously undergone a major rebuild some 150 hours ago, which included firewall, forward fuselage, nose gear upper attachment fitting and nose gear fork. It appears that the cracked fitting may not have been stripped of paint and subjected to Non-Destructive Testing (NDT) inspection at that time. The fact that the edges of the fitting are clean (no dirt or grime) supports the notion that this is a very recent fracture.

Owners and operators should closely examine and conduct appropriate inspection techniques. Closely inspect the landing gear area for various adverse conditions (cracks, nicks, corrosion) that can lead to stress concentrations and eventual failure. ✖

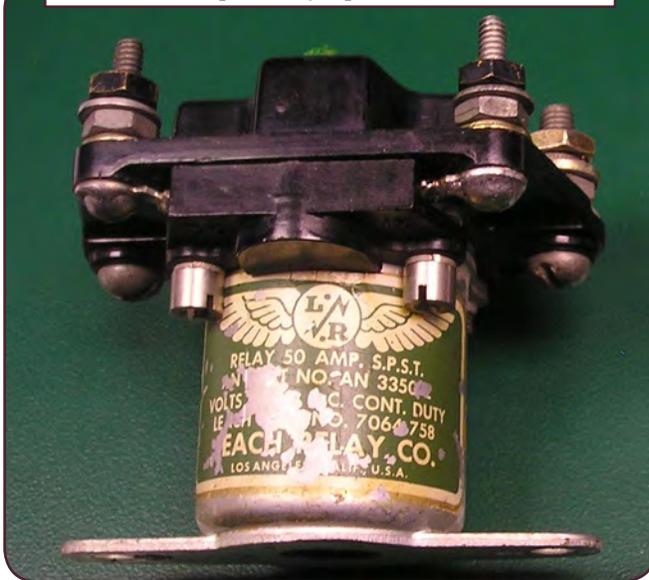
Correct 50 ampere relay - part number AN3350-2

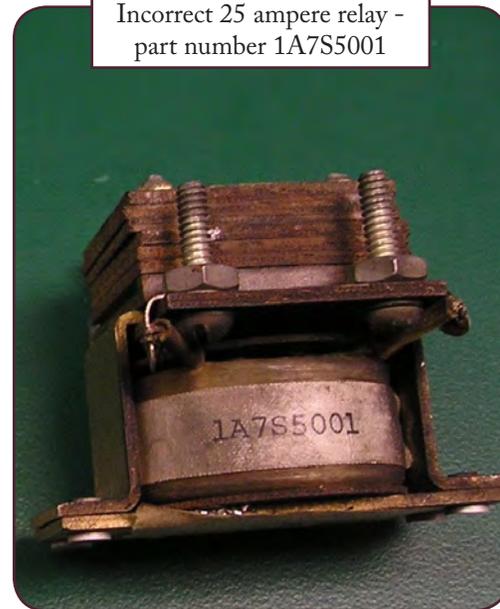
A maintenance investigation revealed that an incorrect 25 ampere (amp) electrical relay (part number 1A7S5001) was installed instead of the required 50 amp relay (part number AN3350-2). The circuit breaker in this system is a 60 amp breaker. Avionics personnel repaired the damaged

Incorrect 25 ampere relay - part number 1A7S5001

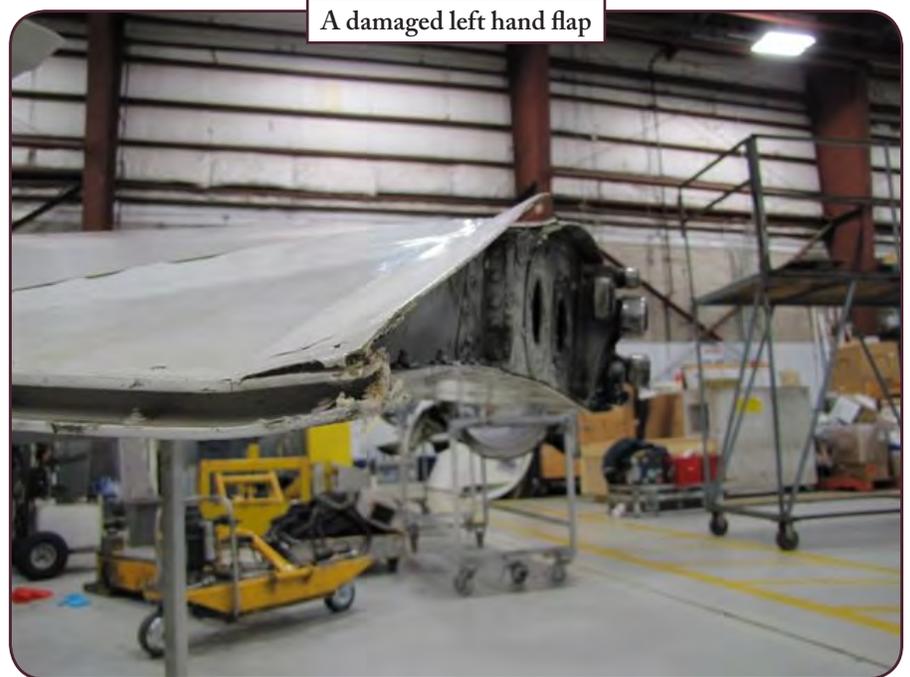
Flap Ball Screw Actuator – Asymmetric Flap Extension

On approach for landing, the crew selected 35-degree flap extension; however flaps abruptly stopped at 15 degrees extension. Following an uneventful landing, the crew noticed the left inboard flap had extended asymmetrical thus causing the flap lower corner to contact and damage a fuselage composite panel. Additionally, the trailing edge of the inboard flap was also significantly damaged.

Subsequent investigation found the cause of this event was due to flap actuator screw jack failure (Time Since New (TSN): 50410, Part Cycles: 47244).

It appears the torque sensor unit would probably not have detected a differential flap torque from the primary flap drive and the secondary flap drive. This is because the primary flap drive would still be turning the worm gear inside of the failed unit, as if all was normal. In this case, even though the now worm gear was continuing to turn, it was not meshing with the now “worn” worm gear on the jackscrew itself and therefore not extending. In the meantime, the other flap jackscrew was working normally and thus extended.

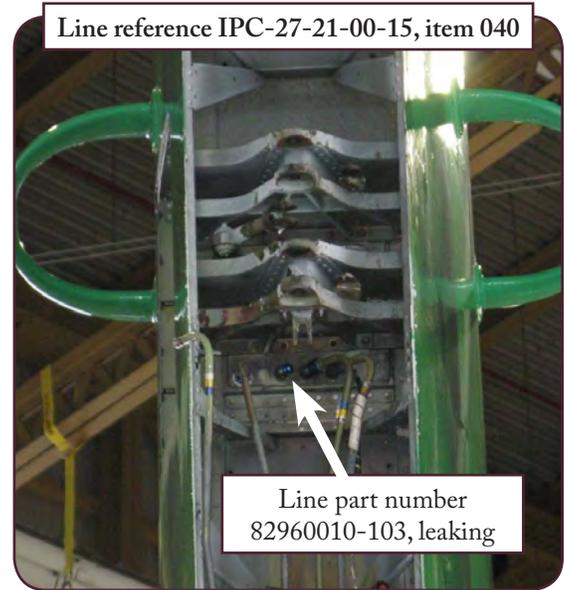
Maintenance personnel removed that rudder assembly to determine the source of the fluid leakage. It was found that the #2 system pressure tube assembly (P/N 82960010-15) had cracked at the bend radius. Additionally, in this same area, #1 hydraulic tube assembly was found significantly chafed (P/N 82960010-103).

In particular, tube assemblies tend to fail at the bend radius and/or fail due to chafing damage from adjoining parts. ✖

Both hydraulic tubes were replaced, #1 and #2 Hydraulic Systems pressure checked and the aeroplane returned to service.

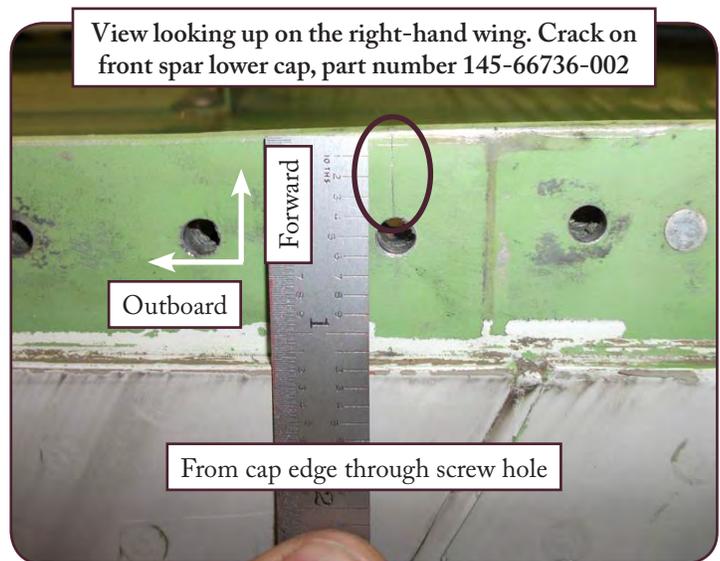
Wing Spar Crack

During a heavy maintenance visit while performing task card E57-22-00-220-808-2, the right-hand wing lower spar cap was found cracked at wing station 3815 (rib 9).

The crack emanated from the cap edge through a screw for a length of 2.159 centimeters (cm) (.850 inches).

The wing spar cap was repaired as per the applicable Structural Repair Manual (SRM) and the aeroplane was made serviceable.

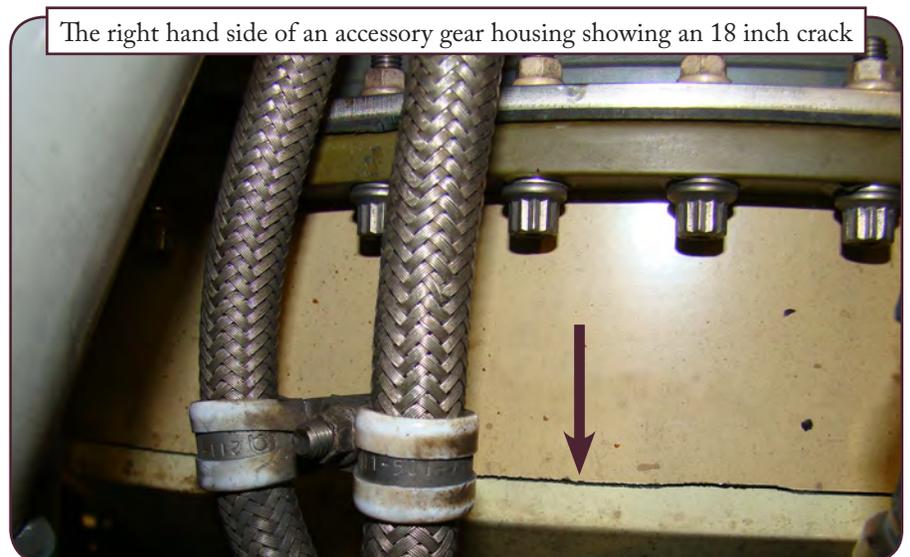
Cracked Engine Case

During troubleshooting of engine power issue, an 18 inch crack on the right hand side of the accessory gear case (magnesium housing), Time Since Overhaul (TSO):2119, was discovered. The crack extended approximately 180 degrees around the main diameter. This led to flexing of the engine case causing major internal rub damage to the rotating group and stationary components. The crack was found during trouble shooting of the engine running hot. The engine did not achieve target torque and was by-passing fuel at max Exhaust Gas Temperature.

It is possible that a previously installed engine truss assembly may not have been shimmed according to the Aircraft Maintenance Manual. This situation could create a stress loading on the engine case contributing to the crack. ✖
