Issue 3/2011

Canadian Aviation Service Difficulty Reports

TP 6980E
(9/2011)

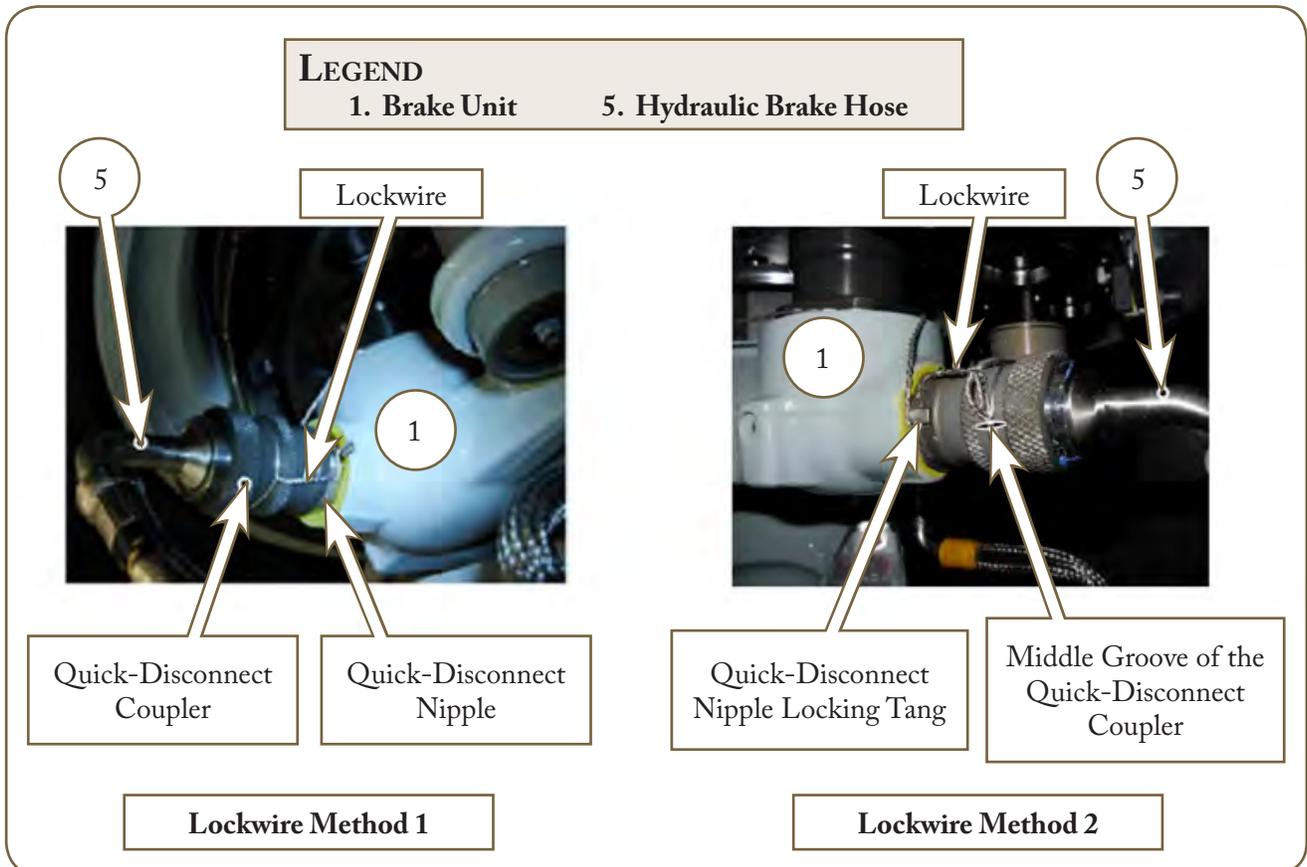
- 3 cases of brake quick disconnect (QD) fittings found loose which caused a landing with a locked / dragging brake. The loose QD allowed hydraulic pressure to be trapped within the brake causing it to remain locked on landing.
- 1 case where 2 QD fittings were found loose, causing the landing with no braking ability on the same gear.
- 3 potential cases where the QD fittings were found disconnected on the production line.

- Cleaning of the brakes could have lead to inadvertent disengagement of the QD locking tang subsequently leading to QD backing off (getting loose).
- QD was not connected properly (locking tang not engaged) after a brake carrier change.

When compared to the CRJ200/700 design, the CRJ705/900/1000 design is more susceptible to an incorrect installation through the inadvertent disengagement of the locking tangs. *(continued on next page...)*

The following Bombardier Aircraft Maintenance Manual (AMM) Temporary Revisions (TR) were released May 2011 which have introduced instructions to utilize 2 methods of lock wire on the brake QD for the CRJ705/900/1000. The addition of the lock wire is to prevent the inadvertent unlocking of the QD.

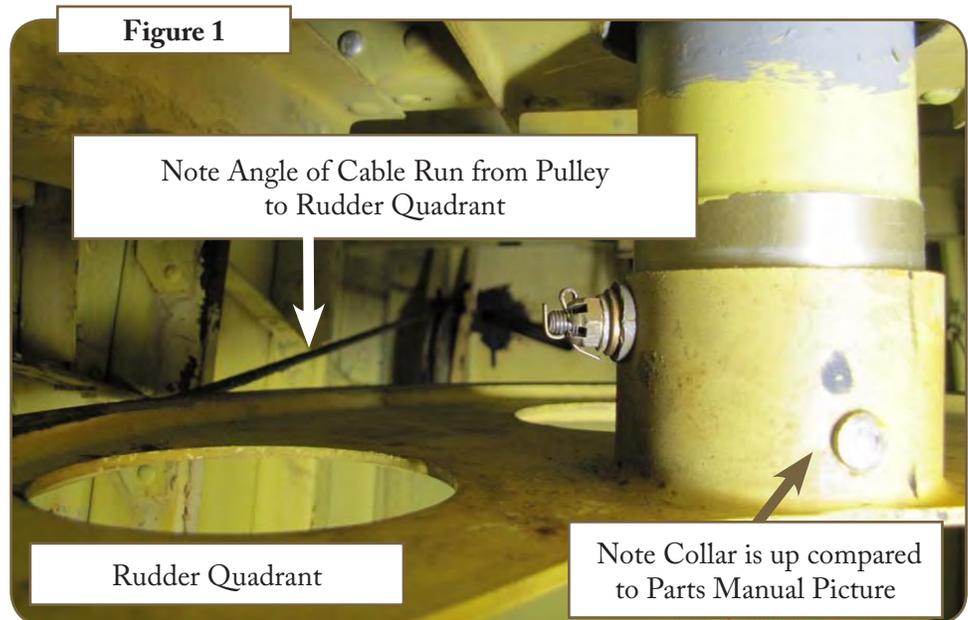
During a scheduled "B" check, maintenance discovered that the rudder quadrant located in the rear fuselage area was installed in an inverted or upside down position on its adjoining torque-tube tower-shaft. The aircraft maintenance engineer (AME) noticed that the flight control cables were not in line with the quadrant assembly as seen in figure 1.

Through the extended operation of the improperly installed rear rudder quadrant, abnormal abrasion and wear of the cable guides occurred as seen in figure 2.

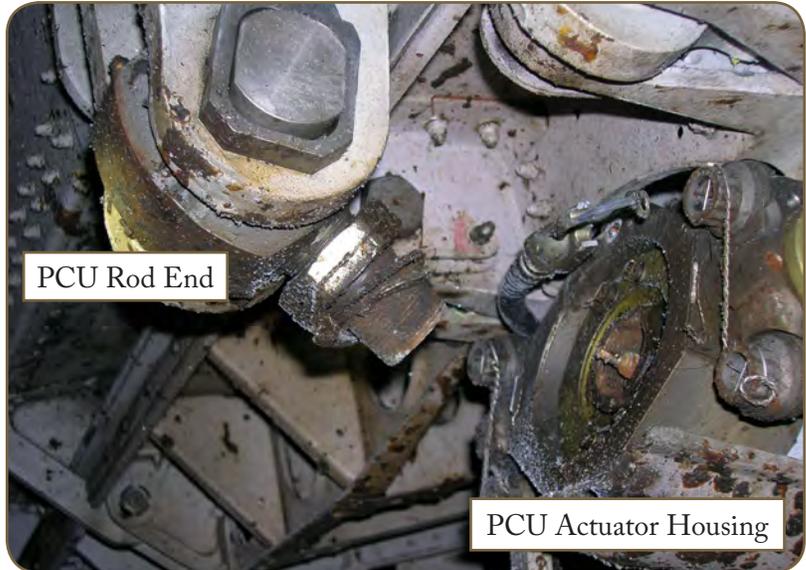
Flight Spoiler PCU Rod End Failure

During flight, a R/H spoiler panel began to float freely where maintenance discovered the #2 R/H Spoiler Actuator threaded rod end assembly had failed and separated from its adjoining PCU housing.

The flight spoiler PCU actuator was replaced, MEL removed and the aeroplane was made serviceable.

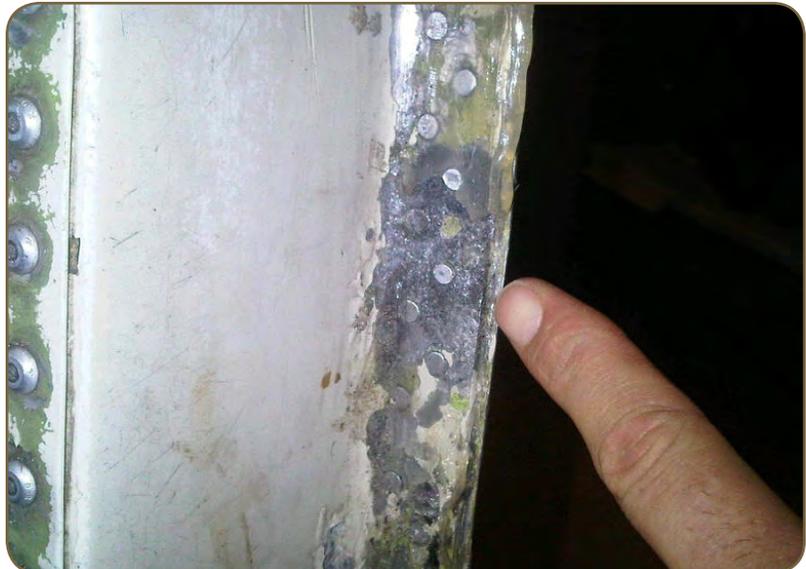
Passenger Door Seat Retainer Corrosion

The aeroplane passenger door seal had a small tear in it causing a pressurization leak. Upon maintenance inspection when the door seal was removed, corrosion was noted.

A further inspection found extensive corrosion through the skin with a width of 2.5 cm (1 in) by 1.27 cm (1/2 in) on the top of the door seal retainer under the seal.

A repair was carried out, the corrosion removed and the aircraft was made serviceable.

Transport Canada Civil Aviation (TCCA) would like to advise all owners and operators of this aeroplane model to be aware of this possible corrosion and BAEs corrective action to address this issue. ✖

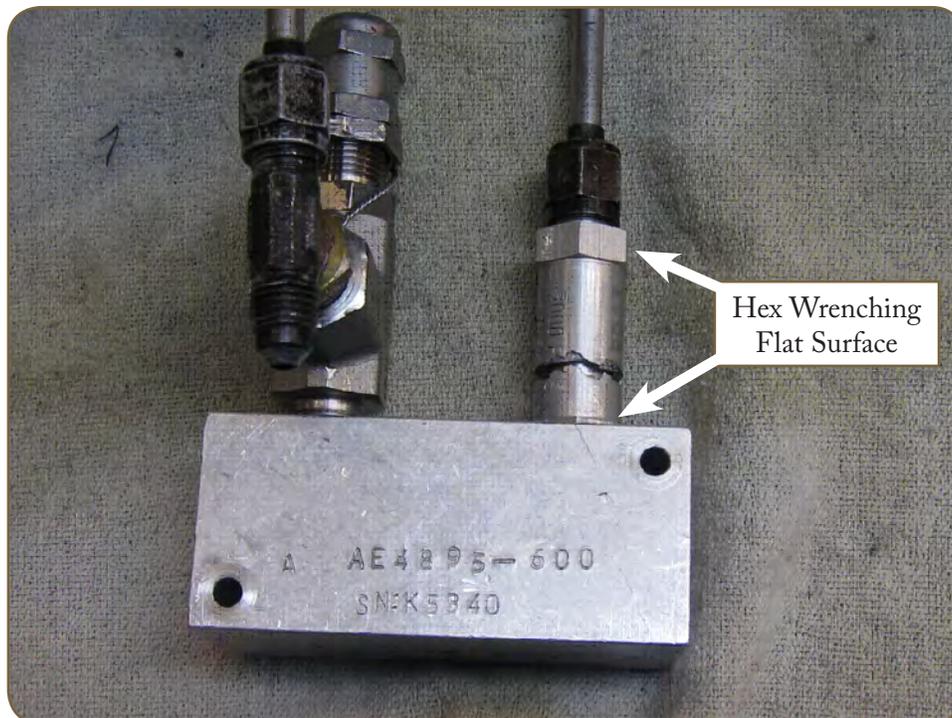
Cargo Door Hydraulic Leak

A hydraulic fluid leak was identified when closing the main cargo door. Maintenance investigation identified hydraulic fluid leaking from the cargo door manifold assembly at the check-valve body due to a circumferential and through crack.

It is suspected that the hydraulic line was torque during installation without the use and support of the check-valves Hex wrenching surface, stressing its cylindrical body and causing its failure.

The manifold assembly was replaced, a leak and function check carried out and the aircraft was made serviceable.

Transport Canada Civil Aviation (TCCA) would like to advise all maintainers the importance in understanding these design features and maintenance practices for the correct installation of hydraulic components. ✖

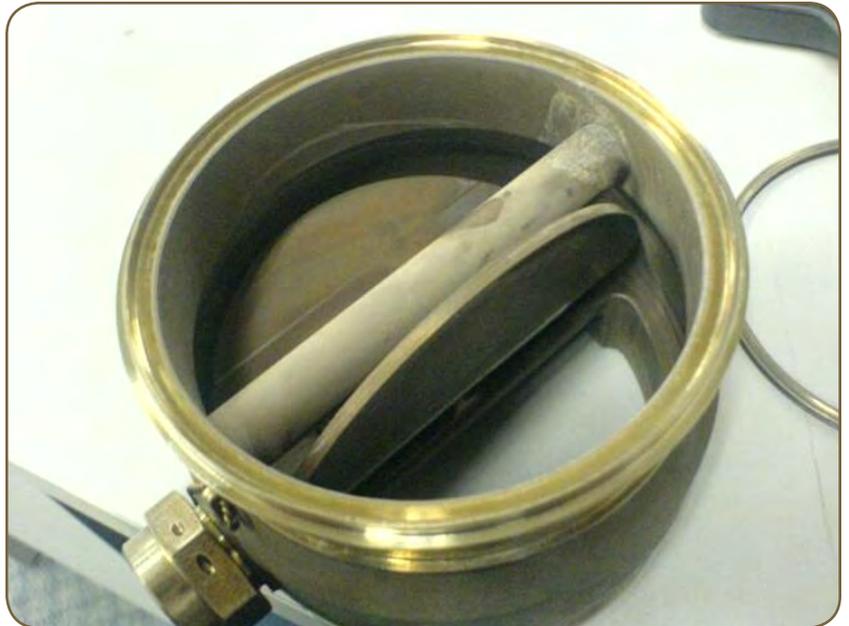
CFM56-7B Engine Check Valve Failure

During descent with the auto-throttle (a/t) engaged, the flight crew encountered a left engine surge and intermittent stalls. The crew disengaged the a/t and using manual throttle inputs, were able to sufficiently control the engines tendency to surge.

Maintenance personnel accomplished FIM 71-05 task 805 and subsequently found the 5th stage compressor check valve stuck open. The valve was replaced as the corrective action and the aeroplane was returned to service.

It is important for maintenance personnel to recognize the characteristics of a failed engine compressor check valve to prevent further engine surging. ✖

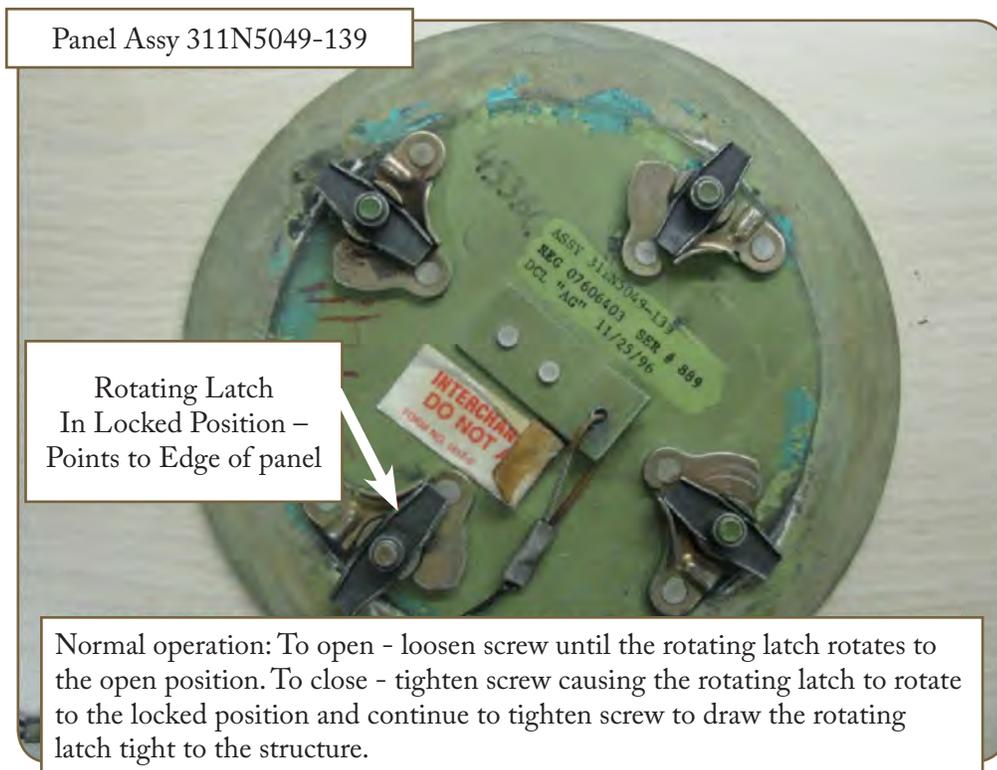
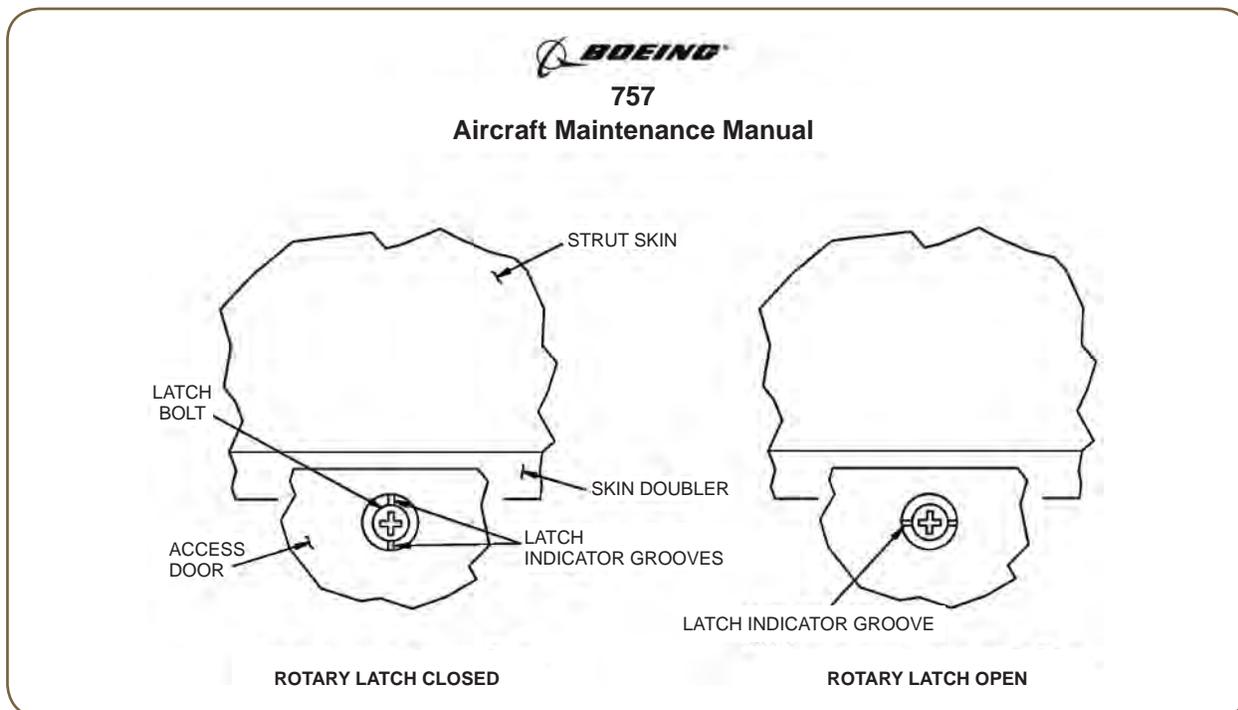
Boeing AMM 54-53-01 defines the correct panel "latch indicator groove" alignment as seen below for a "closed/locked" and "open/unlocked" position.

Also included is a picture of the backside of the panel as seen in the "closed/locked" position. Note that the "groove indicator" marks are a direct indication of the rotating latch position which retains the panel to the pylon structure. ✖

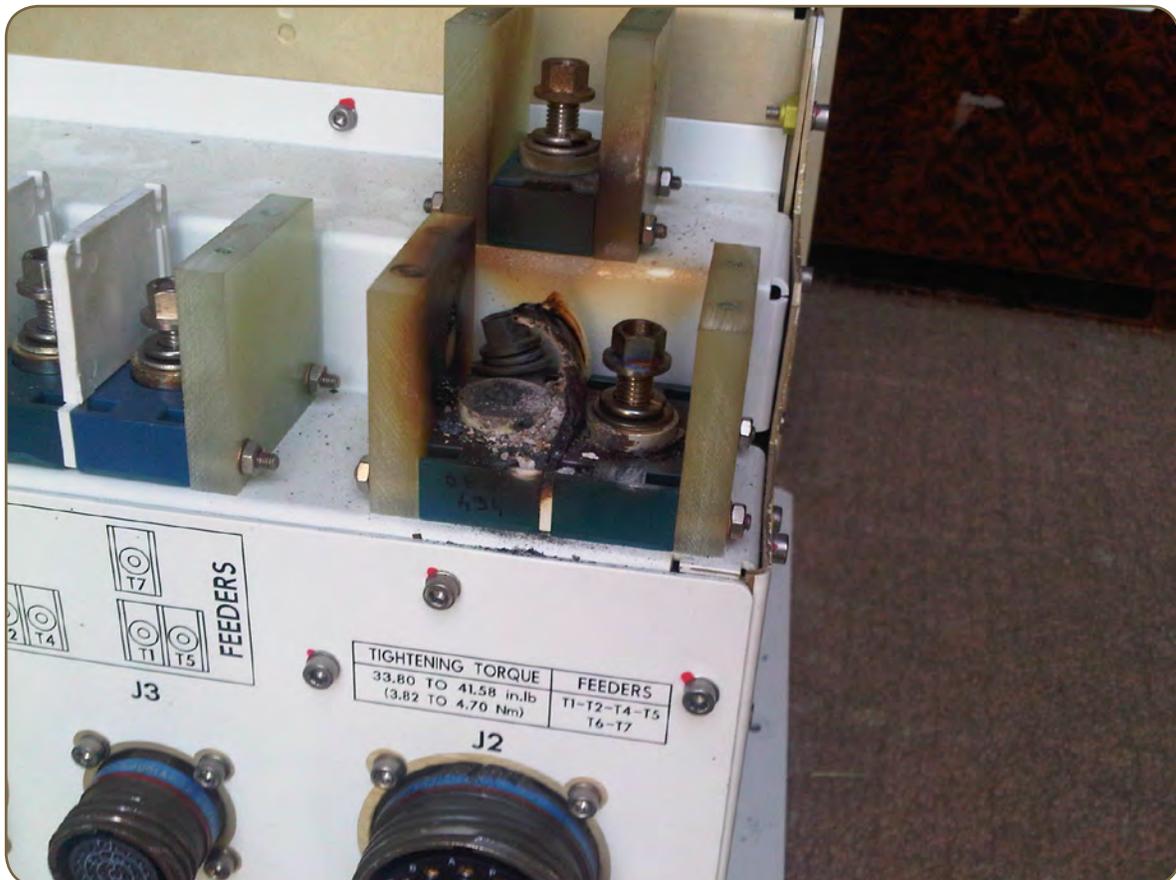
Global Express Secondary Power Center Stud Burn

The flight crew reported that the multi-functional display (MFD) unit 1 went blank. APU would not start and after engine start, "DCU A OFF", Flaps Fail, Fire Sys. Fault, Inboard Brakes Fail, L/H IAPS Fail, Pack Fail, Cabin Pressure Fault, FDR Fail, R/H Eng. Thrust Fault, R/H Eng. Fault, RDC Fault and MFD XTALK Fail messages appeared. MFD 1 and 2 swapped and the failure condition remained on the same side. There were no electrical fault CAS messages except for the DAU A circuit-breaker (CB) had tripped.

Two bus bars (ESS bus) were confirmed with no power and the battery connections were verified all good. On visual inspection of the L/H Secondary Power Center (SPC), the T1 wire-lead and stud was confirmed as badly burnt and melted.

The SPC was replaced and the aeroplane was made serviceable.

Transport Canada Civil Aviation (TCCA) would like to emphasize to all operators and maintainers, the importance of correct wiring installation torque values of wire lead stud attachment points. ✖

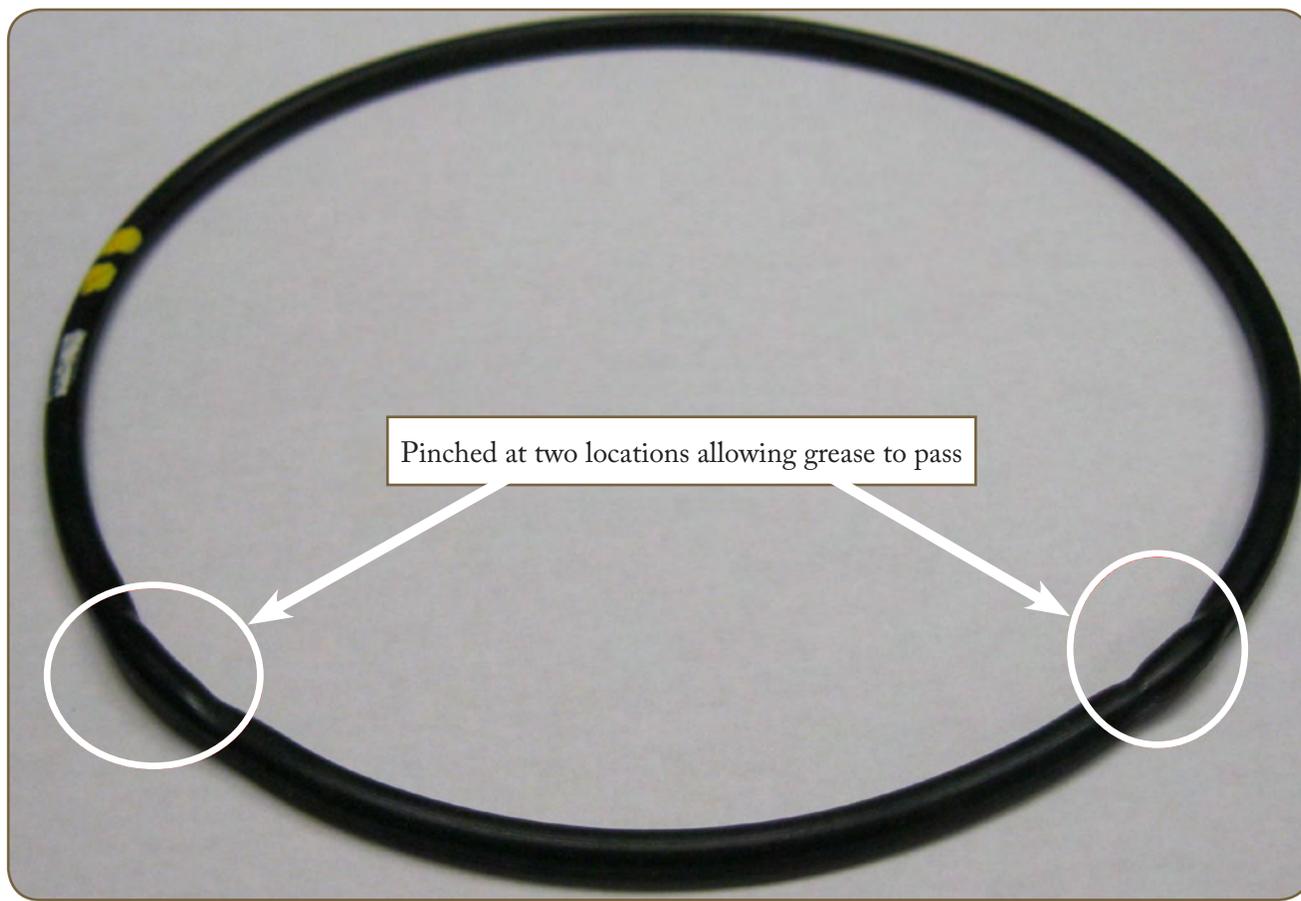
Global Express NLG Trunion End-Cap O-Ring Pinched

Maintenance investigation revealed that the bearing caps recessed O-ring was improperly installed and found pinched, allowing grease to ingress into the pressurized nose fuselage underfloor area.

Grease in that area is potentially dangerous because of the close proximity of four oxygen bottles therefore Bombardier Aerospace has issued advisory wire AW700-53-0328, defining this possible scenario and corrective action.

The O-ring was replaced and correctly installed; cap reinstalled per AMM and the aeroplane was made serviceable.

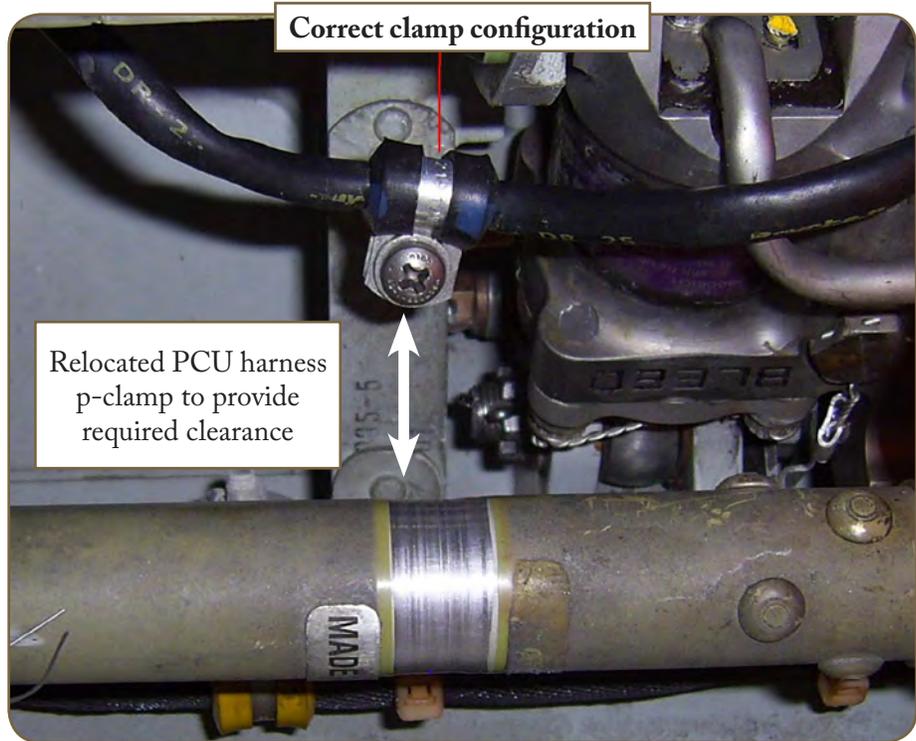
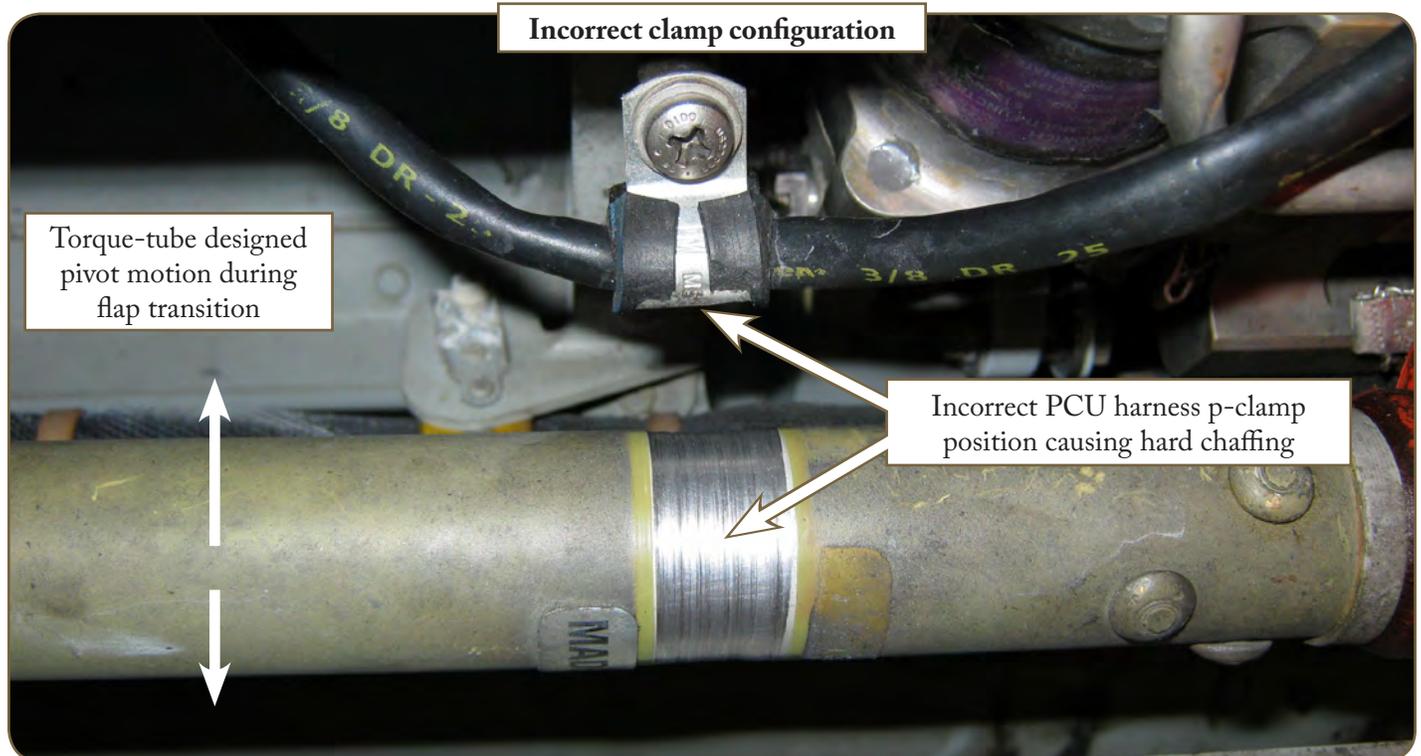
Spoiler Power Control Unit Harness Clamp Chaffing

TCCA advises all operators of this possible PCU harness configuration discrepancy. ✖

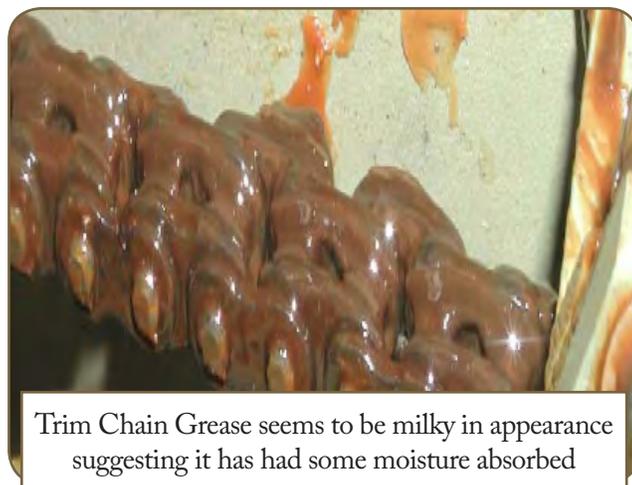
Maintenance personnel carried out a functional check of the elevator trim system but were unable to duplicate the reported condition. Further examination revealed that the elevator trim screw jack assembly lubricant appeared to be milky in color with some water visibly present. Both the L/H and R/H screwjack assemblies were then purged of all contaminated grease/water and lubricated in accordance with the manufacturers’ instructions.

Trim Chain Grease seems to be milky in appearance suggesting it has had some moisture absorbed

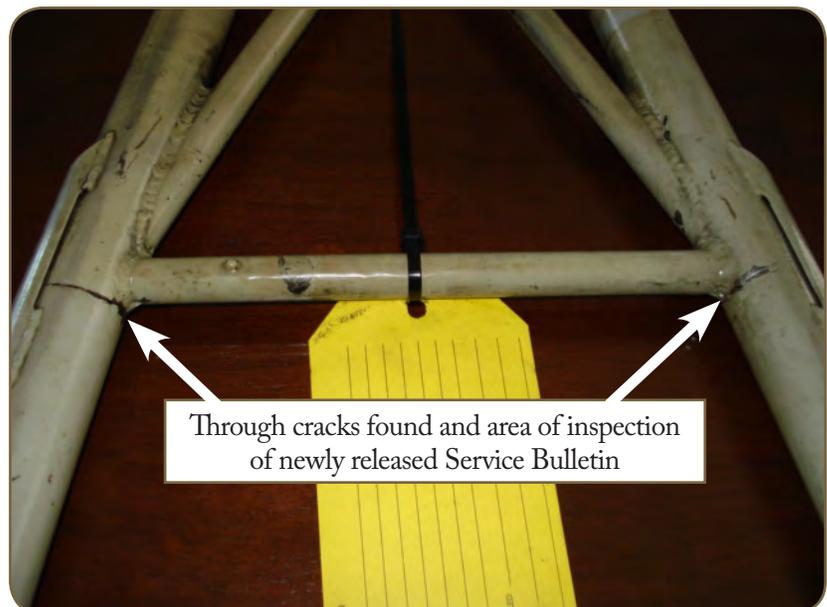
Engine Mount Cracks

Upon a routine servicing, maintenance found the L/H lower engine mount tubular frame to be cracked through on both of the inboard and outboard areas. The engine mount was removed and sent for repair.

TCCA would like to advise all operators that M7 Aerospace have recently issued Service Bulletin 226-71-018 for a detailed inspection of the concerned engine mount area. ✖

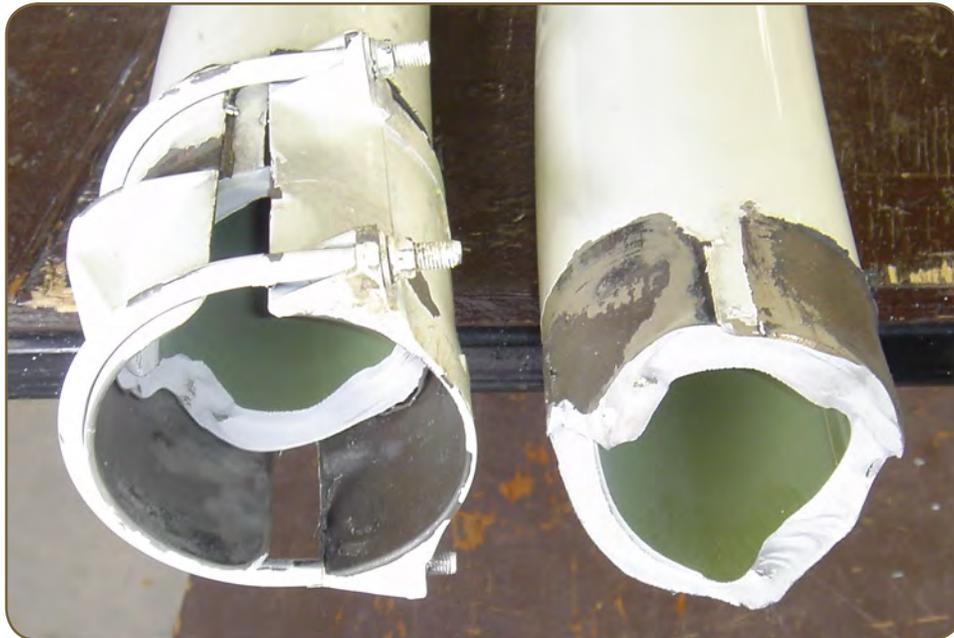
Cross Tube Cracked

While landing on a heli-ski run, a loud bang was heard and there was some slight settling on the right rear side of the helicopter. Inspection by heli-ski guide found no indications so operations continued. Post flight inspection by an AME found the aft landing gear crosstube cracked.

Upon removal, the crosstube was found broken through under the saddle. The crack is believed to have progressed from a small corrosion pit.
