Transport  
Canada

Issue 4/2010

# Feedback

Canadian Aviation Service Difficulty Reports

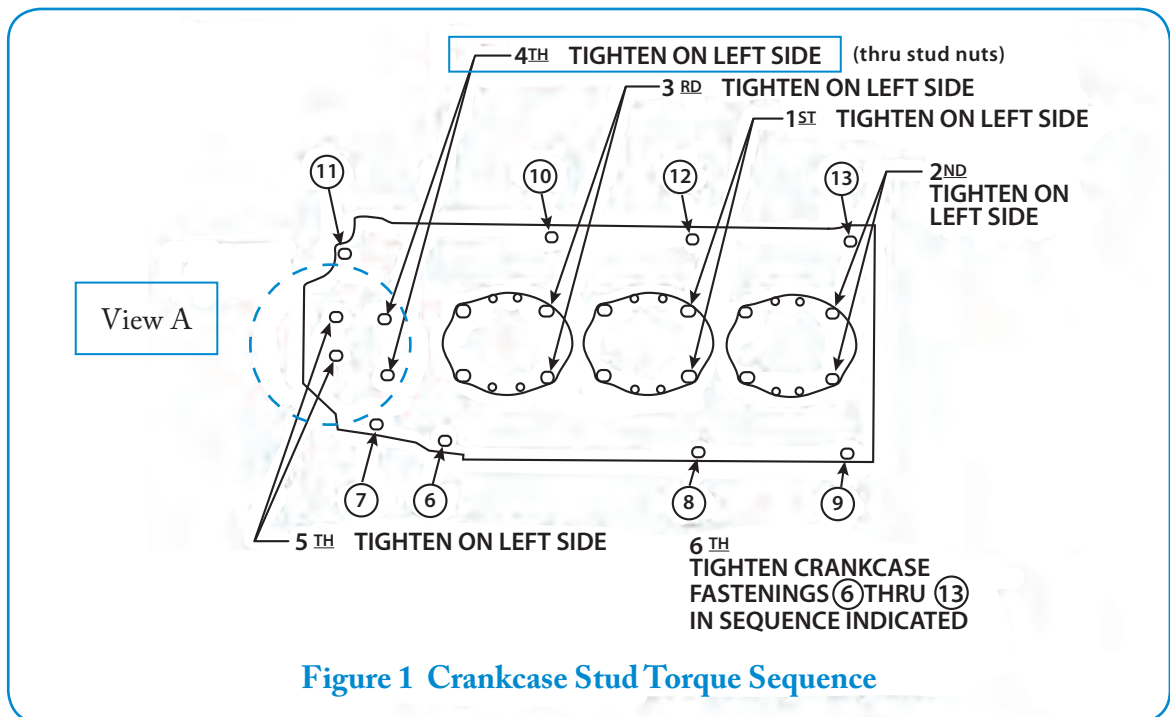
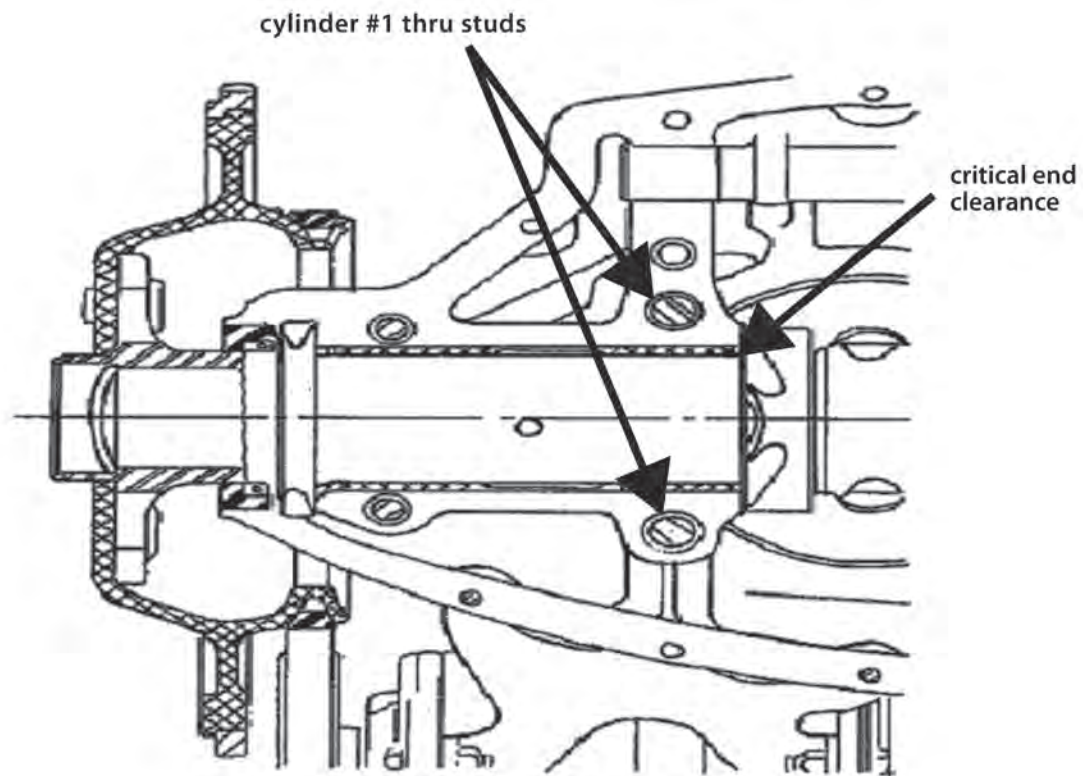
**Figure 2 Crankshaft forward bearing end clearence and thru**

Engine case halves that are loose will allow bearings to work themselves out of place as a result of various action/reaction forces during normal engine operation. This bearing may then move, closing the essential end clearance as seen in figure 2 (view A), and make contact with parts of the crankshaft, resulting in the creation of stress risers and eventual failure of the crankshaft.

Loose engine case halves will not retain bearings in the proper position as a result of various action/reaction forces during normal engine operation. If the essential end clearance as seen in figure 2 (view A) is not maintained, the crankshaft will eventually fail.

Therefore, Transport Canada Civil Aviation emphasizes to all aircraft owners and operators the importance of following the manufacturers' instructions. In particular even if only one cylinder is being replaced all engine case nuts and thru stud nuts need to be properly retorqued. ✖

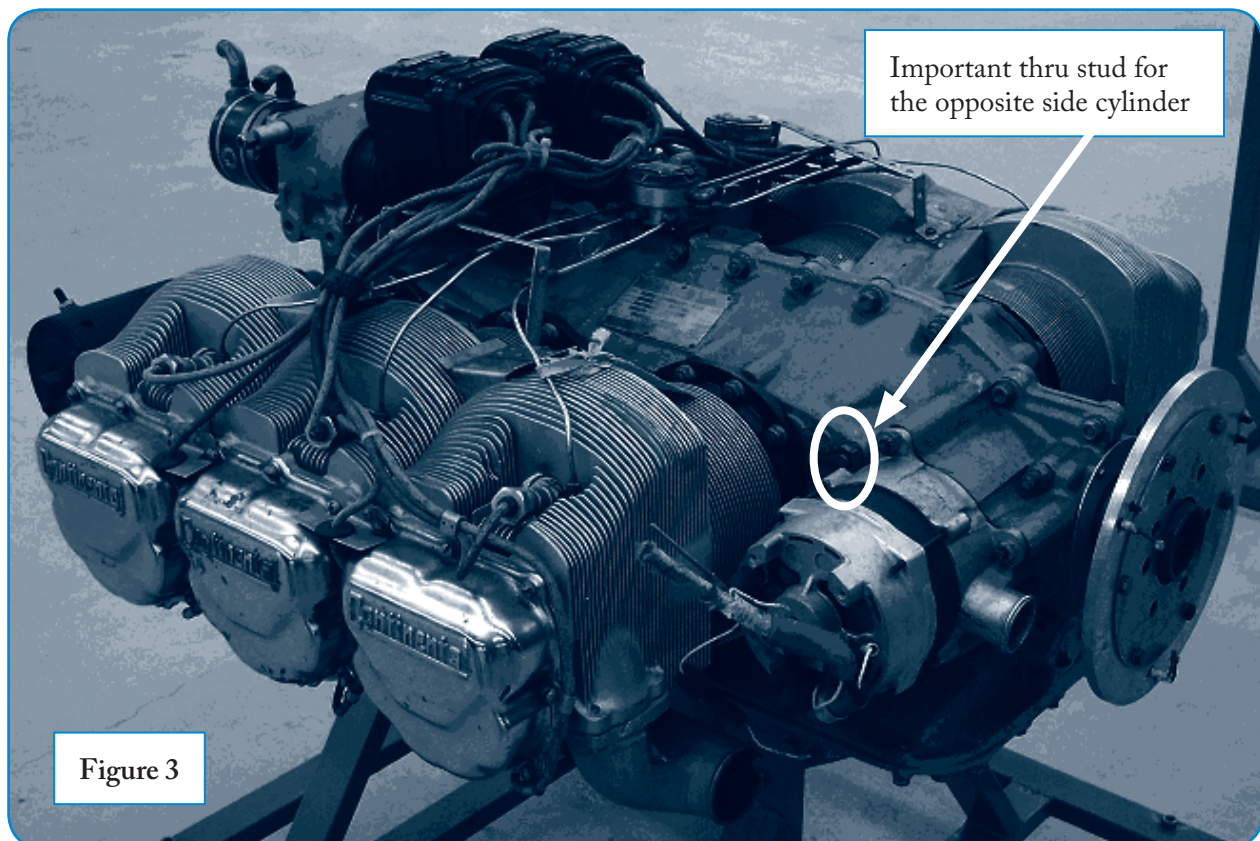
**Figure 3**

not changed unless obviously worn. The nuts on the opposite side (as seen in figure 3 as thru studs) must also be tightened to the proper torque in conjunction with the application of lubricating oil. The manufacturer has provided information that the non-use of lubricating oil or the failure to apply the proper torque will result in an under tension condition on the thru studs and eventual failure of the engine.

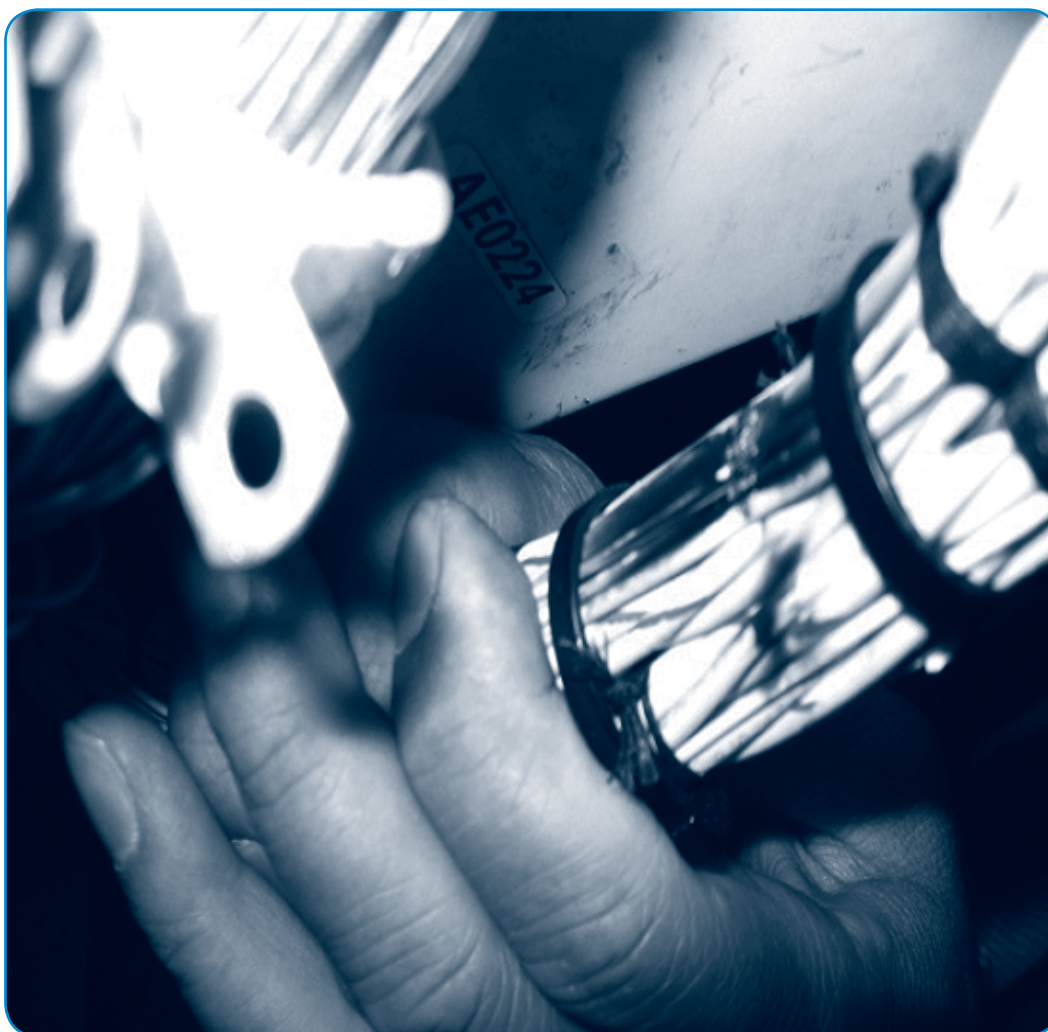
Sparks were noted emanating from an In-Flight Entertainment (IFE) wire bundle section below floor of a Boeing 767. This condition resulted in the tripping of circuit breaker TR-4. Further maintenance investigations found a wire arcing and shorting to a clamp due to its shielding being worn. The bundle was opened, repaired with a sealed splice per SWPM 20-30-12, then cleaned and inspected for further damage. Additional protection with tape per SWPM 20-10-13 was applied and a larger replacement clamp was used. The wire bundle was resecured; TRU #4 and Thales system checked serviceable per Thales AMM SUPP. 44-22-04.

*Always ensure harnesses are well supported through correct clamp sizes and proper shielding. ✖*

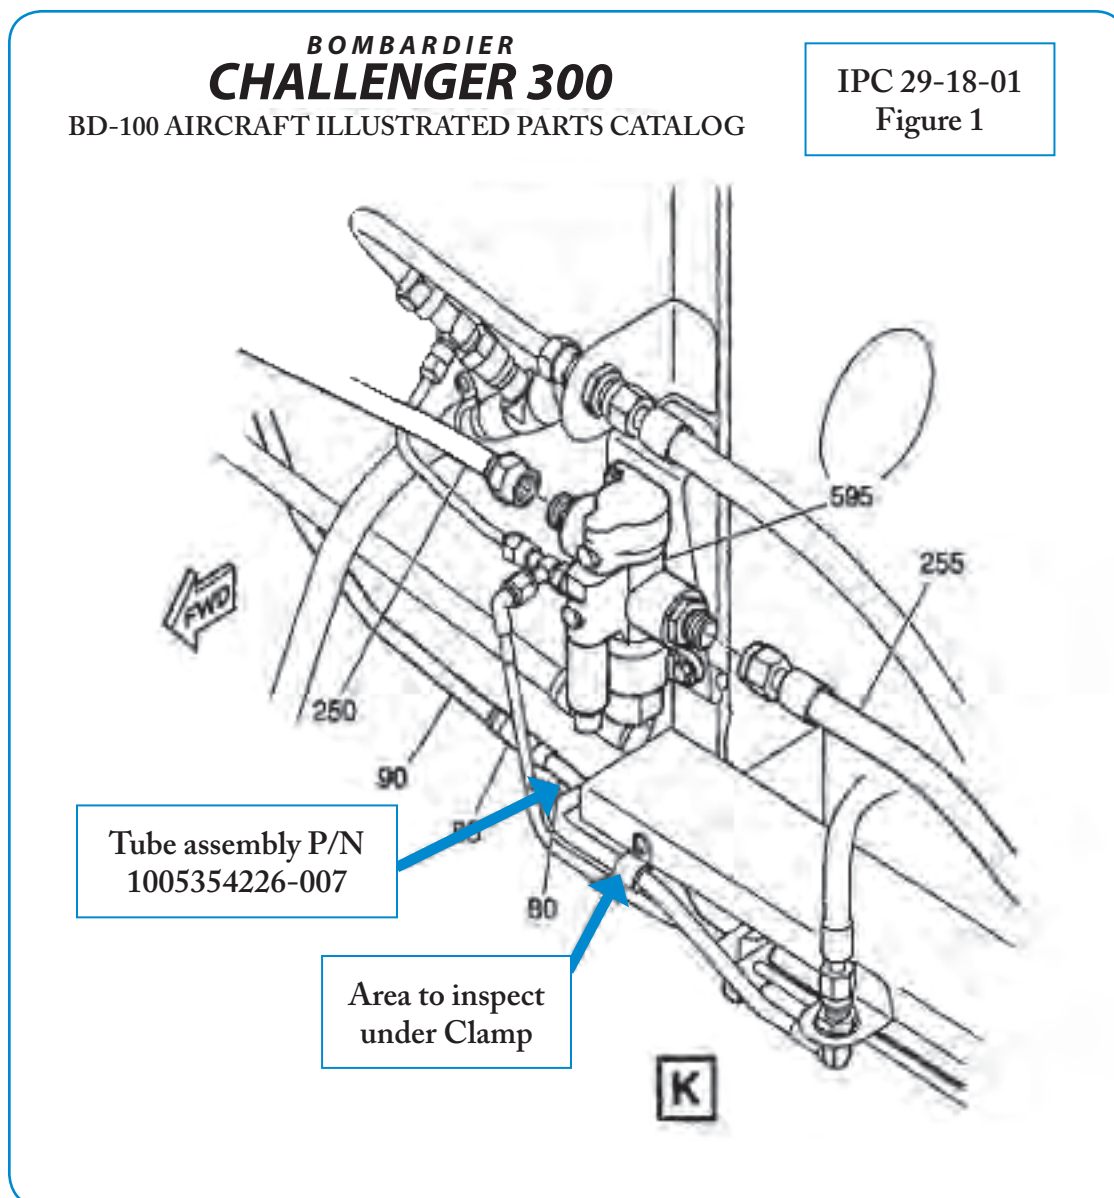
## Chafed Hydraulic Line on Challenger 300

Maintenance found a hydraulic line in the aft equipment bay that had a hole in it caused by chaffing on a fairlead block.

*This is the second SDR received in 30 days for chaffing hydraulic lines in the same area. Proper protection and clearance will prevent line chaffing and prevent in-flight safety occurrences. ✖*

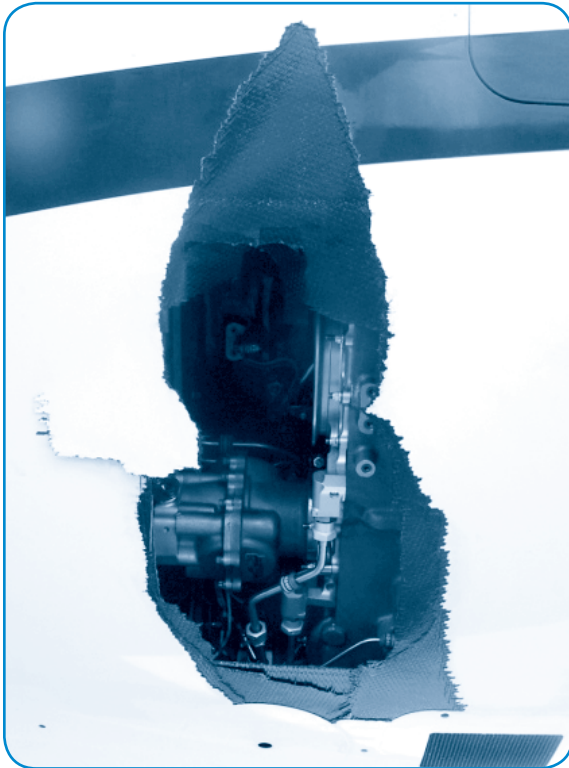
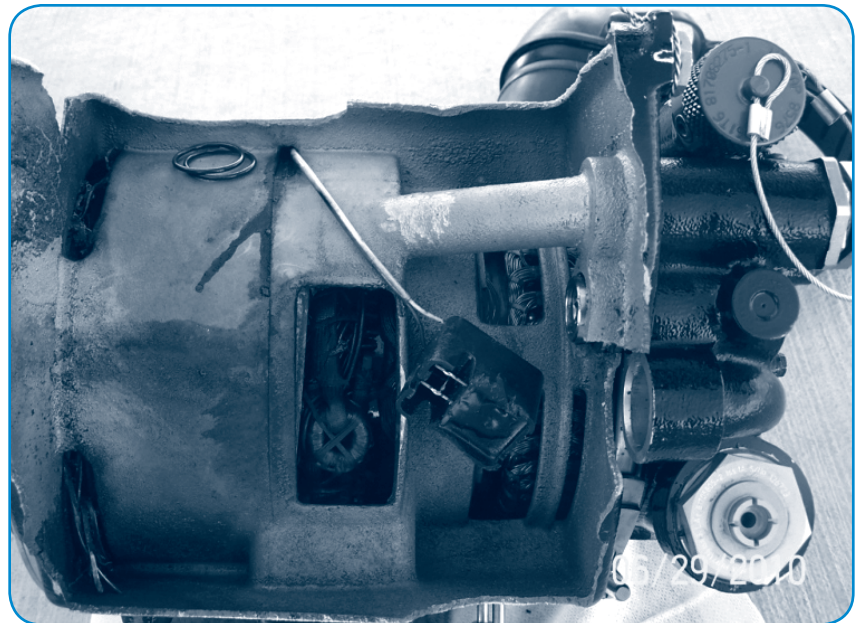
## Variable Frequency Generator Rupture and Failure

In cruise after 8 hours of flight, the aeroplane had a Variable Frequency Generator (VFG) #1 fail. The crew heard a loud bang followed by a "Gen 1 Fail" message on the Engine Indicating and Crew Alerting System (EICAS). A visual inspection conducted after landing confirmed that the L/H engine lower cowling had been punctured and the VFG sump casing was extensively damaged. Additional damage to the VFG #1 oil and the engine driven pump (EDP) drain line was found.

*Failure investigation has revealed that under cold conditions in flight, where the VFG oil viscosity is high, the cooling oil flow is reduced which can lead to rotor diode failure. This investigation has been linked to a recent change in oil filter element material with low oil flow at low temperatures.*

*Bombardier Aerospace has issued Advisory Wire AW700-24-0313 rev 8 and will continue to investigate this occurrence. ✖*

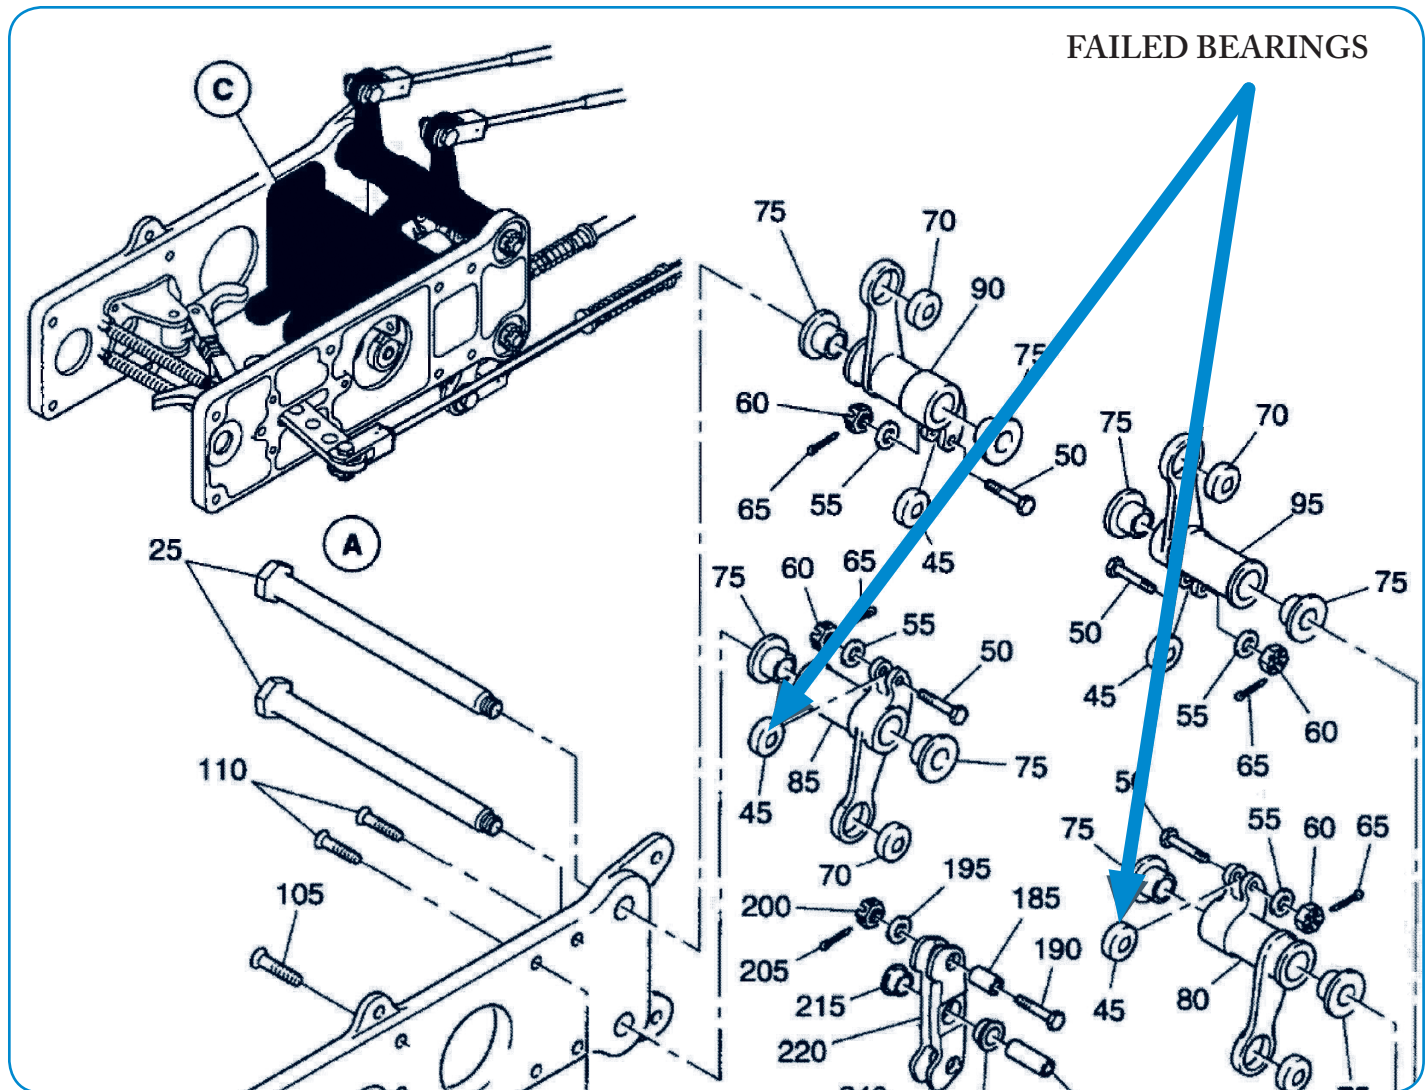
## Loose Bearings

While rigging the parking brake cable, small balls were found at the bottom of the compartment housing the brake control valve P/N 600-88101-125. Upon further investigation, it was discovered that the two follower

bearings for the pilot brake pedal input to the brake control valve were destroyed.

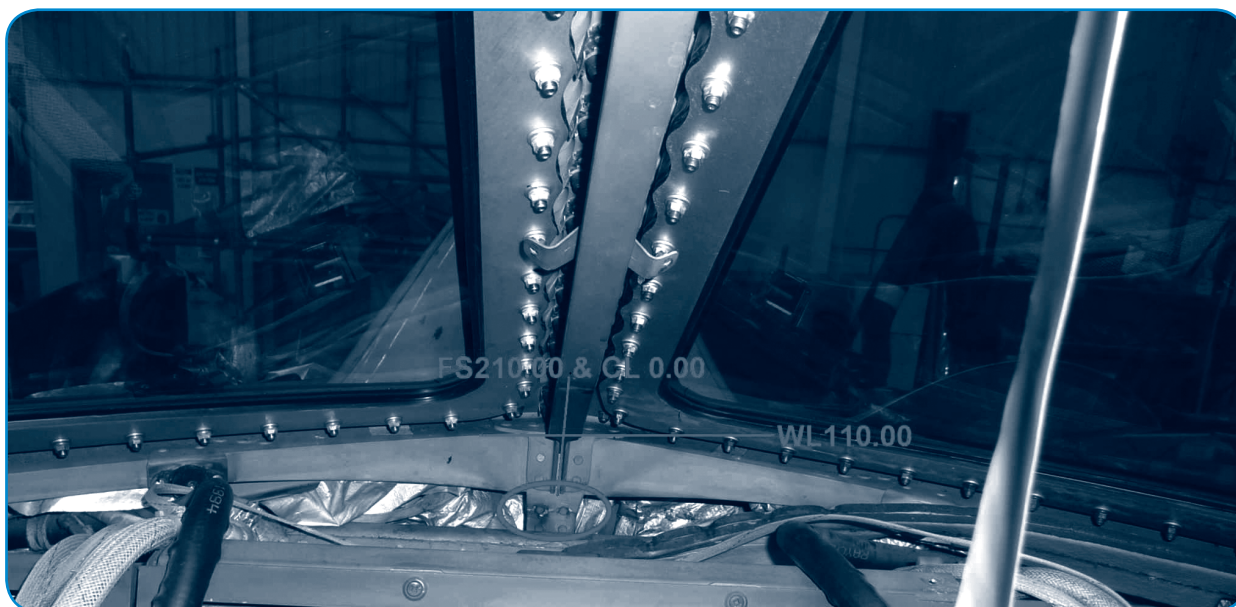
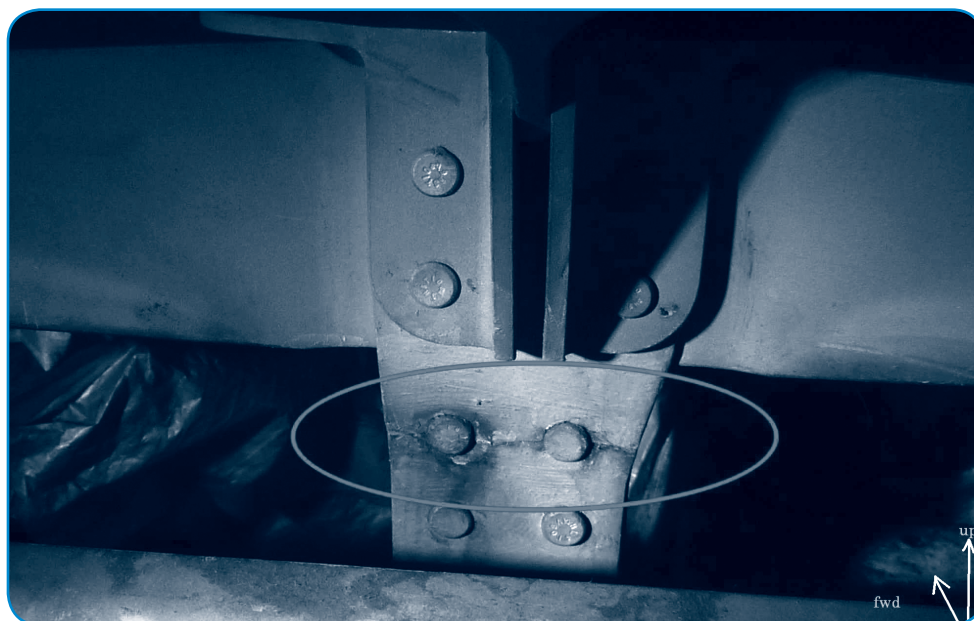
## Windshield Center Post Support Structure Crack

During a scheduled maintenance visit and completion of task RJ2-53-220-604, detailed inspection of a CRJ 100 windshield center post and bulkhead aft post at FS202.75, maintenance found the windshield center post lower forward strap cracked at FS210.00, CL0.00 and WL110. The post strap was repaired per drawing and Structural Repair Manual (SRM) and made serviceable.

*This aircraft had accumulated 32 300 hours of flight and 26 141 flight cycles when this crack was found during a 72 month inspection interval.*

*Transport Canada Civil Aviation would like to emphasize the importance for all maintainers to follow the required maintenance program that is defined by the manufacturer. ✖*

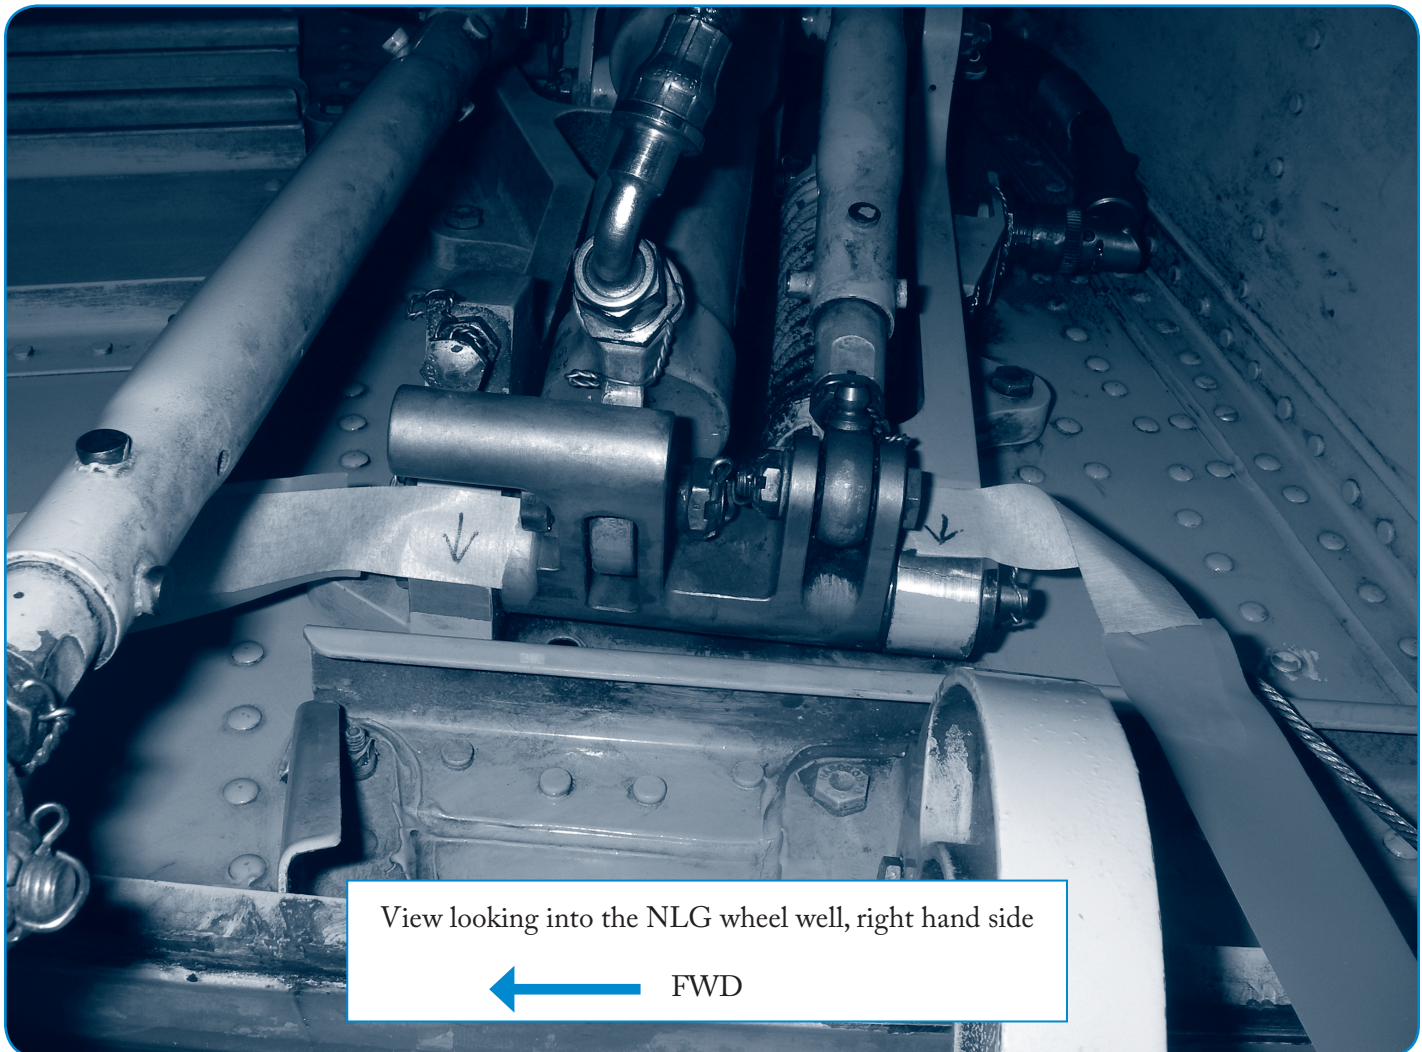
## NLG Door Actuator Support Mechanism Cracks

During a routine inspection, maintenance found cracks on the base of the nose landing gear door (NLG) actuator support mechanism, located in the NLG bay.

The cracks were at both the forward and aft lug pivot points for the lower lever pin. A new NLG door mechanism was ordered, the mechanism was replaced, functional tests were carried-out and the aeroplane was made serviceable.

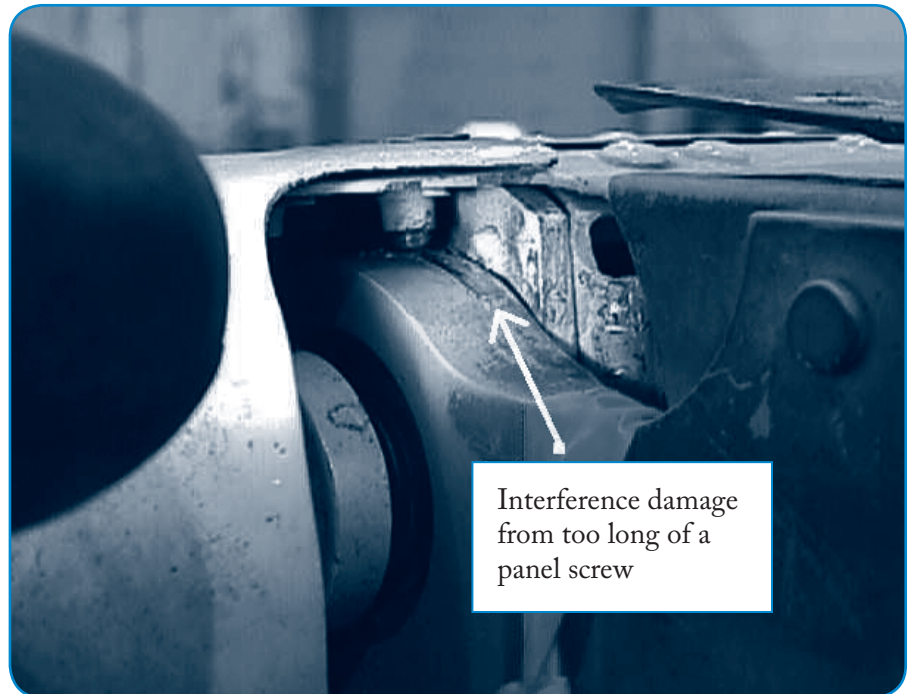
## Elevator Hinge Fitting - Gouged

Upon removal of elevator panels to facilitate inspection; it was discovered that the R/H elevator hinge fitting was grooved/gouged on the top radius of the fitting. It was apparent that the gouging was caused by one of the panel screws that attach the R/H elevator end cap fairing was too long. When the elevator controls were moved, the screw would continue to wear a groove in the fitting. It was later determined that incorrect screws were installed (too long) in the upper elevator access panel.

*Over a period of time, the structural integrity of the elevator fitting could be degraded. As a result, it would be an ideal condition for stress corrosion and possible failure of the elevator fitting. ✖*

The Convair parts catalogue calls for an AN509-10-R7 screw; the rest of the fleet will be inspected for similar condition and rectify as necessary.

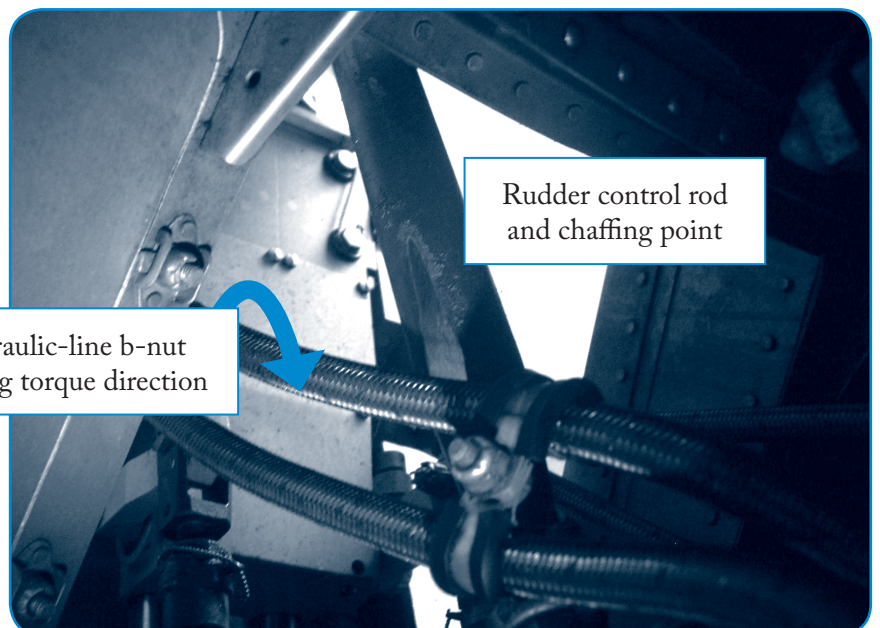
## Rudder Push-rod Chaffing

During a scheduled maintenance inspection, the rudder push-pull non-adjustable rod was found chafing hard against an elevator servo hydraulic pressure line. The rod was replaced with serviceable unit and the lines repositioned.

*It is suspected that the elevator servo pressure line was improperly tightened in a manner that allowed it to twist and in-turn causing it to chafe on the rudder push-pull tube.*

*Transport Canada Civil Aviation recommends that when working in this area to pay close attention to this possible scenario and to always ensure not to pre-load hydraulic lines during installation. ✖*

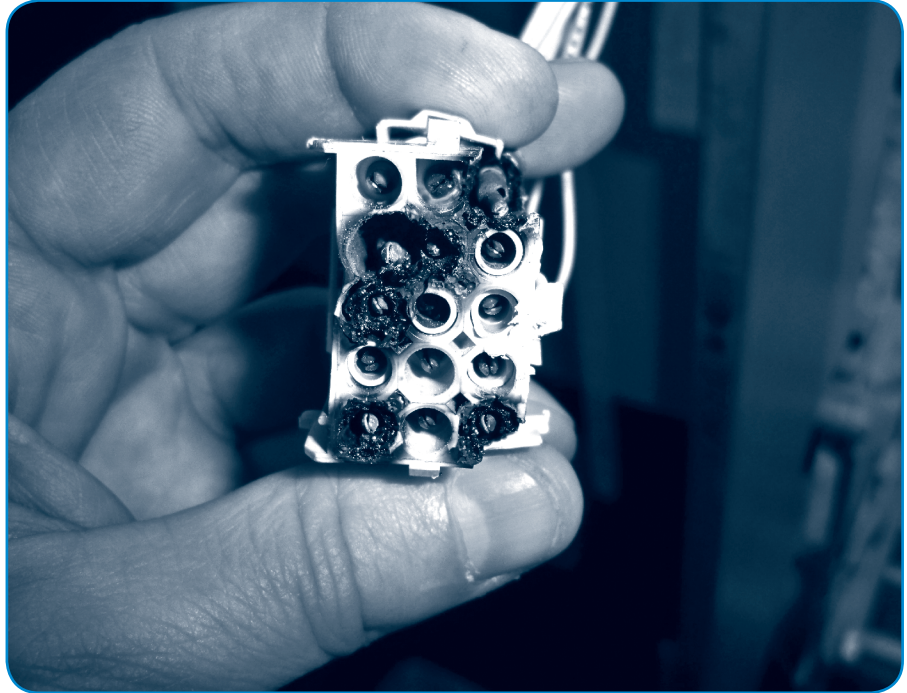
## Cabin Overhead Connector - Overheated

During a major inspection, the L/H overhead light connector 3320-P40 and receptacle 3320-J35 were found severely burnt.

*It is unknown what caused this extensive damage; however, connectors have been particularly vulnerable to condensation in the past, due to condensation within the shell. Special connectors with waterproof features have been developed for use in high humidity areas (e.g. cabin overhead ceiling areas). ✖*

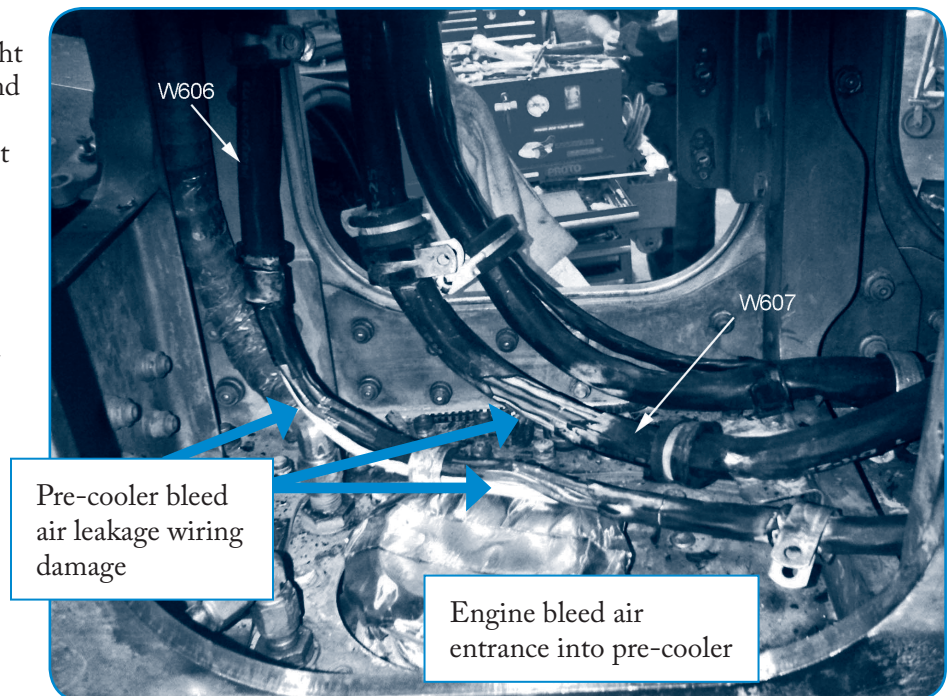
## Pre-cooler Seal Failure and Wiring Damage

While maintenance was performing a scheduled inspection task within the right engine pylon, wiring harnesses W606 and W607 including some adjoining clamps were found with heat damage from a hot air lead at the pre-cooler.

*The pylon harnesses that are being damaged by the pre-cooler engine bleed air leakage provide various engine control and monitoring functions.*

The wire harnesses were repaired as per the standard wiring practice manual (SWPM) and the pre-cooler gasket was replaced and the aeroplane was returned to service.

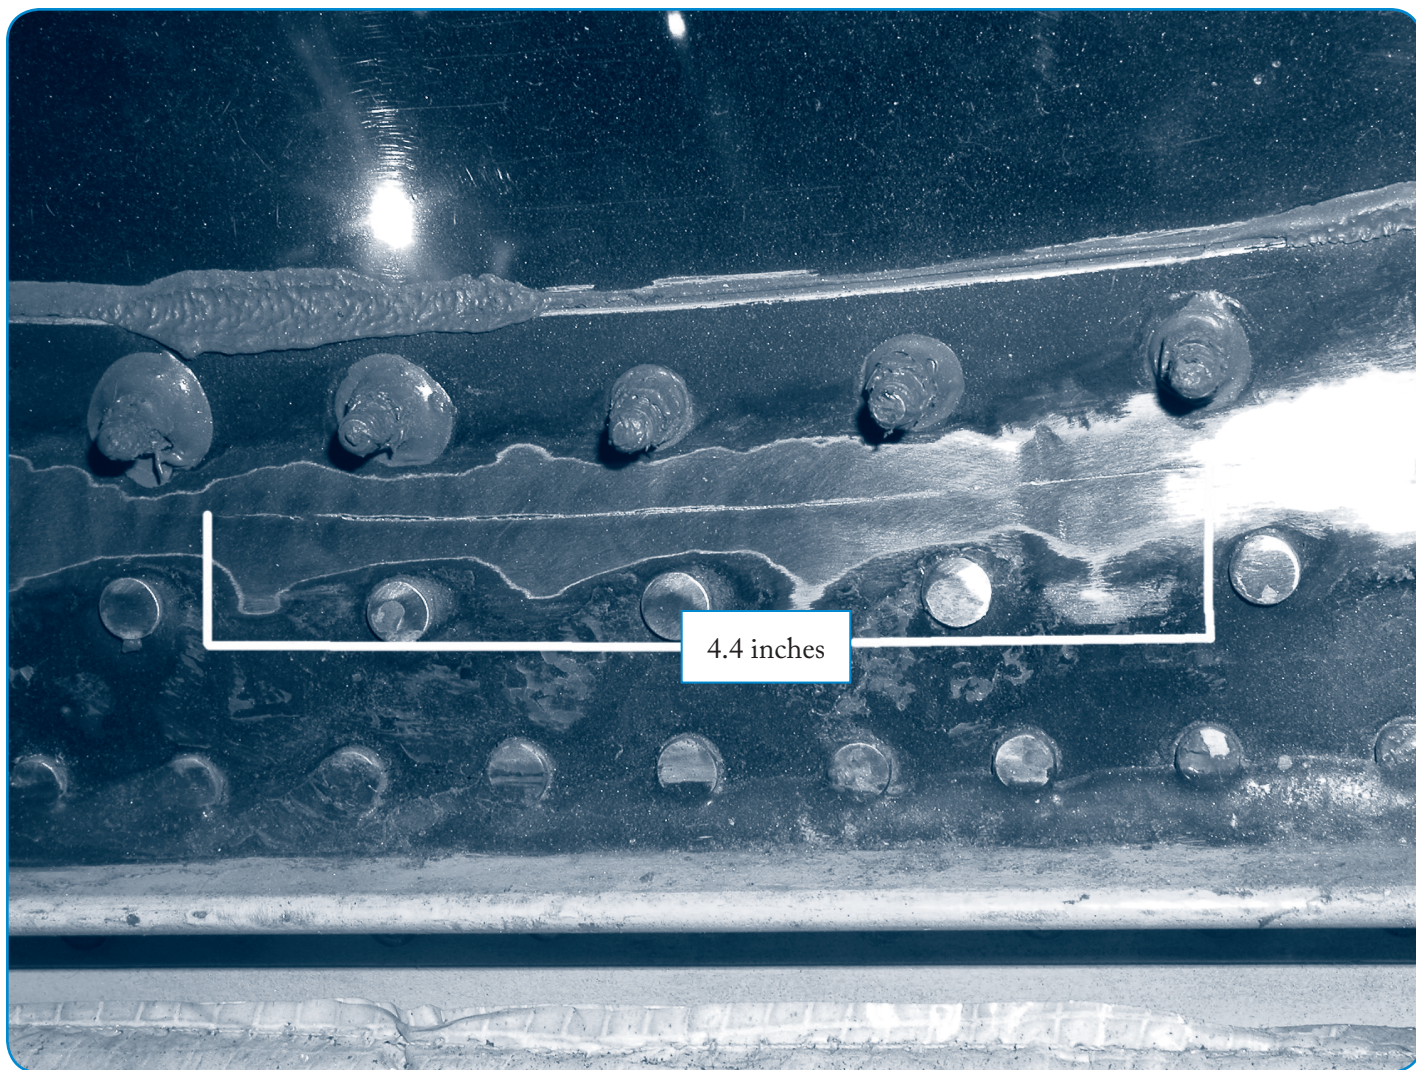
## Metroliner Cabin Window Retainer Crack

The aeroplane was undergoing a cabin inspection for window frame fastener corrosion when maintenance found a crack in R/H #4 window inner retainer. The crack measured 11.176 cm (4.4 inches) running between and parallel to the 2 rows of fasteners at the lower edge of the retained.

*This retainer is the only structure attaching the window assembly to the fuselage and if the crack was*

The window structure was repaired and the aeroplane was returned to service.

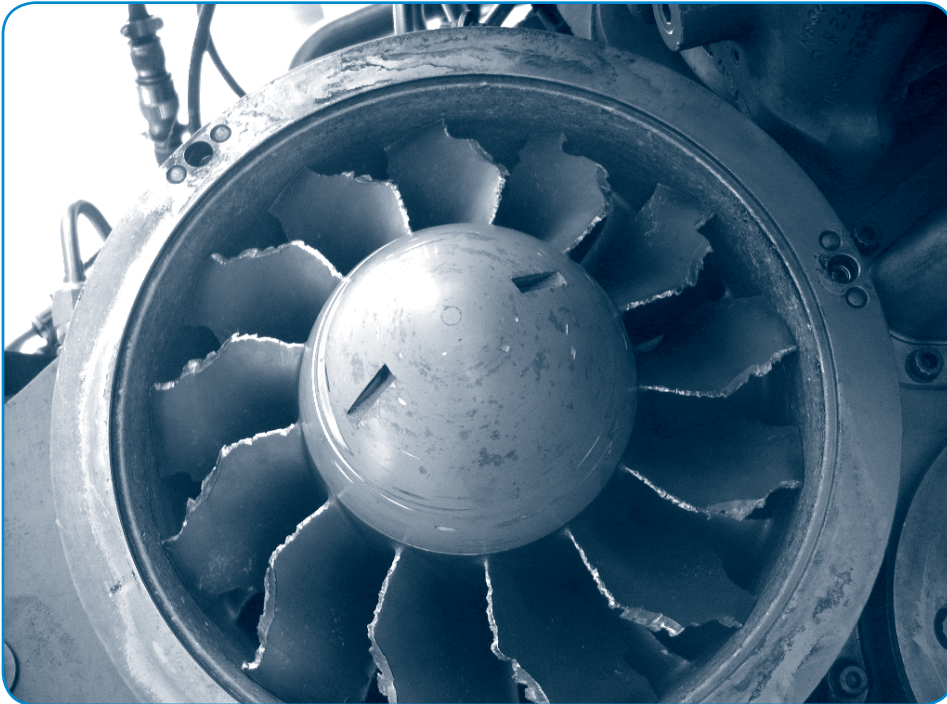
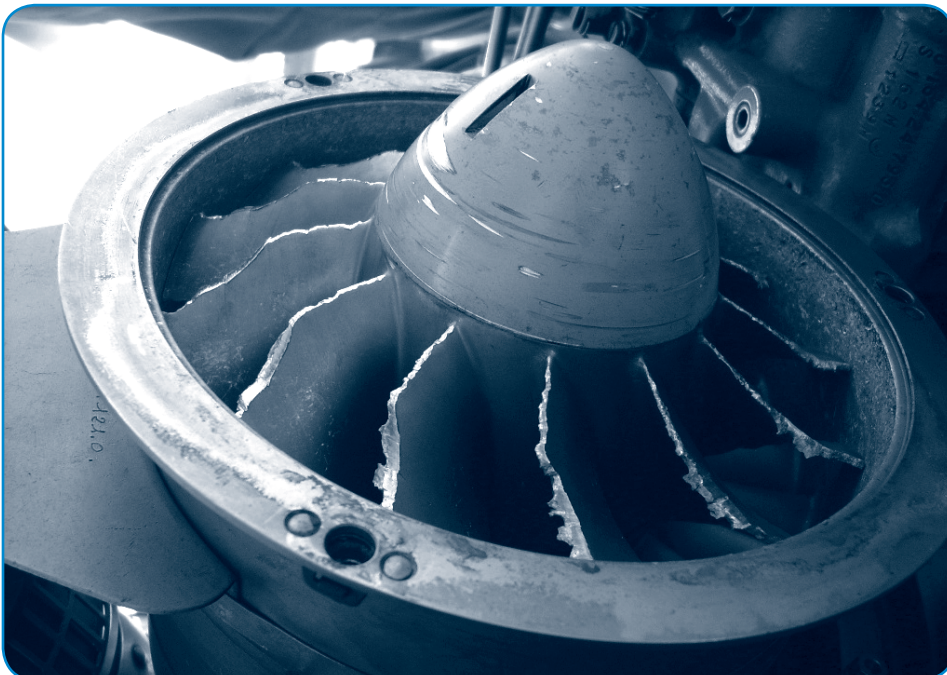
## AS 350B Compressor Damaged

Pilot was taking off from base, reported hearing odd whining from engine during takeoff and power changes. Aborted takeoff and returned to staging area. Opened engine cowl, noted aluminum shavings on engine deck. Visual inspection identified the compressor wash union Part Number (P/N) 350A54-1112-20 welded boss on intake assembly P/N 350A54-1080-04 had broken off

and become ingested into the engine. Aircraft had been subject to scheduled inspection less than 10 hours prior, with no defects noted at that time. Aluminum shavings from welded boss were found ejected out of the bleed valve and out of the exhaust. The steel union did not get ingested, but bounced around in the intake plenum causing substantial damage to the axial compressor. ✖

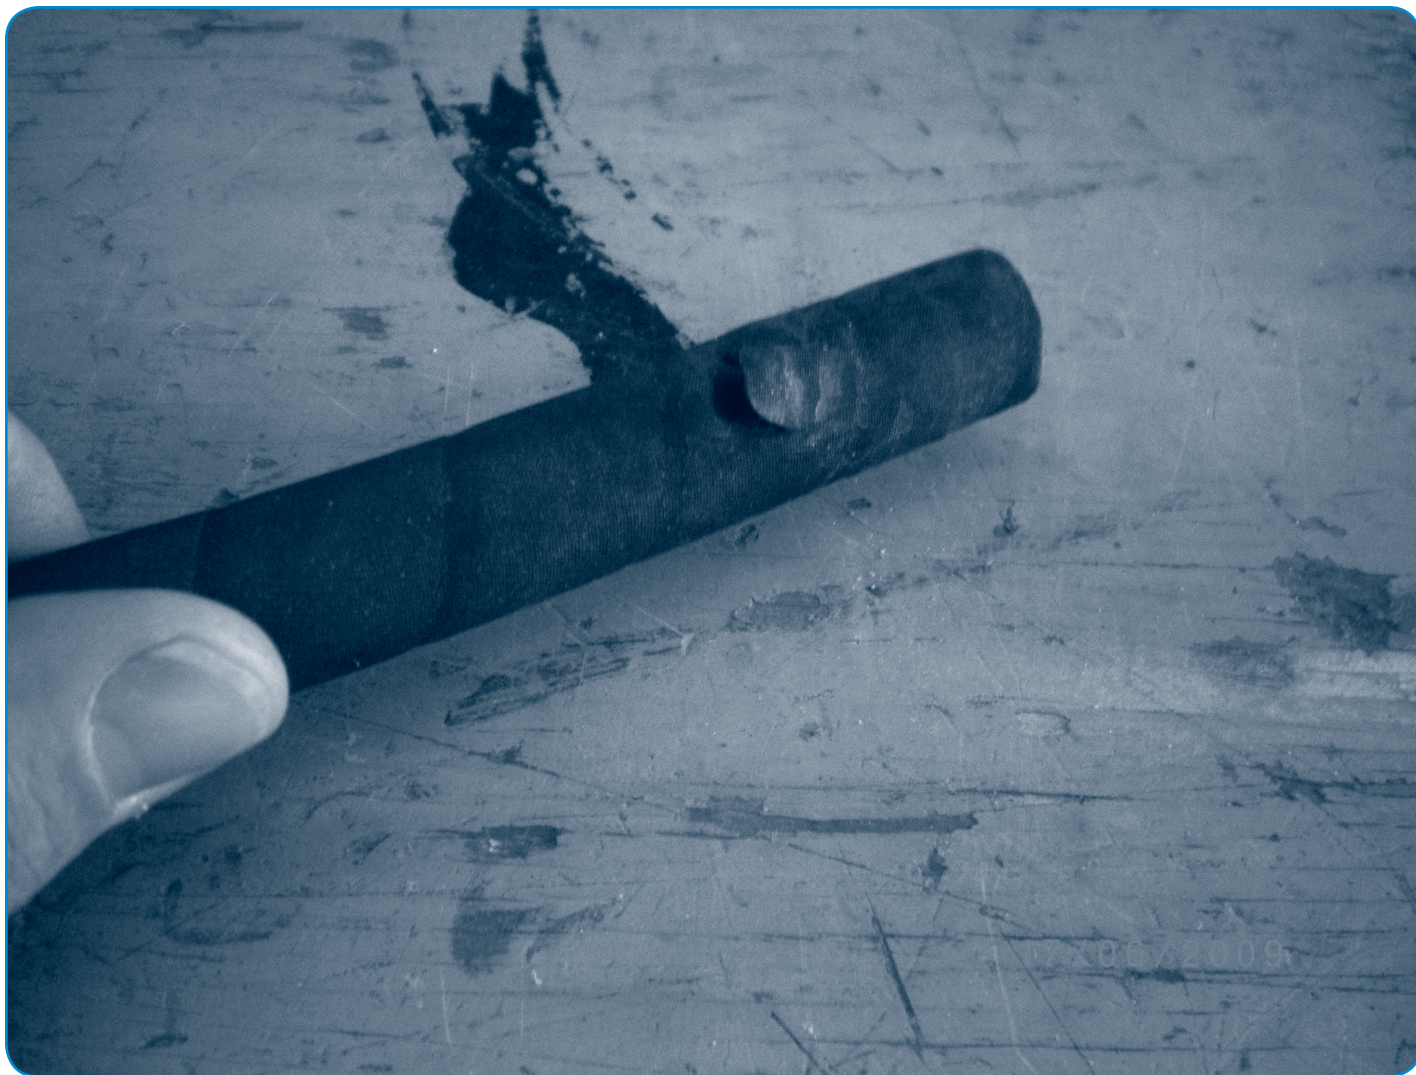
## Anti ice Fuel Filter Leak

During an aircraft ground run, while performing a leak check on the aircraft, the AME discovered a fuel leak coming from the fuel cap location and discovered that the leak was from the transmission deck. The fuel line hose was found cut from the fitting and spraying fuel inside the transmission compartment.

The ground run was discontinued and the fuel hose replaced.

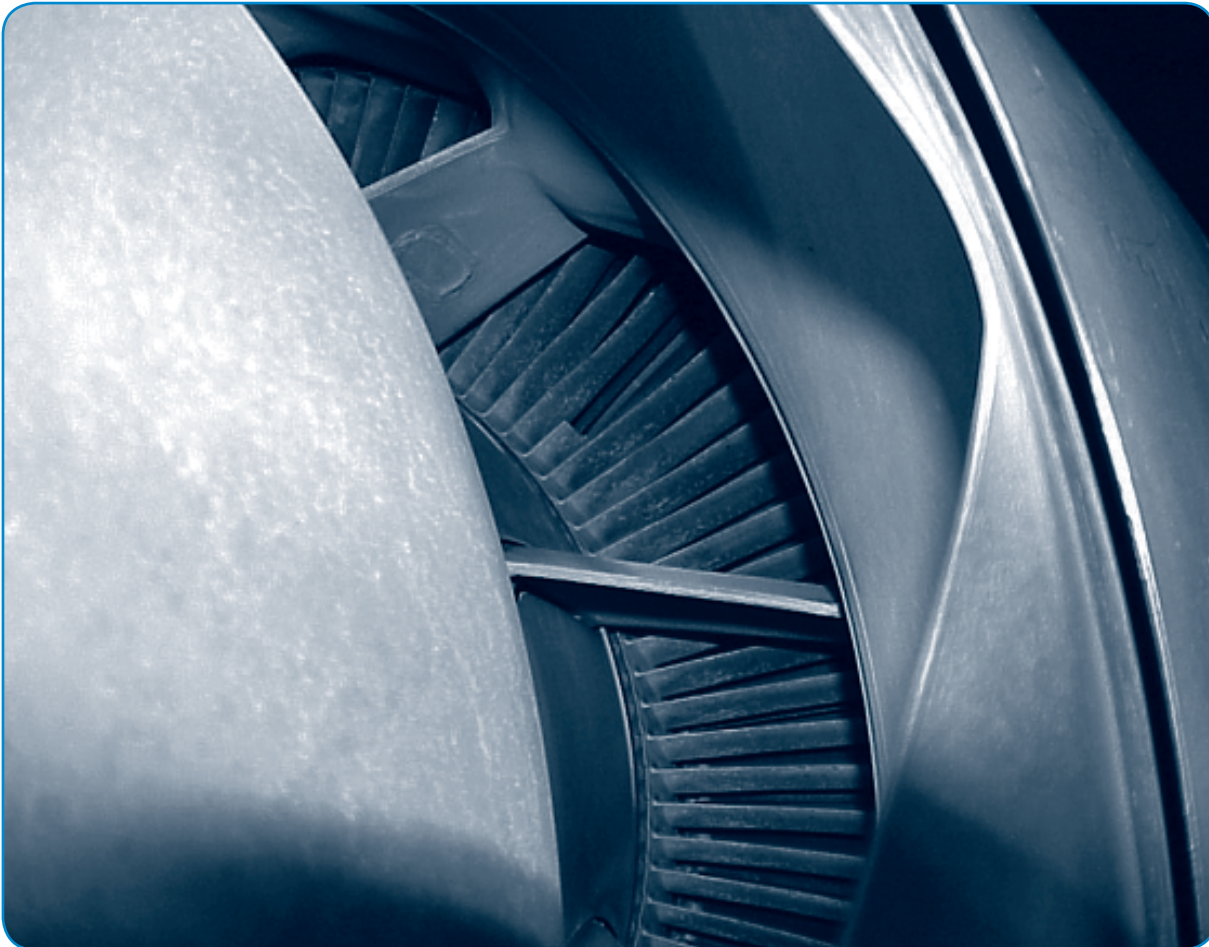
## CF 34-10E Low Pressure Turbine (LPT) Stage 4 Blade Failures

On the ground during visual inspection the last stage turbine was found severally damaged.

*General Electric (GE), the manufacturer of this engine, has completed a root cause analysis of this industry problem and has determined that it is due to low-pressure turbine (LPT) stage 4 blade tip shroud interlock wear, which causes vibration and high cycle fatigue of the blade. It is expected that GE will issue a service bulletin for an on-wing repeat inspection with pass/fail criteria for the blade tip interlock wear.*

*Transport Canada Civil Aviation would like to emphasize the importance of a complete maintenance inspection for all cases of engine vibration exceedances, with particular attention to the last turbine stage for this engine type. ✕*

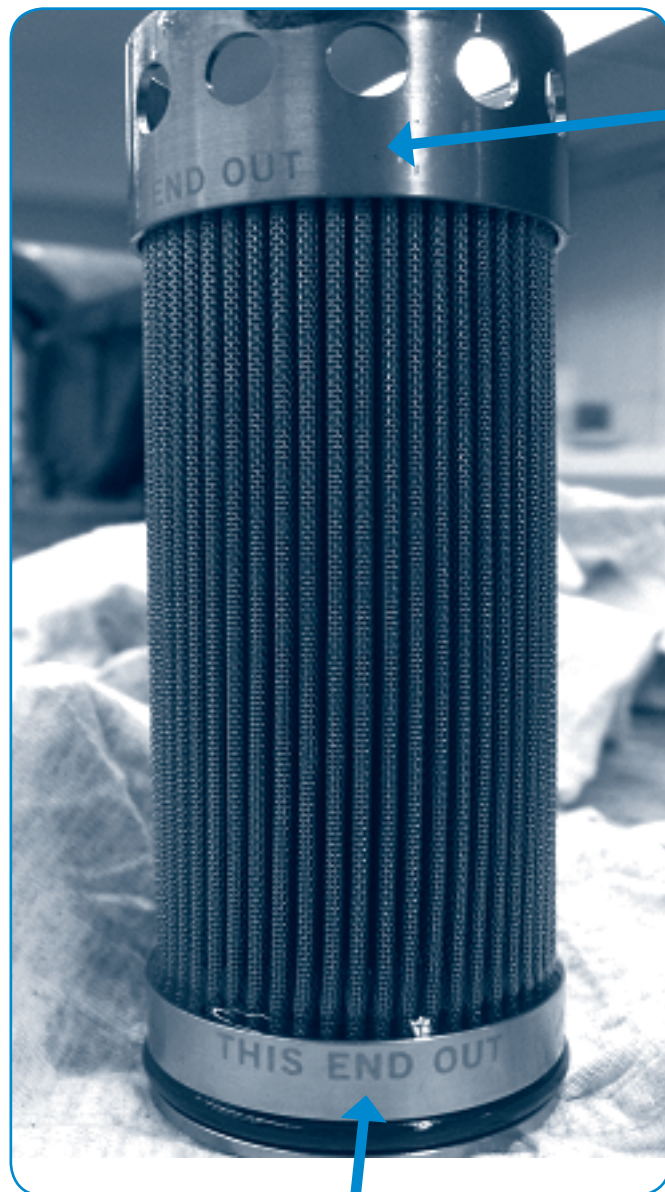
#### Improper labeling

Reads "THIS END OUT"

*Transport Canada Civil Aviation recommends checking this at the next oil filter inspection and to always refer to the Maintenance Manual and to the Illustrated Part Manual. ✖*

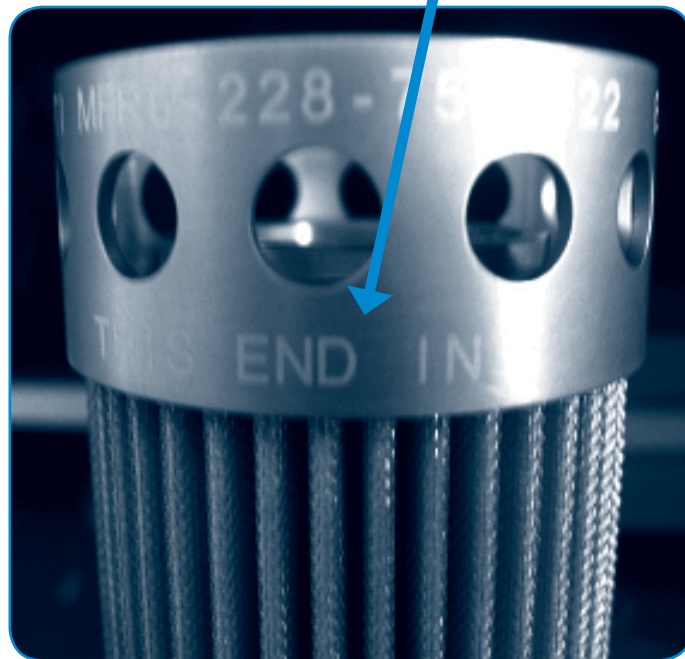
#### Proper labeling

Reads "THIS END OUT"
