TP 6980E
(09/2010)

Issue 3/2010

Canadian Aviation Service Difficulty Reports

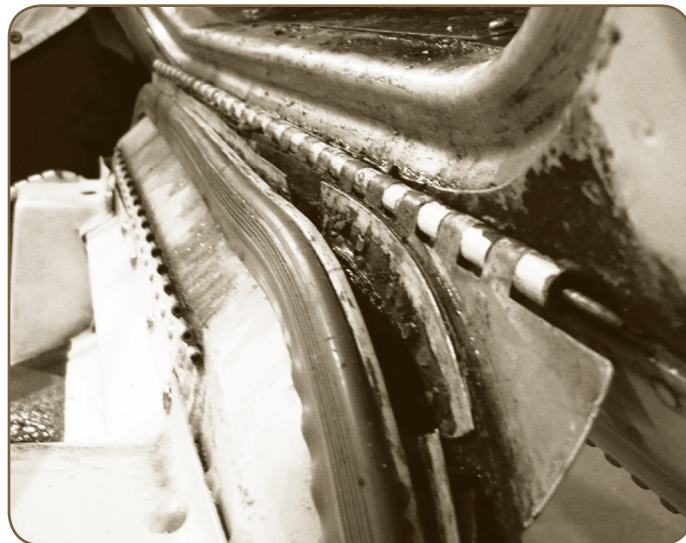
Horizontal/Vertical Stabilizer Interface – Cracked Doubler

During a 1200 Hour Scheduled Inspection, a 7.62 cm (3 inches) crack was found on a manufacturer's installed doubler, located at the horizontal/vertical stabilizer tailplane interface. The aircraft was immediately grounded pending further investigation. Maintenance personnel confirmed that all of the screws were properly secured, however several screws still spun freely.

The SDR submitter stated that it appeared that the loose screws might be a result of the 7.62 cm crack.

Aerodynamic stresses on the horizontal/vertical stabilizer during flight regime can be significant. Any loose hardware in this area can cause undesirable vibrations during flight. ✖

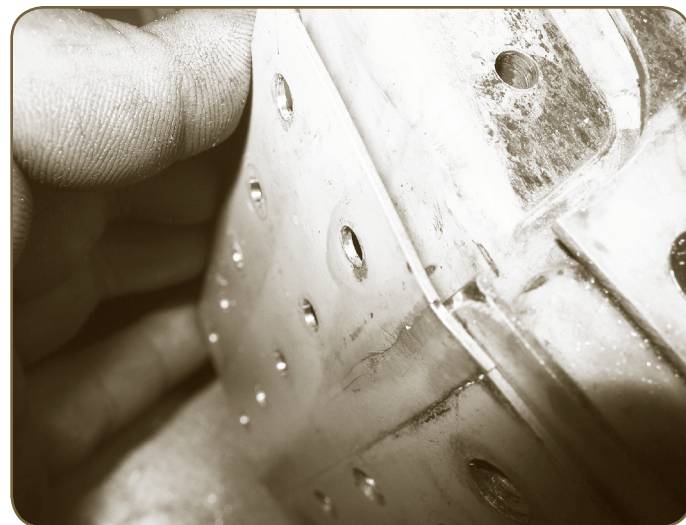
Elevator Torque Tube - Cracks

During major overhaul; the elevator bellcrank torque tube was removed for routine maintenance. Inspection revealed that the bellcrank arms were loose. After removal of the arms, non destructive testing (NDT) inspection revealed cracks on two of the eight taper pin holes.

An earlier SDR also reported a crack which started at the horn attach taper pin and spiraled 270 degrees around the elevator torque tube. In this case, the crack progressed very rapidly since the last inspection that was carried out 82 hours previously.

An SDR search revealed several other reports of elongation/wear of elevator bellcrank taper pinholes. It appears that the taper pinholes may have been incorrectly drilled (oversize) during manufacture. To preclude undesirable flutter related problems; it is recommended that owners/operators be attentive to any excess play in the elevator controls.

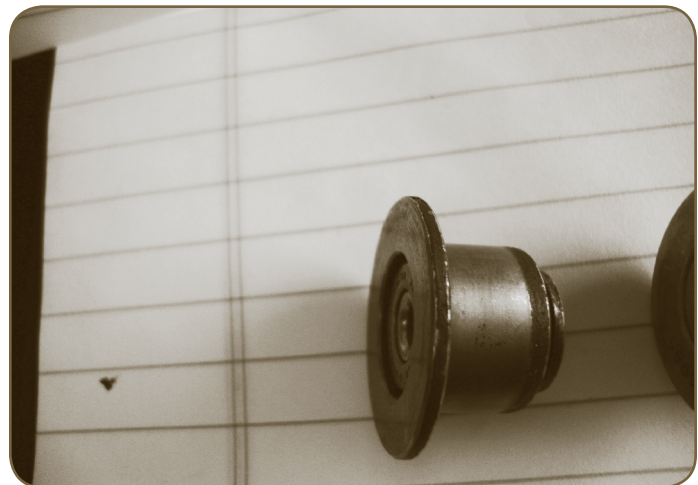
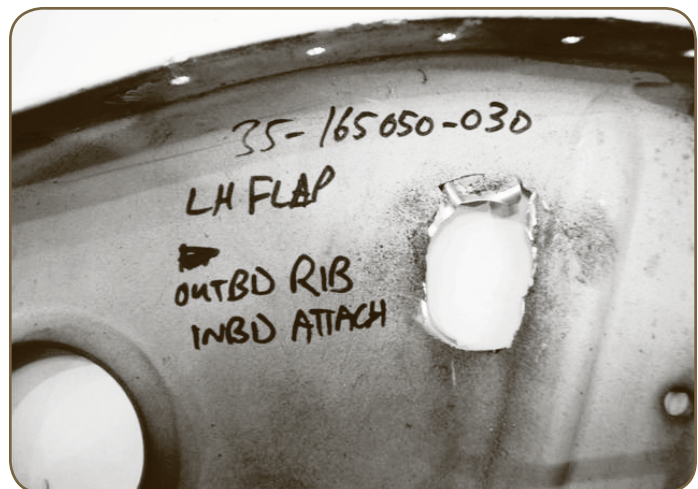
Flap Roller Bearings/Bushings - Wear

During descent to the airport, the appropriate flap selection was made when suddenly the flaps stopped and the ailerons became difficult to move. The crew then selected flaps up but no movement occurred. The crew declared an emergency and carried out an uneventful landing at a nearby airfield. It was later found that the aft attachment point on the L/H outboard flap, had failed inside the flap.

The flap is attached through two ribs on either side of the flap track. The flap roller assembly consists of a roller bearing, a large "hat" section and a Teflon washer. All these parts were found to be jammed into the flap track. It became apparent that the "hat" section bushing had been spinning and wearing into the outboard rib until the

material, 1.27 cm (0.50 inches) thick, eventually failed resulting in a jammed flap.

Further inspection revealed that the problem appears to originate with the roller bearings. The BC-56985 bearings are inside the large bushing and premature wear causes the bearing to move inside the bushing. The operator has modified their B300 inspection program to include a specific requirement to inspect this area both on the detailed 800 hour interval and the routine 200 hour interval inspection. A precautionary inspection on their other B300 aircraft revealed similar premature wear.

previous reports of this nature, however premature roller wear appears to be the root cause of this event. There is a previous service bulletin to replace the flap rib next to the actuator (not the rib next to the flap track). HBC have stated that the current maintenance instructions are specific on the inspection of this area.

It is important to note that flaps are at times subjected to significant aerodynamic loading (buffeting) during take off, approach and landing; thus it is important to carefully inspect these areas for premature wear and/or damage. It is also essential that flaps and all flight controls be precisely rigged in accordance with manufacturers instructions. ✖

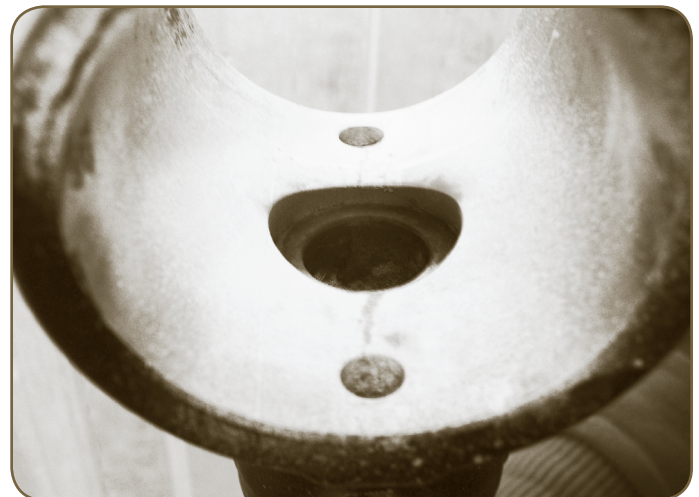
Horizontal Stabilator Horn - Cracked

A precautionary inspection was carried out on the stabilator horn due to reports of cracking on other aircrafts. No cracks were visible from the horn exterior; however, removal of the 2 stabilator halves, the torque tubes and the horn assembly was necessary in order to inspect the inner wall of the horn.

Close examination with magnification and dye penetrant revealed a crack running from each attachment through a bolthole to the balance tube hole on the forward side of the horn. The crack found in the cast aluminum horn appears to be caused by stress corrosion.

In this particular case, the stabilator horn had cracks occurring at the boltholes that may be directly related to FAA AD 74-13-03 (installation of corrosion resistant AN bolts). Any corroded bolts must be changed before further flight. ✖

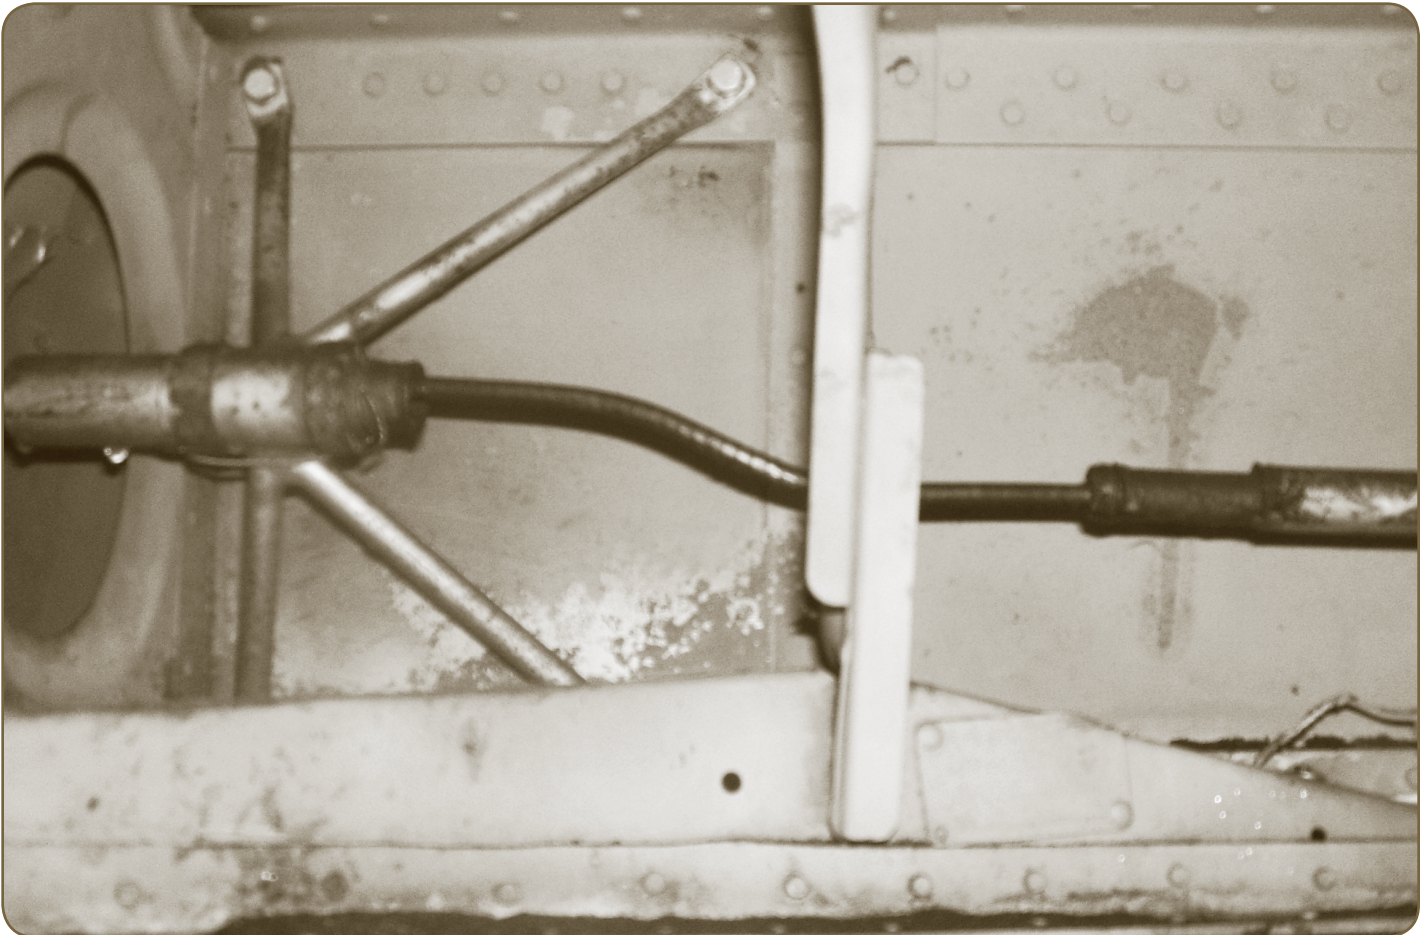
Main Landing Gear – Retraction Push- Pull Cable Conduit

A domestic operator reported that the R/H landing gear collapsed during landing and caused the aircraft to veer off the runway. Subsequent investigation revealed that R/H retraction push-pull conduit was worn between the inner and outer sleeves. Separation of the sleeves did not allow the gear to extend to the full down and locked position. Significant corrosion was also found on the sleeve assembly.

A service history review has revealed numerous problems with the cable conduit assembly resulting in failure of the landing gear to extend fully or retract. Additionally, the retraction motor circuit breaker has popped on numerous occasions, which was directly linked to lack of lubrication of pertinent parts. Other defects such as binding or worn cables have also caused landing gear malfunctions.

The electrically powered landing gear is subject to environmental contaminants that promote corrosion, thus it is essential that adequate lubrication and inspections be carried out. Inspect push-pull cables for signs of excess wear, corrosion, freedom of movement and bends and cracks of the threaded ends.

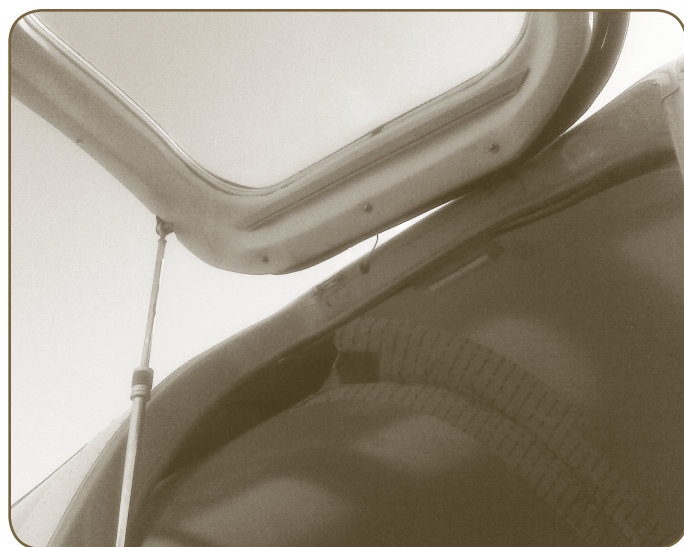
Aft Upper Fuselage Door

Following flight, the pilot reported obvious metal scarring on the fuselage doorframe, perhaps indicating that both the upper and the lower stair door locking mechanism were engaged prior to flight. Because the cockpit "door unsafe" light never illuminated, this would indicate that the lower portion of the aft door remained secured during this event.

Post flight inspection revealed that the forward aft upper door hinge had failed and separated from the door frame/fuselage interface, just leaving the rear hinge to hold the upper door in place. Because there are several contributing factors related to this event; it is unknown if it was the upper door hinge or the upper door latches that failed first.

A review of SDRs revealed other door failures with a complete door separation, which damaged the aircraft during flight. Other door unsafe events were caused because of the worn door latching mechanisms (bushings/springs, latch plates and door cables).

TCCA recommends that owners/operators pay particular attention to premature wear of the door latching mechanisms. Any difficulty in opening, closing or securing the door should be an early indicator of impending failure.

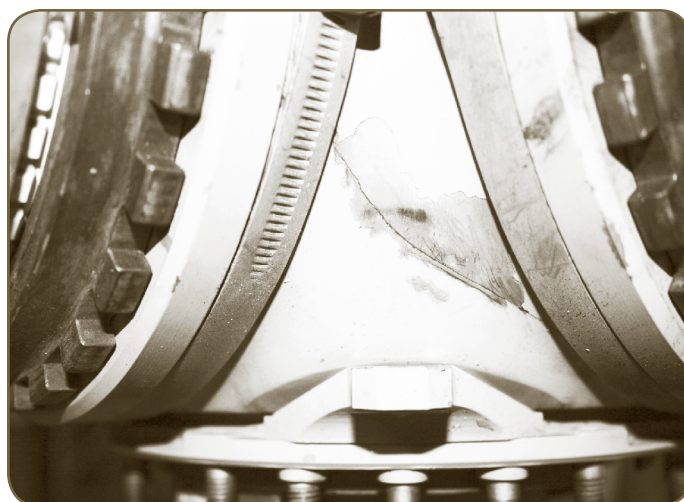
Propeller Hub Crack

After a flight the crew raised a snag for excessive L/H propeller vibration. Maintenance performed an inspection and found the propeller with a significant crack.

The propeller hub assembly was removed and replaced prior to its next flight.

TCCA would like to advise all operators and owners that for any form of vibration, it is essential that the source is found and rectified prior to the next flight.
