**ISSUE 3/2022**

# **AVIATION SAFETY LETTER**

### **[TSB final report A21Q0052—Collision with a lawn tractor during landing](#)**

## TSB final report A21W0071—Collision with terrain

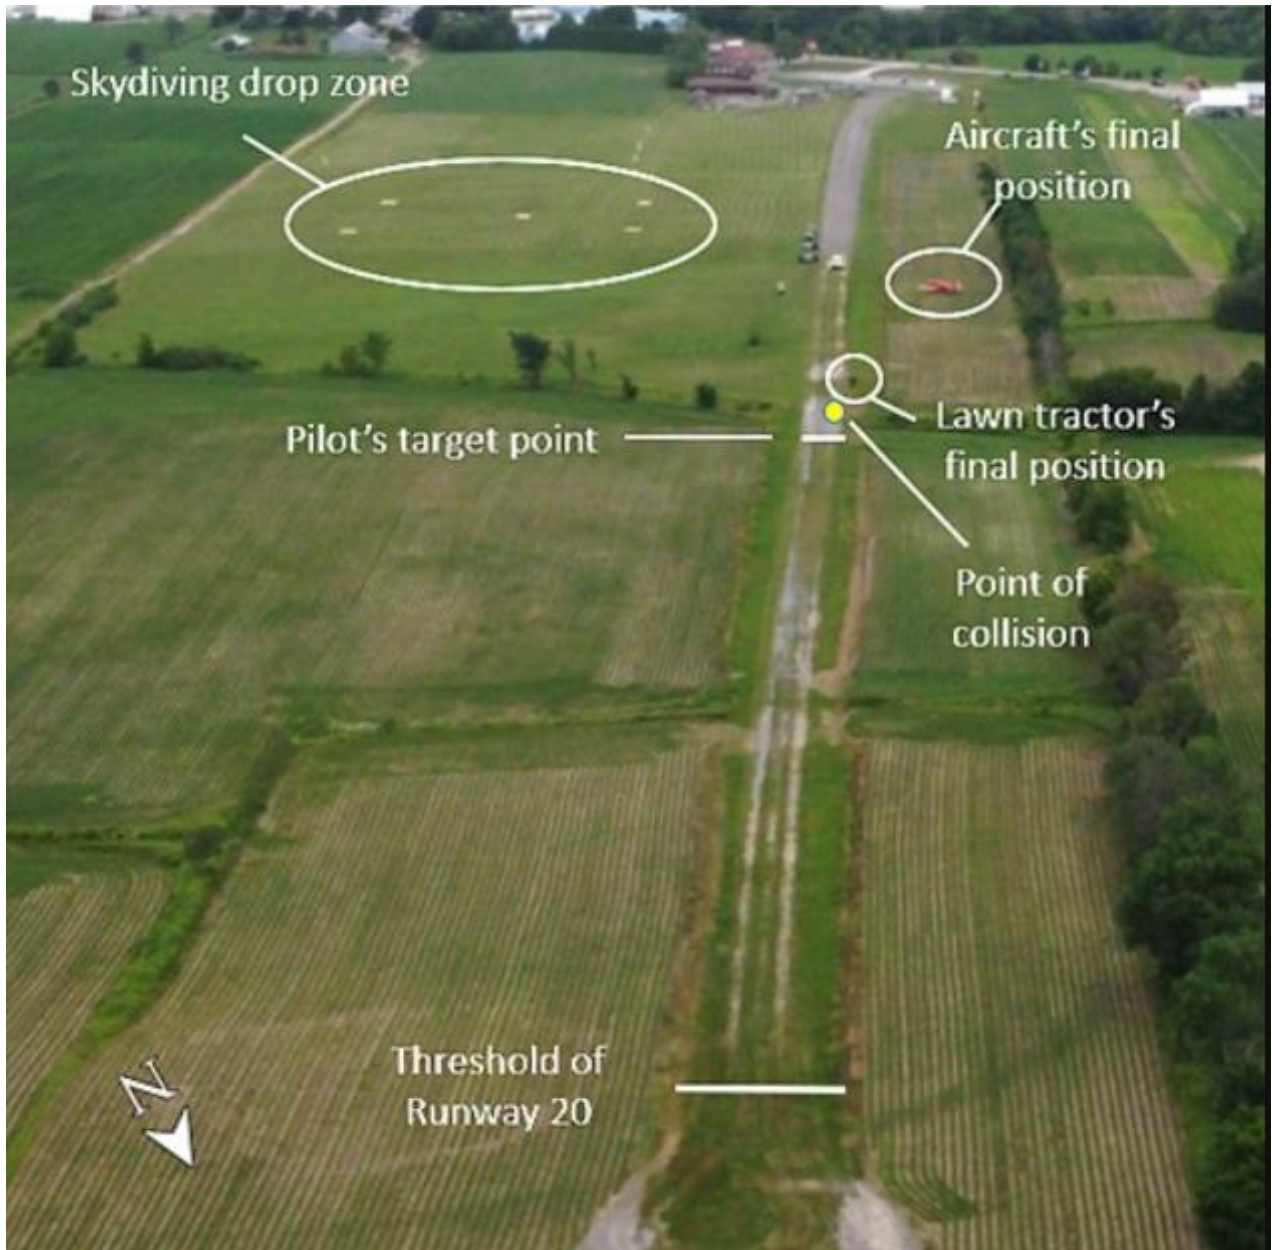
*Figure 1. Aerial photograph of the Saint-Esprit Aerodrome showing the threshold of Runway 20, the skydiving drop zone, the target point, the point of collision, and the final positions of the aircraft and the tractor (Source: TSB)*

The aerodrome manager uses a subcontractor, the same one since 2017, for this purpose. CES2 does not have written procedures for maintenance of the aerodrome, nor are such procedures required by the CARs. However, according to a verbal agreement between the aerodrome manager and the subcontractor, the grass is to be cut only when the Twin Otter is on the ground at CES2 and no skydivers are in the air, given that the drop zone is adjacent to the manoeuvring areas (Figure 1).

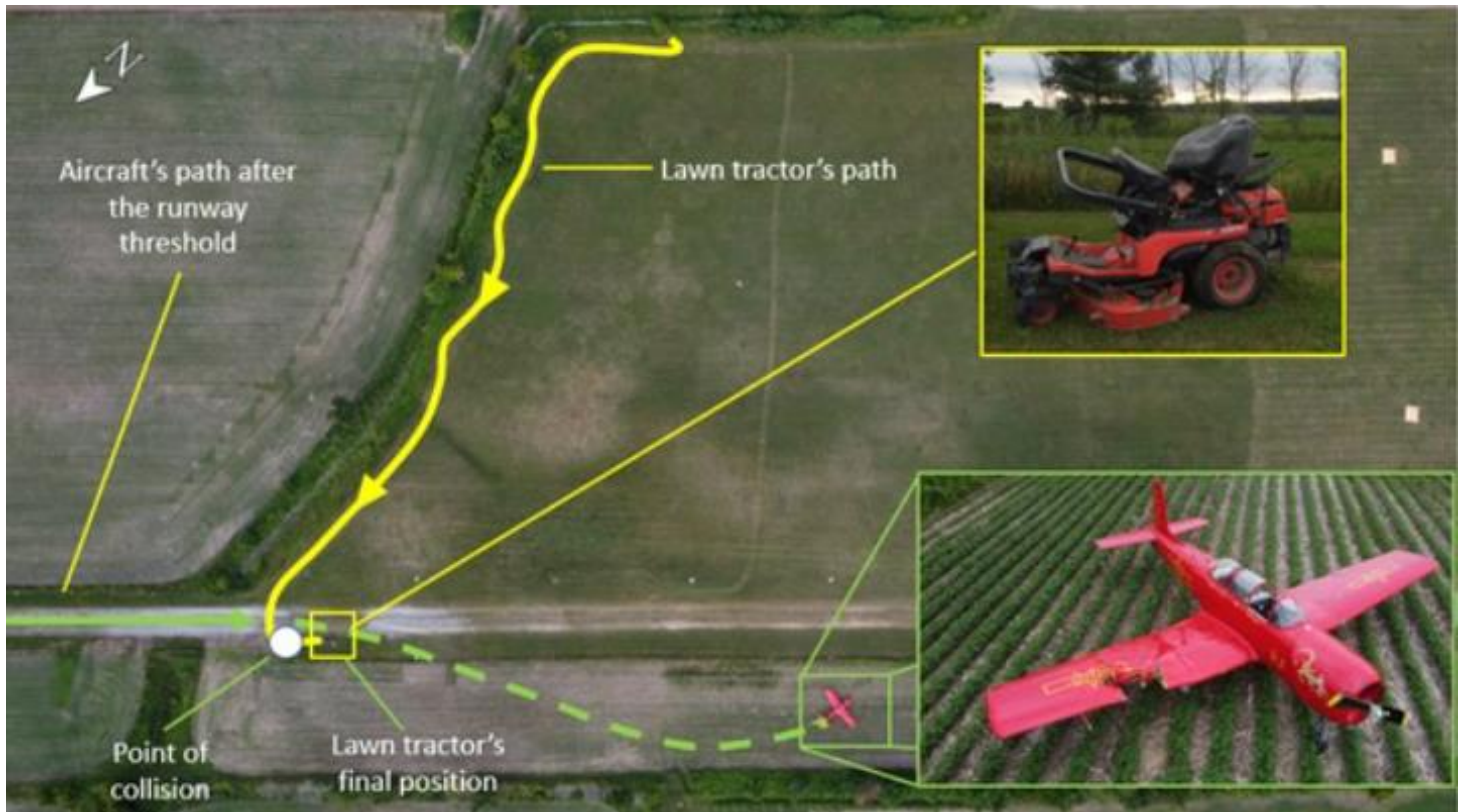
Seeing damage to the right wing, the pilot realized that he had struck something. He exited the aircraft and saw the lawn tractor to the right of the runway not very far from the touchdown point. The aircraft had struck the tractor, and the driver was fatally injured. The pilot was not injured. There was major damage to the aircraft's right wing (Figure 2).

Figure 2. Aerial photograph of the point of collision at the Saint-Esprit Aerodrome, showing the tractor's path and the aircraft's path, and the extent of the damage in the close-ups (Source: TSB)

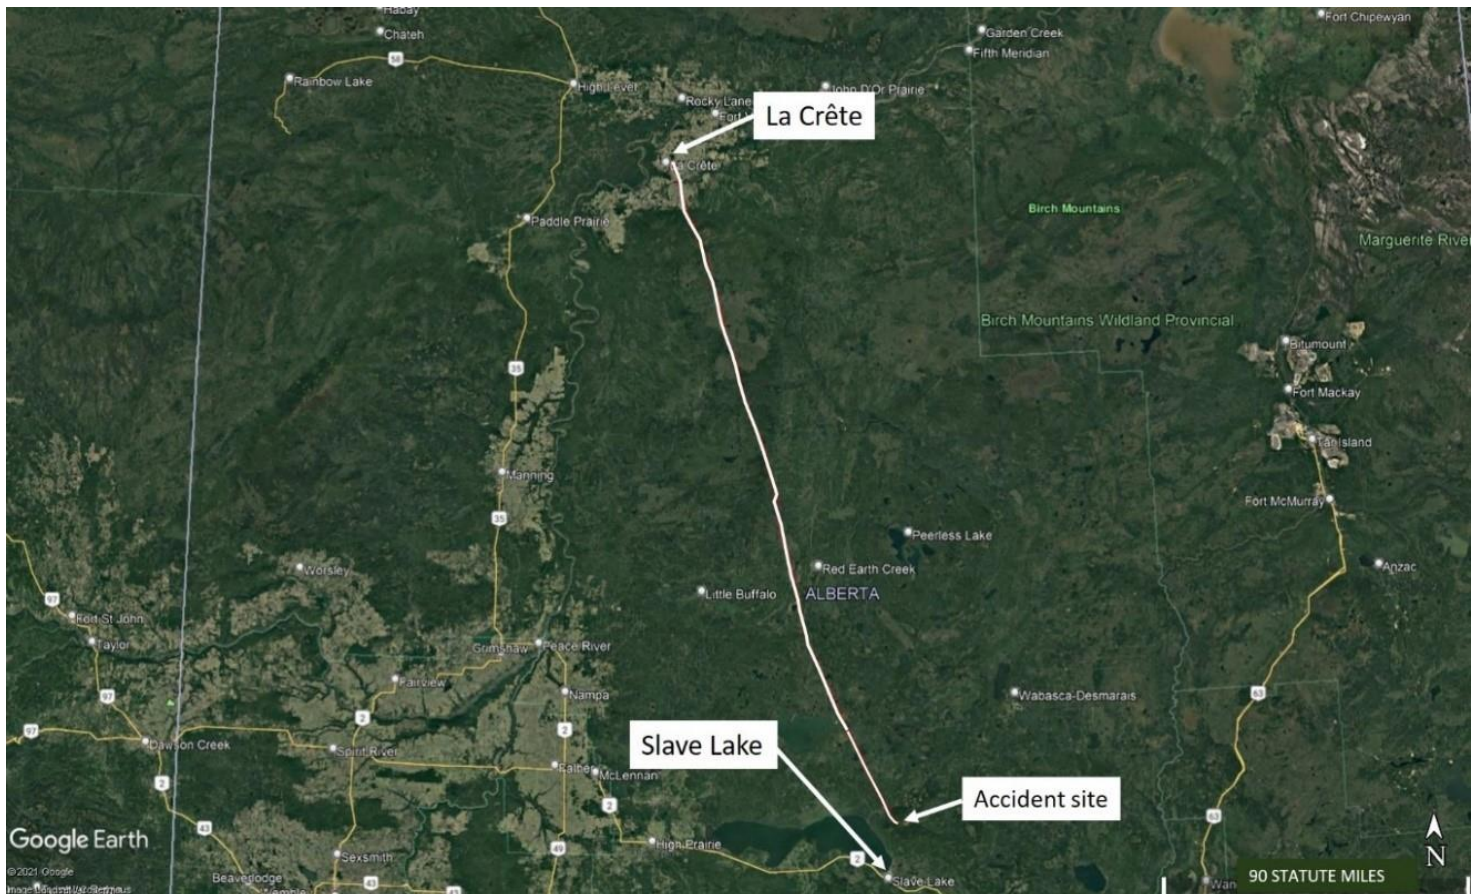
Figure 1. Map showing the occurrence flight track (Source: Google Earth, with TSB annotations)

The aircraft departed at 0900 in visual meteorological conditions and initially climbed to 3 500 ft ASL on a southerly heading (figures 1 and 2). Along the route to CYZH, the aircraft reached an altitude of 4 000 ft ASL before descending, likely due to cloud ceilings. When the aircraft was 14 nautical miles (NM) north of CYZH, the pilot changed the destination in the global positioning system (GPS) from CYZH to CYLL. The aircraft's track then turned to the east toward CYLL and toward rising terrain. At this time, the aircraft was at 3 000 ft ASL or 500 ft above terrain.

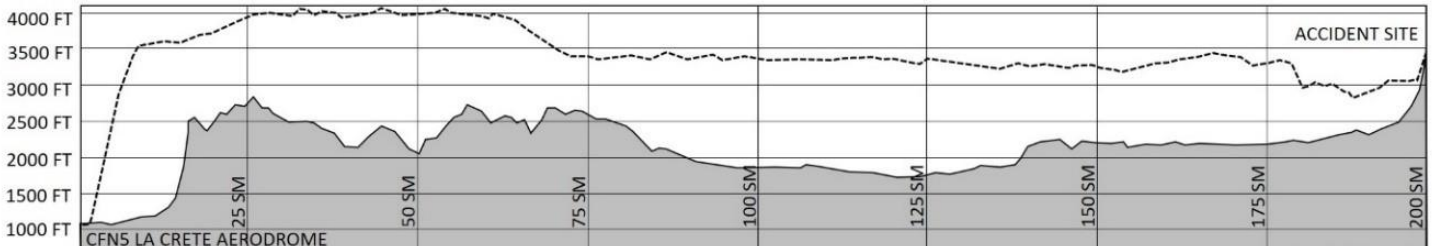
*Figure 2. Graph showing the terrain and vertical flight path profile, with altitudes indicated in feet above sea level and distances indicated in statute miles from La Crête Aerodrome (Source: TSB, based on data from the aircraft's digital engine monitor)*

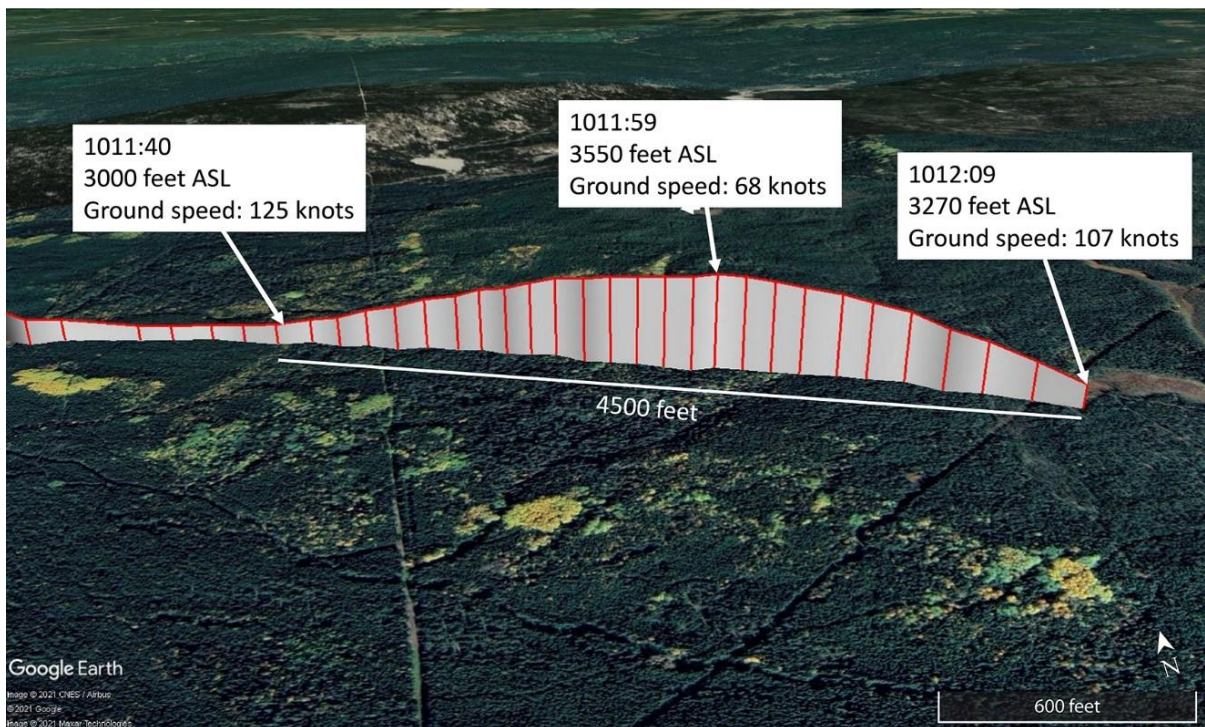
Figure 3. Aerial photo showing the flight path before the collision with terrain  
(Source: Google Earth, with TSB annotations)

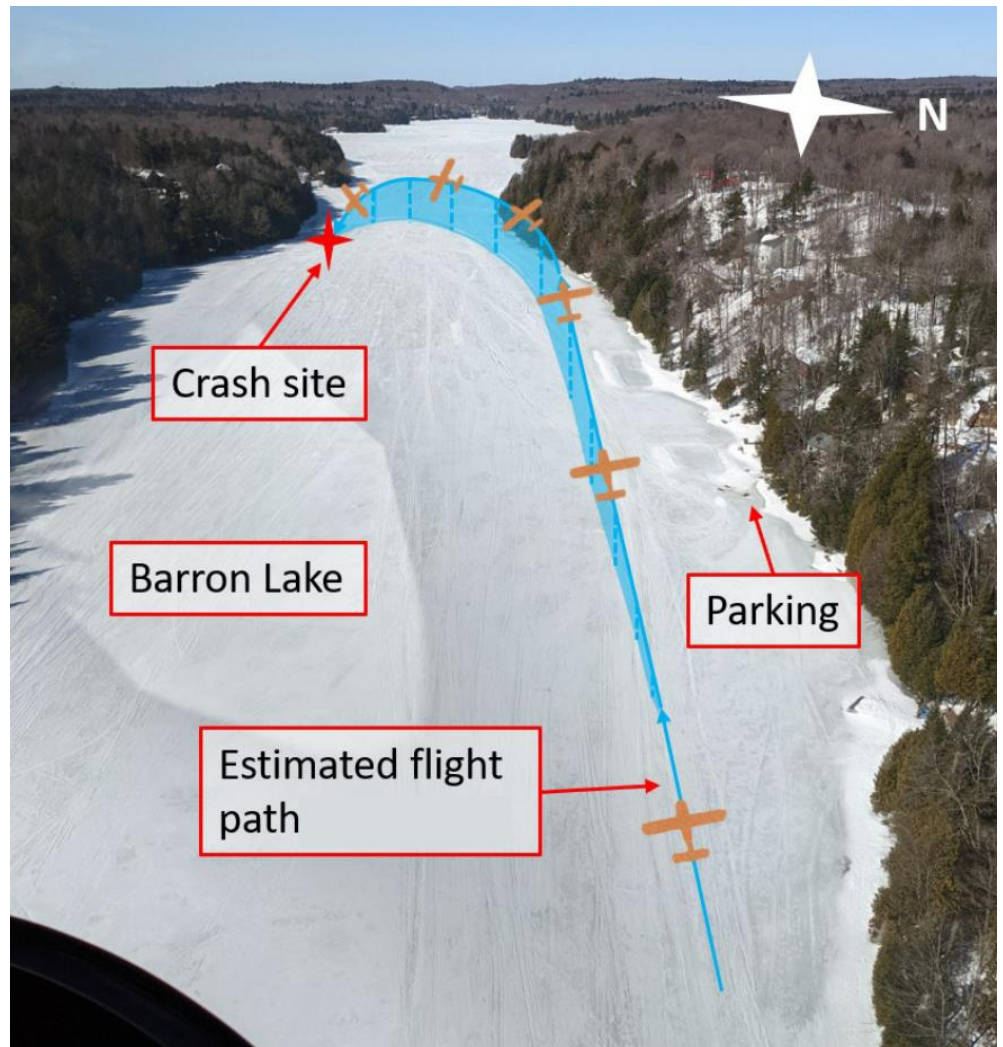
When the aircraft took off from the frozen surface of the lake, westbound, the flaps were set to 40°. The aircraft climbed to nearly 50 ft above ground level (AGL), close to the north shore of the lake and began turning left with the flaps still at 40°. The aircraft entered a spin to the left and struck the surface of the lake in a near-vertical attitude, with the left wing contacting the surface first (Figure 1).

Figure 1. Estimated flight path of the occurrence aircraft (Source: TSB)

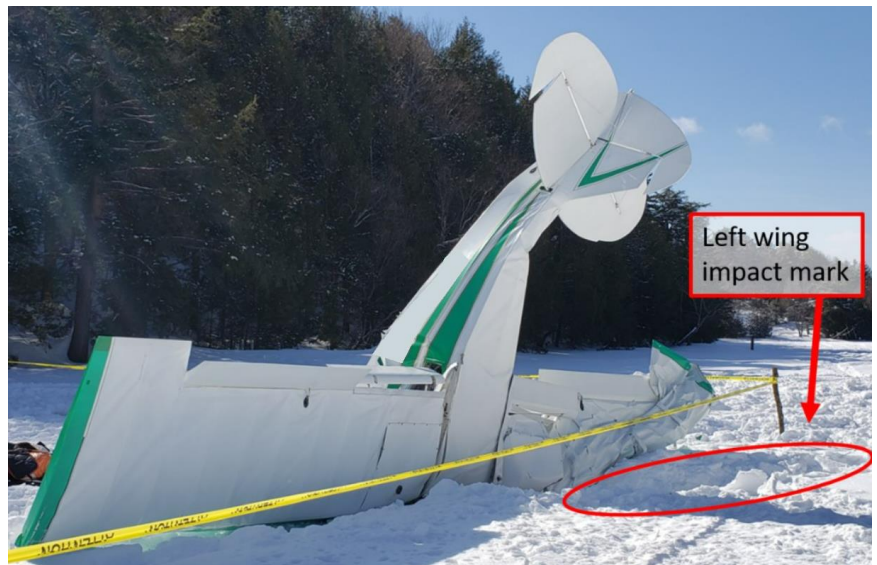
The wings had partially separated from the fuselage, but the cables controlling the ailerons were under tension and still attached to the cabin. The cable and pulley system that controls the elevators and rudder was checked to the extent possible; when the cables below the fuselage were pulled, the elevators and rudder moved freely. The control column and connecting

Figure 3. Photo of the wreckage (Source: TSB)

cables were torn off by the impact forces. Damage to the wings and structure was the result of impact forces and the work of the first responders.

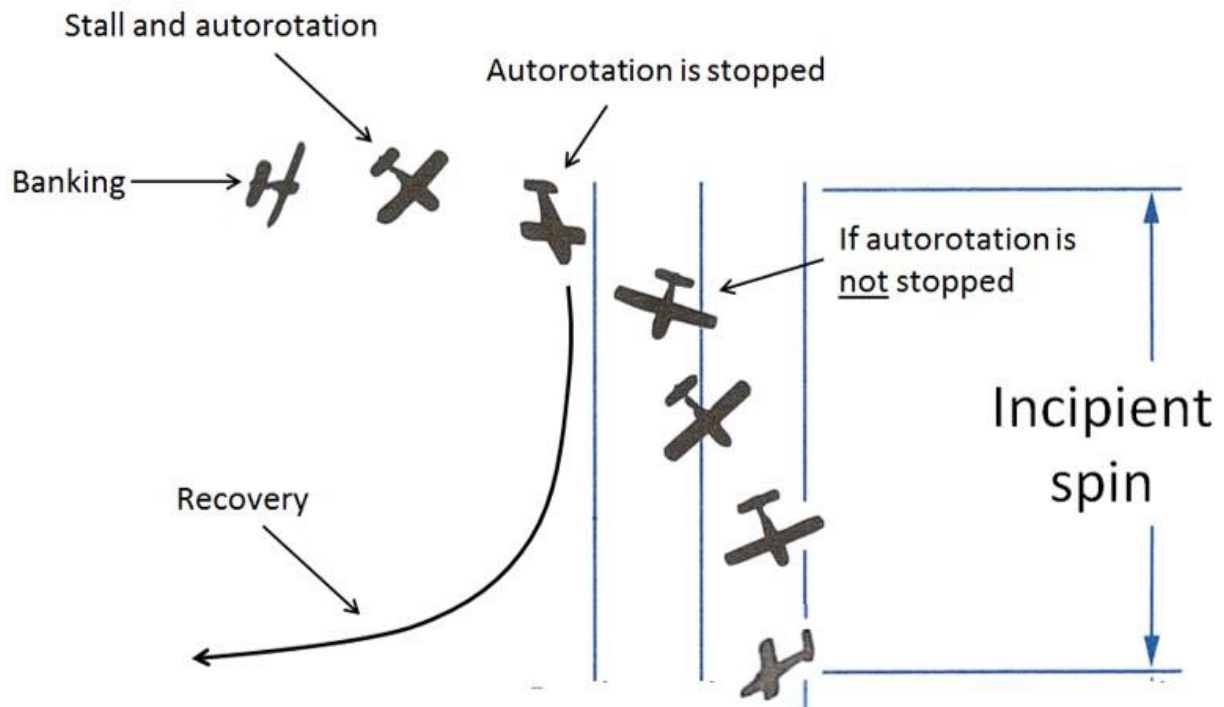
Generally, even if the pilot takes the necessary measures to stop the autorotation as soon as it begins, the aircraft is in a vertical position while accelerating rapidly, and a high altitude is necessary to regain a horizontal flight path. If the autorotation continues, the aircraft could stabilize in a spin and follow a spiral path downward (Figure 4).

Figure 4. Incipient spin (Source: TSB, based on Transport Canada, TP 1102, Flight Training Manual, 4<sup>th</sup> Edition [revised 2004], Figure 2-31)
