No.		1/2
N°	AL-99-03	
Date	1999-08-11

SERVICE DIFFICULTY ALERT

CONSOLIDATED CANSO PBY5A NOSE GEAR DOOR TORQUE TUBE

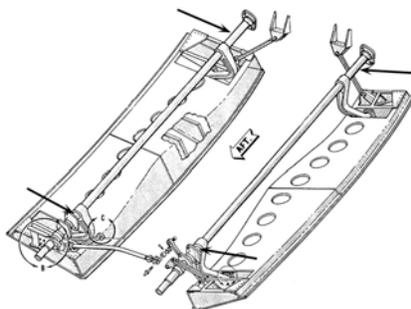
A recent Service Difficulty Report has been received outlining the results of an investigation on the integrity of an operator's nose wheel door torque tube assembly. The investigation on the Canso PBY5A found visible external corrosion at the left aft operating arms; upon removal, severe internal corrosion was found. Upon removal of the right torque tube internal corrosion was discovered.

What prompted the investigation was a report issued by the United Kingdom's Air Accident Investigation Branch as a result of a Catalina crash upon landing that occurred 27 July 1998 in the Southampton water (AAIB bulletin No. 1/99 Ref. EW/C98/7/9 Category 1.1). The report concluded that the accident was caused by the severe corrosion in the nose gear operating mechanism torque tube.

The UK report goes on further to explain that corrosion inside the tube would have been completely concealed from inspection as both ends were closed; the construction of the tube assembly, however, makes it possible for liquid to enter and remain undetected.

Transport Canada therefore recommends that the left and right torque tubes be removed and inspected for corrosion, particularly at the aft curved levers, at the next convenient maintenance opportunity.
