Learn from the mistakes of others; you'll not live long enough to make them all yourself . . . **Issue 1/2005**

## Beware of the 180° Turn Back to the Runway...

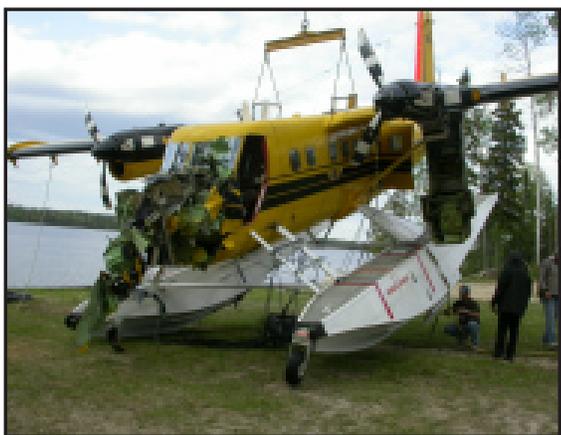
located on top of the floats, indicating that the tanks were filled to capacity. He pressed a button on the yoke to retract the probes, and the aircraft immediately nosed over into the lake in a wings-level attitude and began to sink. The accident occurred at approximately 18:00 EDT. The pilot extricated himself from the aircraft and held on to the side of the partially submerged aircraft. A witness to the occurrence immediately boarded a powered aluminium boat and went to assist the pilot, while a second witness travelled to Hornepayne to notify the authorities and emergency services. Once the pilot reached the shore, he was taken to a nearby cottage where he remained until emergency services arrived. The aircraft came to rest on the bottom of the shallow lake, in an inverted attitude, with the floats above the surface of the water.

1. The operator's DHC-6 standard operating procedures (SOP) were not followed, and the vital action checklist was not fully completed during the approach. As a result, the bomb door armed switch on the centre panel was not selected OFF after the previous water bombing run, and prior to the scooping operation.

3. The hinged cover plate for the bomb door push button switch was not re-installed following maintenance to replace the push button switch. The push button was exposed, making an inadvertent selection more likely.

The operator has verified that every Twin Otter aircraft in their fleet is equipped with the cover plate over the bomb door push button switch. The operator will ensure that any future modifications to aircraft will be standardized to decrease the potential for inadvertent operation of systems.

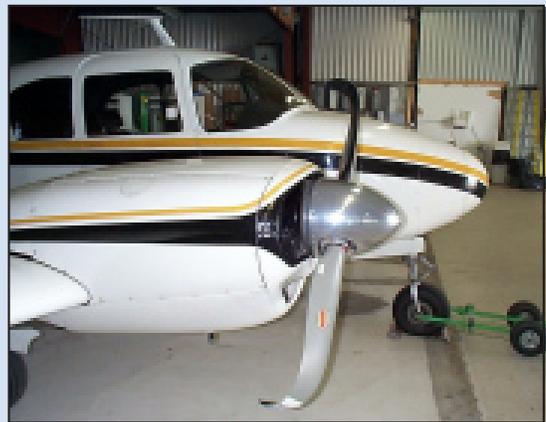
Here is a lesson that could have happened to any of us, and from which we can all learn. The pilot had just taken off in a Piper PA23-160 Apache from a long, paved runway, when he noticed that gasoline was leaking from the left wing fuel cap. The fuel tank cap had been improperly closed after refuelling or during the walk-around. The pilot assessed that there was enough runway remaining to land straight ahead, and he lowered some flaps and lowered the landing gear. Unfortunately, there was not enough time for the landing gear to complete the extension cycle and the aircraft landed on its belly. Both propellers were bent and the flaps were damaged. In this situation, a quick circuit and return to point of departure would have likely been enough to solve the problem. An open door or cargo door indication could lead to a similar situation. The golden rule of aviation always remains the same: *Aviate, Navigate, and Communicate.* △

*Propellers are shown after the occurrence, damaged beyond repair.*

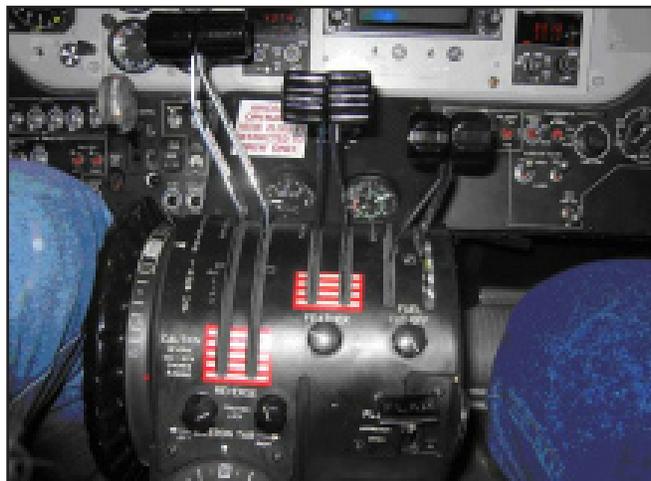
On June 3, 2004, during training exercises, the captain of a Beech 99 Airliner could not advance the power levers during a balked approach procedure. During the overshoot, the captain had called for power, gear and flaps up, but found that the power levers were stuck when an attempt was made to move them. The gear and flaps had been raised by the training pilot in the right seat, and with reduced power, the aircraft began to settle to the ground. The training pilot reached over to assist the captain, and pushed the power levers forward. The engines eventually spooled up and the overshoot was completed. Unbeknownst to the crew, the aircraft's belly pod had touched the runway prior to the overshoot. The belly pod damage was later discovered during a maintenance inspection.

*Transport Canada (TC) reviewed this incident and is of the opinion that the throttles were operating normally, there was no "jam" and there was no aircraft defect or design problem. The design of the idle stop is such that the throttles may only be retarded into reverse after they are lifted and, conversely, that they will only move forward into positive thrust when they are in the lower position. In this case, when the pilot inadvertently pushed the throttles up, they did not move forward because they were blocked by the forward idle gate. This*

*behaviour of the throttle "system" is similar to that in all the King Air family of airplanes. The throttles were "blocked" by the gate but were not "jammed." In this case, the throttles operated as they were designed.*

*It can be accepted that a pilot might apply enough upward pressure on the throttle levers to encounter the face of the "gate" and have forward travel blocked, thus preventing application of more than idle power. However, in this case, the crux of the problem was the upward force coupled with the procedure whereby the wheels (and flaps) are raised prior to full or maximum continuous power being applied. The procedure, as described in the letter above, is contrary to the recommended procedure in the flight manual, and is not good airmanship. The flight manual implies that not only is the power to be applied first, but a subsequent rate of climb is to be achieved before raising the gear. Leaving the gear down until after the power is set ensures for the proviso that the aircraft will touch on the wheels if the sink rate is not arrested in time. TC agrees that "jamming" of power levers would need to be investigated and corrected, but believes that in this case "jamming" is not an appropriate categorization of the event. The more relevant lessons to be drawn from this incident are shortcomings in pilot technique, safe training practices, crew resource management, standard operating procedures and adherence to aircraft flight manual procedures. Raising the flaps and gear before establishing climb power and speed is clearly poor airmanship and contrary to the aircraft flight manual. These issues have been addressed with the operator involved. —Ed. △*
