No.		1/3
N°	AV-2006-01	
Date	2006-02-08

SERVICE DIFFICULTY ADVISORY

PRATT & WHITNEY PW 100 ENGINE SERIES ELECTRICAL SYSTEM CARE

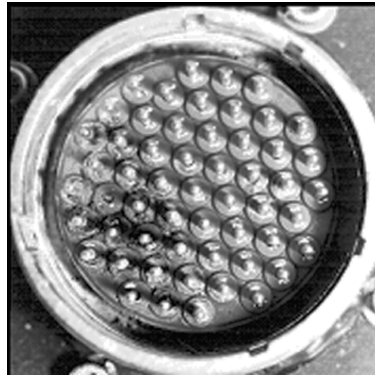
Field reports and product service history have clearly identified that contaminated, loose, wet and corroded engine electrical connectors have led to undesirable and numerous in-service events.

**Oil and Dirt Ingress
Infiltration d'huile et de saleté**

TCCA recommends that each time an electrical connector is disturbed that a proper visual inspection be performed, paying particular attention to damaged pins, corrosion, cleanliness and security.

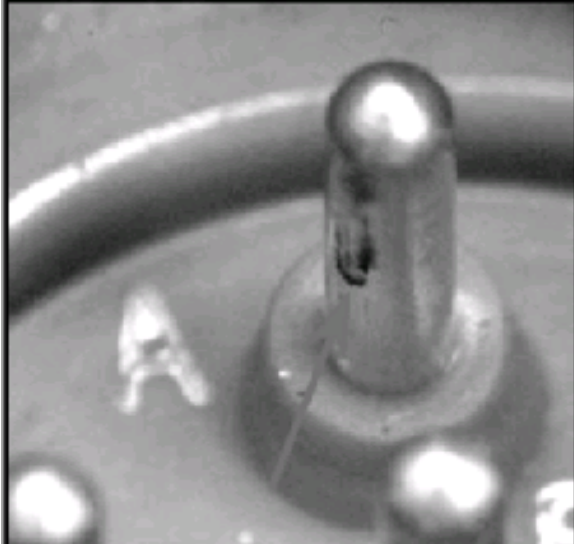
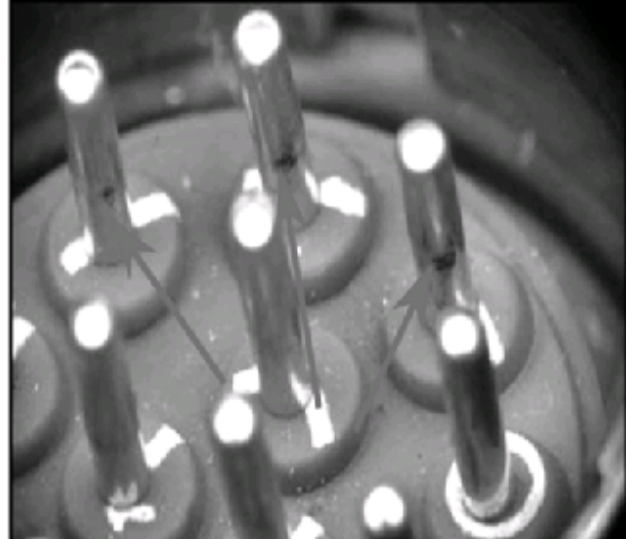
Pin Fretting and Oxidation
Usure de contact et oxidation des broches
