Learn from the mistakes of others; you'll not live long enough to make them all yourself . . . **Issue 4/2003**

## Pilot Error or Poor Management?

On October 15, 2001, a Piper PA-31 departed Yellowknife, Northwest Territories, at 20:43 on a night IFR charter flight to Fort Liard. One pilot and five passengers were on board. On arrival at Fort Liard, in conditions of moderate to heavy snow, the pilot initiated a non-directional beacon (NDB) approach with a circling procedure for Runway 02. At about 22:33, the aircraft struck a gravel bar on the west shoreline of the Liard River, 1.3 NM short of the threshold of Runway 02, and 0.3 NM to the left of the runway centreline. The aircraft sustained substantial damage, but no fire ensued. Three passengers were fatally injured, and the pilot and two passengers were seriously injured. This synopsis is based on the Transportation Safety Board of Canada (TSB) Final Report A01W0261.

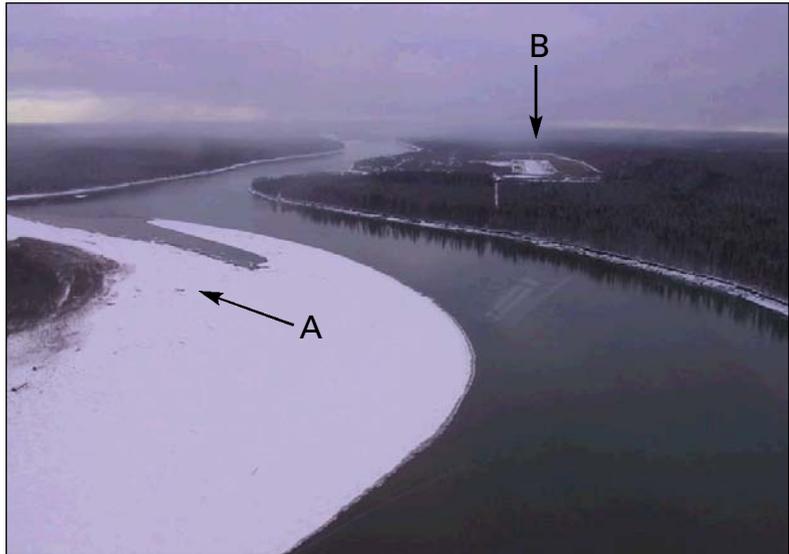
The pilot did not express any concerns and there was no warning of the impending impact. The aircraft contacted the ground in approximately a 5° nose-low and 5° to 10° left-wing low attitude, and remained upright. The impact forces did not significantly compromise the survival space in the cabin or cockpit areas. The pilot sustained severe head injuries and the right seat passenger sustained fatal head injuries due to impact forces. These injuries may have been prevented or reduced in severity had the upper torsos of these occupants been restrained by the available shoulder harnesses.

*Aerial view shows wreckage at arrow A, and intended landing runway at arrow B.*

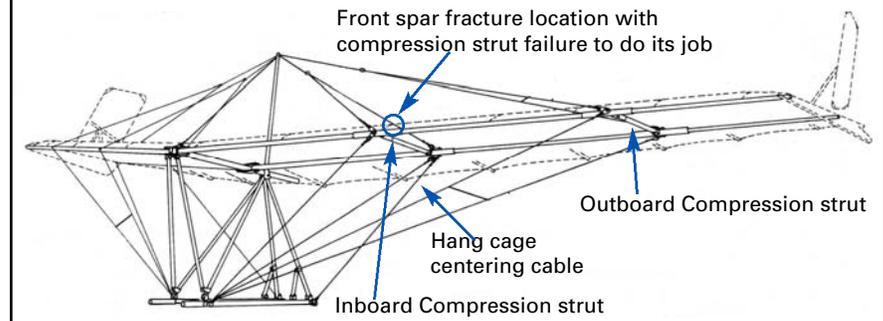
### Pterodactyl Wing Spars, Struts and Rigging

The official investigations listed these accidents as “Undetermined,” but the follow-up factory investigations found the answers. In each case the spar failed just outboard of the inboard spar sleeve junction, where the inner set of rigging cables joins the spar. The spar failed upwards and twisted as it failed, giving a very distinctive signature to the failure.

These spar failures all had the same signatures and the same causes—the inboard compression strut had failed to do its job. Each wing has two compression struts. The compression struts are designed to keep the front and rear tubular spars apart and also to take the wing’s inter-spar compressional forces. Without the inboard compression strut in place, both spars will move together until one breaks. The rear spar is prevented from moving forward by the hang cage centering cable, so the front spar is the one that fails.

The key defence against these kinds of spar failures is a good pre-flight inspection. Special care should be taken to inspect these after the aircraft has been re-assembled or has undergone maintenance affecting the compression strut area.
