*Learn from the mistakes of others; you'll not live long enough to make them all yourself . . . Issue 4/2004*

## VFR Flight Into Adverse Weather— Collision With Terrain

On June 6, 2002, a Cessna 182P was on an afternoon flight from Abbotsford, B.C., to Calgary, Alta. It failed to arrive at its destination. Emergency locator transmitter (ELT) signals were detected and the wreckage was located 17 NM northeast of Hope, B.C., at an elevation of 4 048 ft above sea level (ASL). The aircraft was destroyed. The four persons on board were fatally injured. This synopsis is based on the Transportation Safety Board of Canada (TSB) Final Report A02P0109.

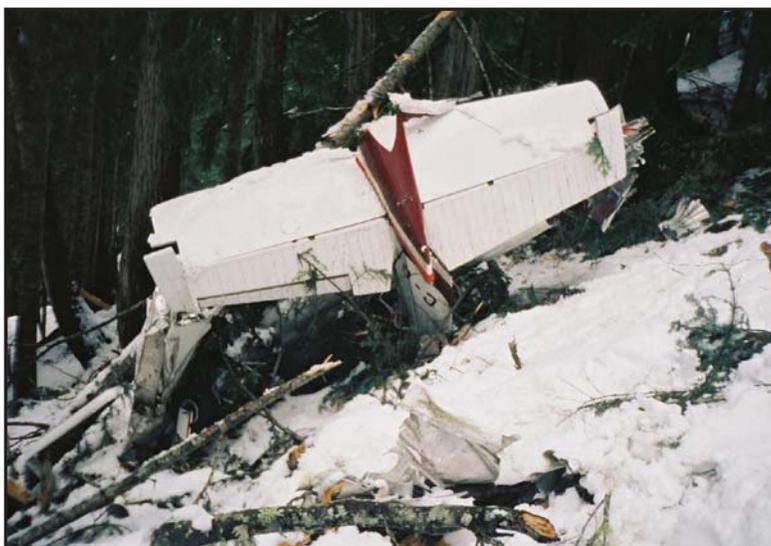
The wreckage was found on a heavily wooded, west-facing 45° slope. This site is about 1 NM south of the direct track from Abbotsford to Revelstoke. Tree damage and contact markings showed that the aircraft's flight path was mainly vertical at the time of impact. The wreckage was examined for pre-impact defects and none were found.

The aircraft's flight path was mainly vertical at the time of impact, indicating the aircraft was not under control. The severity of the damage and the angle at which the aircraft contacted the terrain indicates the aircraft was likely in a spiral dive at impact, not in a stalled condition. As indicated by the last GPS-recorded aircraft position and the accident position, the aircraft was travelling southward prior to impact. The fact that the fuselage was pointing 330° may be indicative of the aircraft being in a spiral dive. The most likely scenario to account for this accident involves a known phenomenon encountered by pilots flying in mountainous terrain. The high ground obscures the natural horizon and, in this occurrence, the difficulty in seeing the horizon would be exacerbated by the low cloud.

When he encountered rising terrain and lowering cloud, the pilot probably lowered the aircraft's nose to avoid entering cloud and started a turn to reverse his course. Because no horizon would be visible when looking outside the aircraft, the only way to maintain control during this turn would be by reference to flight instruments. For unknown reasons, the pilot lost control of the aircraft, and because of the relative proximity of the terrain, the aircraft struck a tree before the pilot was able to recover control.

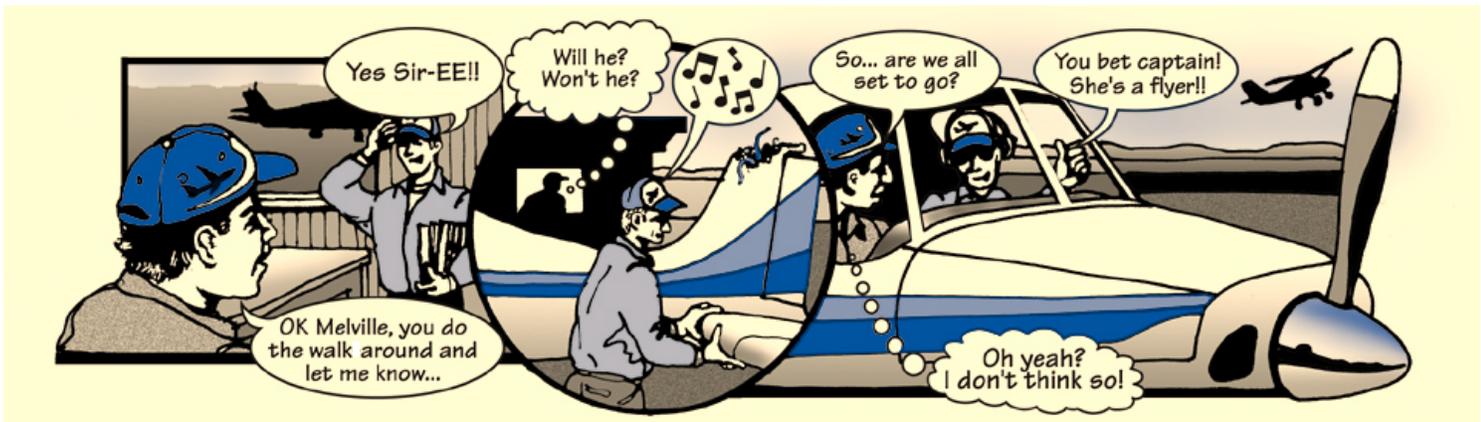
A customer rented a Piper Cherokee 140 at the school where I taught flying, and taxied it under the wing of a McDonnell Douglas DC-9. It didn't fit. The trailing edge of the DC-9's aileron neatly sliced through the top of the 140's rudder. The pilot must have felt a jerk, accompanied by the sound of ripping fibreglass, but he didn't stop. He continued to the runway, took off, flew back to our base and parked the Cherokee on the flight school ramp. He paid for the flight without mentioning the damage.

eyes and looked again when he saw the top of the rudder. Wires for the missing rotating beacon and rear navigation light hung over the jagged edge.

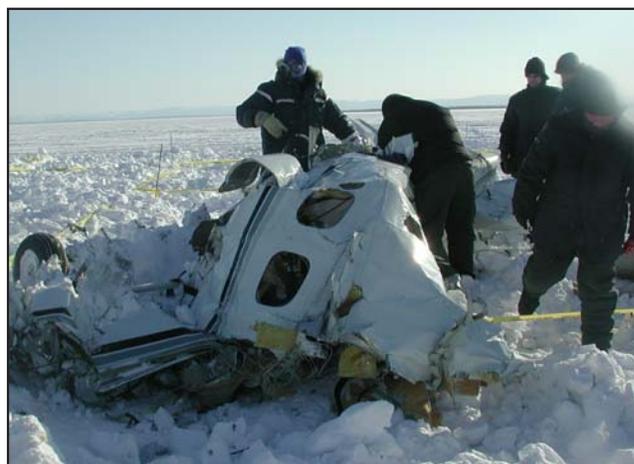
1. For an unknown reason, the attitude indicator gyro stopped functioning during the approach to Goose Bay.
2. The aircraft was not equipped with a serviceable turn coordinator, which would have allowed the pilot to assess and correct the aircraft's flight attitude even after the attitude indicator had failed.
3. Control of the aircraft was lost, and the pilot was not able to recover from the spiral dive that ensued.

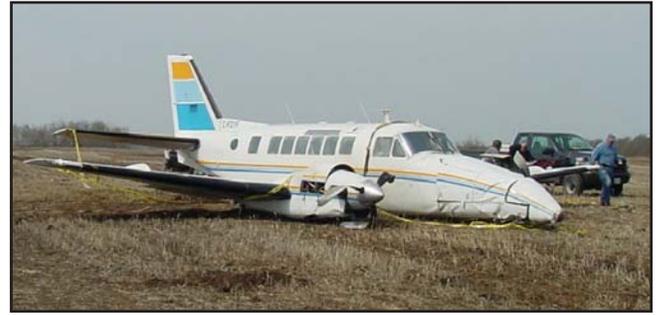
1. During flight, the horizontal stabilizer trim actuator worked free of the mounting structure, and as a result, the flight crew lost pitch control of the aircraft.
2. During replacement of the horizontal stabilizer trim actuator, the upper attachment bolts were inserted through the airframe structure but did not pass through the upper mounting lugs of the trim actuator.
3. The improperly installed bolts trapped the actuator mounting lug assemblies, suspending the weight of the actuator and giving the false impression that the bolts had been correctly installed.

4. Dual inspections, ground testing, and flight testing did not reveal the faulty attachment.
