Transport  
Canada

# Issue 1/2013 **Feedback**

Canadian Aviation Service Difficulty Reports

TP 6980E  
(1/2013)

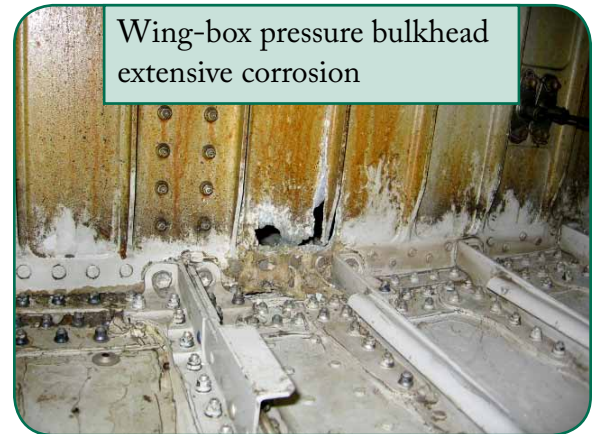
During a standard maintenance inspection check, extensive corrosion was found at forward wing-box bulkhead frame 39. The corrosion had perforated the pressure structure between stringers 55 and 54 left-hand side below waterline z-2557.

*The standard inspection interval of this area is set at a 5 year interval where this aeroplane was last inspected on March of 2011. Depending on the aeroplanes operating environment and upon the operators' discretion, this interval can be reduced to accommodate possible discrepant findings as seen with this service difficulty. ✖*

The bulkhead was repaired through the guidance of an Airbus Repair Approval Sheet (RAS) and made serviceable.

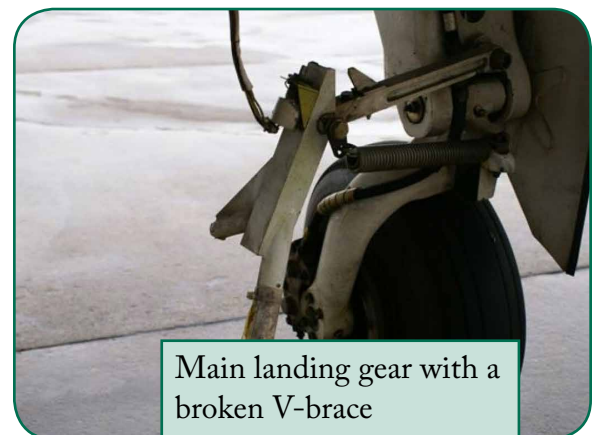
Following a landing, it was discovered that the left hand main landing gear V-brace was separated from the gear actuator point. Had the aeroplane taxied any further, the landing gear would have collapsed. A precautionary visual inspection on the right hand landing gear also revealed that the right hand V-Brace was cracked.

A detailed inspection using the magnetic particle inspection (MPI) technique on another aeroplane in their fleet found both the right hand & left hand V-braces to be cracked.

*Federal Aviation Authority (FAA) Airworthiness Directive 97-06-10 mandates SB 2361 to inspect the "A" Frame assemblies using both visual and dye penetrant methods but not MPI methods. The FAA has been advised accordingly. ✖*

*Beechcraft Service Bulletin (SB) 2361 recommends that should fatigue cracks be found on the main landing gear "A" Frame assemblies, then to install subject part number 105-8100-75 & 76. This should further support the strength of the attachment bracket for the hydraulic actuator connection.*

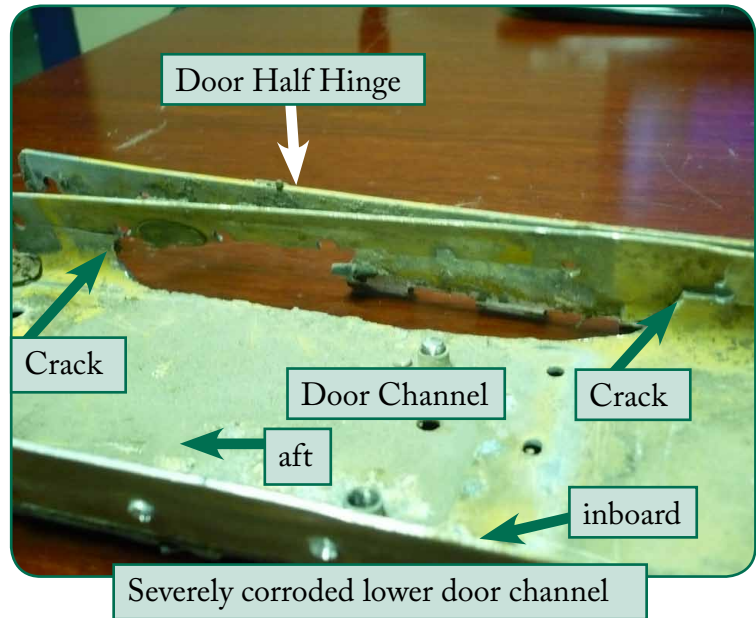
During servicing for the next flight, it was noted that the main cabin door lower step would move when stepped upon. Further investigation found the lower door channel had a 15.24 cm (6 inches) crack and the door side half hinge was broken 5.08 cm (2 inches) from the aft end. The channel (part number (P/N) 50-430043-619) half hinge (P/N 50-430043-547) and hinge pin (P/N 50-430043-393) were replaced due to severe corrosion.

*The main door and steps require continuous inspections due to consistent use from passengers and exposure to environmental contaminants that promote corrosion. In this case, it appears that this step had been in this deteriorated condition for some time. ✖*

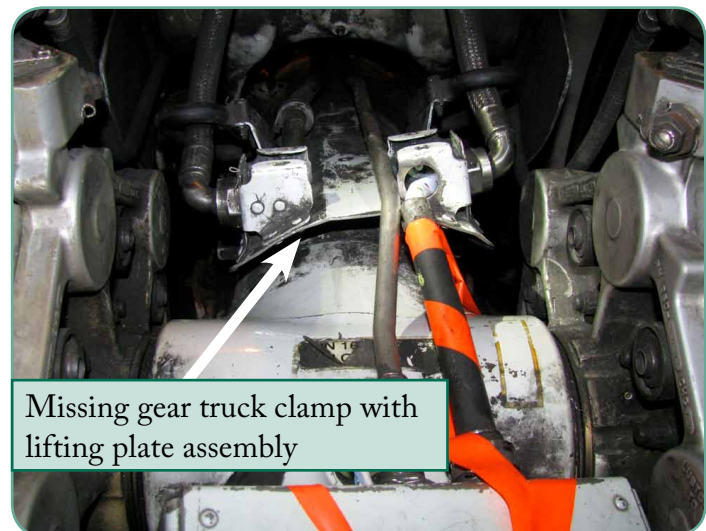
At the next maintenance opportunity, an investigation revealed that a clamp assembly was broken and had failed on the gear truck/bogie. The anti-skid wiring and conduits were also damaged. The damaged clamp, wiring and conduits were repaired making the aeroplane serviceable.

In order for this damage to occur, it appears that the plate assembly that the clamp secures was being pulled upwards (with the oleo at full extension) by the two flexible wiring conduits that travel up the gear strut.

*Further investigations revealed that these two flexible conduits on the right-hand (R/H) gear were about 5 cm (2 inches) shorter than the ones on the opposite main landing gear causing the stress on the clamp.*

*The investigation is still ongoing into this apparent discrepancy of gear harness conduit length and is suspected to be a quality control issue from the supplier of the discrepant harnesses. In the meantime, Transport Canada Civil Aviation (TCCA) would like to advise all owners, operators and maintainers of this possible condition of clamp failure. ✖*

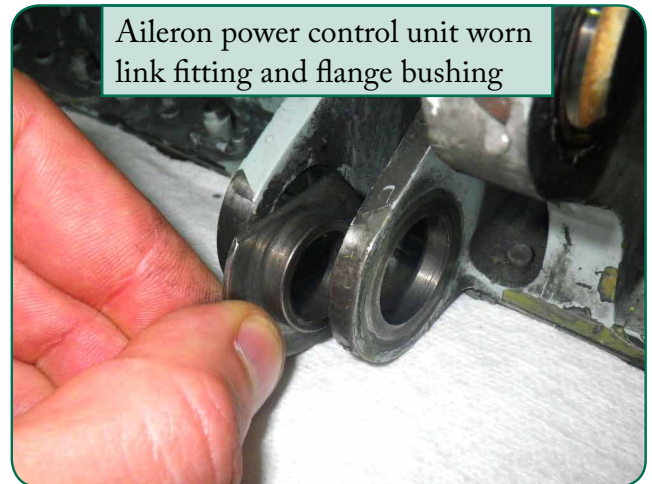
The Aircraft Maintenance Engineer (AME) was performing a detailed inspection of the right-hand (R/H) aileron panel and surrounding area as per a planned task when he found the R/H aileron out-board power control unit (PCU) link attachment fitting on the aileron to be worn. The excessive wear occurred where the attachment bolt flange bushing is installed. The flange bushing was found loose and had migrated slightly and showed evidence of rotating within the link-fitting.

*This condition can cause excessive backlash in the aileron system and damage to the PCU link and attachment fitting.*

The aileron panel assembly was replaced with a serviceable unit and the aeroplane was returned to service following the heavy maintenance check.

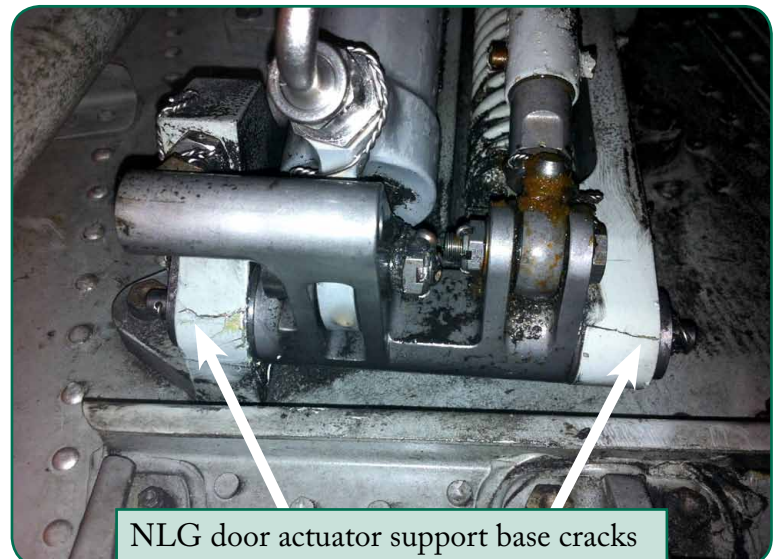
During a routine inspection, the maintenance engineer found cracks on both lower lugs of the nose landing gear (NLG) door actuator support base. The base is mounted on the right wall in the forward section of the nose wheel well.

The base was replaced and the aeroplane was made serviceable.

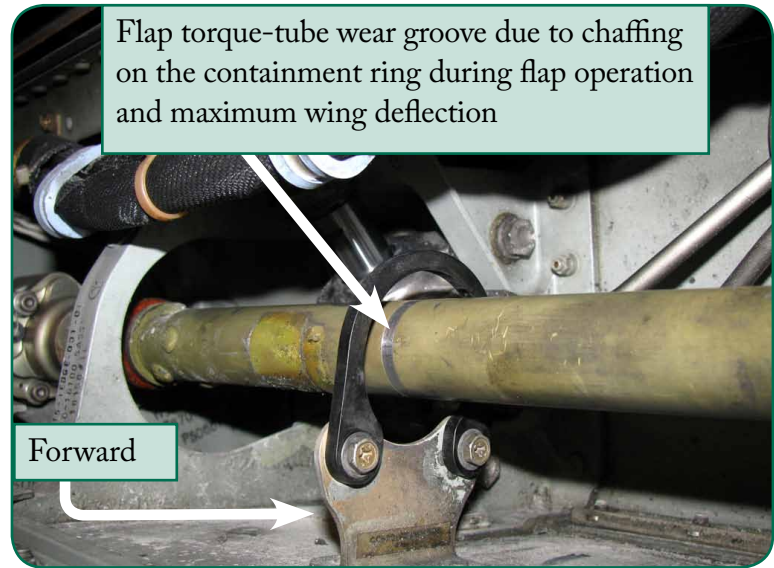
During a routine service check inspection, circumferential damage was found on the left-hand flap drive torque-tube at wing station (WS) 128 to WS 97. It was discovered that the torque-tube had been rubbing on the plastic containment ring during flap operation and maximum wing deflection, causing a chaffing condition.

The torque-tube was worn beyond limits and was replaced making the aeroplane serviceable.

*Bombardier Service Bulletin (SB) 670BA-27-049 introduces a slightly larger containment ring to increase the clearance with the torque-tube and removes the possibility of a chaffing condition during flap operation and maximum wing deflection. ✖*

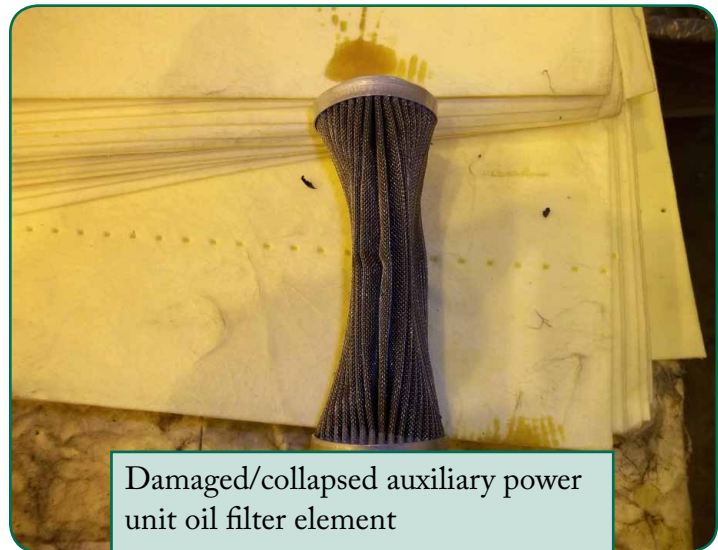
A collapsed filter was found during a scheduled replacement of the auxiliary power unit (APU) oil filter element per task 000-49-360-714 (2000 hours interval). The filter was replaced, leak checked and the aeroplane was released for service.

The filter had no trace of excessive contamination to cause the element to collapse where the likely cause was determined to be due to an incorrect installation.

*It is important to note that for the correct installation of the APU oil filter and to prevent its inadvertent damage, the filter element must first be installed to the lube-module, followed by the oil filter bowl assembly. ✖*

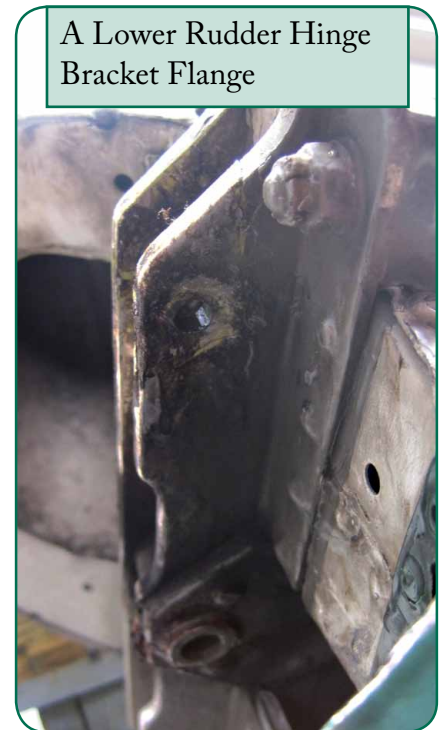
A visual inspection revealed a stress corrosion crack 6.35 cm (2.5 inches) in length, located on the lower rudder hinge bracket flange extension, adjacent to the rudder push pull rod end attachment point.

*Possible contributing factors to stress corrosion cracks could be attributed to flight loads associated with floatplane operations, salt water environment and exposed rudder actuating rod end. ✖*

The rudder was removed to facilitate the replacement of the bottom bracket.

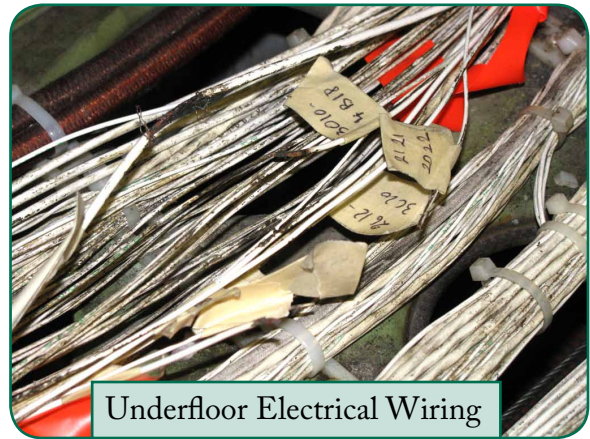
Underfloor Electrical Wiring

During taxi out for departure, the crew noticed a strong burning smell in the cabin and cockpit. The pilot elected to stop the aeroplane in the central deicing facility and the flight attendants proceeded to disembark all passengers.

During maintenance troubleshooting, several unusual defects were noted. The #2 cargo smoke detector failed to “test”, the #1 standby pump “hot” caution light illuminated and the #1 bleed control circuit breaker “popped” whenever the switch was selected to “off”. Further investigation revealed numerous electrical wires in the wiring channel located under the cabin floorboards on the left-hand side at passenger Row 1, were chafed/blackened and “shorted” to each other. The damaged wires were repaired, electrical circuits tested and aeroplane returned to service.

*It is advisable that maintenance personnel be particularly mindful regarding the condition of electrical wiring, particularly in older model aeroplanes. ✖*

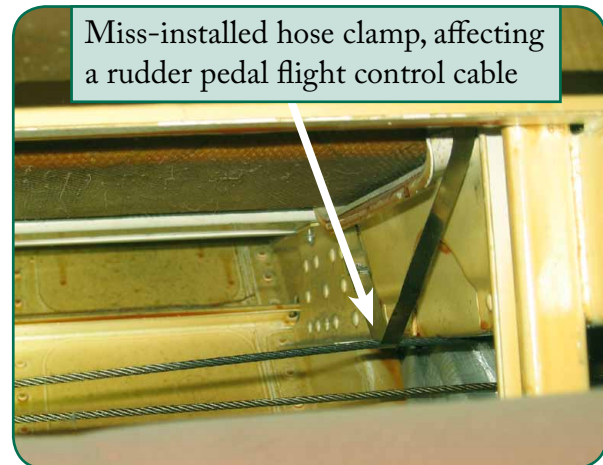
Following the troubleshooting of an air-conditioning fault, an unusual noise was heard coming from under the floor area around frame 20 (mid fuselage) when operating the rudder pedals.

A visual inspection confirmed that a stainless steel hose clamp for an air-conditioning distribution duct was mistakenly secured around an adjacent rudder control cable.

Chaffing marks were found on the transverse floor beam channel and a repair was performed as per Structural Repair Manual (SRM) 53-00-5.

Miss-installed hose clamp, affecting a rudder pedal flight control cable

The rudder cable was visually inspected, tension checked and a Non-Destructive Testing (NDT) was performed, with no faults found.

All other cables in the sub floor area were inspected for the same potential defect with no fault found making the aeroplane serviceable.

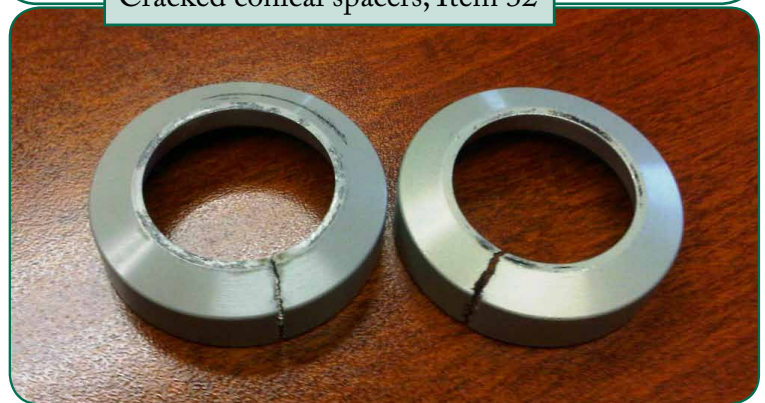
The conical spacer was discovered cracked when the left main landing gear (MLG) retract actuator was removed for access to address another problem. The right MLG was also found with the same cracked conical spacer.

The nature of the crack indicates it is being over-loaded on the conical surface resulting in the fracture.

*Bombardier Learjet engineering have been advised of this event, including two others in the past 4 years. Learjet analysis has confirmed that the cracking of these spacers is due to stress corrosion and does not create a safety issue.*

Cracked conical spacers, Item 32

Both of the conical spacers were replaced, making the aeroplane serviceable after the initial problem was corrected.

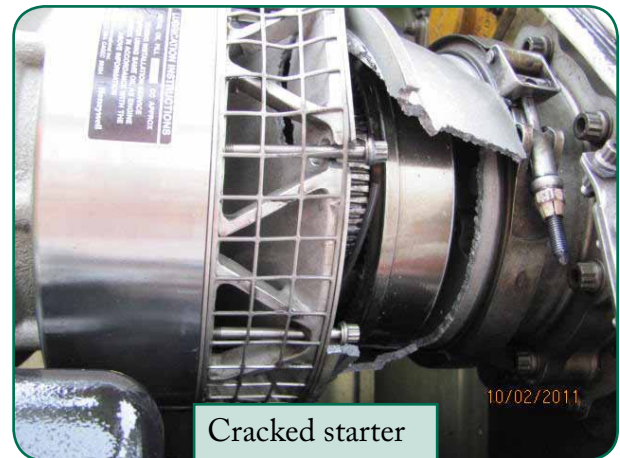
Maintenance found that the number 1 engine starter sustained significant fracture damage to the housing assembly. With the CFM56 shared oil with the starter it is suspected that this was the exit point for the engine oil. Using recorded data, it was confirmed that the oil pressure limitations were not exceeded. Maintenance actions and engine runs carried out as per the aircraft maintenance manual and the aeroplane was released for service.

*The exact cause of the failure is not known, however the overhaul report stated that the 'Failed gear housing allowed oil loss, ultimately causing an in flight shut down. ✖*

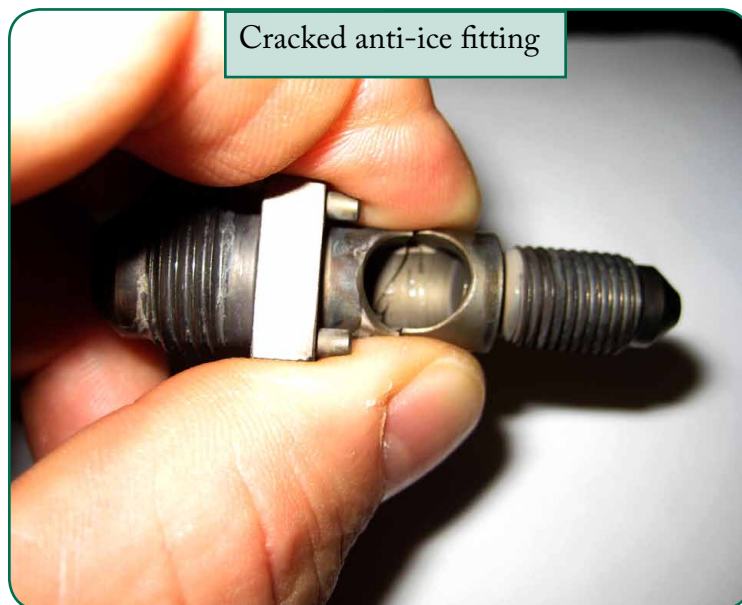
The engine would not develop full power at altitude. Maintenance discovered that a fitting on the anti-ice shield was cracked, affecting the p2t2 sensor. This caused the single red-line (SRL) computer to control the exhaust gas temperature (EGT) incorrectly. The fitting was replaced and the aeroplane was returned to service. No further incidents were reported by flight crew.

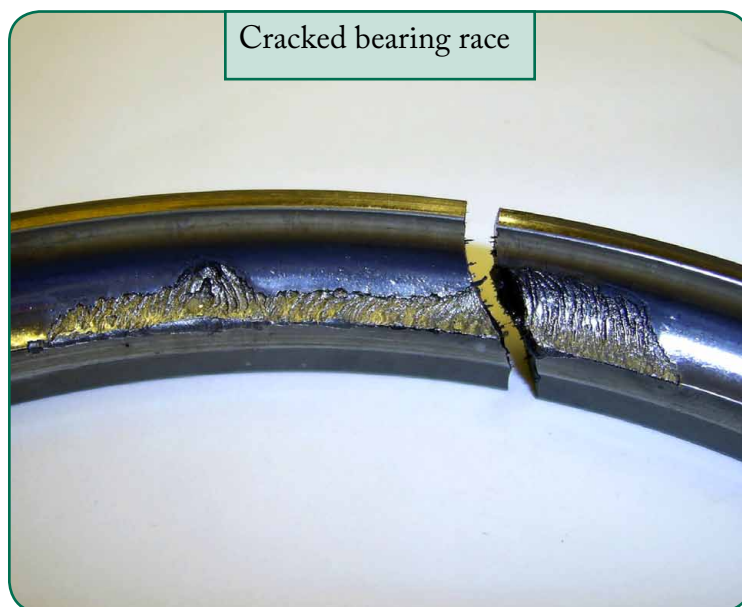
During the replacement of the aeroplane's left propeller actuator, the engineer noticed that the #1 blade outer race located inside the propeller hub was broken. A visual inspection of the #1 blade outer race revealed plating missing on the lower section of the race near the fracture point and bearing marks along the race. Fragments of metal were also observed at the fracture point, standing straight as if the race was magnetized. The remaining blades were removed and the #4 blade outer race was found with a small area of plating missing and bearing marks along the race. The propeller hub is currently being replaced. Similar damages were reported a few weeks previously on the right propeller of the same aeroplane. The hub assembly has been shipped to a repair station for a detailed inspection/evaluation.

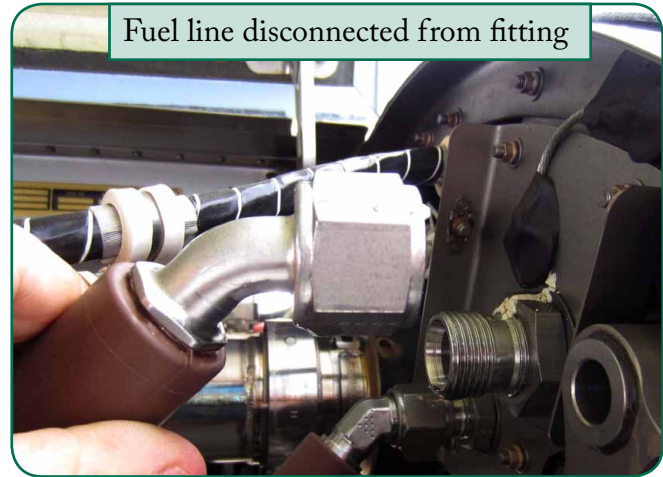
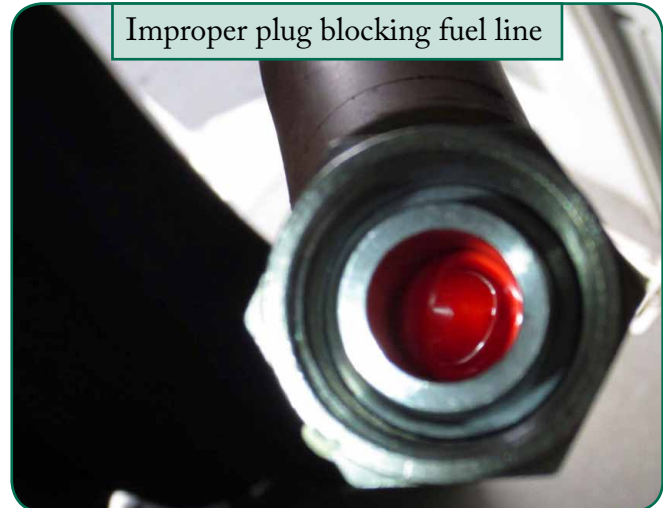
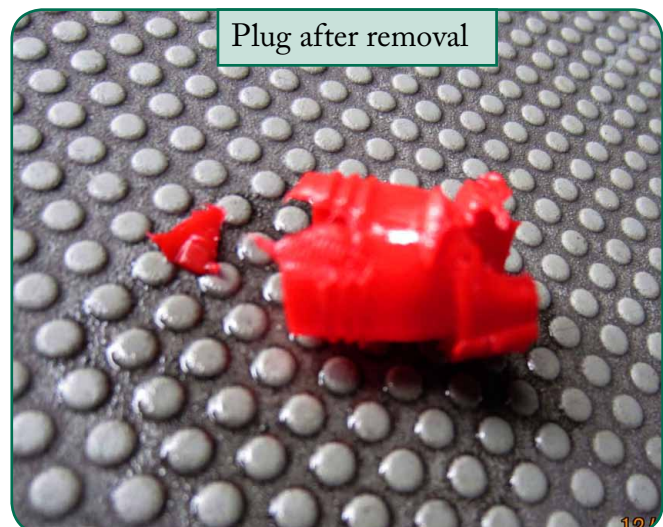
Pilot reports that after takeoff at approx 1200 Feet, during clean up of the flight deck configuration, the #2 engine fuel auxiliary pump was selected off. Approximately 5 to 10 seconds after the pump was selected off, the engine began to surge with an associated fuel pressure master caution light and then the engine failed. The pilot returned to base.

Maintenance found a protective cap inside a flex line going to the Fuel Metering Unit.

*Improper use of various tooling including protective caps can cause many problems such as blocked pitot/static ports, weight on wheel configuration problems as well as damaged structure or components. Instructions for correct tool use must be followed at all times including ensuring that the tool is in proper condition. Any warning devices or flags to remind maintainers to remove the tool prior to maintenance release must also be in place and intact. ✖*

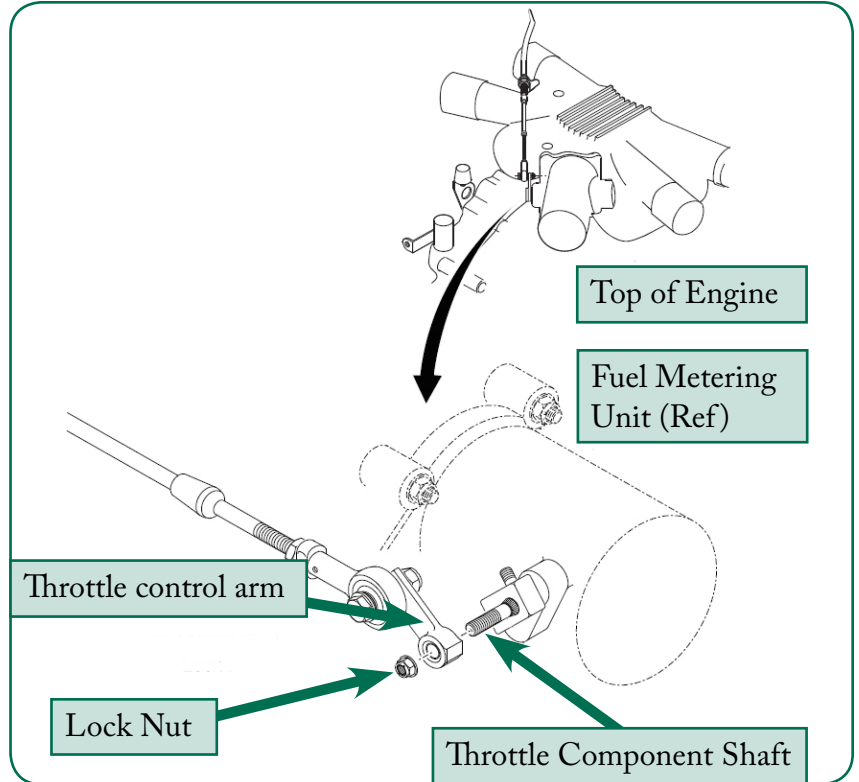
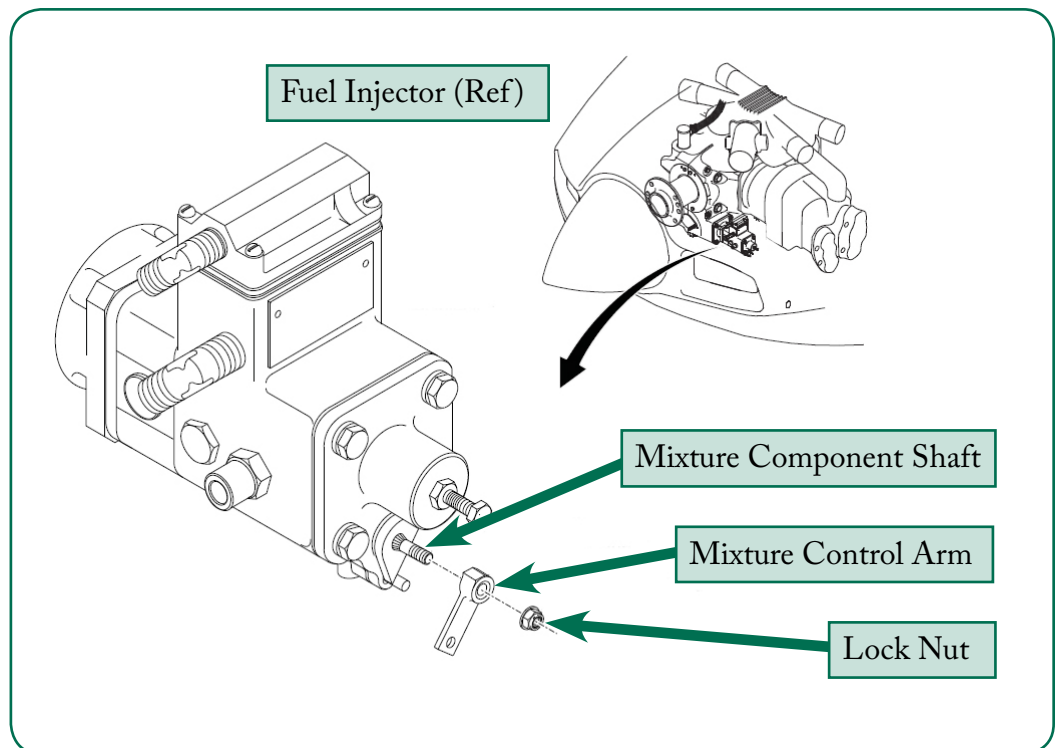
On final approach, the engine would not respond to throttle input. The engine was shut-down with the mixture lever cut-off and the aeroplane landed short of the paved runway in the grass. There was no injury to the crew or passengers and no physical damage to the aeroplane. A post-flight inspection revealed damage to the splines on throttle body lever-to-cable hook-up.

*Diamond Aircraft has released Service Information Letter 20C1-006 which describes inspection and maintenance of both the throttle and mixture control arms. It is important that operators inspect their aeroplanes in accordance with these instructions.* ✂
