TP 185E
Issue 1/2014

AVIATION SAFETY LETTER

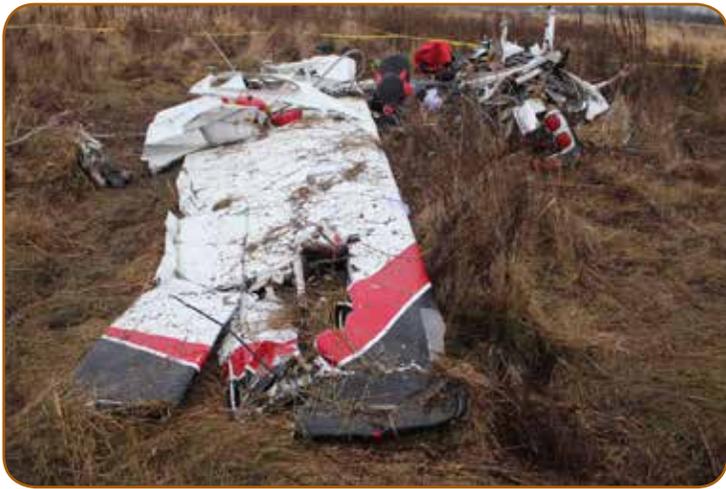
Wreckage of Cessna Cardinal 1.9 NM west of the threshold of Runway 07 at CYOW

At approximately 19:12, the aircraft entered a steep right turn with a rapid descent, and struck power lines before impacting the ground 1.9 NM west of the threshold of Runway 07. Radar data show that, while on the approach, the aircraft twice deviated

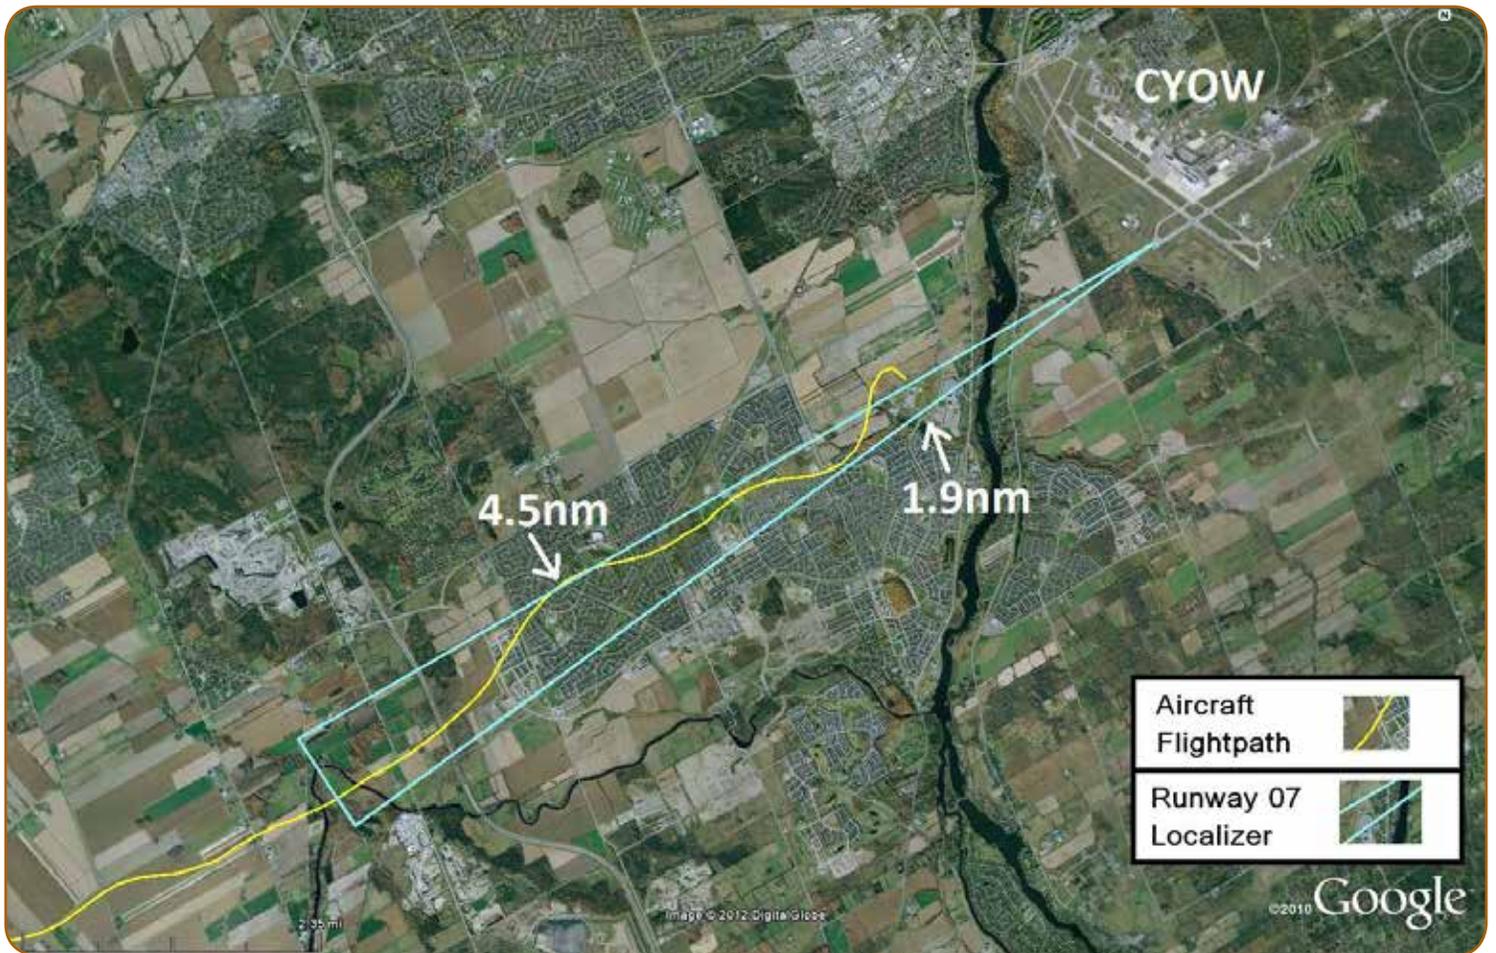
Figure 1—Aircraft's flight path showing its deviations from the localizer during the final approach.

significantly from the localizer to a point that would have caused the localizer indications on the aircraft instruments to go to full deflection. Airspeed on the approach was maintained above 100 kt until the loss of control (Figure 1).

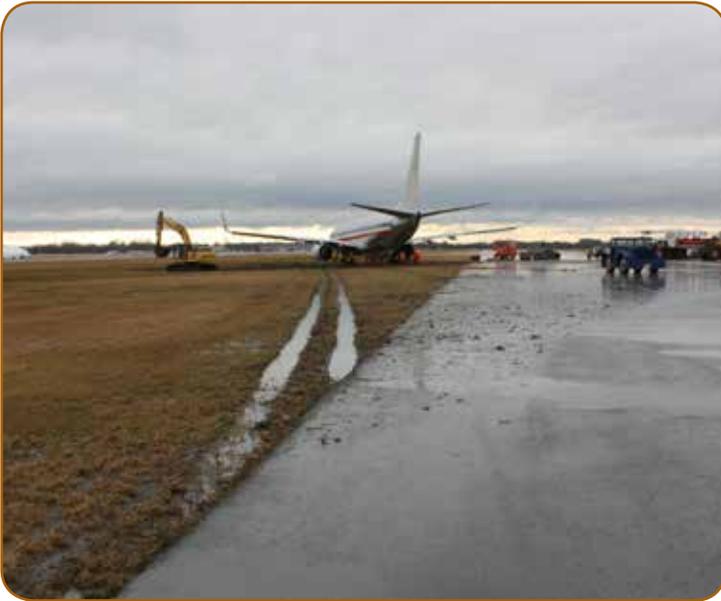
Boeing 737 off the runway

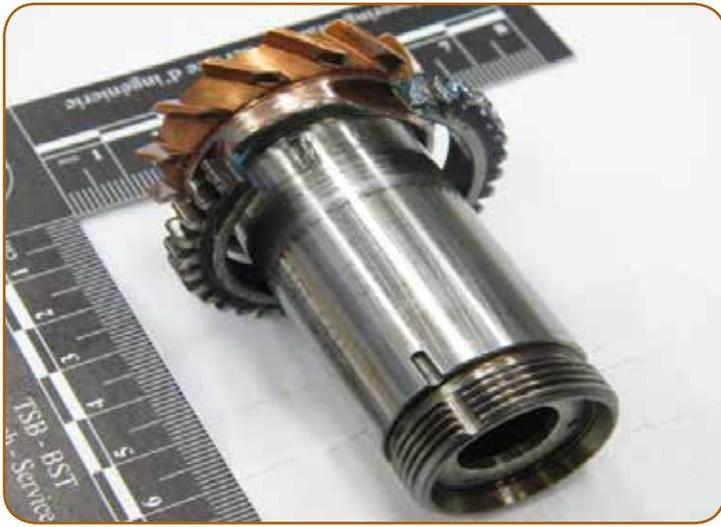
The torque sensor had accumulated approximately 6 470 hr since overhaul in 1997. The torque sensor assembly does not have a designated overhaul period and is normally overhauled with the engine. The laboratory analysis indicated that the case hardening of the gear tooth flanks and roots of two spur gears in the torque sensor gear train was below the manufacturer's specification requirements and likely led to the wear of the loaded faces and flanks of the gear teeth. The combined wear of the two gears likely caused an abnormal vibration that produced excessive cyclic loading and eventual fatigue cracking in the tooth roots of the intermediate gear. The intermediate

spur gear subsequently separated into several fragments and caused the loss of power transmission to the high-pressure, engine-driven fuel pump. The immediate result would have been fuel starvation of the engine, flameout and loss of power.

Failed gear on the torque sensor shaft

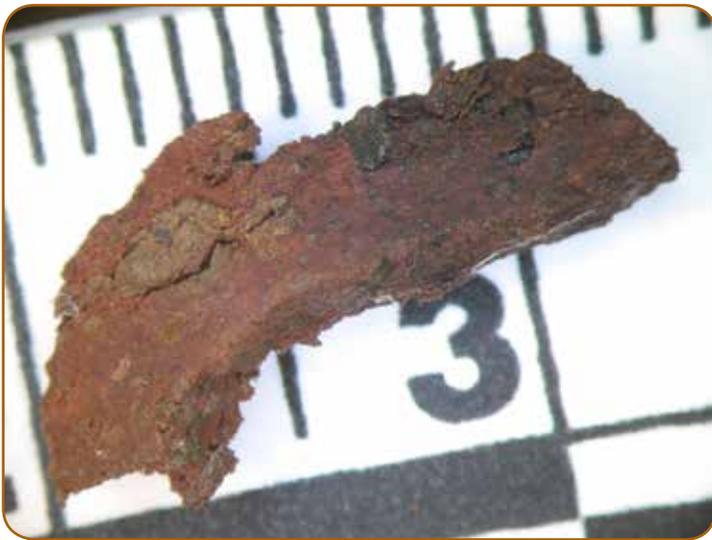
The left engine lost power due to fuel starvation. Investigators found debris in a fuel pump nozzle, which reduced the amount of fuel the pump delivered to the left collector tank. Fuel depletion in the left collector tank caused the engine to shut down while usable fuel remained in the left inboard tank. Additionally, the fuel cross-feed valve remained closed, which meant that the left engine was only receiving fuel from the left fuel tank, rather than from both tanks.

Debris found in fuel pump nozzle (ruler scale is cm)

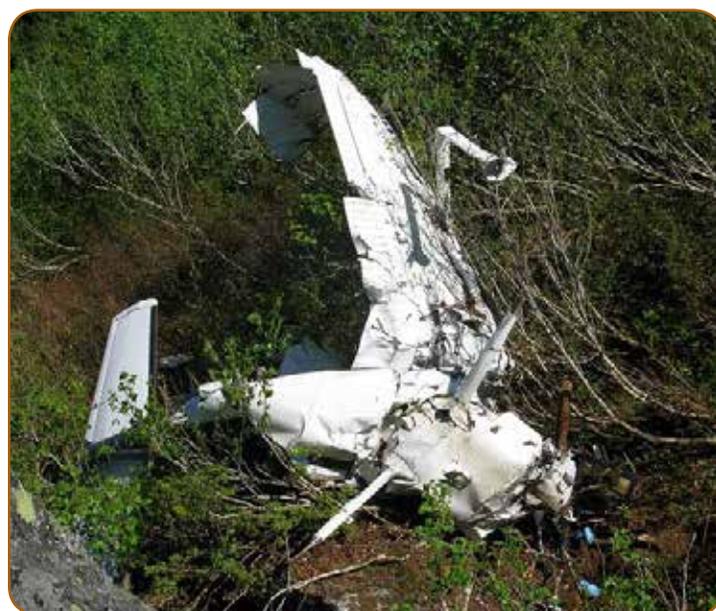
Wreckage of Cessna 152

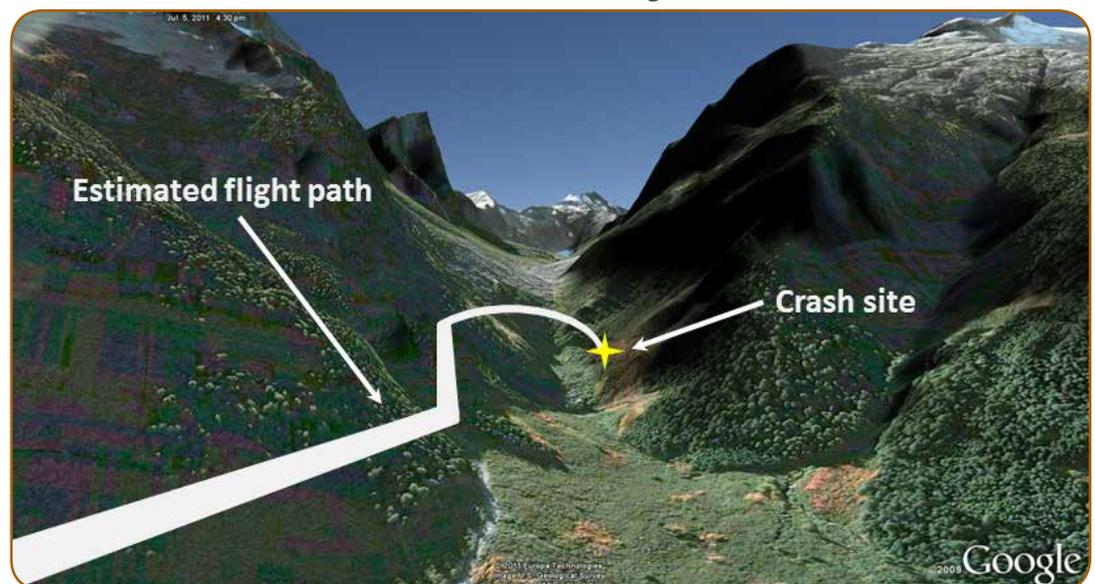
It is not known why the aircraft was at such a low level before the crash. However, conducting a turn at a low altitude would have increased the risk level of the manoeuvre and was not in accordance with the flying school policy regarding minimum flight altitudes. If the instructor delayed the decision to initiate the turn-around, it would have further reduced safety margins. With the flaps in the up position, the stall speed would have been 7 kt higher than if the flaps had been fully down. In addition, it is possible that once the turn was initiated, the aircraft encountered a downdraft on the shadow side of the valley, which could have caused the aircraft to sink. If the pilots were not cross-checking their instruments, it is also possible that the loss of horizon and visual illusions caused by the surrounding terrain may have caused the pilots to inadvertently stall the aircraft while conducting the turn.

Estimated flight path with shadows at the time of the accident (Image: Google Earth)

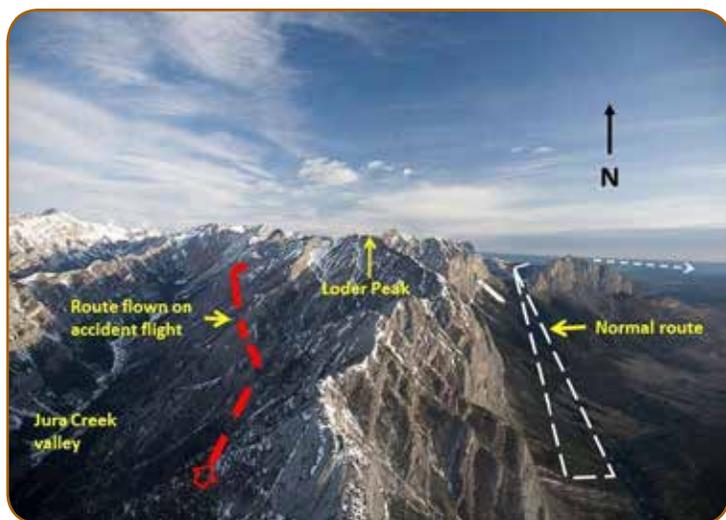
Route of flight

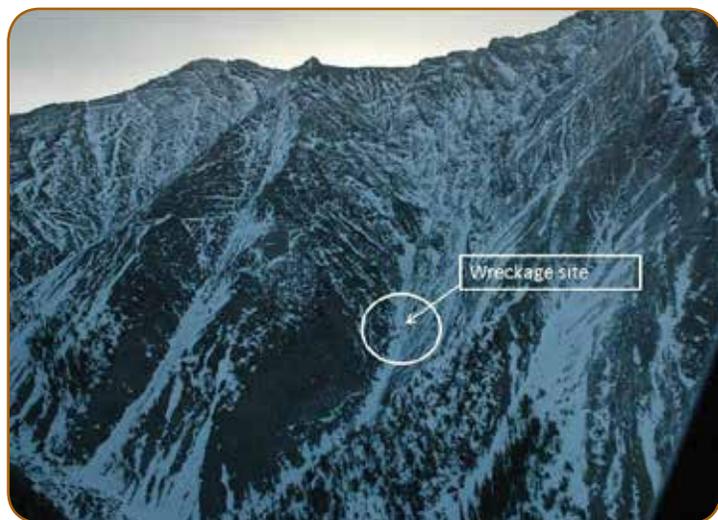
Wreckage site

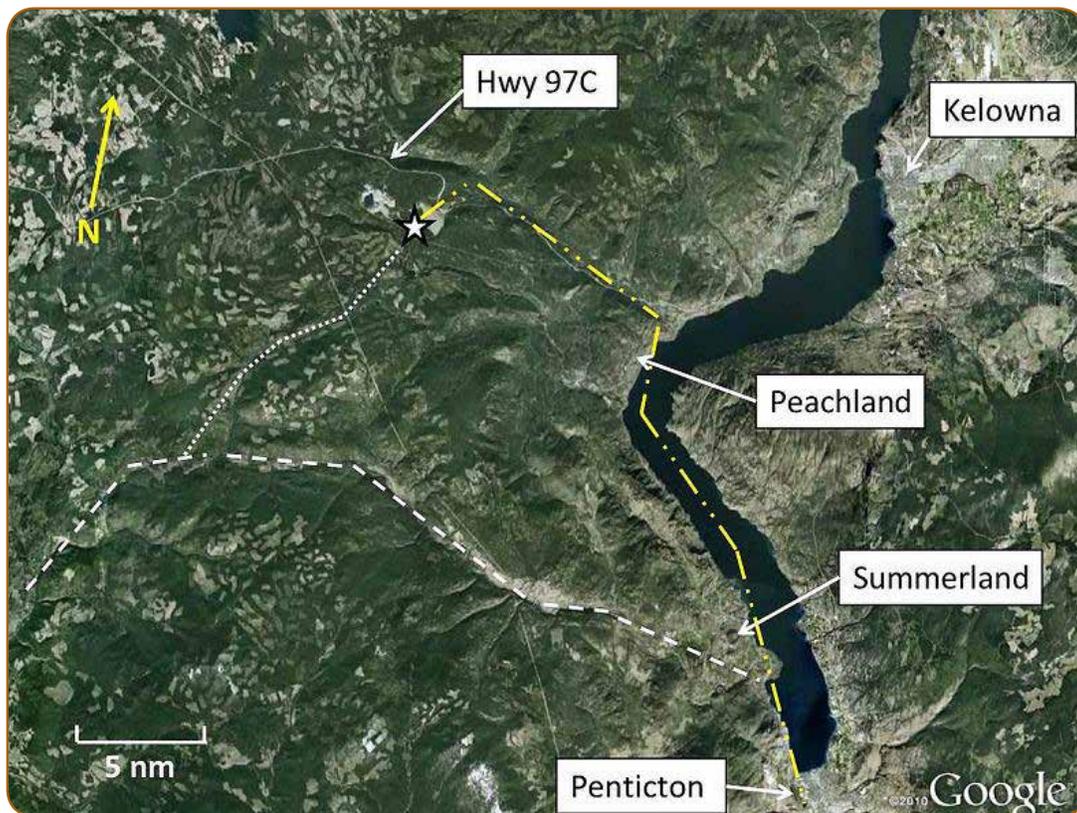
The pilot decided to conduct the flight despite being aware that visibility to the west (the flight planned route) was reduced by smoke. Reduced visibility was almost certainly encountered in the vicinity of Brenda Mines.

Map showing the probable route up the lake to the accident site (dashed/double-dotted line), the published VFR route to the west of the lake (dashed line) and the low ground route connecting the two (dotted line)

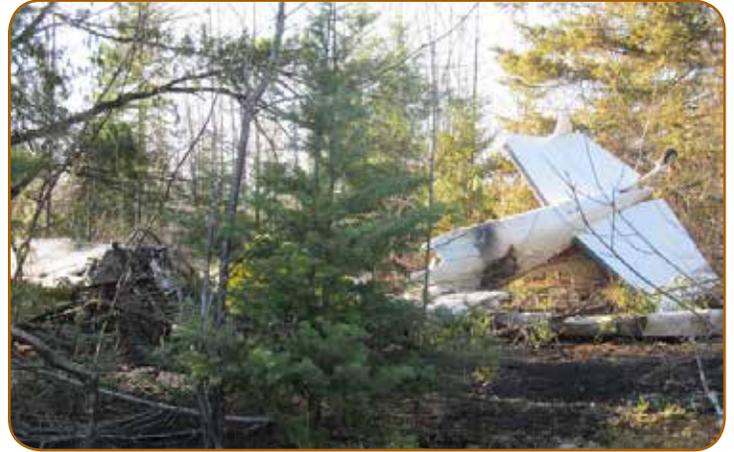
— On May 4, 2013, a **Cessna 185F** took off from Runway 25 at Mont-Laurier aerodrome (CSD4), Que. with a pilot on board. Runway marks made by the left wheel extended into the sand located off the runway, indicating that the aircraft had left the runway before taking flight. Once in flight, the aircraft banked left, crashed nose first in the opposite direction and caught fire. The pilot was killed. The TSB sent the seat to the laboratory for further analysis. *TSB File A13Q0077.*

Cessna 185F at Mont-Laurier on May 4, 2013

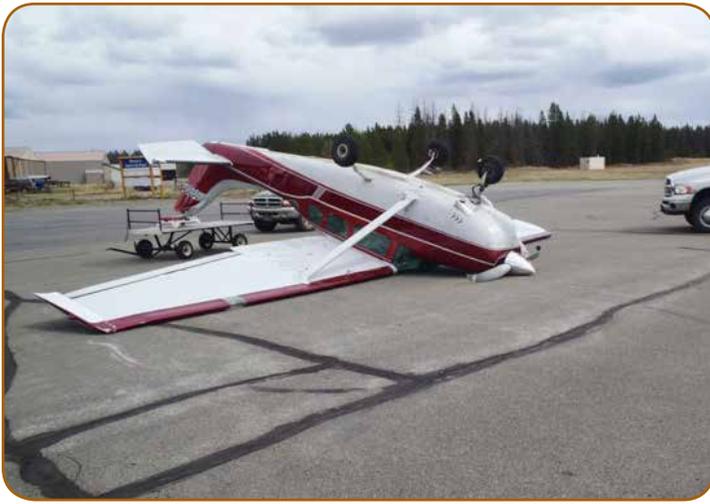
TSB File A13P0080

— On May 13, 2013, a **Cessna 205** was being run up after maintenance by an aeronautical maintenance engineer (AME) on the apron at Anahim Lake Airport (CAJ4), B.C., when the aircraft flipped over its nose. It was reported that the aircraft had a 5 kt tailwind and was just powering up (about ½ throttle) when a whirlwind gust caught under the tail. The AME was alone on board and was not injured, but the aircraft was substantially damaged. *TSB File A13P0080.*

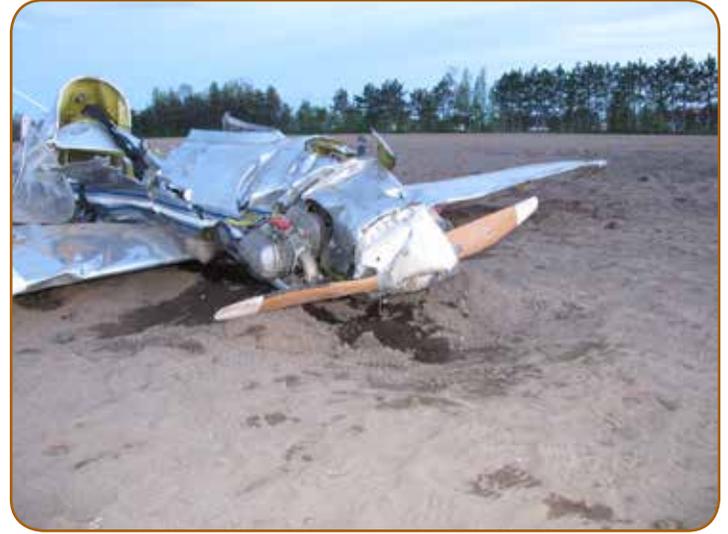
— On May 18, 2013, an **amateur-built Hummelbird** aircraft was conducting a local VFR flight from Mascouche Airport (CSK3), Que., in clear and calm weather conditions. While the aircraft was above Lavaltrie, Que., the pilot made a distress call without specifying the nature of his difficulties. The aircraft crashed at an impact angle of about 60° into a sandy field. The pilot suffered fatal injuries. The aircraft was substantially damaged but the propeller was relatively undamaged. The engine was taken to a TSB laboratory for assessment. *TSB File A13Q0086.*

Hummelbird amateur-built, May 18, 2013

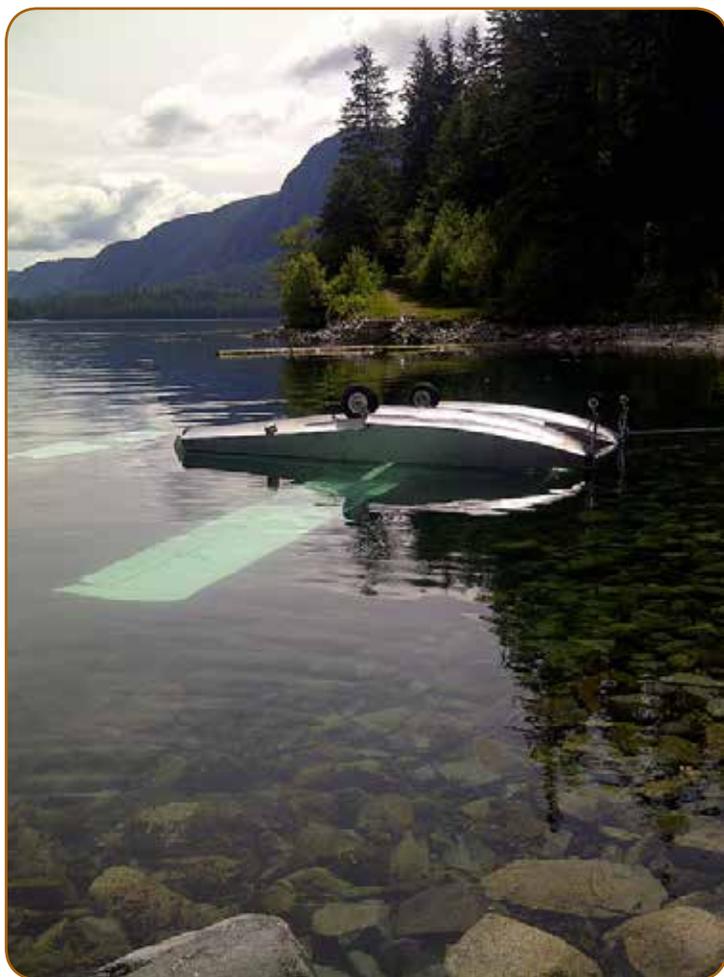
17:45 PDT. The one person on board was confirmed deceased. The aircraft was equipped with a 406/121.5 MHz emergency locator transmitter (ELT), but no transmission was received or reported by others. *TSB File A13P0086.*

Sunken DHC Beaver on May 21, 2013 near Stuart Island, B.C.

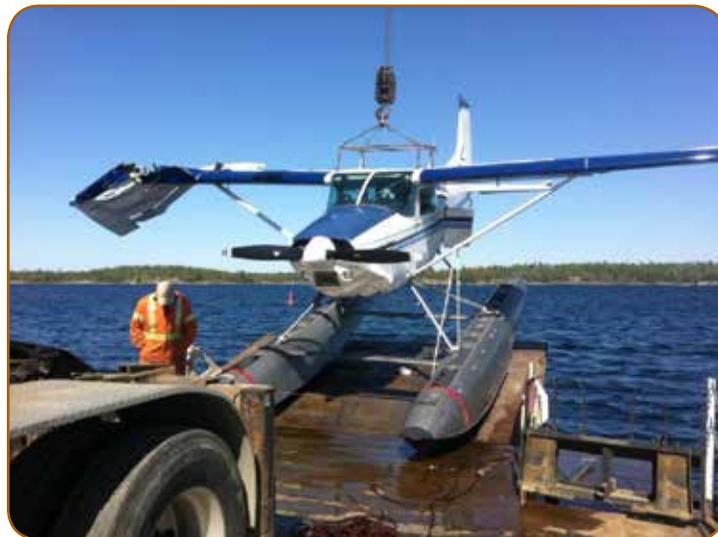
TSB File A13O0099

— On May 25, 2013, a **Cessna 180K on floats**, with an instructor and a privately licensed student on board, was performing cross-wind landings in the Georgian Bay, 8 NM W of Parry Sound, Ont., as part of the student's training to obtain a float endorsement. After several cross-wind takeoffs, they flew an approach in a NE direction with the wind reported from the WNW at 5–15 kt. Visibility during the flight was unlimited, and the landing was to take place in the leeward side of an island where the water surface was calmer. After a briefing from the instructor, the student remained as the pilot flying and selected 20° of flap. The approach was stable, but when the aircraft touched down on the water the left float dug in and the aircraft veered to the left and became inverted. The instructor tried to take control of the aircraft but was unable to right the aircraft before it became inverted. The student and instructor were wearing shoulder harnesses and, after the aircraft stopped, they released themselves from the harnesses and both exited the aircraft through the right cabin door.

The aircraft came to rest approximately 50 ft from a small island. Although both retrieved life jackets from the aircraft, they decided the distance to shore was minimal and carried the life jackets instead of wearing them. After a short period of time, a boat passed by and called rescue services. Neither pilot was injured; the aircraft sank in approximately 10 ft of water. *TSB File A13O0099.*

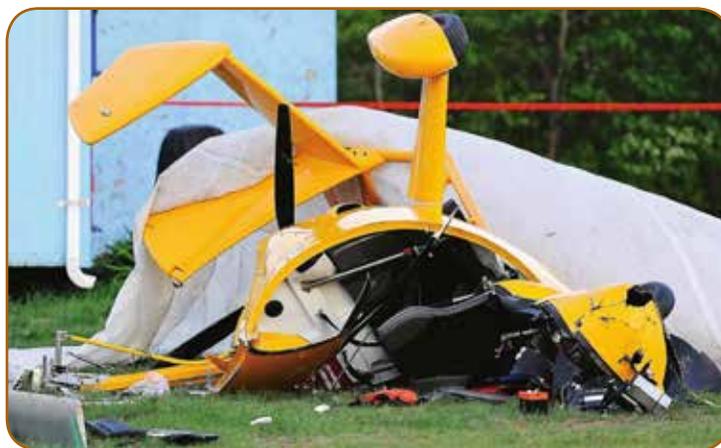
— On May 28, 2013, a **Delta Trikes Aviation J-RO 914 UL gyroplane**, with the owner/student pilot on board, took off from a grassy area off the left side of Runway 24 at St-Lambert- de-Lauzon aerodrome (CST7), Que., in order to conduct a local flight. This grassy area is often used by aircraft such as gyroplanes and ultralights. During the climb, control was lost and the aircraft crashed about 2 000 ft from the threshold of Runway 24, 150 ft southeast of the runway.

The pilot died in hospital. The aircraft was destroyed by the impact but there was no post-crash fire. Two TSB investigators went to the accident site. The reasons for the loss of control are not yet known. *TSB File A13Q0089.*

Gyroplane accident at the St-Lambert- de-Lauzon aerodrome

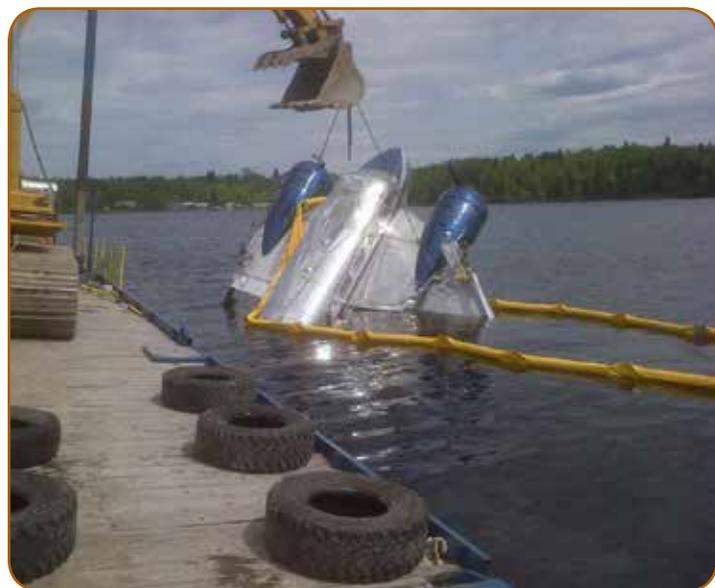
— On May 30, 2013, a **float-equipped Beech 18** was departing Cochenour (Red Lake), Ont., en route to McCusker Lake, Ont., on a camp service flight with a pilot and one passenger on board. On departure, the aircraft banked slightly right then 90° left. The left wing tip struck the water, and the aircraft cartwheeled and sank. The two occupants sustained fatal injuries; the aircraft was substantially damaged. *TSB File A13C0058.*

Beech 18 being recovered out of Red Lake, Ont.

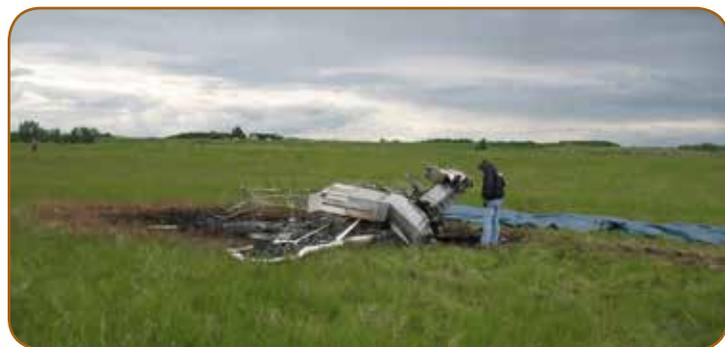
TSB File A13C0063

— On June 13, 2013, a **Piper PA-14** was departing North Battleford/Cameron McIntosh Airport (CYQW), Sask., en route to Calling Lake, Alta. Shortly after takeoff, the aircraft banked into a turn, descended and struck the ground. A post-impact fire ensued. First responders reached the scene shortly after the accident occurred. The two occupants were deceased and the aircraft was destroyed by impact forces and fire. *TSB File A13C0063.*

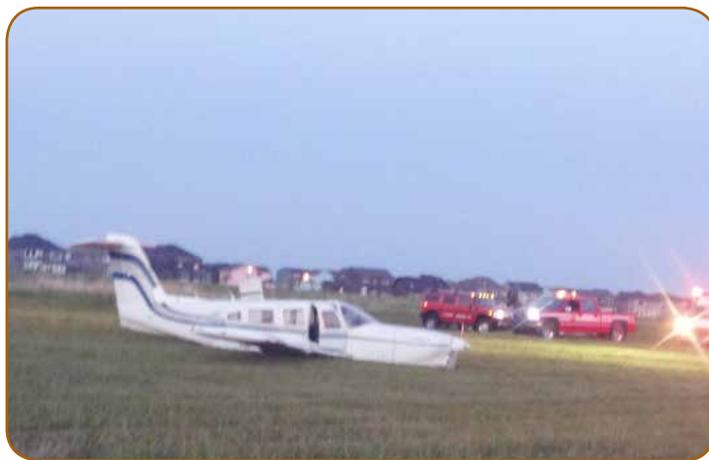
TSB File A13W0090

— On July 1, 2013, a **Piper PA-32RT-300T (Turbo Lance II)** was arriving at Okotoks (CFX2), Alta., from Elko (CBE2), B.C., when the engine began to lose power while downwind for Runway 16. The pilot switched fuel tanks with no change. With insufficient power to maintain altitude, the pilot conducted a successful forced landing in a stubble field approximately 1 km north of the airport. Two passengers and two dogs exited the aircraft, and additional fuel (approximately 30 L) was added for an attempt to reposition the aircraft to the airport. Shortly after becoming airborne from the stubble field (1 ft stubble), the aircraft struck a chain-link fence and landed heavily short of the runway, resulting in substantial damage to the aircraft. The pilot sustained injuries. *TSB File A13W0090.*

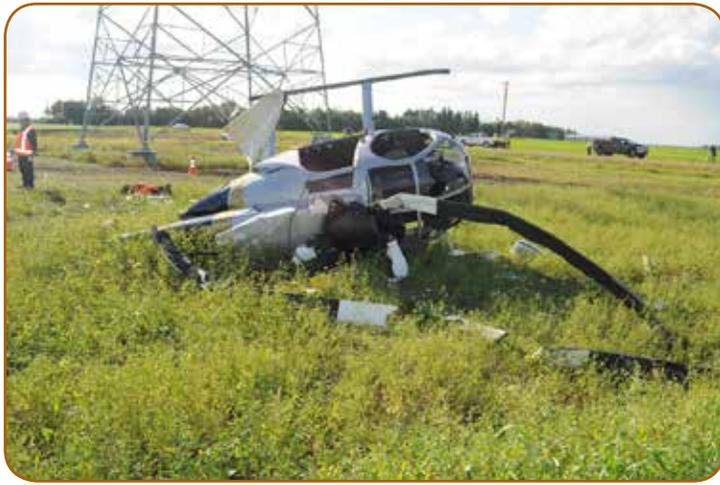
— On July 5, 2013, a **Hughes 369D (500D)** helicopter was operating 5 NM NW of Fort Saskatchewan, Alta., in support of the construction of a 500 kV transmission line. While hovering next to a lattice tower, the main rotor blades struck the tower structure and control of the helicopter was lost. The helicopter crashed near the base of the tower, and the pilot and lineman both received serious injuries. The helicopter was substantially damaged; there was no post-impact fire. *TSB File A13W0093.*

Downed helicopter near Fort Saskatchewan, Alta.

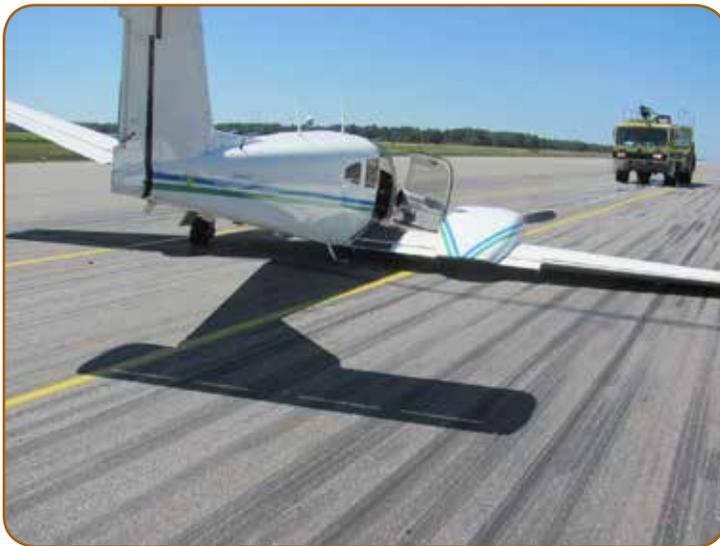
TSB File A1300134

— On July 11, 2013, a **Piper PA-44-180** aircraft was conducting stop-and-go circuits on Runway 30 at Sault Ste. Marie Airport (CYAM), Ont., with one instructor and two students on board. During the occurrence landing, the student retracted the flaps as the aircraft was slowing down and inadvertently retracted the landing gear at the same time. The aircraft right main landing gear and nose landing gear retracted. The right wing suffered damage and the propellers on both engines struck the ground. There were no injuries. *TSB File A1300134.*

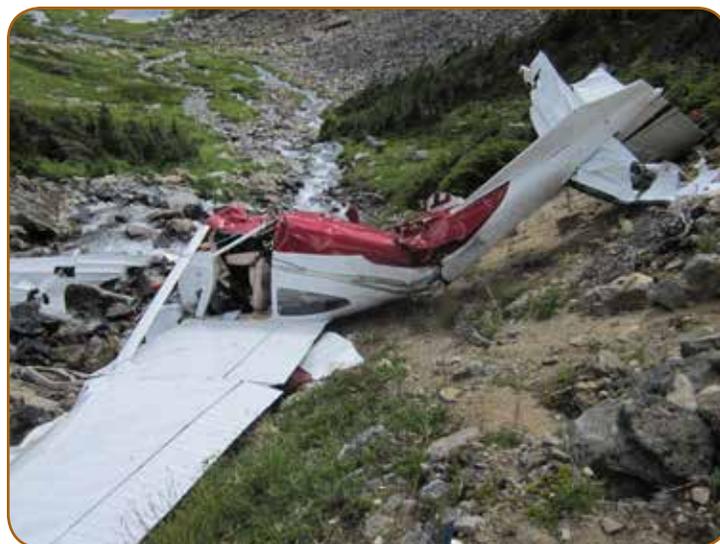
The pilot was deceased. There was no fire. The coroner's office said it is not known why the pilot elected to fly up the Alnus Creek valley. No indications were found of power or control loss prior to impact. Physical evidence was consistent with high power setting upon contact with terrain. High altitude and high air temperatures resulted in high density altitude, factors known to degrade aircraft performance. This accident is consistent with other accidents the TSB has investigated where pilots have intentionally flown into rising terrain, and degraded aircraft performance resulted in the aircraft being unable to stay above the terrain. *TSB File A13P0154.* △
