TP 185E
Issue 2/2019

AVIATION SAFETY LETTER

TSB Final Report Summaries

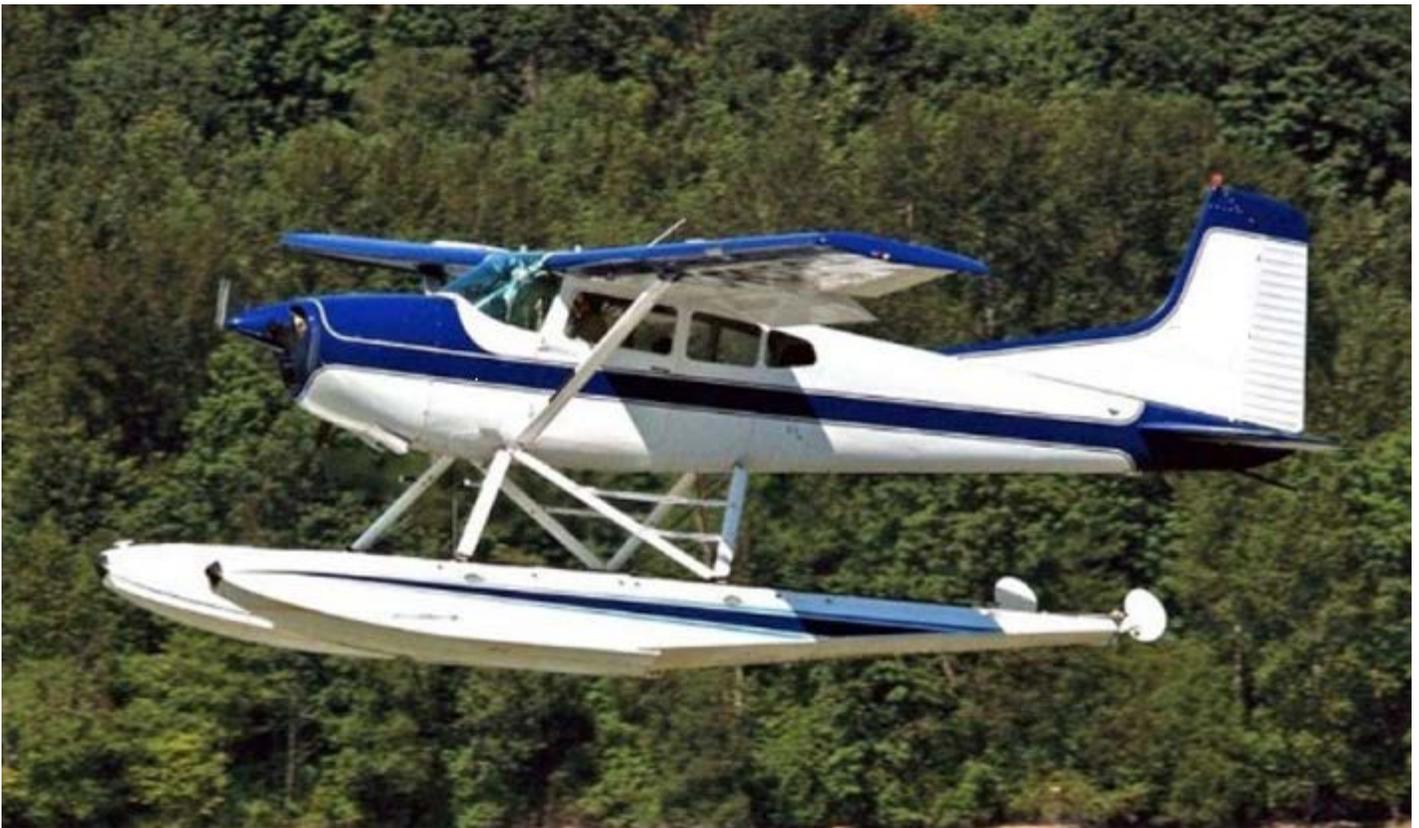
On 01 August 2018, following a local flight in the morning, the float-equipped Cessna 180H aircraft (Figure 1) was refuelled. At approximately 12:54, the aircraft departed from Tyax Lodge on Tyaughton Lake, B.C., for a local sightseeing flight to take photographs, with 3 people on board. The pilot-in-command (the pilot) was seated in the front left seat, a passenger was seated in the front right seat, and another company pilot was seated in the rear left seat to provide local geographical knowledge.

*Photo credit: Ray Barber
Figure 1. Occurrence aircraft*

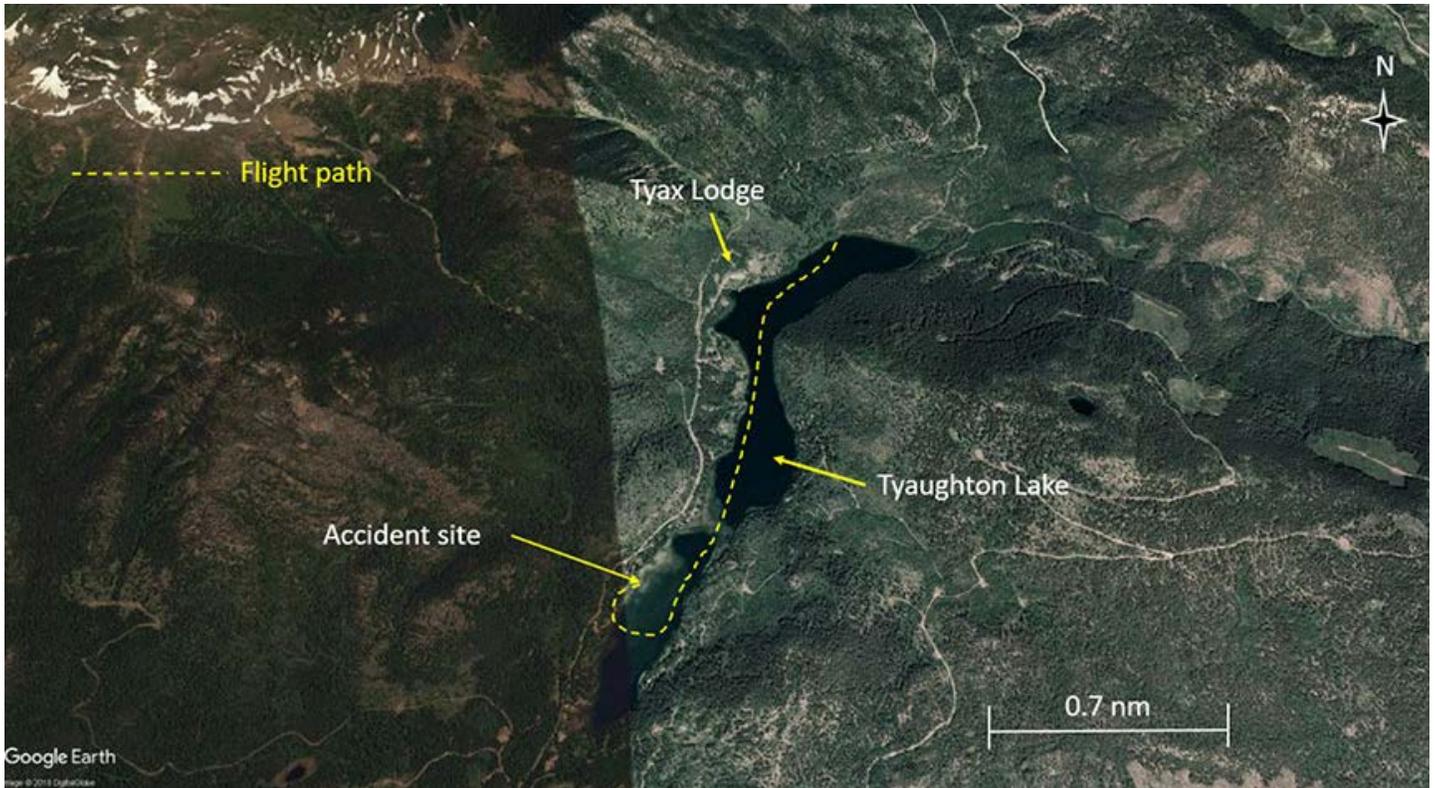
Figure 2. The occurrence aircraft's flight path (Source: Google Earth, with TSB annotations)

Shortly after takeoff, while the plane was climbing through approximately 300 feet (ft), the other pilot seated in the rear seat observed fuel leaking from the left wing and communicated that information to the pilot. The pilot in the rear left seat reportedly told the pilot to turn around and return to land on the lake. Given the local terrain, the pilot reduced the airspeed and banked the aircraft steeply to the right, turning back toward the lake. The aircraft then abruptly rolled further to the right and struck the lake in a near-vertical attitude at approximately 12:55 (Figure 2). The aircraft was substantially damaged on impact and sank.

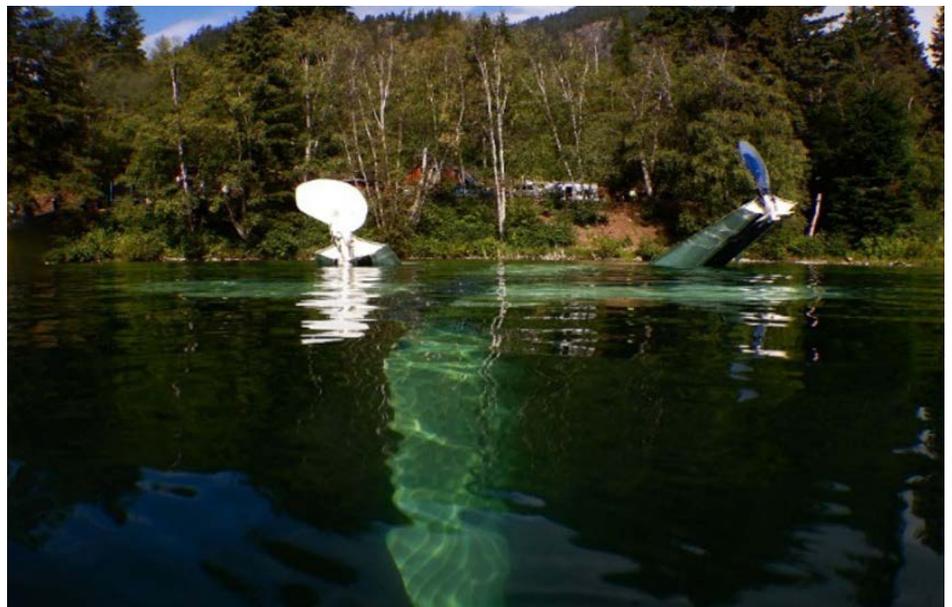
Tyaughton Lake is approximately 3 300 ft ASL. The aircraft struck the lake in a near-vertical attitude and came to rest inverted, in 10 to 15 ft of water about 50 ft from shore, with the floats partially above the water (Figure 3).

The majority of the wreckage was located near the fuselage. Both floats had severe damage to the tips

Figure 3. Accident site (Source: Royal Canadian Mounted Police)

and showed impact damage resulting from the contact with the water. All of the control surfaces were accounted for. An examination of the flap system indicated that the flaps were in the 20° position at the time of impact. All damage to the airframe was attributable to impact forces. The fuel selector was found to be set to both tanks, which contained sufficient fuel for the remainder of the flight. The left fuel cap had not been replaced after refuelling and was found hanging from its chain. Damage to the engine and propeller were consistent with a high power setting at the time of impact.

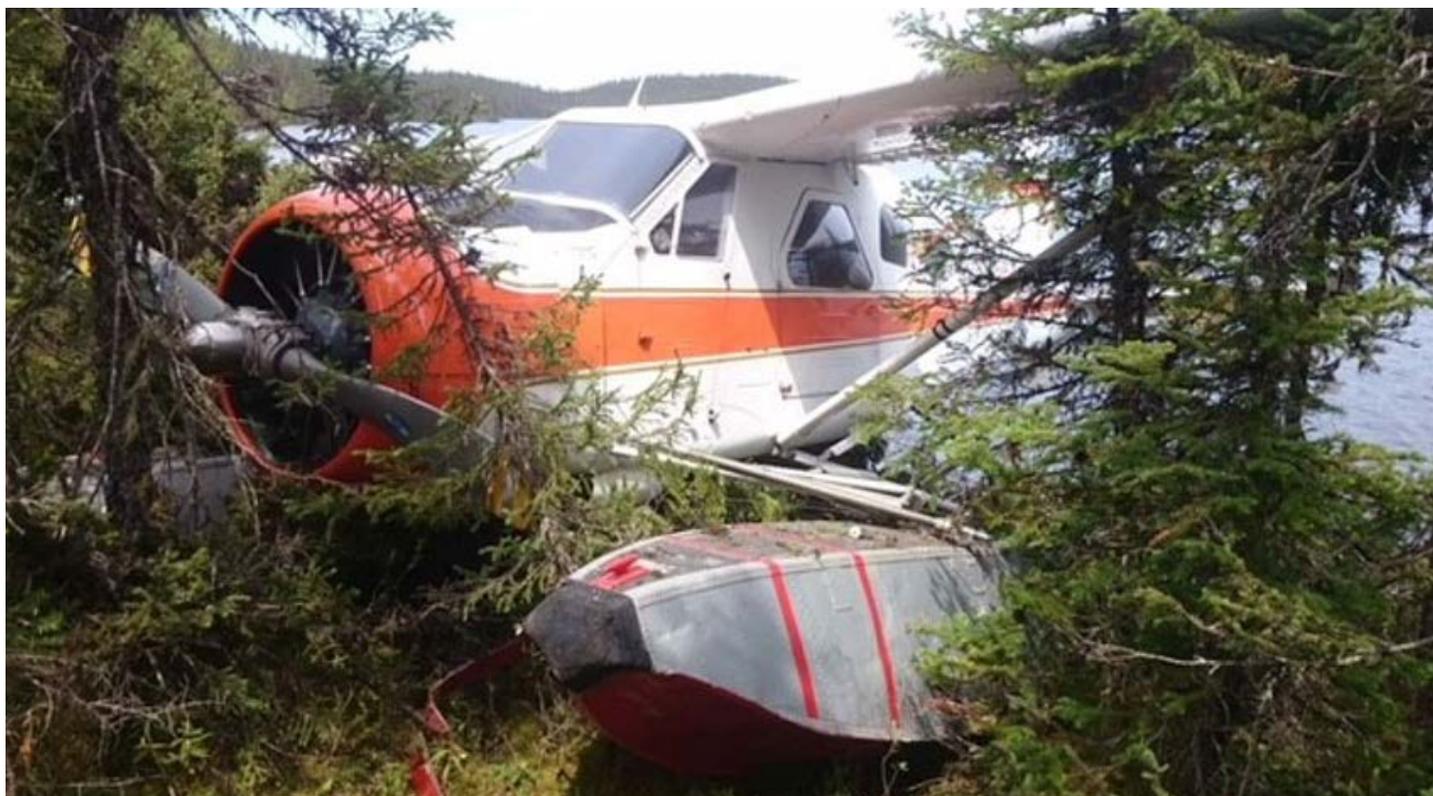
Once take-off speed was reached, the pilot manoeuvred to lift the floats off the water. However, the pilot considered that the remaining distance on the lake was insufficient to complete the takeoff and climb safely, and therefore decided to shut off the engine to reject the takeoff. The aircraft continued straight ahead and could not be stopped in time to avoid colliding with trees (Figure 1).

Figure 1. The aircraft after colliding with trees (Source: Air Saguenay)

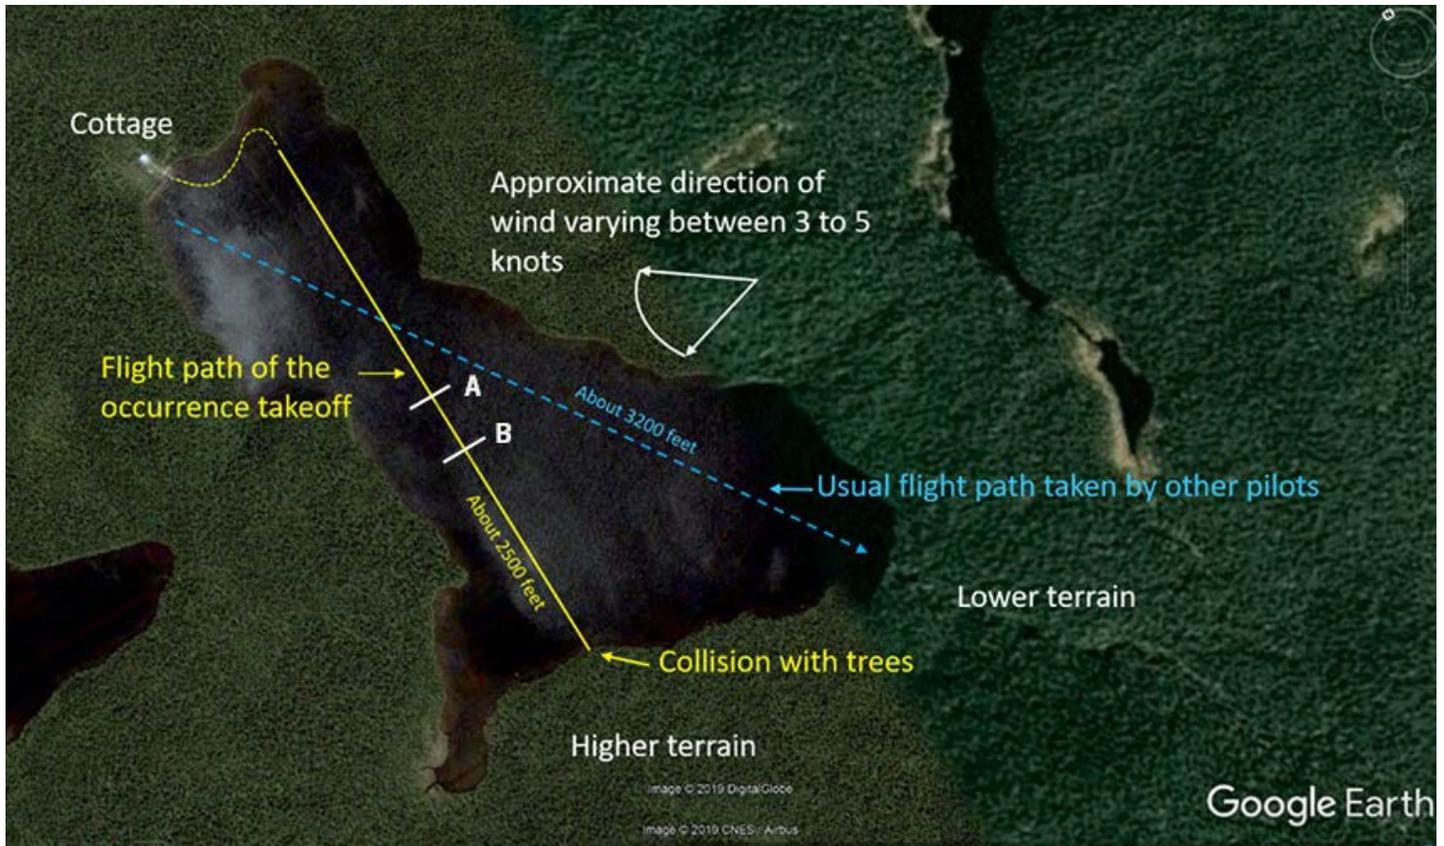
This estimate may vary depending on the type of seaplane. If the aircraft is past this point when the takeoff is rejected, the remaining distance may be insufficient to allow the aircraft to come to a complete stop, resulting in a risk of collision with the shore. In this occurrence, the pilot did fly over the area at low altitude before landing.

Figure 2. Diagram showing the flight path of the occurrence takeoff on Jules Lake in relation to the usual flight path taken by other pilots, as well as estimates of the minimum distance required for takeoff from the surface of the water (Point A) and the optimal point for a rejected takeoff (Point B) according to the performance tables (Source: Google Earth, with TSB annotations)

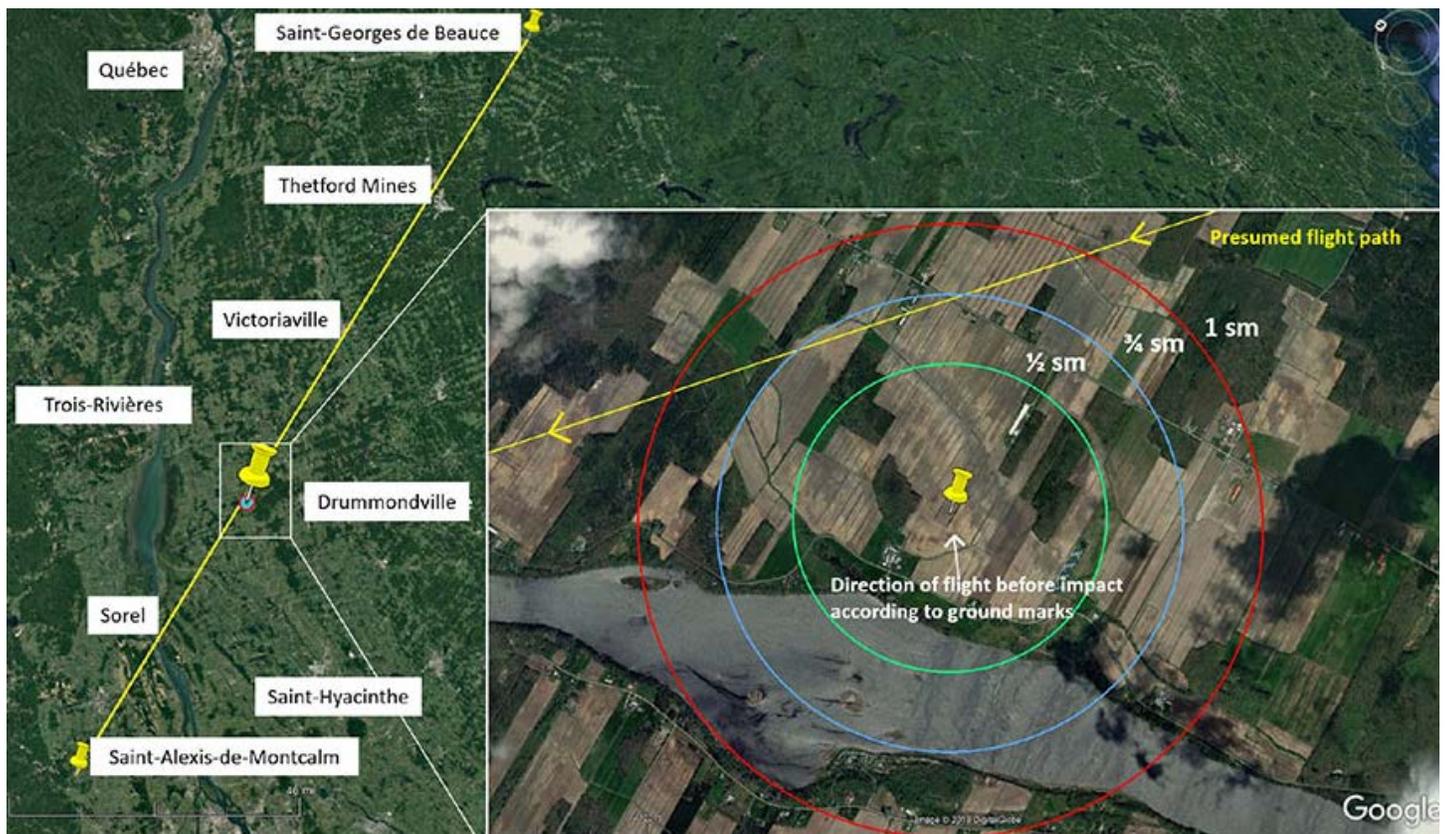
Figure 1. Presumed flight path of the occurrence aircraft, with inset showing the presumed visibility (represented by circles) at the time of the occurrence, and the direction of flight prior to impact, based on ground markings (Source: Google Earth, with TSB annotations)

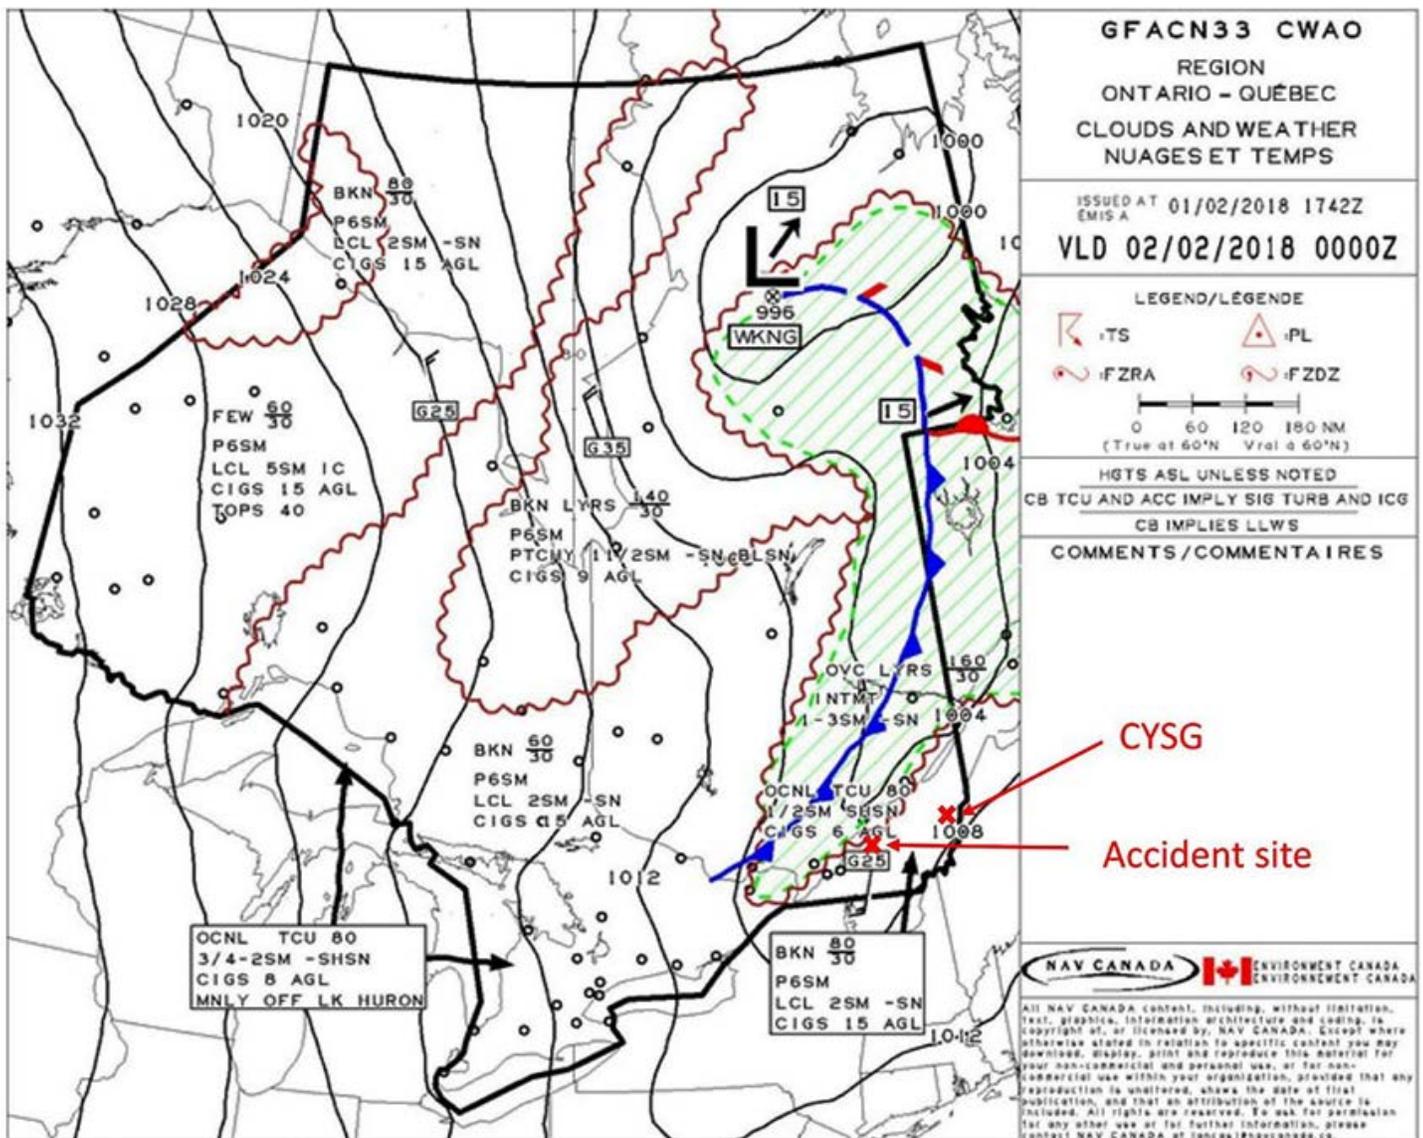
In this occurrence, the weather data available to the pilot forecasted weather conditions at certain locations between Saint-Georges de Beauce and Saint-Alexis-de-Montcalm that were below the minima required by the

Figure 2. Clouds and weather GFA chart issued at 12:42 on 01 February 2018 and valid at 19:00 (Source: NAV CANADA, with TSB annotations)

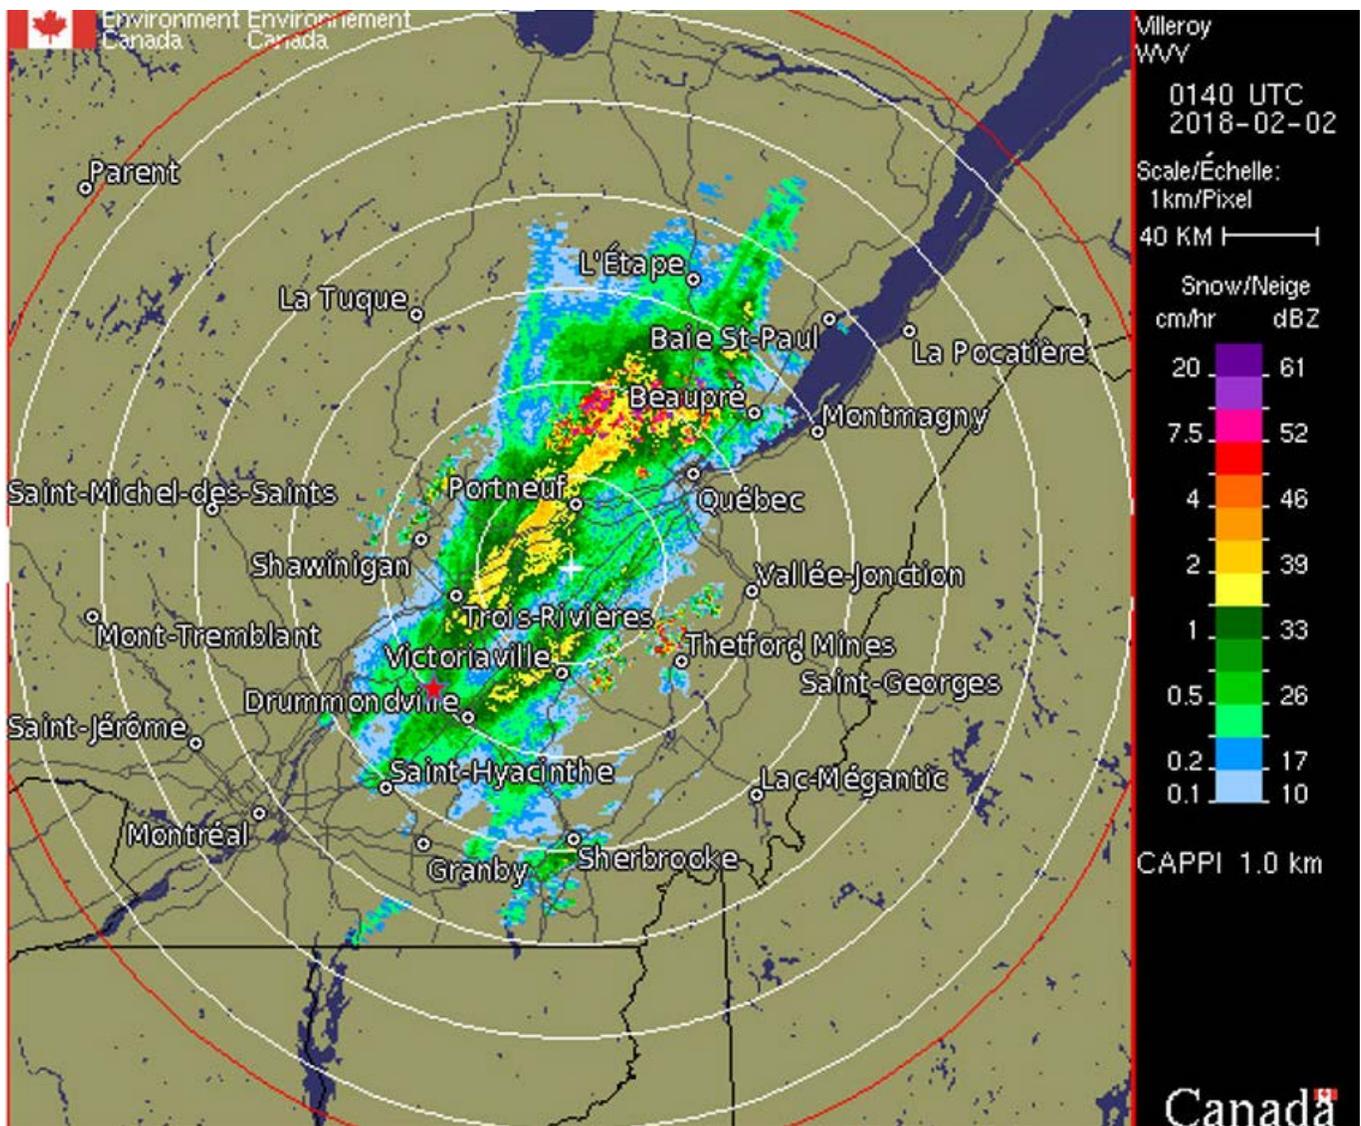
After analyzing the weather conditions present in the Saint-Joachim-de-Courval area at the time of the accident, the investigation determined that the surface visibility would have been no more than 1 SM in snow showers. It is very likely that the slant visual range was less than 1 SM. In addition, the risk of frost noted in the weather forecasts meant there was a risk of a layer of frost covering the helicopter's windshield and thus further reducing visibility during flight.

Figure 4. Screen capture of Villeroy weather radar at 20:40 on 01 February 2018
(Source: Environment and Climate Change Canada, with TSB annotations)

Note: The red star indicates the accident site.
