Transport  
Canada

TP 185E  
Issue 2/2014

# AVIATION SAFETY LETTER

TSB Final Report Summaries

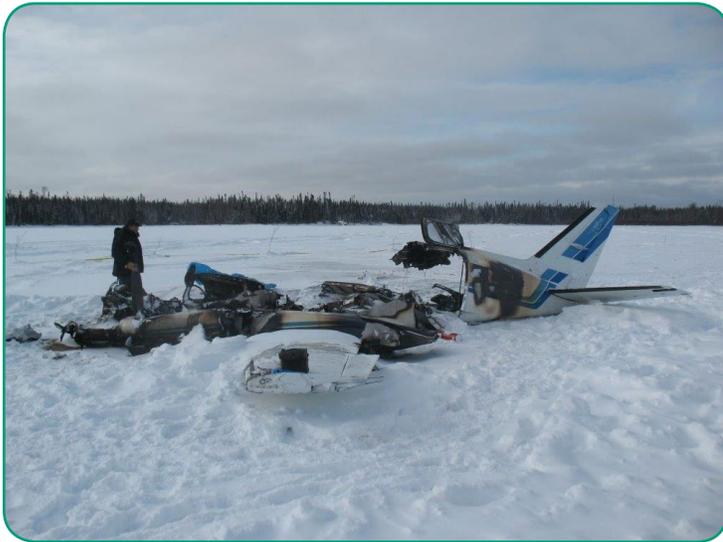
TSB investigators arrived on scene approximately 26 hr after the accident. The aircraft struck the frozen surface of the lake in a right wing-low attitude at both a high rate of descent and forward speed. Contents of the aircraft, such as baggage and cargo, were found strewn halfway up the wreckage trail, indicating an early breakup of the cockpit and cabin area. The wreckage trail was generally aligned with the extended centreline of the runway. It was approximately 380 ft long, and the aircraft had come to a rest in an upright position, facing a southeasterly direction (Photo 1). Damage to the propellers suggests that the engines were producing power at the time of the impact. A post-impact fire consumed a majority of the aircraft.

*Photo 1. Wreckage on site*

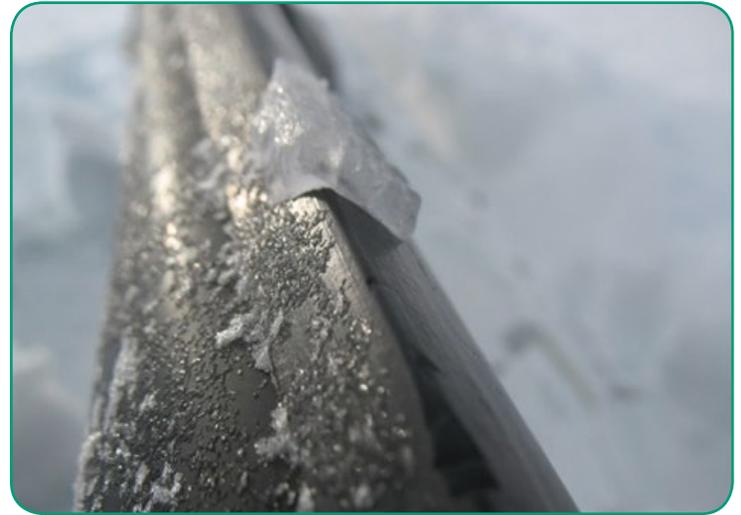
An approximate 4-ft section of the right wing leading edge containing the stall warning vane was torn off and found approximately halfway down the wreckage trail. This section of leading edge was not affected by the fire and exhibited some clear and mixed ice that was approximately  $\frac{3}{8}$  in. thick (Photo 2). The stall warning vane was not heated and exhibited hard packed ice inside the stall warning housing, trapping the vane in a downward position (Photo 3).

*Photo 2. Leading edge ice*

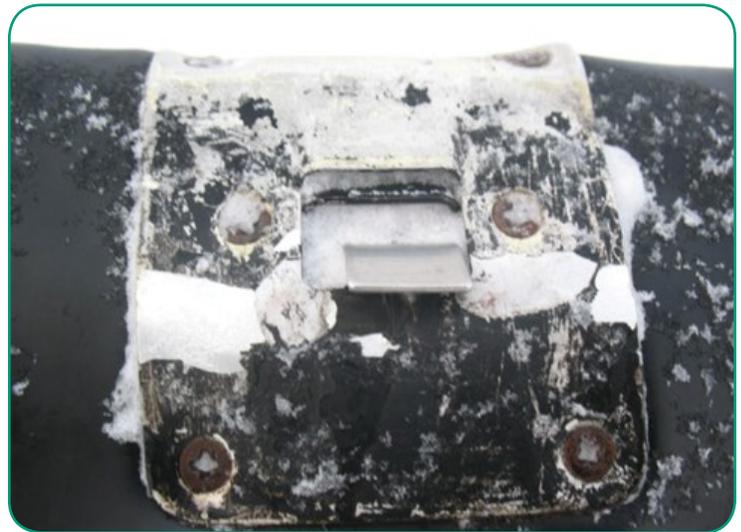
*Photo 3. Stall warning vane*

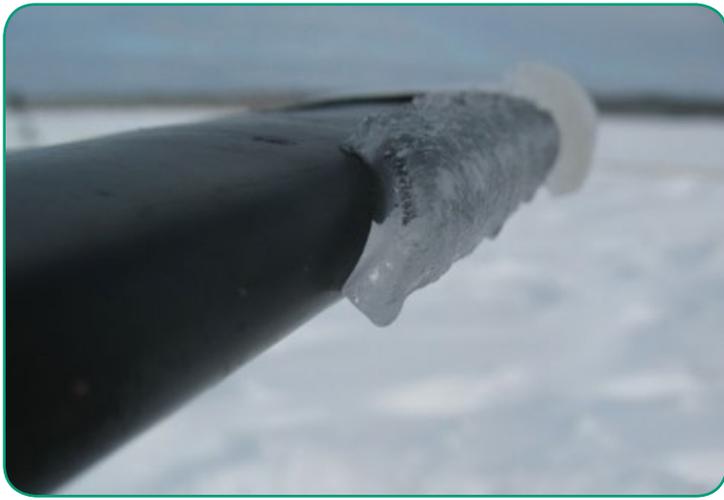
The left horizontal stabilizer leading edge was also not affected by the fire and exhibited ice accumulation (Photo 4).

Photo 4. Ice on the horizontal stabilizer leading edge

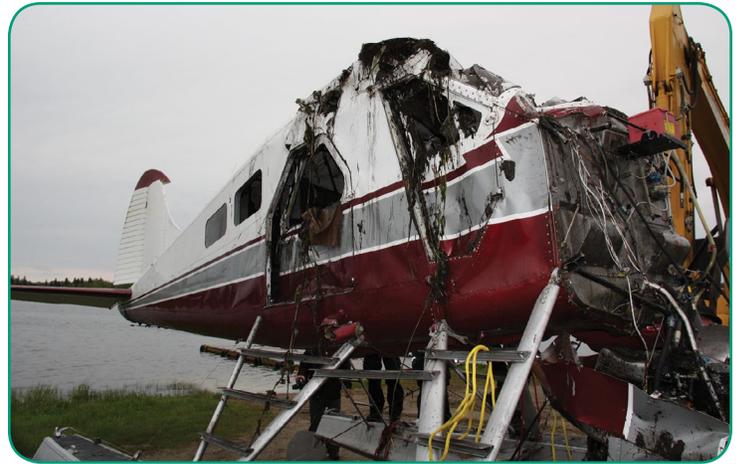
*The floatplane, shown here after being removed from the water, was heavily damaged in the crash.*

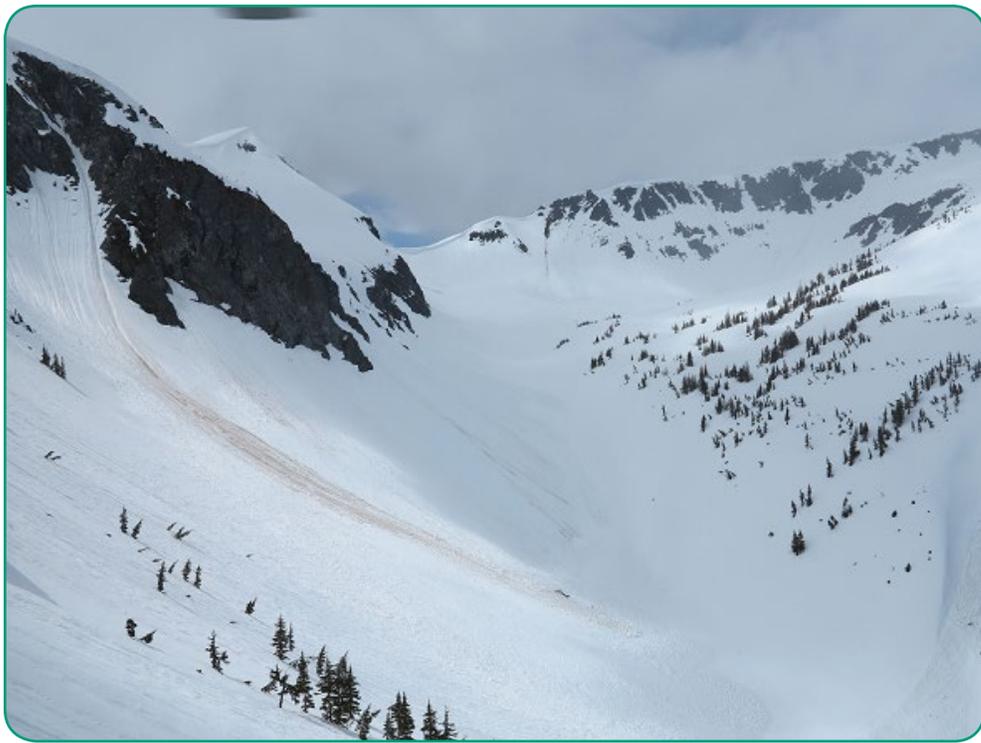
An aerial view of the crash site on the mountainside: the tail-end of the helicopter appears as a small dark line on the snow of the mountain valley.

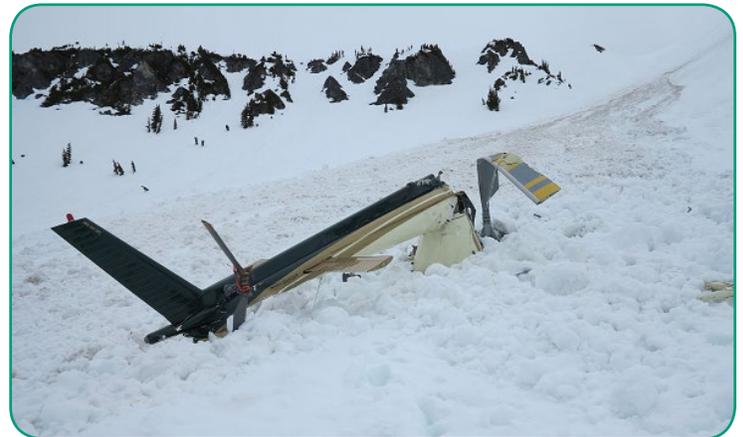
*The rotor and tail-end of the crashed helicopter, protruding from the snow of the mountainside*

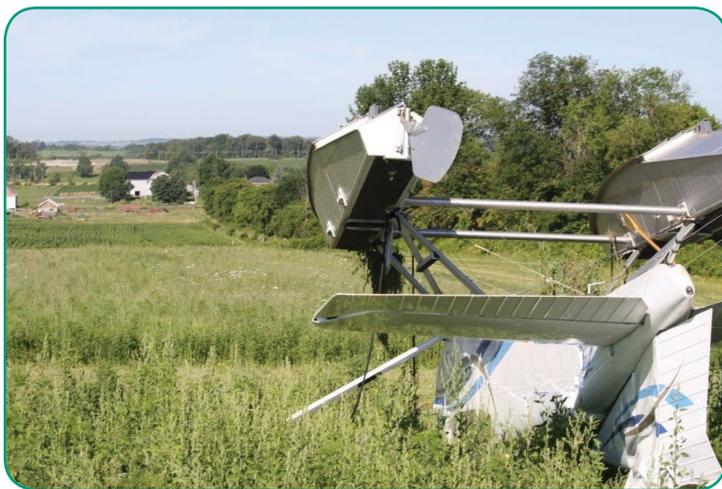
*TSB File A13O0142*

— On July 25, 2013, a **Cessna 185B** was flying from Billy Bishop/Toronto City Airport (CYTZ), Ont., to Orillia Airport (CNJ4), Ont. While en route, the engine stopped. The pilot made a forced landing in a farm field and the aircraft came to rest inverted. When the aircraft was righted, the right fuel cap was found hanging from the attaching chain. Six L of fuel was recovered from the tanks. The aircraft was substantially damaged; however, the pilot was uninjured. *TSB File A13O0142.*

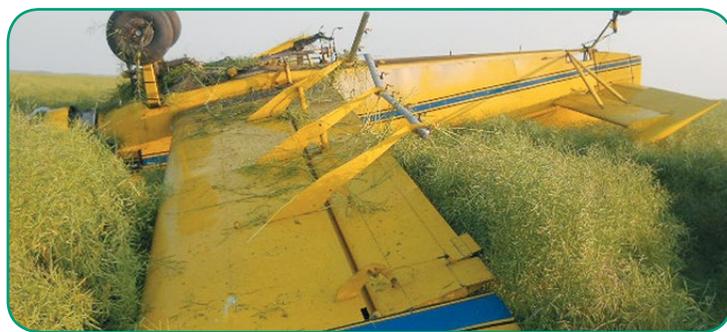
*TSB File A13C0096 (RCMP photo)*

— On August 13, 2013, an **Air Tractor AT401** was departing Quill Lake, Sask., on an application flight. During the takeoff run, the engine (Pratt & Whitney R-1340) sputtered and lost power. The pilot rejected the takeoff, but could not stop the aircraft on the runway. The aircraft continued 200 feet past the end of the runway into a canola field, and overturned. The pilot suffered minor injuries and the aircraft sustained substantial damage. Some of the chemical (Silencer) and some avgas was released from the overturned aircraft. The aircraft operator is recovering it for repair. *TSB File A13C0096.*

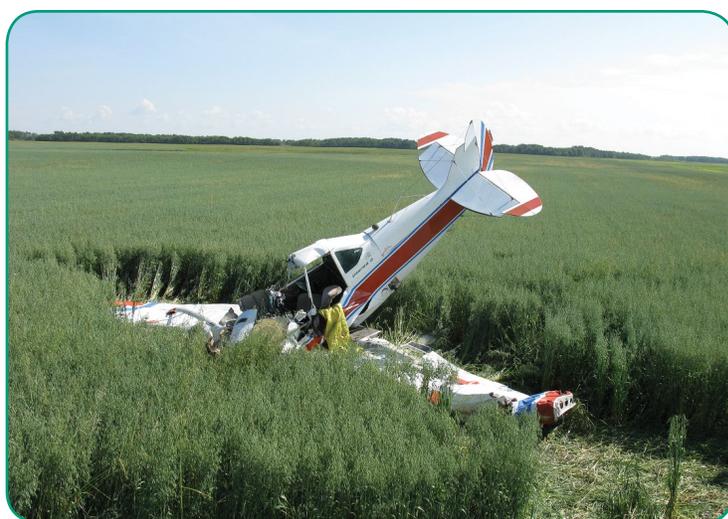
*TSB File A13C0102*

— On August 16, 2013, a **Piper PA-25-235 Pawnee** departed Rose Valley, Sask., on an aerial application flight. The aircraft wreckage was discovered in a grain field, and the pilot had sustained fatal injuries. The aircraft was substantially damaged, but there was no post-crash fire. TSB investigators were deployed to the site. An inspection of the wreckage revealed both fuel caps were missing and both fuel cells contained residual fuel only. First responders and TSB investigators did not notice any evidence of a fuel leak or spill in the surrounding area. Investigators searched the crop in the surrounding area and the aircraft operating areas at the departure point but did not locate either fuel cap. *TSB File A13C0102.*

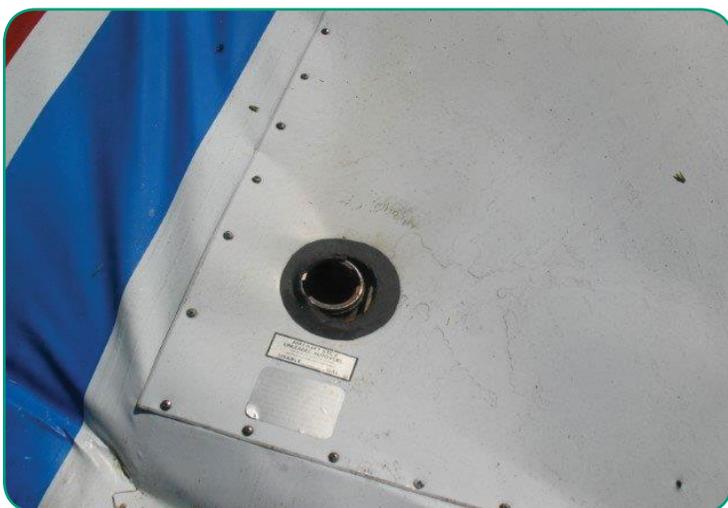
*TSB File A13C0102*

*Both fuel caps were missing and could not be found.*

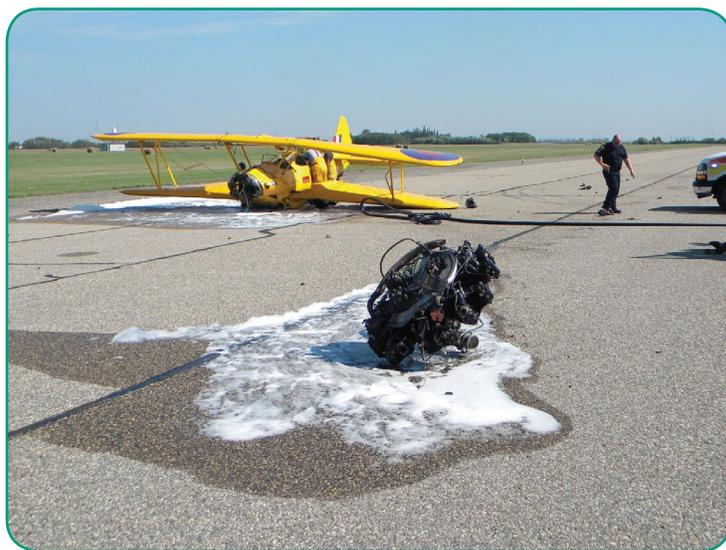
*TSB File A13C0116*

— On September 10, 2013, a **Boeing B75N1 Stearman** was en route from Regina, Sask., to St. Andrews, Man., with a stop for fuel in Brandon, Man. Upon takeoff and initial climb from Runway 26 at Brandon, one of the propeller blades failed at the blade root (Hamilton Standard 5404) and departed the aircraft. A severe vibration ensued which broke the Continental W670 engine from the engine mounts, causing the engine to fall off in flight. The aircraft pitched up and became uncontrollable. The aircraft struck the runway in a nose down attitude and both occupants sustained serious injuries. There was no fire and both occupants were taken to hospital. *TSB File A13C0116.*
