Transport
Canada

TP 185E
Issue 3/2018

AVIATION SAFETY LETTER

TSB Final Report Summaries

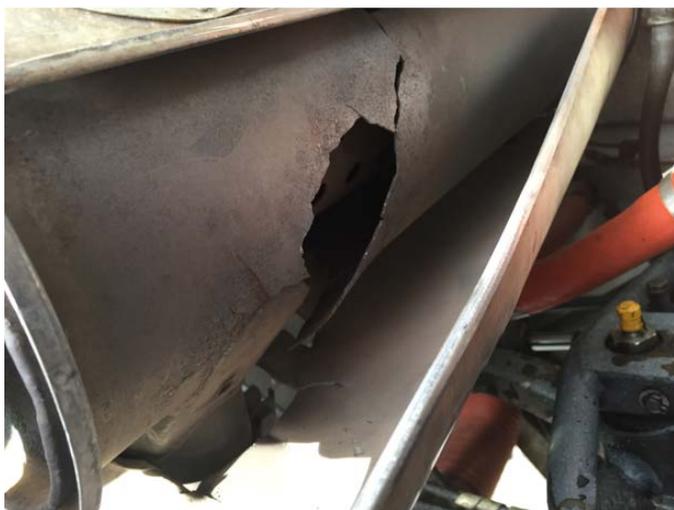
Figure 1. Damaged muffler

We became aware of the defect approximately 13 flight hours/3 months following the completion of the Airworthiness Directive (AD) CF-90-03R2 Muffler Inspection (The AD requires the muffler to be inspected annually or every 150 hours).

The Aircraft Maintenance Engineer (AME) who performed the AD did not remove the heat shroud to facilitate the inspection and instead chose to open it at the split line and use a mirror to perform the inspection. As the AME did not remove the shroud as required by the AD, it is probable that he overlooked a defect in the muffler that contributed to the failure. △

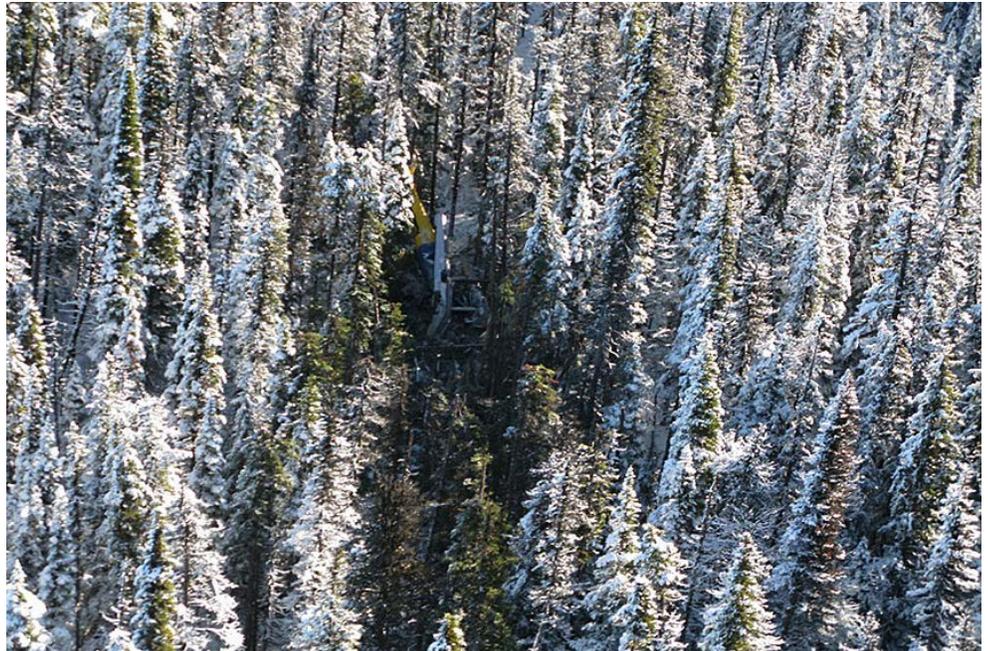
The aircraft was substantially damaged when it struck trees and the ground (Figure 2).

The majority of the wreckage was located near the fuselage. Both wings and both floats had separated from the fuselage, and each of these components showed impact damage resulting from contact with the trees. The fuel selector was found set to the forward tank, which contained sufficient fuel for the remainder of the flight to Laidman Lake. Damage to the engine and propeller were consistent with a high power setting at the time of the occurrence.

Figure 2. Photo of the accident site showing the aircraft wreckage, as viewed from the direction of flight

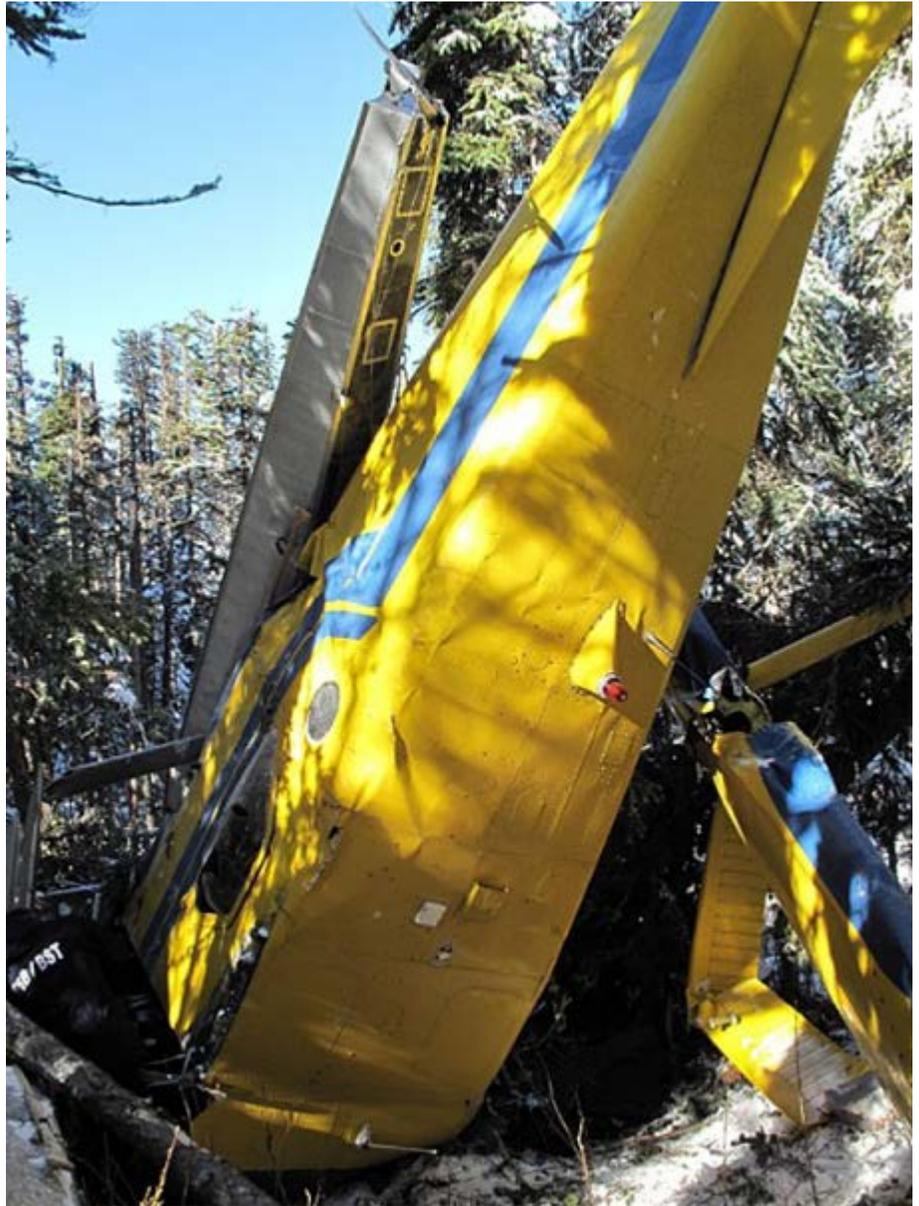
The aircraft entered the trees in a wings-level, slightly nose-high attitude, at an elevation of approximately 4 600 ft ASL. The initial impact occurred when the aircraft's right horizontal stabilizer struck the treetops. The aircraft then continued through the trees in the direction of flight for approximately 130 ft before pitching forward and striking the ground in a steep nose-down and right-wing-low attitude. The aircraft came to rest nose down and semi-inverted (Figure 3).

Figure 3. The occurrence aircraft at the accident site

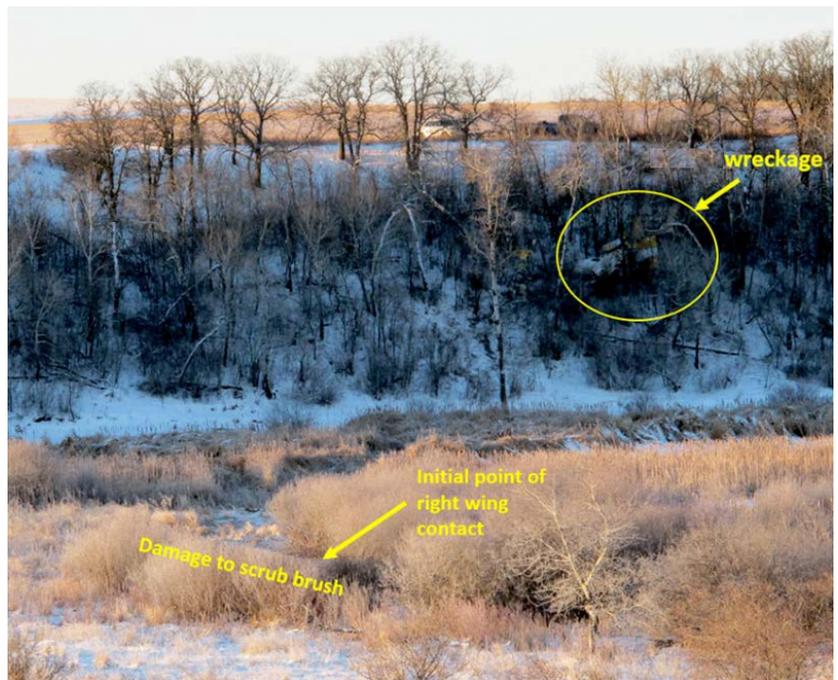
The right wing contacted scrub brush roughly 8 ft from the marsh surface (Figure 2). Damage to the scrub brush indicates that the aircraft was

Figure 2. View of the initial impact site and wreckage

in a 5° descent while banking approximately 23° to the right. The right wing-tip and fuel tank were torn away on contact with the frozen marsh. The aircraft travelled across the marsh for about 300 ft before colliding with the steeply rising tree-covered terrain on the southwest side of the valley. The left outer wing-panel had broken away after contacting a tree, at a height of about 15 ft, and lay on the right side of the wreckage trail, near the side of the valley. The aircraft came to rest, inverted, halfway up the side of the valley, approximately 425 ft from the initial point of contact with the marsh surface. The aircraft was destroyed by impact forces.
