TP 185E
Issue 4/2017

AVIATION SAFETY LETTER

TSB Final Report A15Q0126—Loss of Directional Control and Collision with Terrain

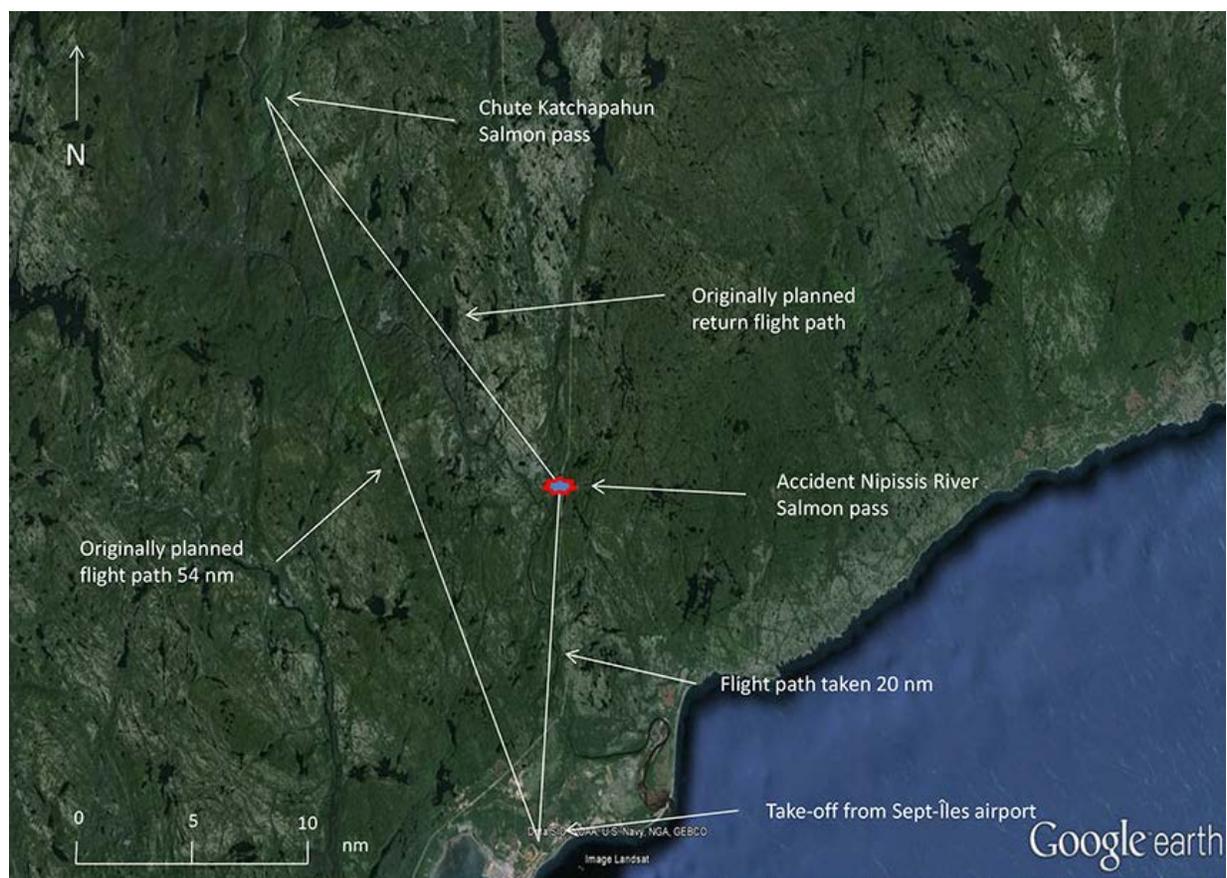
Figure 1. Flight path of helicopter (Source: Google Earth, with TSB annotations)

On September 2, 2015, the Bell 206B helicopter was flying from the airport at Sept-Îles, Que., with one pilot and four passengers on board. The purpose of the flight was to inspect a salmon pass approximately 20 NM north of Sept-Îles. During the final approach, a few feet from the ground, the helicopter began an uncommanded rotation to the right and, after turning a few times, crashed heavily into a rock on its front right side. The accident occurred at about 9:40 EDT. The male passenger occupying the front left seat and the female passenger occupying the rear central seat sustained fatal injuries. The pilot and the other two passengers, who occupied the left and right rear seats, sustained serious injuries. The 406-MHz emergency locator transmitter activated on impact. A fire started in the engine tailpipe but was immediately extinguished by persons on site.

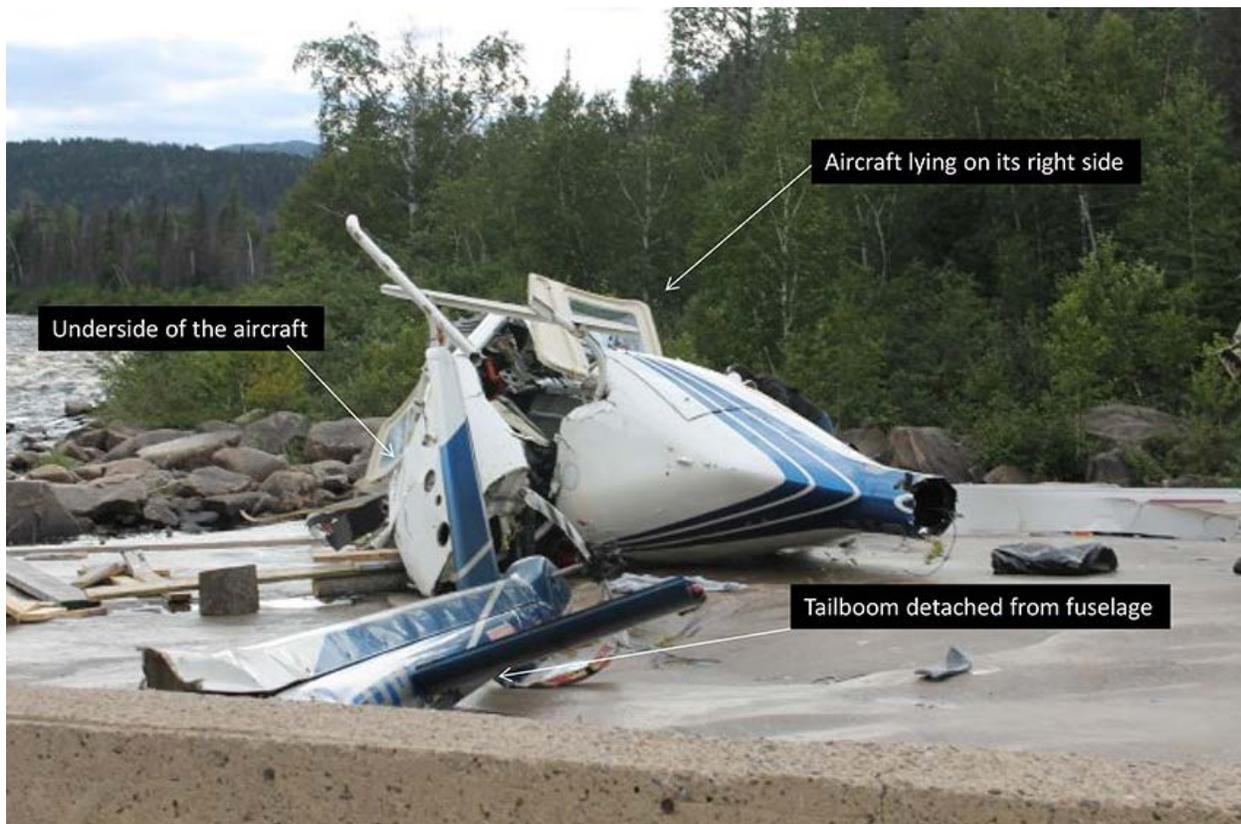
Figure 2. Aircraft wreckage

The helicopter collided with the rock nose down and rotating to the right. The engine did not stop immediately, and a minor fire broke out in the tailpipe but it was immediately extinguished by persons on site. On impact, the tail boom detached and came to rest behind the aircraft. Severe damage to the skin on the rear of the right-hand side and the rear stabilizer was noted. Damage to the skids confirmed impact on the right side, with the nose of the aircraft pointing toward the ground. All damage resulted from the impact with the rock. The floor of the aircraft was severed at the rear of the cabin, causing the fuel tank to split.

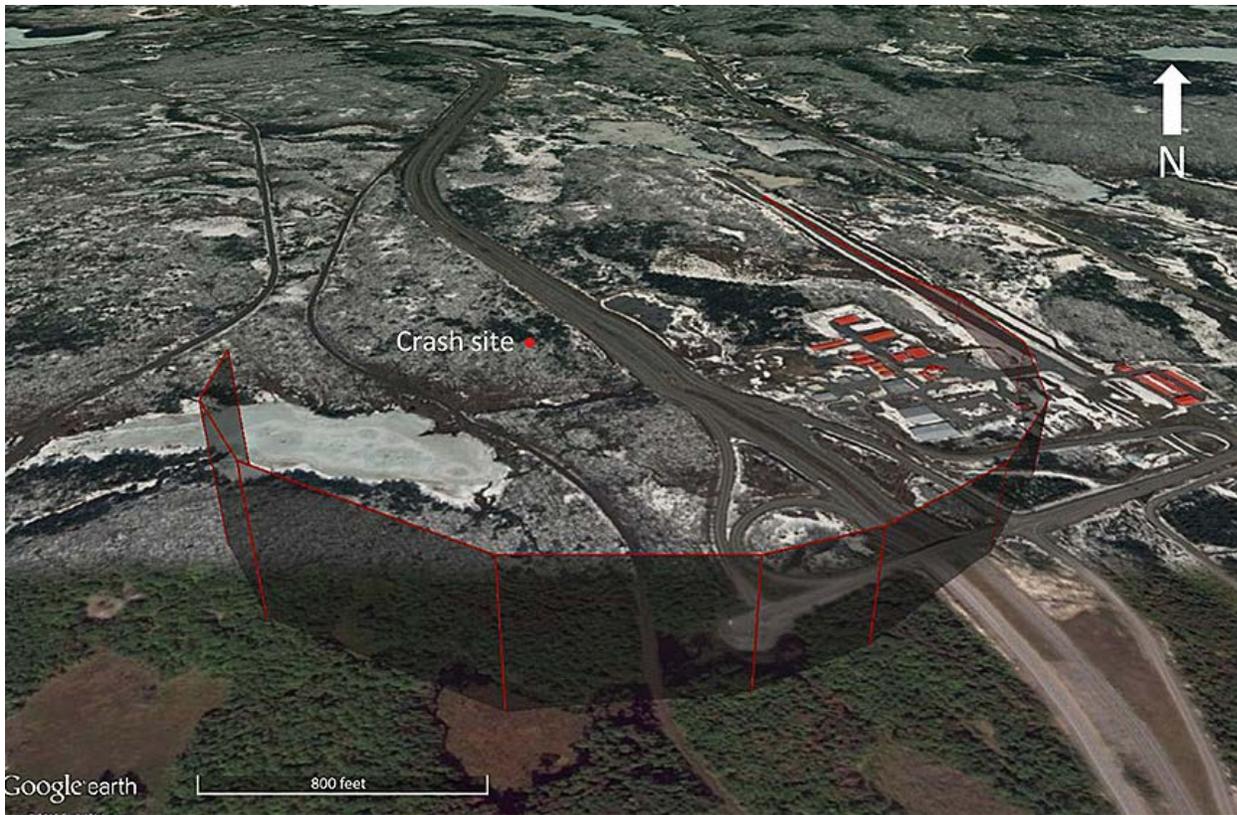
Figure 1. Flight path using recovered GPS data (Source: Google Earth, with TSB annotations)

On this day, the aircraft departed from Parry Sound (CNK4) at 19:17 EST under night VFR for a flight to Tillsonburg (CYTB), Ont. The pilot did not file a flight plan prior to the flight, and there is no record of him requesting a weather briefing from NAV CANADA. Data recovered from an onboard portable global positioning system (GPS) showed the aircraft taxied on Runway 35 before it took off from Runway 17. The aircraft became airborne just prior to the mid-point of the runway at 19:25:15.²

1. Given the pilot's total flight time, training, and limited night flying experience, it is likely that he did not adequately assess the hazards associated with a night VFR departure from an aerodrome with limited ambient and cultural lighting.
2. The pilot, who was probably not proficient at flying with reference to the instruments, may have become spatially disoriented after losing visual reference to the surface off the departure end of the runway and lost control of the aircraft.

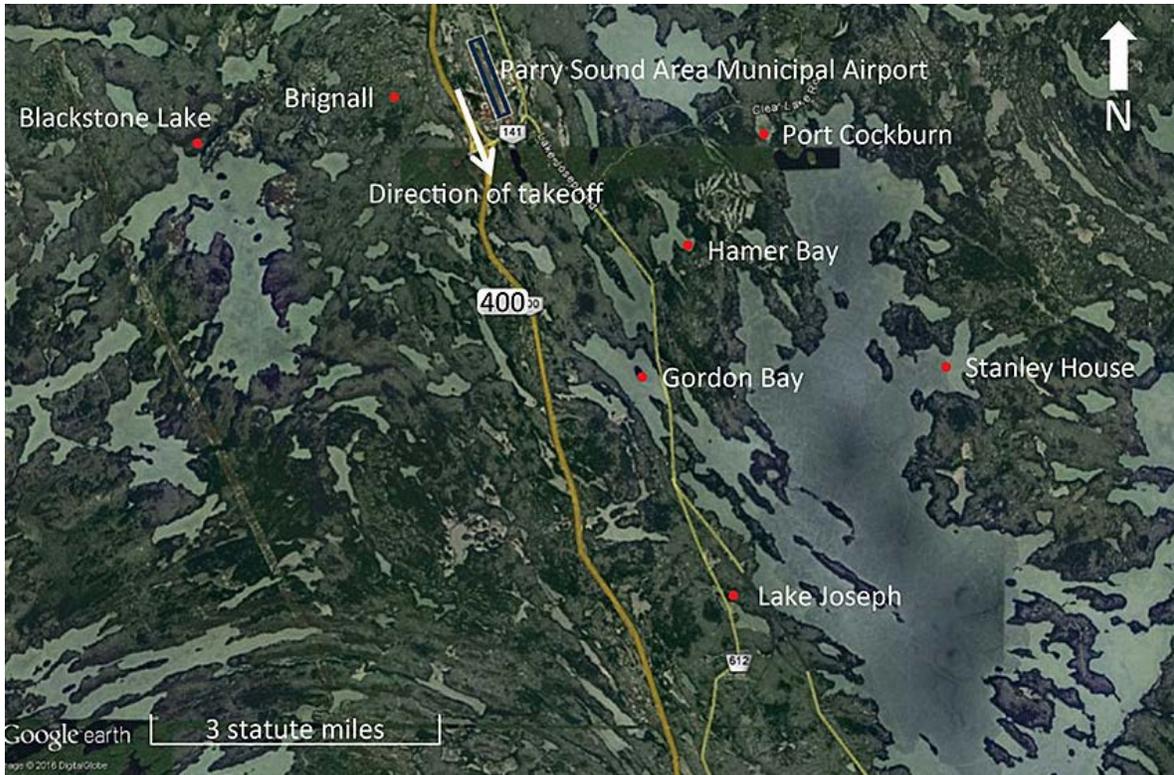
Figure 2. Departure airport and surrounding area (Source: Google Earth, with TSB annotations)

Once the airport lighting was lost from view, there would have been few visual cues available outside the aircraft. There were not many lit ground features on the flight path, particularly to the west of the airport in the direction of the turn, and limited ambient illumination would have been available from the waning crescent moon. After takeoff, visual references would have been greatly reduced, and the pilot would have found himself in a black hole situation.
