Transport
Canada

Feedback

Canadian Aviation Service Difficulty Reports

TP 6980E
(4/2012)

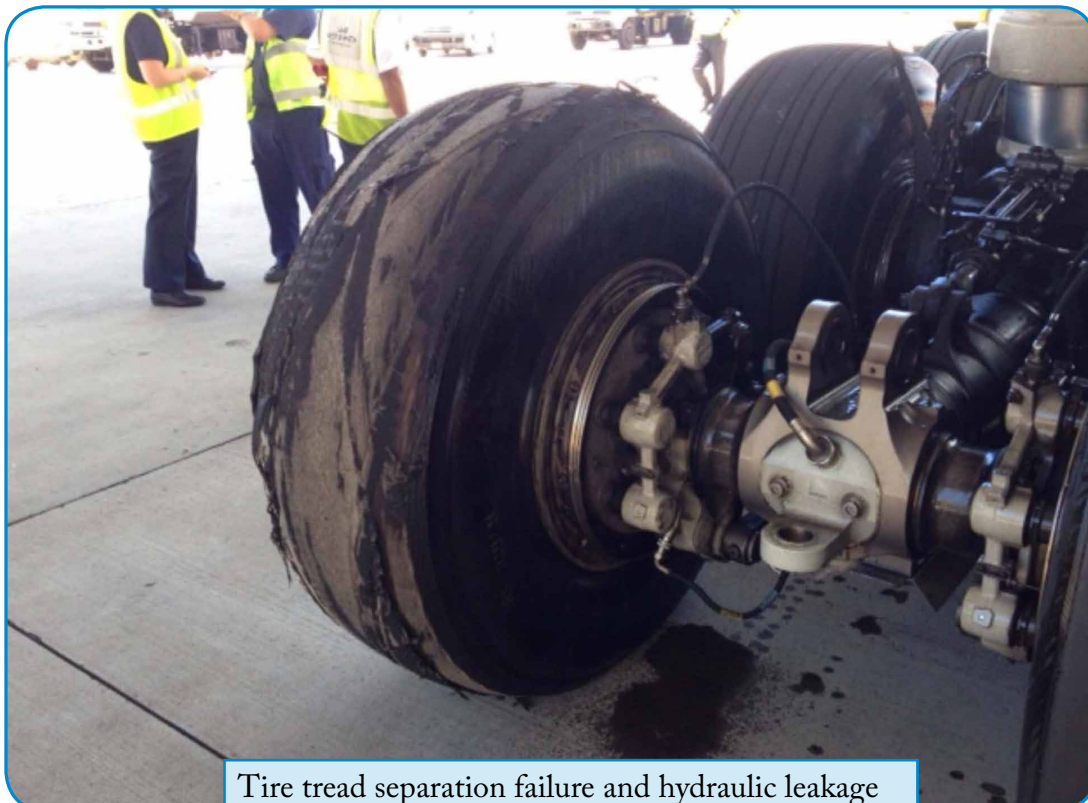
During cruise and approximately 4 hours prior to landing at the scheduled destination, the crew reported low hydraulic quantity in the center hydraulic system. An emergency was declared prior to landing and the aeroplane was met by emergency vehicles on arrival. The crew performed an uneventful landing, shut the engines down on the runway and was towed to the gate due to the inoperative steering system from the loss of the center hydraulics. Maintenance inspection at the gate confirmed extensive tire damage including the under-wing area and flap panel along with the associated tires brake line, which was the source of the hydraulic fluid loss.

Through further analysis and the retrieval of tire debris from the departing airport, it was concluded that the tire failed on take-off, damaging the aeroplane and causing the eventual loss of the hydraulic system. Concerns were raised of possible foreign object damage (FOD) being picked-up off the runway, causing the tire failure, but no direct evidence to support this was found.

The tire was replaced and sent to Bridgestone where a complete shop inspection and analysis was performed where no conclusive findings or indication of its failure or FOD was found. With this particular tire, an initial retread was applied where there were no clear indications of low adhesion between the tire retread components. The tire had also completed 139 landings prior to its failure and typically flaws with material or workmanship during the retreading process would result in a tread separation quickly after installation.

Tire tread separation failure and hydraulic leakage

The concluding corrective action defined by Bridgestone is the standard tire maintenance practice of the operator which includes checking for indications of damage from FOD or any signs of developing bulges or bubbles. Maintaining correct tire pressure inflation are also essential preventative measures to help guard against the possibility of tread separation, tire failure and possible extensive aircraft damage. ✖

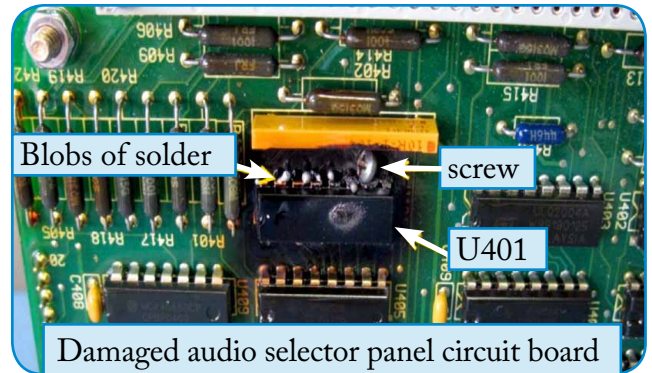
The aeroplane returned to the gate due to loud feedback on the captain's audio channel and a report of electrical smell. Maintenance confirmed that the captain's audio selector panel (ASP) failed, causing the electrical smell. The defect was resolved through the replacement of the ASP and tested as per Aircraft Maintenance Manual 23-50-00.

Feedback from the operator through the ASPs shop teardown report confirmed its failure due to foreign object damage (FOD) where a dislodged screw was found within the unit, causing a short.

It is suspected that while the aeroplane was in operation, a screw was inadvertently dropped into the ASP, causing the eventual failure of the unit.

Transport Canada Civil Aviation would like to advise all operators and maintainers of the dangers of FOD. ✖

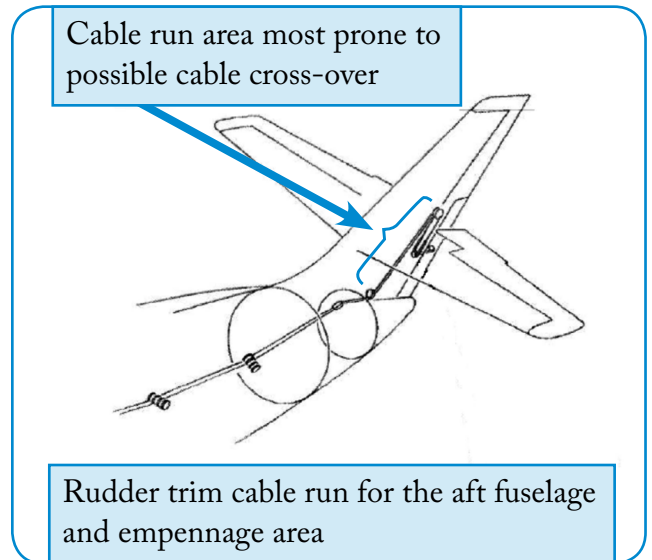
During a maintenance inspection of the rudder trim tab control system, it was noted that the rudder trim cables were crossed in the leading edge of the rudder above the lower leading edge panel.

The Aircraft Maintenance Engineer, through consultation with other operators, has confirmed several other similar occurrences where it has been stated that rudder cable cross-over in the vertical stab is a known problem and "it is easy to do".

Both cables were replaced due to minor kinks noted and installed correctly as per Aircraft Maintenance Manual (AMM) 27-23-11.

Transport Canada Civil Aviation is advising all BAE 3112 operators and maintainers of the possibility for the elevator trim cables to be twisted and to follow the AMM 27-23-11 procedures closely. ✖

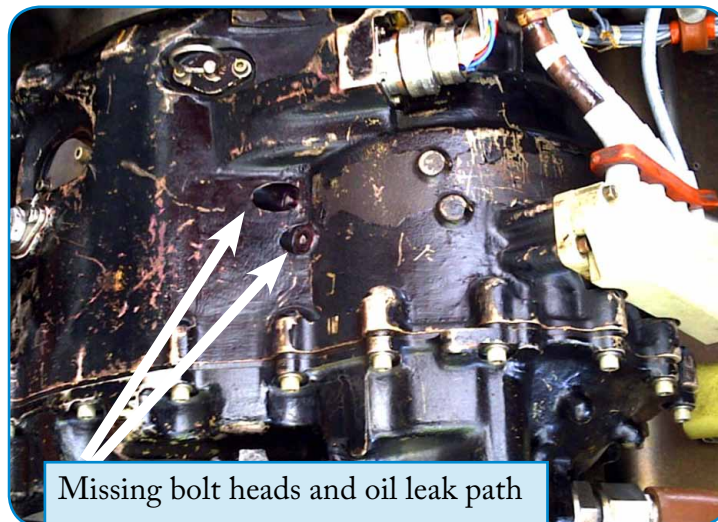
The flight crew disconnected the left Integrated Drive Generator (IDG) approximately 3 hours into the flight due to the drive light and Engine Indication and Crew Alerting System (EICAS) message illuminating. Maintenance discovered two adjustment bolt heads missing and oil in the cowl.

Oil is believed to have escaped under pressure past the broken bolt heads.

The operator has only seen this issue once before in 1999. The suspected issue is the stator and housing clearance wearing over time. As the clearance increases, the load being applied to the IDG makes the stator try to turn inside the unit due to the magnetic field and the rotation of the rotor (1200 rpm). The stator moves more and more as the wear on the bolt holes increase (elongation of the holes is evident on the housing).

The IDG was replaced and the aeroplane was made serviceable.

Transport Canada Civil Aviation would like to advise all aircraft maintainers of the possible inherent wear characteristics for this style of electrical generator. ✖

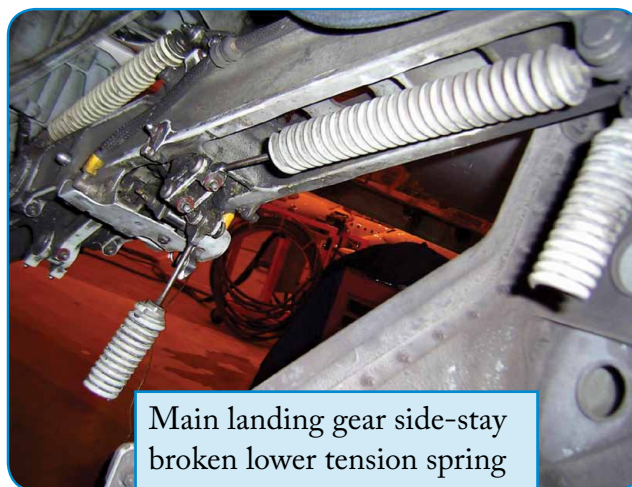
It was during a service check walk-around inspection when maintenance found a broken left-hand main landing gear side-stay lower tension spring.

The tension spring was replaced and the aeroplane was made serviceable.

The standard walk-around inspection for any aircraft is the most widely used inspection task in aviation. Often enough, it is also the last inspection task done before flight and because of this it is considered an essential task for the continued safe operation of the aircraft. ✖

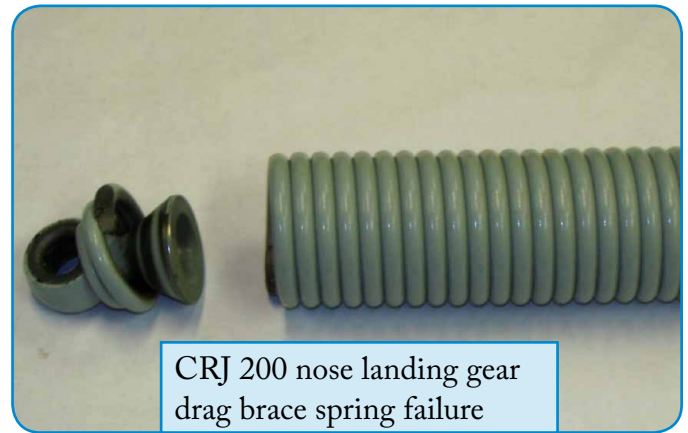
On a pre-flight first flight of the day walk-around check, it was noticed that on the nose landing gear, the right hand drag brace spring was broken and hanging.

The function of the drag brace gear spring is to assist the operation of the drag brace assembly towards its over-center, down-locked position.

The failure of a spring may lead to a possible inability to safely over-center the drag brace and down-lock the gear.

The discrepant spring was replaced and the aeroplane was made serviceable.

Transport Canada Civil Aviation would like to advise all owners, operators and maintainers to pay close attention to the condition of these springs. ✖

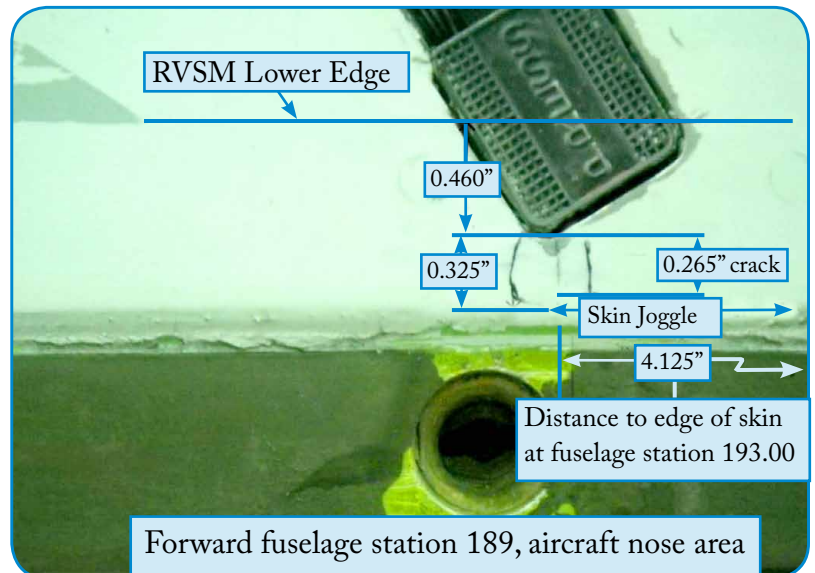
During a scheduled in-house task for a scratch and dent survey of the external fuselage, the Aircraft Maintenance Engineer noticed a crack emanating from the aft latch cut-out of the left hand electronics bay door at the nose of the aeroplane.

The crack was located at Fuselage Station 189, water-line 75.25 just below the Reduced Vertical Separation Minimum (RVSM) critical area. The damage was reported to Bombardier where the aeroplane was returned to service in accordance with temporary disposition Repair Engineering Order (REO) 601R-53-11-2189.

A similar occurrence has been found on another CRJ of the same operator where Bombardier engineering has been notified.

Transport Canada Civil Aviation is advising all CRJ operators and maintainers to be aware of this area for possible crack formations and the available Bombardier repair order. ✖

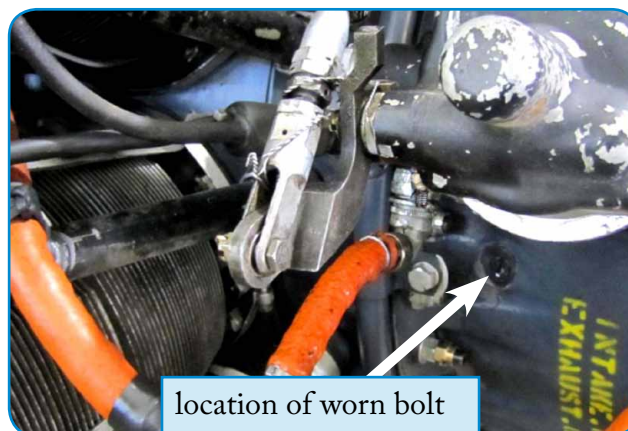
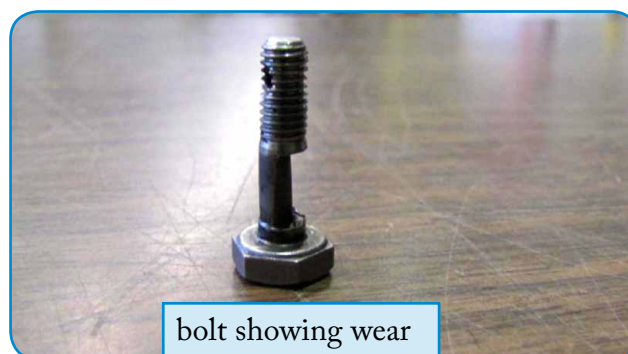
The bolt that attaches the left hand propeller governor cable fork end to the propeller governor lever was found severely worn part way through the shank of the bolt. This was discovered during a scheduled engine maintenance check. When the lever was wiggled to check for tightness and security, obvious play was noted. The rod end bearing in the lever was solid within the governor arm. The bolt was removed and found worn.

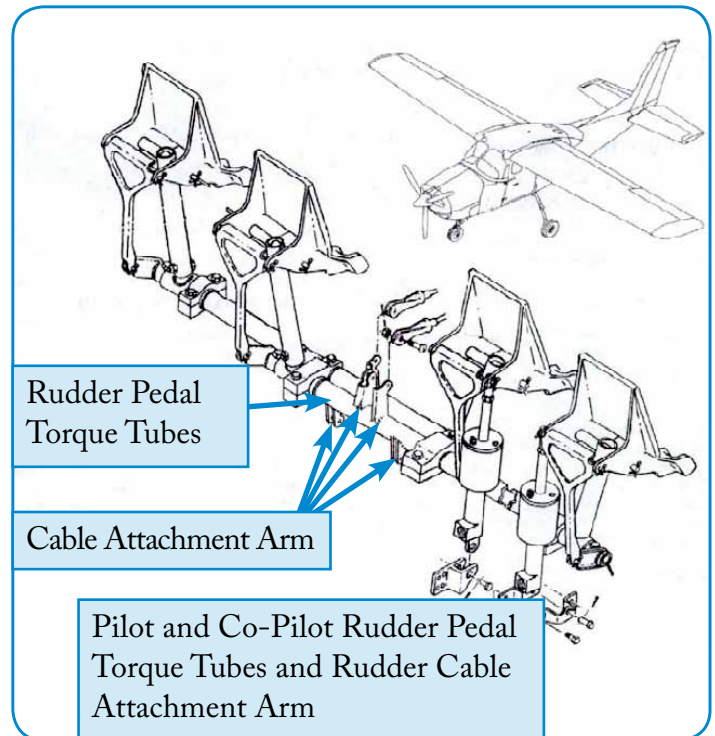
During inspection, the pilots left hand rudder pedal arm, part number (P/N) 0411307, was found loose and severely corroded at the torque tube, P/N 1260465-5. Internal inspection of the mounting arm and stub end of the torque tube revealed severe corrosion in various locations. Two of the four rudder pedal mounting arms showed significant internal corrosion.

Additionally, the interiors of torque tubes, P/N 1260456-5 & 12600456-6, were also found significantly corroded when disassembled. The inboard rudder torque tube bearing blocks were found cracked on both sides.

The Federal Aviation Authority is aware of the corrosion problems and has advised Transport Canada Civil Aviation that Cessna will soon issue Supplemental Inspection Number (SID) 27-20-01 to verify the integrity of the rudder pedal torque tube assembly. (effectivity 21059062 thru 21059199). Areas of particular concern are rudder torque tubes, cable attachment arms and weld area degradation due to corrosion or fatigue. ✖

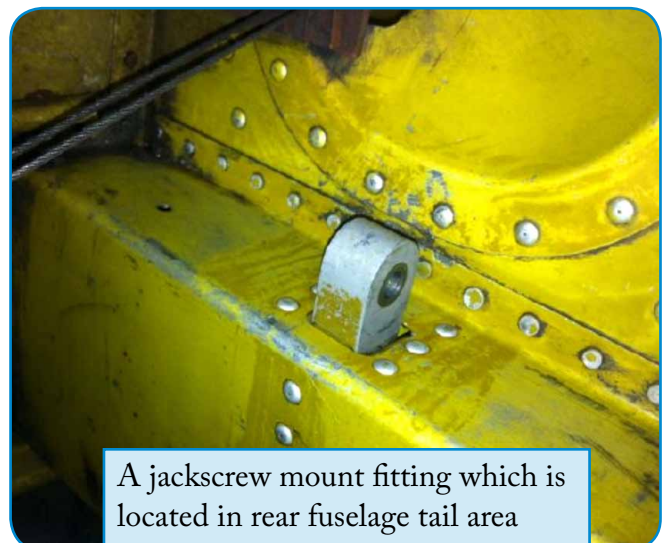
During a repetitive inspection of the horizontal stabilizer trim jackscrew; it was found that the bottom jackscrew mount was loose and was working into its fuselage-mounting retaining bracket.

Following the removal and disassembly of the fuselage-mounting bracket, it was discovered that three mounting rivets and their associated holes were worn (elongated) causing the bracket to become excessively loose.

This is an area that needs attention during inspections. Should the jackscrew mounting bracket become jeopardized; it could cause an undesirable flutter condition affecting the stabilizer trim flight control system. ✖

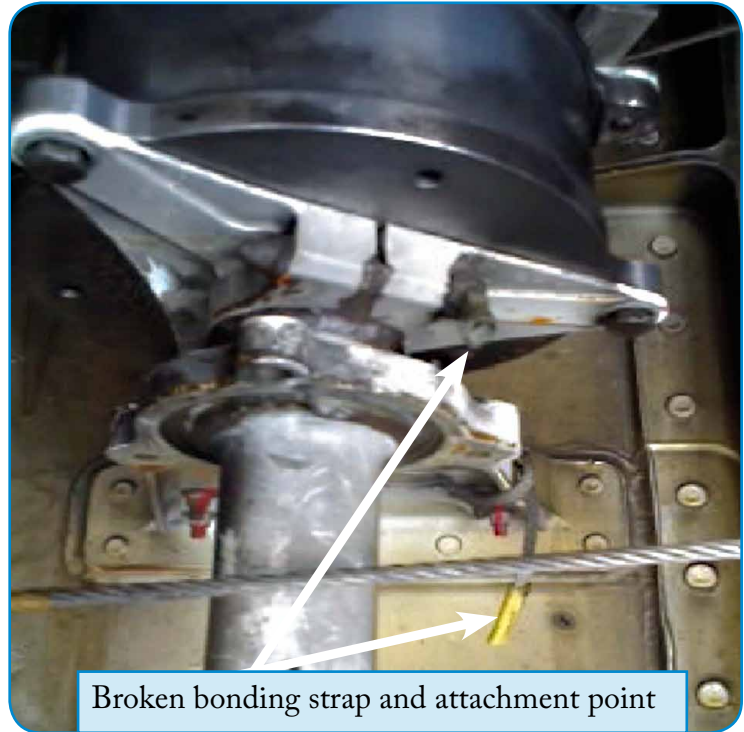
This binding fault occurred on three occasions prior to this event where no fault was found.

Further maintenance investigations revealed a broken bonding strap on the right-hand aileron torque tube located in the right main landing gear wheel-well. These bonding straps have been known to cause the stiff aileron fault and from examination of the area, evidence of the strap having interfered with the bearing support was noted.

Broken bonding strap and attachment point

Embraer have issued Service Newsletter (SNL) 190-27-0009R01, defining this possible scenario with recommendations for the proper installation of the bonding strap to prevent interference. ✖

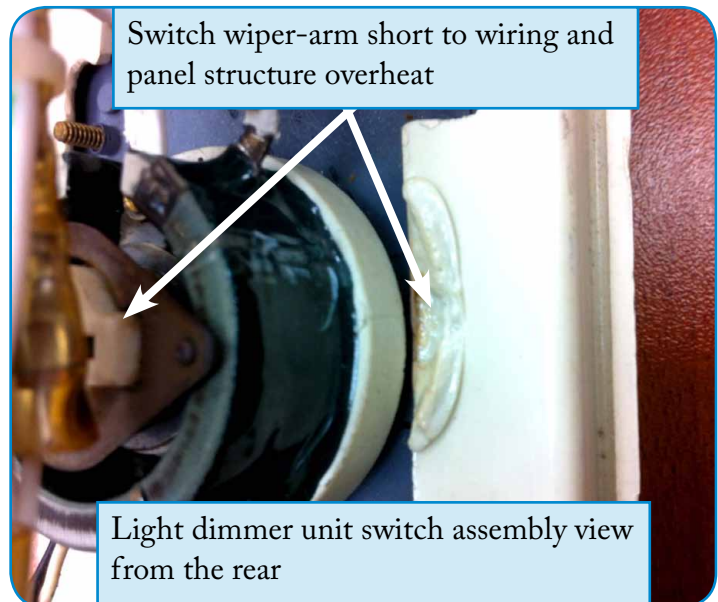
The co-pilots instrument backlighting system was snagged as inoperative. Maintenance found the co-pilots light dimmer unit switch had failed due to its potentiometer wiper-arm coming into contact with the surrounding wiring behind the instrument panel causing the light dimmer to short out. This in turn caused the potentiometer to overheat, melting the panel and leaving burn marks on the surrounding wiring.

Switch wiper-arm short to wiring and panel structure overheat

Light dimmer unit switch assembly view from the rear

The wiring was re-secured away from the potentiometer and the switch assembly was replaced.

The installation and correct support of wiring is essential to ensure the safe continued operation of all aeroplanes. ✖

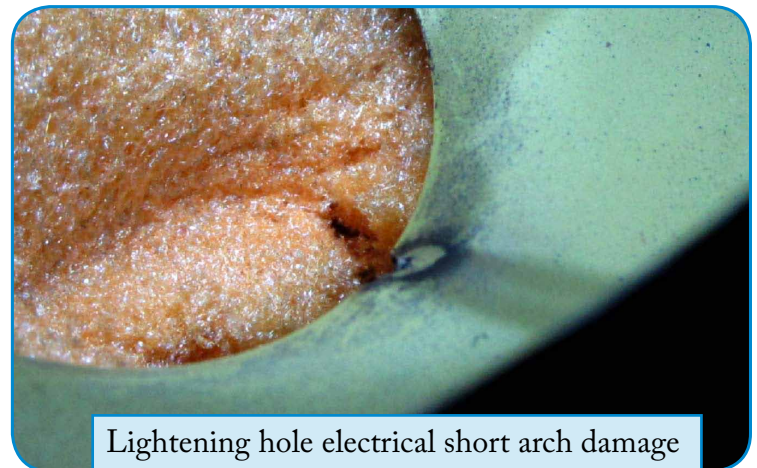
During a major inspection of the aeroplane, all cockpit windshields were removed for inspection of associated structure. Upon installation of new windshields, the airframe wire connections for the right-hand heated windshield were too short so were removed from the cockpit overhead run for replacement with new longer wires. Upon removal of the wire loom, one wire # H307/C12 was noted in having a significant burn mark. Further inspection showed a corresponding burn mark in a lightning hole where the wire passed through at frame 15.

The discrepant wire loom was installed 12 years previous as part of Service Bulletin (SB) 30-005, however a braided hose or grommet was not used at the lightning hole as a means of chafe protection defined in the SB. There were no previous reports of windshield heat defects recorded in the log book. The damaged lightning hole was repaired per Structural Repair Manual (SRM) procedures and the wire loom replaced.

Lightening hole electrical short arch damage

Correct wire harness support, insulation and protection from chaffing are essential standard practices for the continued operation of an aeroplane. With this case, not only was the defined task for a grommet installation missed during the incorporation of a SB by the Aircraft Maintenance Engineer (AME) responsible, the applicable standard practice was omitted also.

As AMEs, we are all responsible in knowing and following our Instructions for Continuing Airworthiness (ICAs), as with this scenario being the SB and Aircraft Maintenance Manual Standard Practice reference. ✖

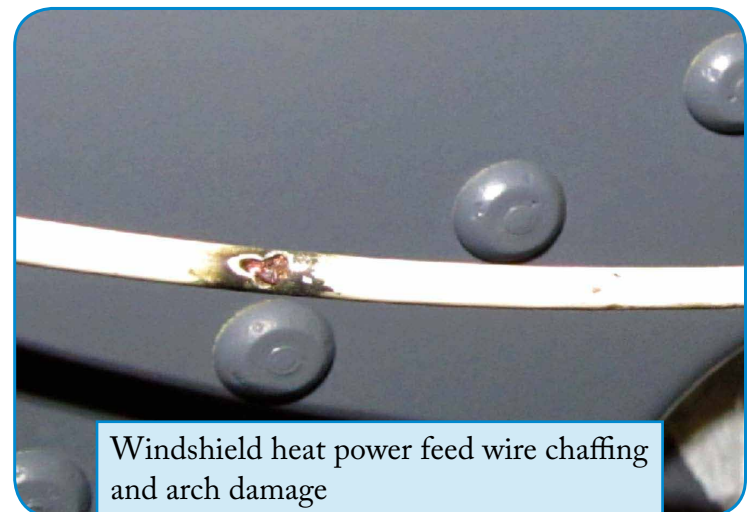
Windshield heat power feed wire chaffing and arch damage

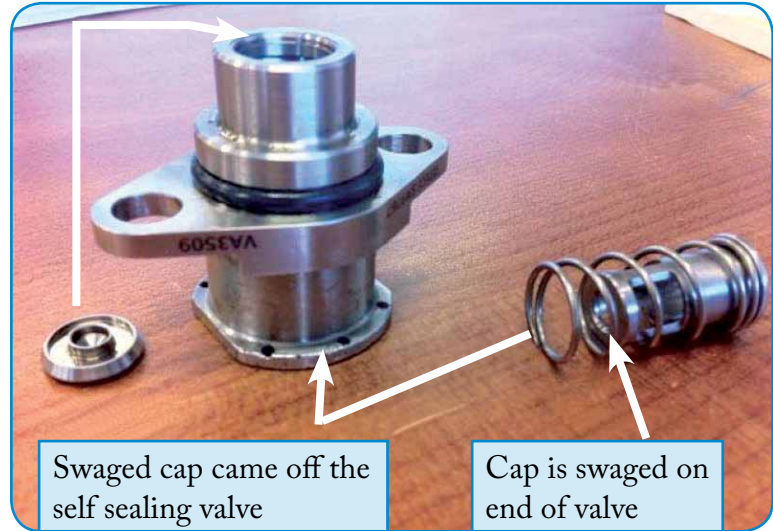
During master magnetic chip detector (MCD) inspection, on removal of the MCD probe, the self sealing valve broke off and fell down the oil tube. The oil tube was removed to recover the parts, the MCD housing was replaced (part number VA3509), the parts were sent to engineering and Rolls Royce was advised.

Caution is advised whenever disassembling aeroplane components. Thankfully in this case, the broken piece was easily recovered and did not damage another component. ✖

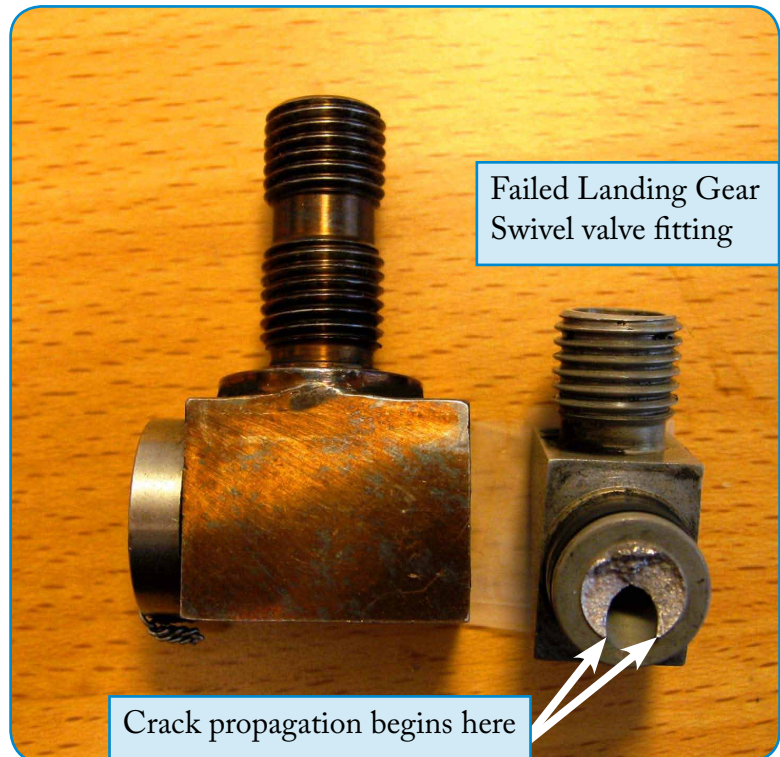
On climb-out during gear retraction the crew noticed a decrease in the hydraulic pressure while the pump was running with an eventual complete fluid loss. The aeroplane returned to the airport and the landing was uneventful. The cause of the problem was a failed landing gear (LDG) down-lock actuator hydraulic swivel valve. A fitting of the valve had split and allowed the loss of the hydraulic fluid.

Through the research of our Service Difficulty Report database via the Web-based Service Difficulty Reporting System (WSDRS), a high failure rate of these swivel valves was noted.

The swivel valve was replaced and the aeroplane was made serviceable.

Transport Canada Civil Aviation and SAAB engineering are working together to address this issue and a possible design change is pending for a change of swivel valve material through a Service Bulletin.

All operators and maintainers are asked in the meantime to pay close attention to these LDG swivel valves for hydraulic fluid leaks which could indicate a possible internal crack condition. ✖

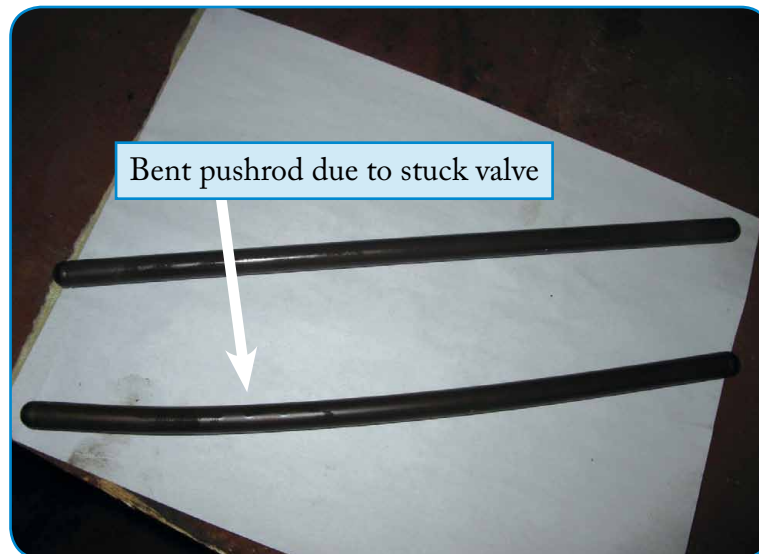
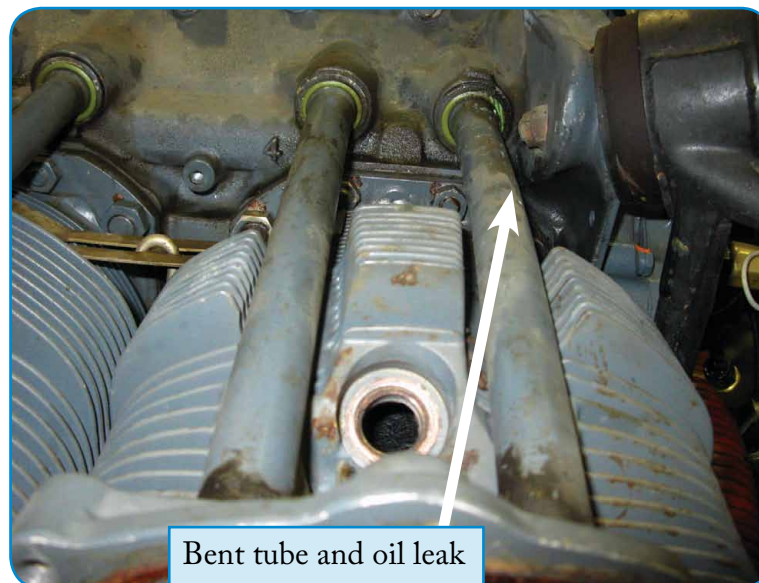
The aeroplane had to land because of a loss of engine power and high vibration. A stuck valve and bent push rod were found on the left-hand rear cylinder (engine was on condition). The customer decided to replace the engine with an overhauled unit. No damage to the aeroplane.

Operating a piston engine on condition can certainly offer significant cost savings to the owner. This does however come with certain risks. Extra maintenance can be performed to help mitigate those risks. As mentioned in a previous Feedback article, Avco Lycoming Service Bulletin (SB) 388 and Service Instruction (SI) 1425A provide great information regarding engine operation and valve maintenance. Both are available to the general public on Avco Lycoming's web site. (<http://www.lycoming.textron.com/>). ✖

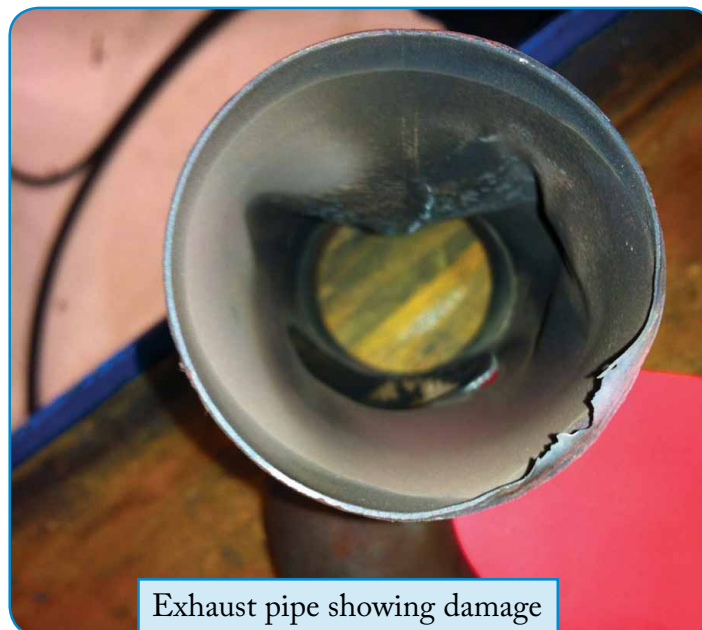
During the 100 hour inspection, cylinder #4 exhaust riser was found bulged at the collector. The bulge is consistent with the direction of cylinder #4 exhaust flow. Upon removal, the exhaust was noticed to be quite thin and appeared to have lost material. A gentle tap with a soft faced hammer easily collapsed the pipe. The engine has individual cylinder head temperature and exhaust gas temperature probes so overheating would be unlikely. Engine cylinder #4 was still serviceable, no other issues were found.

Exhaust pipe showing damage

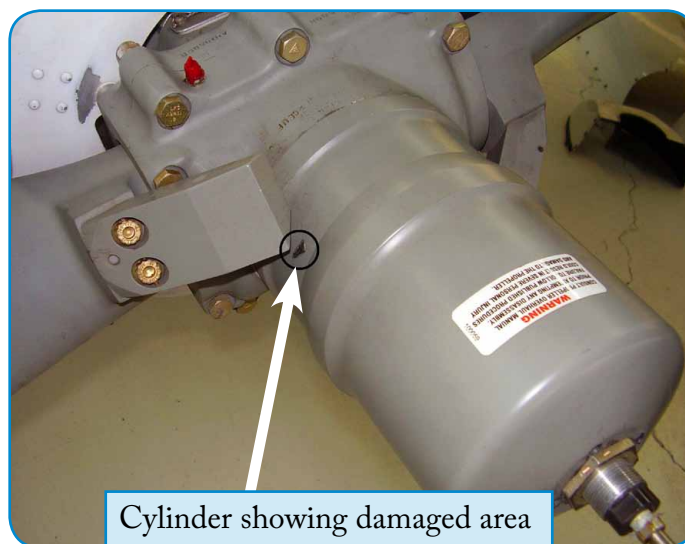
An investigation revealed improperly installed counter weights at some point in the propeller's history. A careful inspection is required after any maintenance task. ✂

Cylinder showing damaged area

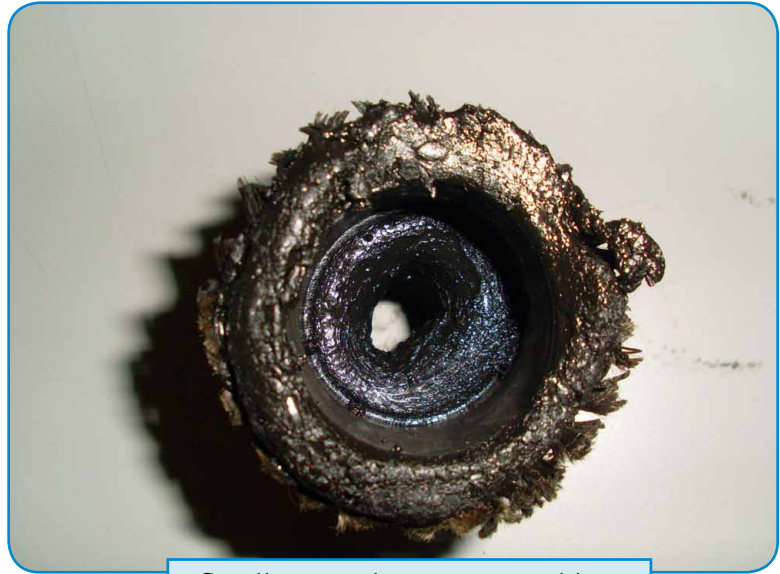
Left-hand engine was shut down after losing engine oil pressure in flight due to oil starvation. The aeroplane landed safely at the closest airport. A ground inspection revealed that the oil starvation was caused by a swollen engine breather line coupling that caused breather restriction. This restriction caused an internal engine pressure build up and oil escaping through the engine bearing labyrinth seal and accessory gearbox output shaft seal. A negligible oil leak was found on the left-hand engine cowling because a majority of the oil was internally burnt in the engine and could not be detected in-flight by the crew.

The swollen breather coupling, part number 159P10019-75, on the left-hand engine breather line rear section was repaired prior to 1997 and is not the original breather installation. The coupling was replaced. A ground run-up and a flight test revealed no more oil consumption on the left-hand engine.

Swollen coupling causing oil loss

Both engines breather lines were inspected for defective couplings before maintenance released the aeroplane.

The importance of proper inspection and attention to manufacturers' instruction (including their Service Bulletin publications) cannot be understated. In this instance it is likely that all instructions were followed, however the failure still occurred. It is also important that the manufacturer has access to the failed components so as to determine the root cause and develop fleet wide corrective action. ✖
