Transport
Canada

Feedback

Canadian Aviation Service Difficulty Reports

TP 6980E
(4/2013)

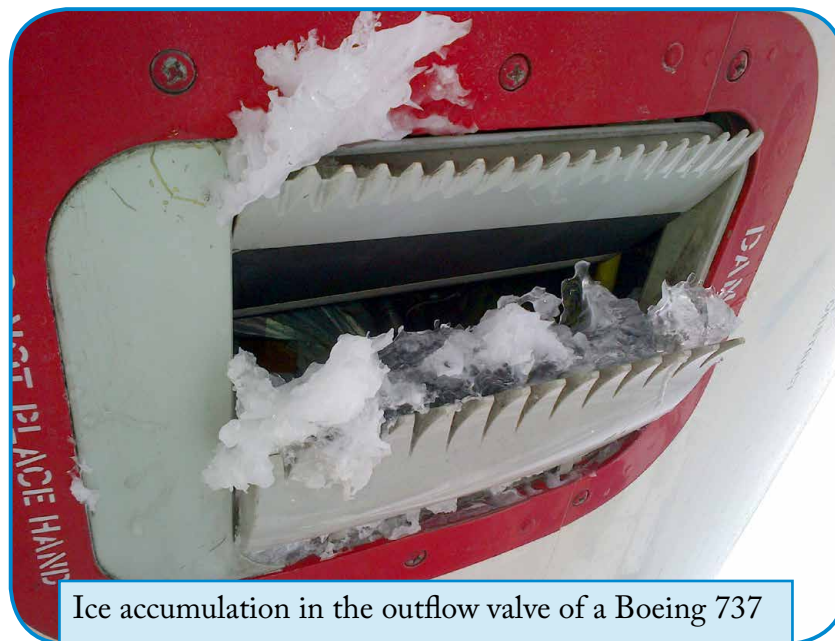
While the aeroplane was climbing through 35 000 feet, the crew found the pressurization to be fluctuating and the outflow valve to be unresponsive. During a descent to see if the issue would be resolved, the outflow valve went to full open and the aeroplane rapidly depressurized. The crew initiated a rapid decent and oxygen was deployed for the crew and passengers. The aeroplane returned to its origin and landed without any further issues where there were no reported injuries to crew or passengers.

After arrival, maintenance inspected the aeroplane and immediately found a substantial amount of ice around and in the outflow valve. This ice would have restricted the movement and control of the valve. Including the outflow valve, additional ice was found around the drains and tail skid. Further inspection revealed that a potable water 4-way coupling had released in the aft section of the aeroplane causing water to be sprayed directly onto the outflow valve from the inside of the aeroplane, as seen in the attached figure.

As stated by the operator, the reason for the 4-way coupling failure was due to a frozen water line where upon review of this event, it was discovered that Boeing had published fleet team article 737NG-FTD-38-07001.

To summarize this article, Boeing has determined that operator diligence towards ground handling in cold weather operations in reference to Aircraft Maintenance Manual (AMM) 12-33-01/02 is essential to prevent such events. Also stated is that Boeing Service Bulletin 737-38-1057 is available for the addition of shroud/drains and heaters for the 4-way coupling along with the replacement of various solid tubing with either flexible non-heated or heated hoses. ✖

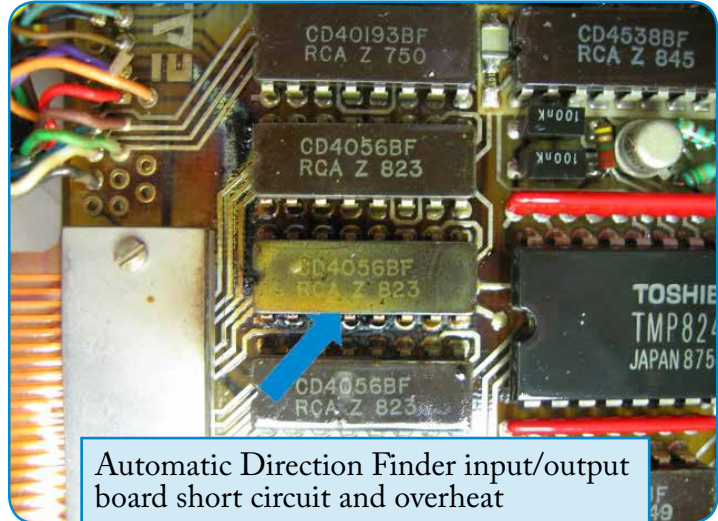
“The root cause has not been established, but it may be a short circuit between the ground and +28V DC transfer light signals localized:

- at green indicator lights DS3 or DS4 (potentially caused by water intrusion)*
- or*
- on the I/O board between the ground and +28V DC transfer light tracks near the connector P1 (potentially caused by a foreign object, debris or pollution).”*

Automatic Direction Finder input/output board short circuit and overheat

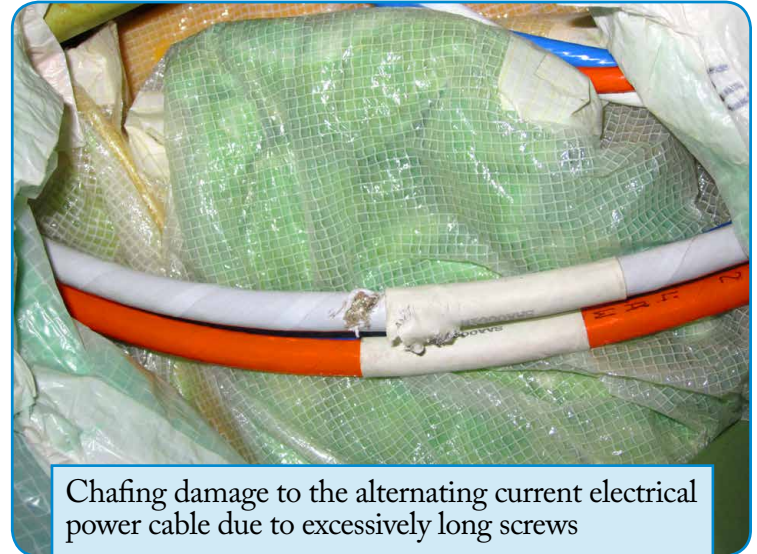
Shortly before entering operational service, a foreign interior completion center had installed the finished interior in the baggage bay. At this time, an upper intercostal was added to support the ceiling headline paneling. It was later found that the screws & bolts used to install the intercostal were excessively long and were chafing into the generator #1 power feeder cable. The feeder cable is installed above the headliner paneling and in an inaccessible area that the installer could not see while installing these improper screws.

Soon thereafter, it was discovered that the screws had damaged the insulation layers of the feeder cable and possibly the conductor of the feeder wires. The document holder will soon be issuing an engineering order to carry out a repair.

Chafing damage to the alternating current electrical power cable due to excessively long screws

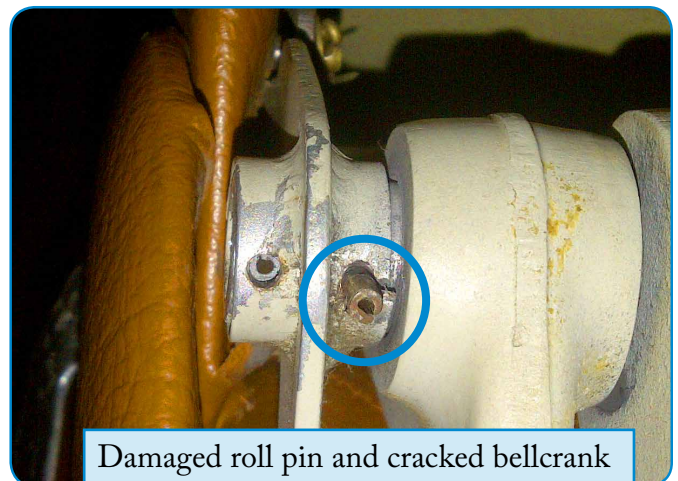
The bellcranks were found cracked where they connect to the “crank-weld assembly” on both the left and right hand side. The pins that secure the bellcrank on the left hand side had partially sheared placing the load on 2 of the 4 holes and appeared to cause the cracks to spread open. Damage to the right hand bellcrank was less severe and the pins were intact. Complete failure of the bellcranks or securing pins would cause the seat backrest to fully recline without warning.

Damaged roll pin and cracked bellcrank

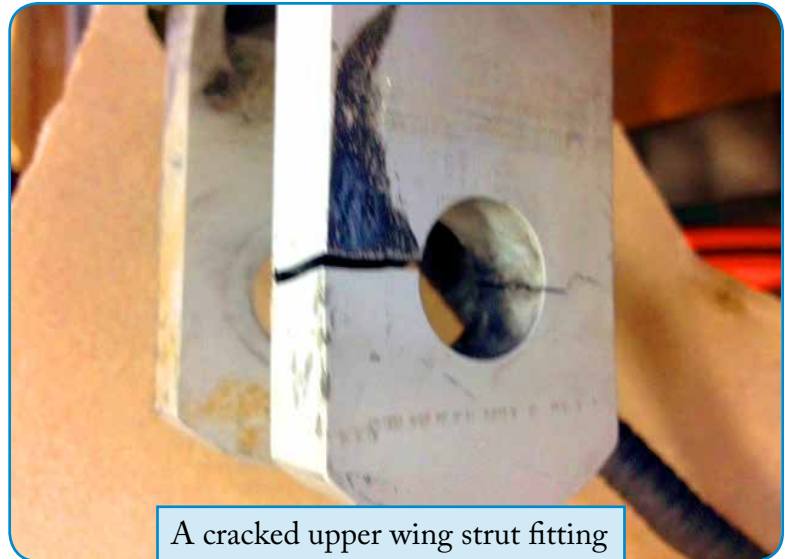
While completing a scheduled inspection in the wing area, a significant crack was found at the aft portion of the upper wing strut fitting. Further inspection revealed that the crack located on the fitting ear left only 6.35 mm (¼ inch) of material remaining.

Cessna examined the failed right hand aft upper wing strut fitting part number (P/N) 2621008-202 and determined the mode of failure as high cycle fatigue.

A cracked upper wing strut fitting

Cessna are planning corrective action and will conduct additional cyclic testing on the wing struts to verify that the current inspection in Chapter 4 of the Model 208 Maintenance Manual (MM) is adequate. It is also Cessna's position that any aeroplane operated on floats should be following the "Severe Inspection Time Limits" and not the "Typical Inspection Time Limits". The Cessna MM will be revised accordingly. ✖

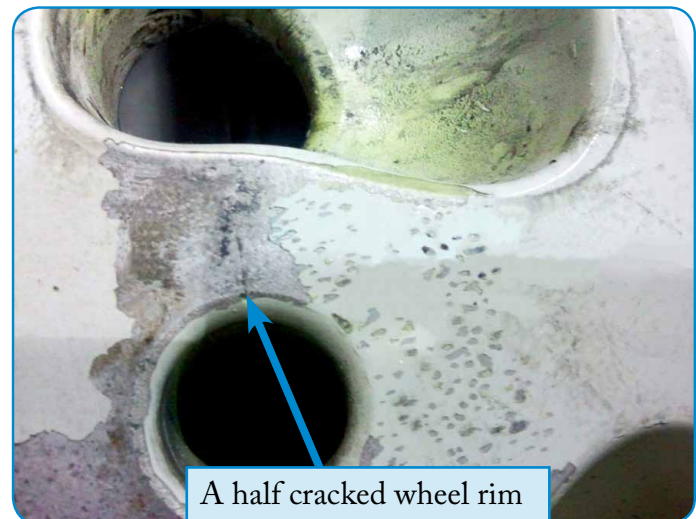
A 1.8 cm (0.700 inch) long crack was found on the out-board wheel half during a routine shop overhaul procedure. The method used to detect the crack was a high frequency eddy current (HFEC) inspection. The crack originated on the mating surface between the spoke and bolt hole.

A half cracked wheel rim

The crack was detected using the HFEC method, Transport Canada Civil Aviation emphasizes the importance of close visual inspections during all daily and service check walkarounds for all gear related equipment. ✖

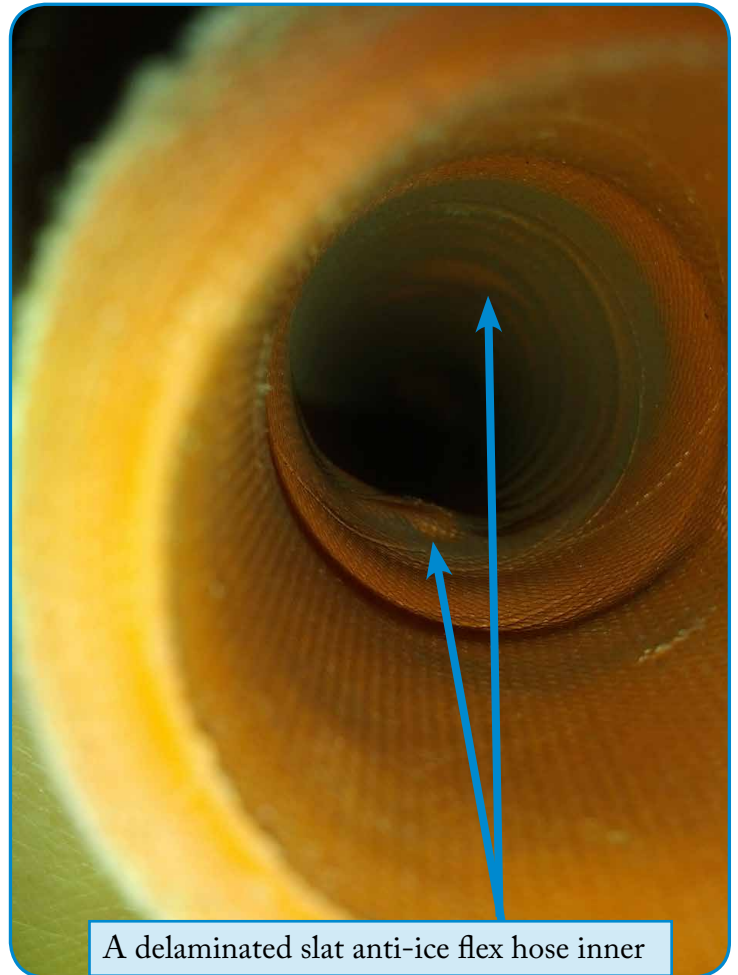
During cruise flight, the crew noticed that the left wing inboard leading edge slat was not shedding ice with the anti-ice selected. Upon maintenance investigation, the anti-ice flex hose for the left inboard slat was removed and found to be delaminated in several areas of the inner lining.

As explained by the operator, the remaining 3 other slat flex hoses were inspected where 2 more hoses with mild delamination of the inner lining were found.

All four slat anti-icing hoses were sent to Dassault (Falcon) Continuing Airworthiness Engineering. Through their investigative efforts, it was concluded that from the possible torsion imposed on the hose during installation, heat-buildup and delamination can occur. Due to this possibility, all affected Aircraft Maintenance Manual installation procedures were revised.

The hose was replaced and the aeroplane was made serviceable.

Also, it was decided to de-escalate or drop the hard-time airworthiness limitation from 700 hours to 400 hours for this anti-ice hose. ✖

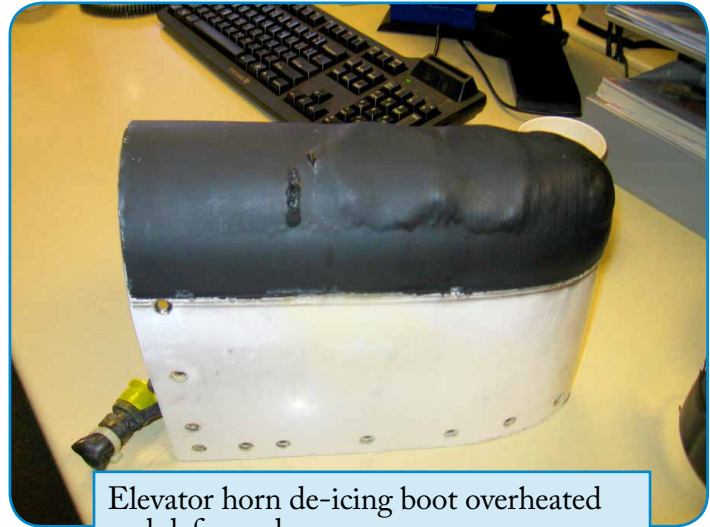
The left-hand elevator horn failed in flight (“amber fail” on push-button annunciator panel).

Upon removal of the faulty left hand elevator horn assembly, maintenance noticed that the de-icing boot itself was deformed due to excessive heat. An elongated hole was also noticed on the de-icing boot and it is suspected that this is where an electrical short occurred, causing the overheat condition.

Elevator horn de-icing boot overheated and deformed

The fiberglass fairing was burned through and required replacement including the installation of a new de-icing boot.

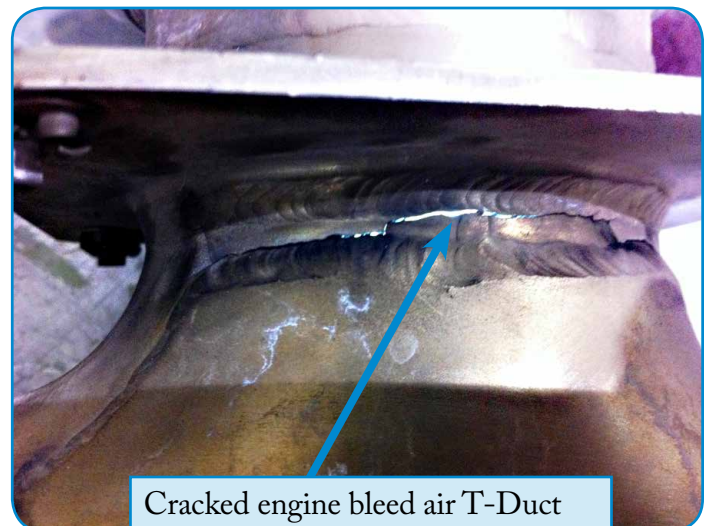
During a scheduled maintenance inspection task, the engine bleed air T-Duct below the pre-cooler on the right-hand pylon was found cracked.

Cracked engine bleed air T-Duct

The T-Duct was replaced, making the aeroplane serviceable.

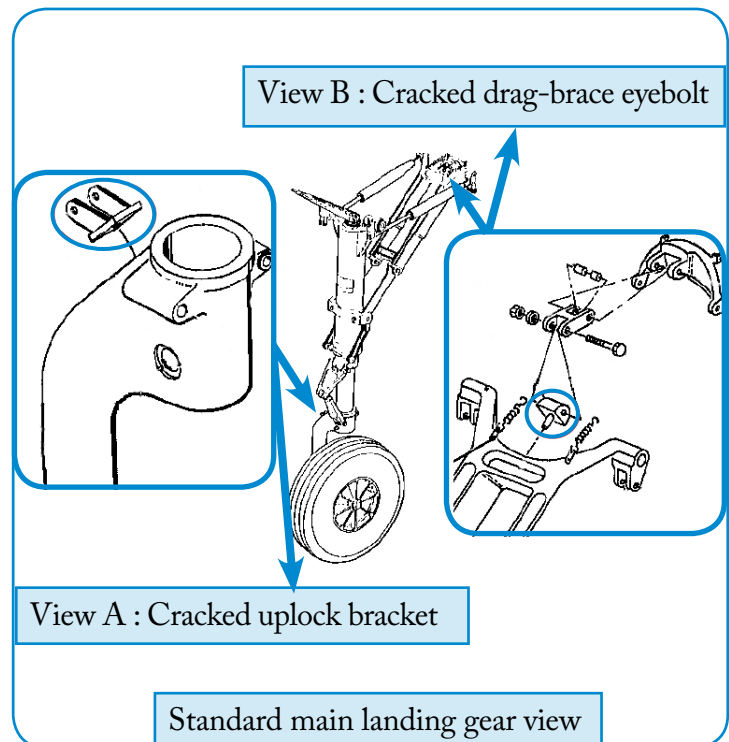
During a 5 year main landing gear (MLG) inspection, cracks were discovered in the uplock bracket (View A) and the drag-brace eyebolt (View B) by the non destructive testing (NDT) technician.

The requirement to NDT the faulted items for this landing gear at the 5 year visit are not required by the manufactures inspection maintenance program and it was through the proactive initiative of the maintainer that these cracks were found.

The discrepant parts were replaced and the MLG assembly was made serviceable for re-installation onto the aeroplane.

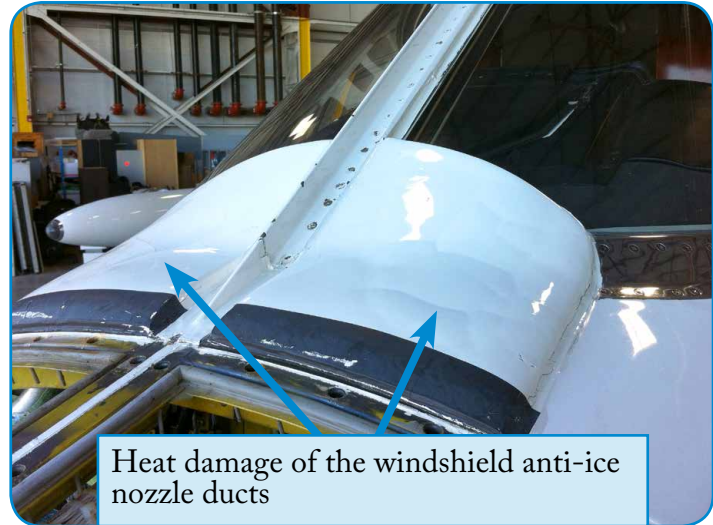
Maintenance troubleshooting discovered the windshield ram air modulating valve had internally failed (input shaft had separated from the internal bellows). The valve was replaced and the system function tested serviceable.

As a result of the failing windshield ram air modulating valve, both the left and right windshield anti-ice nozzle ducts received extensive heat damage.

The left and right ducts were removed for repair and the windshields were inspected for possible heat damage.

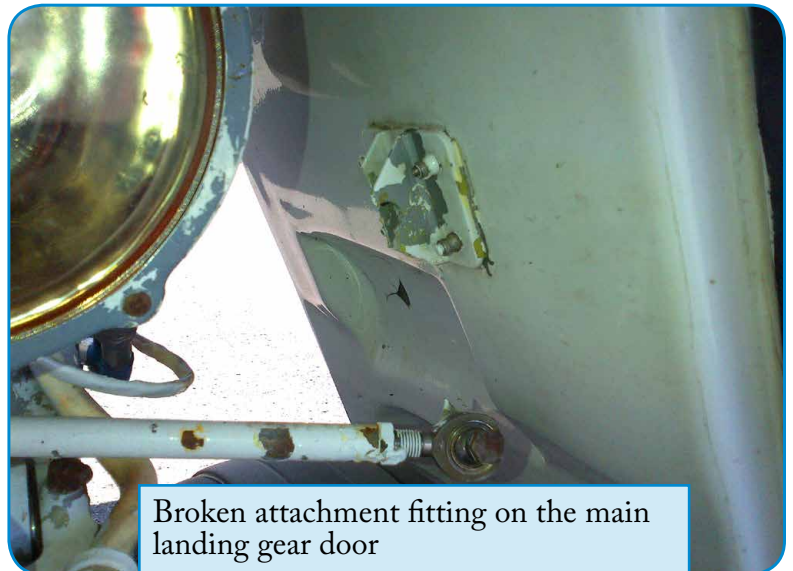
On departure during taxi-out, the line-maintenance crew notified the flight-crew that the left-hand main landing gear (MLG) door was flapping in the wind. Just prior to this, a Sikorsky S-92 had been operating in close vicinity to the aeroplane, violently rocking the aeroplane. It is suspected that the downwash from the helicopter caused the gear door fitting to crack as there was no dirt to indicate a pre-existing crack.

Broken attachment fitting on the main landing gear door

The fitting was replaced and the aeroplane was returned to service.

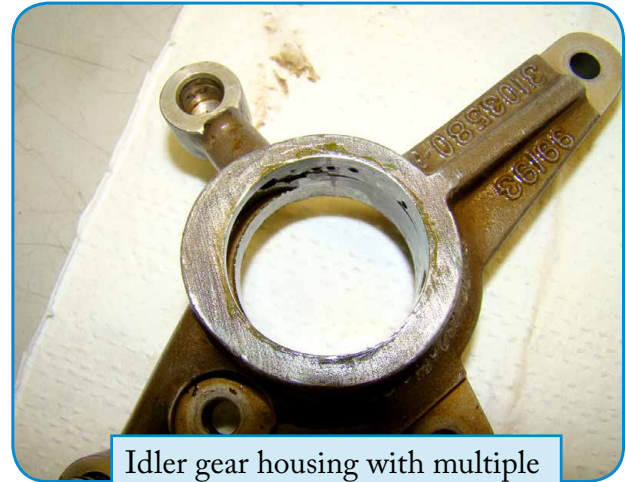
This engine failure was caused by a loss of drive to the fuel pump and fuel control unit which ultimately shut the engine down. The reason for the loss of drive was the idler gear bushing had backed out of the housing assembly. This caused the gear to migrate out of position and loose contact with the other gears in the system. This unit had been overhauled and the bushing replaced (likely more than once) in its service history. It is not known how many times this procedure had been accomplished on this particular unit (it is not a serialized part and as such is not tracked).

Idler gear housing with multiple safety pinning holes drilled

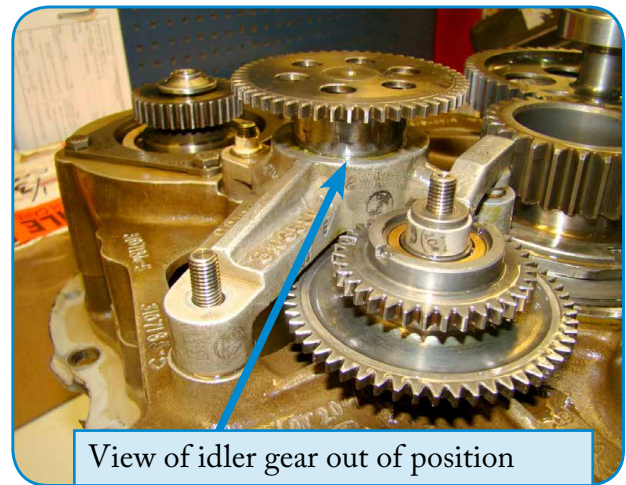
View of idler gear out of position

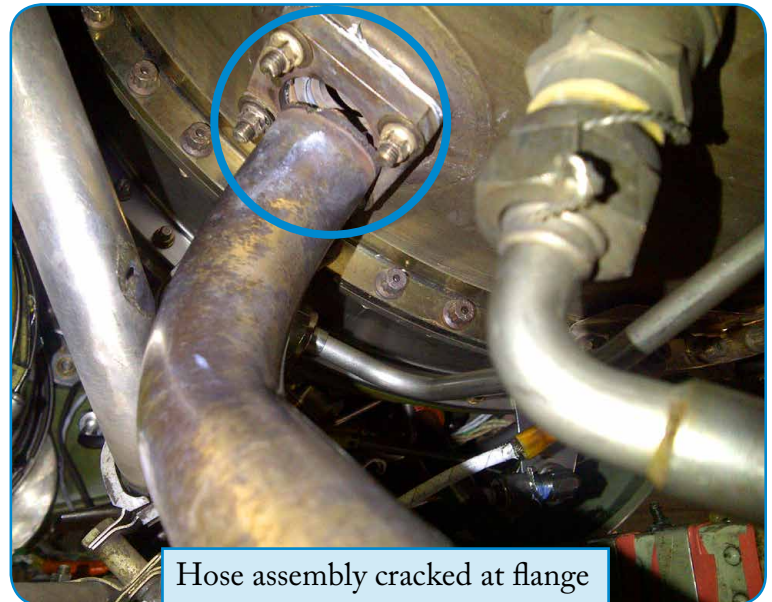
When ground testing an engine for an unscheduled propeller dynamic balance, the right-hand (R/H) engine flexible p3 bleed air hose cracked at the flange and separated from the engine case. This caused abnormal exhaust gas temperature values, loss of power, pressurization system failure (only from R/H engine supply) and engine inlet anti-ice failure.

The flexible hose assembly became loose and chaffed on the R/H engine fire extinguisher spray pipe causing its failure. Hot air coming from the broken flange burned the electrical wires causing failure of the R/H engine computer, the fluctuation in the temperature indicator and caused the engine cowling seals in zone 1 to melt.

Hose assembly cracked at flange

*There is a post Service Bulletin line assembly available (part number 13711543L401) that addresses this problem. (Service Bulletin 21-JM 7797)**

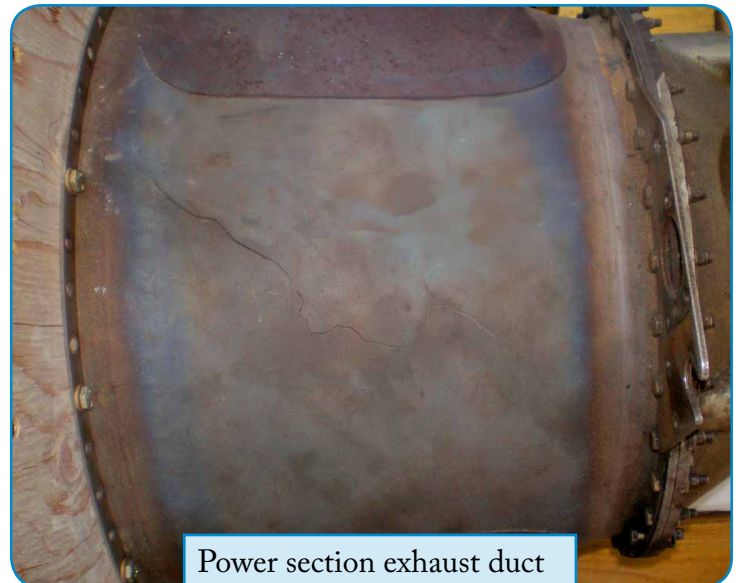
During a routine inspection, a crack was noticed on the exhaust duct between the "b" flange and "c" flange of the power section.

Power section exhaust duct

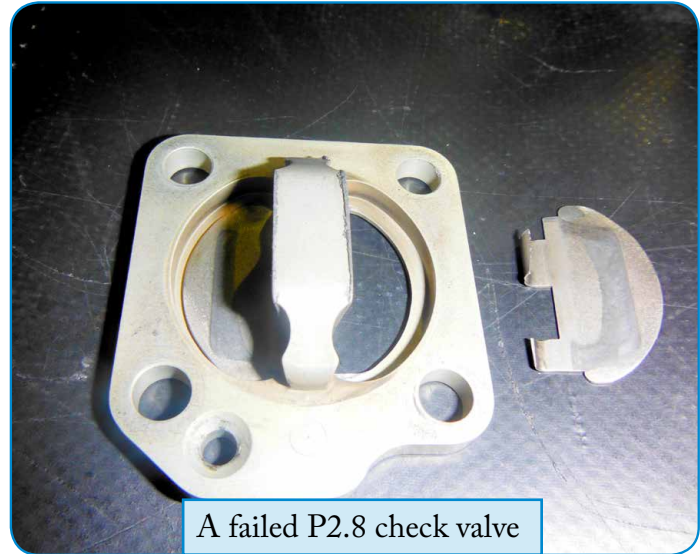
During a 50 hour inspection on an Augusta AW139, a piece of the P2.8 check valve was found in the engine compartment of the #2 engine.

A failed P2.8 check valve

Service Bulletin 41042 introduced a more robust check valve with improved hinges and contact area for the butterfly. It is obvious that there is still a potential for valve malfunction (due to the hostile environment in which the valve is located). Transport Canada Civil Aviation recommends maintainers inspect this area as per maintenance instructions and any time access permits. ✖

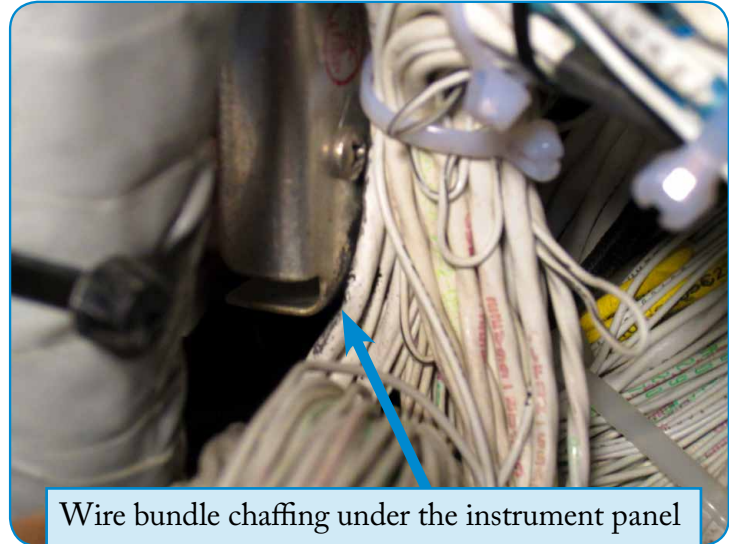
A pilot reported lateral cyclic impulses was felt in all flight regimes when the autopilot was on. Extensive trouble shooting was carried out over a 3 week period. The final rectification of the problem was the replacement of wire C943D22 which was found chaffing on the aircraft structure under the instrument panel on the left-hand side. The wire that was replaced was found in wire bundle K-TJ3-4B which was part of the EFIs modification.

Wire bundle chaffing under the instrument panel

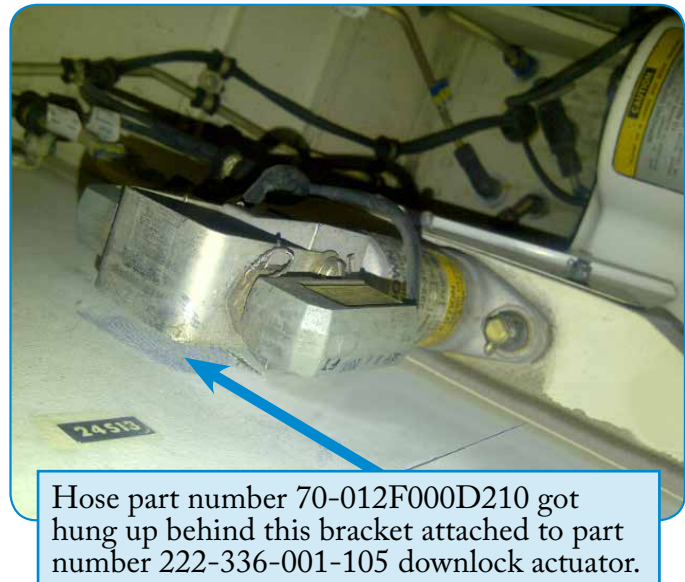
An Aircraft Maintenance Engineer (AME) arrived and determined that the L/H wheel brake hose part number (P/N) 70-012F000D210 was hung up on the down lock actuator P/N 222-336-001-105 not allowing the L/H gear to extend. The AME was able to free the brake hose and extend the L/H gear.

Hose part number 70-012F000D210 got hung up behind this bracket attached to part number 222-336-001-105 downlock actuator.

The L/H and R/H brake hoses were replaced and the hoses repositioned to prevent interference, heat shrink was installed on the hose with chafe tape on the landing gear strut to prevent chafe and adel clamp along with the hose repositioned to prevent future fouling. The gear was swung on jacks several times. The aircraft was returned to service.

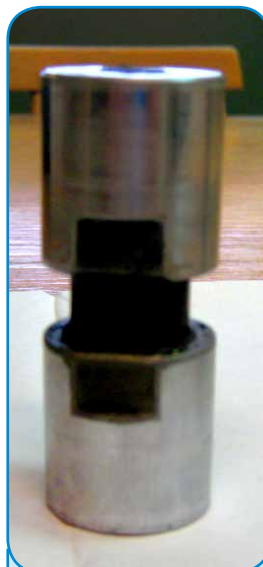
Figure 1

Through the evaluation of the operator, it was suspected that the cause of the universal joint bolt failure may have been attributed to stress corrosion imparted by a possible over-torque of the locking-nut and/or aggravated due to the aeroplanes previous operational environment. As a subsequent precautionary measure, the operator removed all flap transmission universal joint bolts (quantity 4, part number (P/N) 65-76606-1 and quantity 4, P/N 65-76607-1) for a magnetic particle inspection (MPI) resulting in a second bolt being indentified with a hair line crack, as seen in figure 3.

Missing retention nut and bolt threaded end

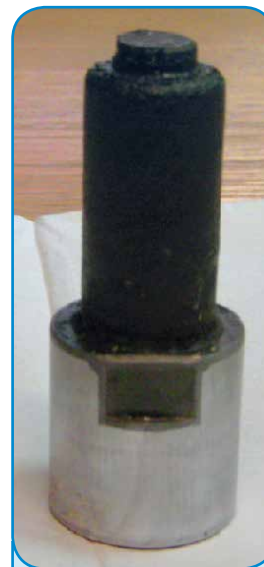
Figure 2

Missing bolt threaded end and extensive corrosion

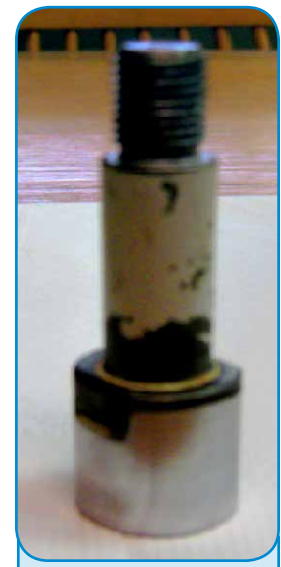
Figure 3

Universal joint bolt threaded end intact but hairline crack detected

A review of Boeing’s available maintenance documents in relation to this event identified the issuance of Service Bulletin 737-27-1265 in March 2005 which recommends the replacement of the universal joint bolts with a newly designed bolt.

The bolt material was changed to address stress corrosion and a self-locking castellated nut with cotter pin was added to address the potential backing-off and loss of the bolt.
