Transport  
Canada

# Feedback

Issue 1/2016

Canadian Aviation Service Difficulty Reports

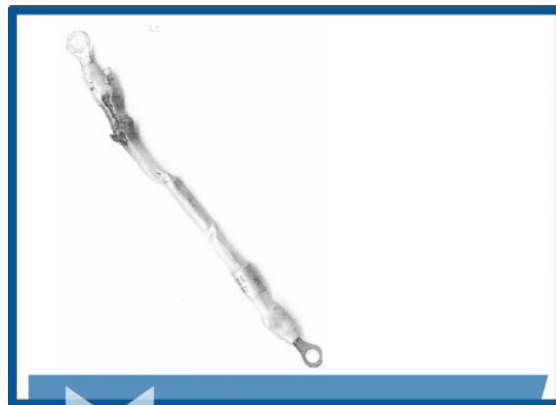
**Cause:** 30-126-5AA link went dead short – reason unknown.

**Note –** The landing light switch circuit has no fuse or circuit breaker to protect it, hence its burn out.

The failed diode link assembly discussed in the article is shown in the photo. Note that the sleeve covering the link is melted and split from the heat generated when the link failed by short circuit.

Transient voltage suppressor diodes usually fail short, but may also fail open. If they fail open, there is no longer protection of susceptible components against subsequent transients. For the more common case of failing short, a significant surge current can occur. This was the failure mode in the occurrence helicopter and the surge current was large enough to damage the wiring in the landing light controls.

**Action Taken:** Contacted Bell, replaced burnt wiring in landing light control circuit and replaced 30-126-5AA link

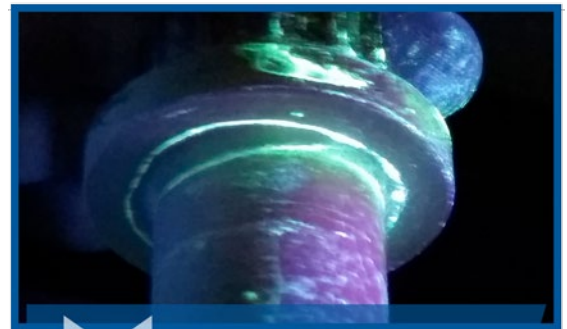
During the second 200 hour non-destructive testing inspection, a crack was detected in the right lower forward wing bolt.

Crack on a wing bolt as seen with non-destructive testing.

Don't take any chances with wing attachment bolts. The lower forward wing bolt is the most important wing bolt in a Beech King Air since it carries most of the wing load. There are four wing bolts on each wing and these bolts have a life limit and also require regular inspection. Wing bolt holes also require inspection on regular basis as per the manufacturer's instructions. Some Beech King Air aeroplanes have spar straps installed to prevent the loss of a wing, in case of wing bolt failure. Newer King Air aeroplanes have been fitted with a completely different lower forward spar attachment.

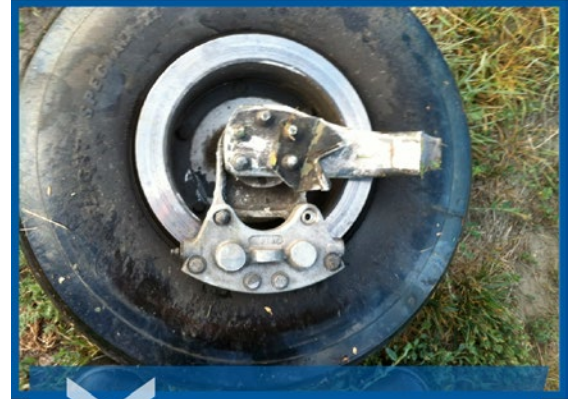
At about 20 miles per hour on the takeoff roll, the aeroplanes left main gear spring snapped off about 6 inch up from the axle. Consequently, the aeroplane spun to the left and tilted down, resulting in the propeller impacting the ground and a sudden stoppage of the engine. The aeroplane came to rest on its left wing. The pilot did not sustain any injuries. The aeroplane only had about 120 gallons of spray chemical on board at the time of incident.

Separated wheel assembly with part of the broken main gear spring still attached.

This type of landing gear failure can have dire consequences. Fortunately, the aeroplane was moving at slow speed at the time of failure. Crop dusters operate from un-improved runways and the landing gear gets a real work out. Spring gear is generally very robust but fatigue damage can occur. The aircraft inspection program has generally been adequate to prevent this type of failure.

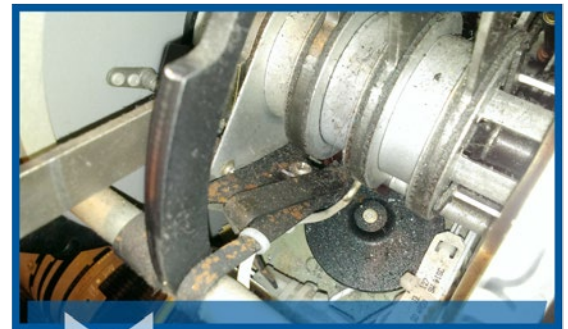
A part was found loose in the control quadrant, it was separated from the mounting tang. It is possible that loose parts in this area could jam the engine controls.

Broken spring in the engine control quadrant.

It is important to carefully inspect the engine control quadrant for broken parts and foreign objects in order to ensure that engine controls are free to move without restriction. Engine control friction locks wear out over time and need to be maintained to prevent unintended engine power changes that could cause a hazardous situation.

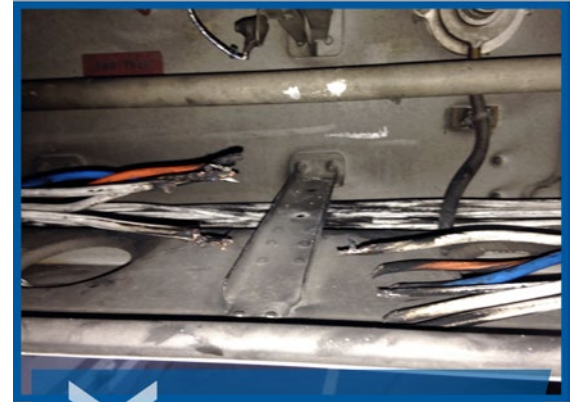
The aeroplane was removed from service and maintenance personnel started to investigate the reason for the failure, after several days of troubleshooting it was found that the left hand wing root had a burnt wire bundle.

Damaged wire bundle aft of the rear spar.

A routine inspection of the area should have found the chaffed wires before the whole wire bundle burnt through. This area is not normally accessed except when called up for inspection.

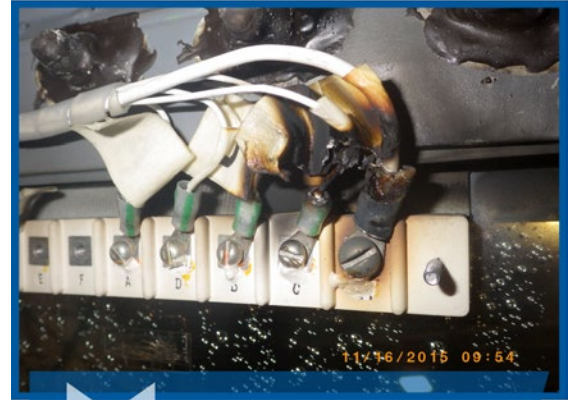
Sparks were observed from the right windshield during climb and dissipated once windshield heat was selected off.

Signs of excessive heat was noted at the terminal block on the windshield. The masking tape left on the wires to help identify them during the last window install was burnt which was the source of the flames observed by the flight crew. A torque check of the terminal screws was carried out and found tight but under the value prescribed in the aircraft maintenance manual.

It was then discovered that the windshield heat only works on "warm up", but not in "norm" during the functional test.

Burnt tape can be seen on the wires connected to the windshield terminal block.

The controller was swapped out for troubleshooting. The right hand windshield heat circuit breaker was reset. An operational test of the right windshield heating system was serviceable in accordance with aircraft maintenance manual chapter 30-41-00.

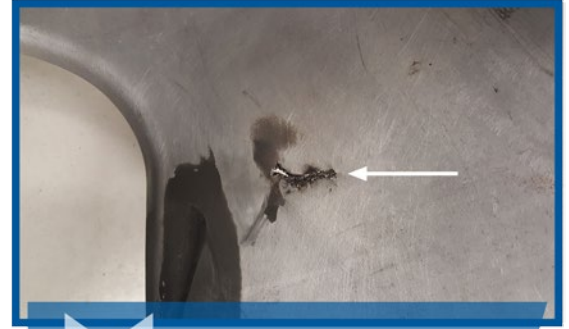
The pilot reported that the left hand propeller heat amperage was indicating "low". Upon further examination/troubleshooting, maintenance discovered the propeller heat wiring harness had no protective sheathing installed. With no protective sheathing, the wire rubbed against the spinner and caused the harness to arc and burn a hole through the spinner. The spinner was deemed unrepairable and a new spinner was installed. The wiring harness was repaired and installed securely with protective sheathing to prevent re-occurrence of damage.

Damage on the spinner caused by the propeller de-ice wires.

This type of damage is preventable by doing proper inspections when called up by the inspection program. Keep in mind that propeller blades rotate through 90 degrees every time the propeller is taken out of feather or feathered and that movement has to be taken into account when inspecting this area.

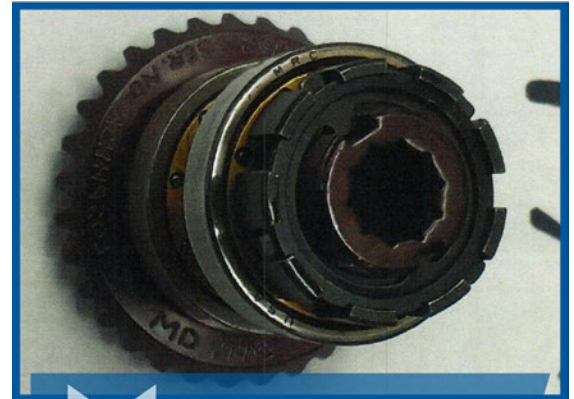
A part with an incorrect part number was found installed on the front frame accessory drive pinion gear. The part installed had the correct dimensions, but is not listed in the General Electric parts catalog. The correct part number should have been 4001T99P03. The bearing is required to be replaced at overhaul. It is assumed that it was replaced at the previous overhaul; therefore it likely has accumulated 367 hours since new. General Electric verified that this part number bearing is made for a different application than for the CT58-140-2 front frame accessory drive. The bearing had no indications of failure or abnormal wear.

Bearing with improper markings for application.

This engine came from an American operator and was last repaired/overhauled in an overseas facility. Transport Canada Civil Aviation would like to caution maintainers to be cognizant of the possibility of non-approved parts and hardware installed in aeronautical products.

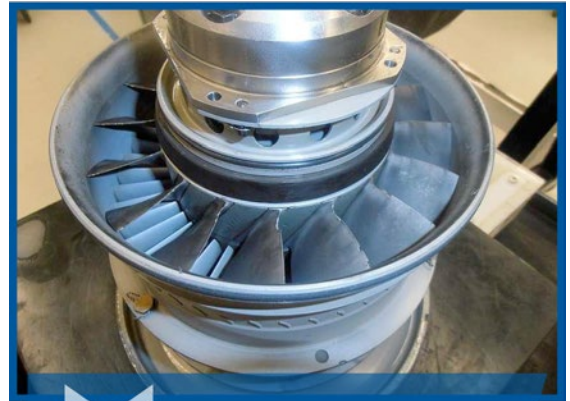
During scheduled maintenance, after having a foreign object damage (FOD) incident on the other engine, it was decided to inspect the compressor. The first stage compressor blades were found with heavy impact damage. The second and the third stage blades were found with very minor nicks. There was no other noticeable FOD found on the rest of the compressor, the gas generator case apex entries and the diffuser tubes. It appears that an object was ingested by the compressor damaging the first stage blades, and subsequently exited the inlet area through the inlet case.

There was no foreign object recovered from the engine during investigation by the engine shop. This aeroplane had a previous FOD incident on the other engine a month earlier. After a dual FOD on the same aeroplane, maintenance did a thorough investigation and found the aeroplane had wing/nacelle heavy metal work completed two years previously for a wing life extension program by another Approved Maintenance Organization (AMO). Surmising left over FOD from the repair process, maintenance found a 1/4-1/2 inch bulb/stem piece of cherry max fasteners stuck in behind a cowl chafe strip. It is suspected that other material of this type left behind from the prior repair had liberated itself and entered the inlet area and created the damage. The compressor area had not been inspected for a while so actual date of incident is not available.

Engine compressor showing foreign object damage to the first stage blades.

It is unfortunate that increased inspection of this sort is often reactive in nature rather than proactive. Maintainers and repair shops are reminded to be vigilant and be sure to remove materials and tools that can be left behind in 'quiet areas' of aircraft that can pose a FOD danger.

A more robust FOD prevention program was instilled. During maintenance, especially of engines, cowling are wrapped in blankets and a complete blow down with air of the whole engine and nacelle area is completed, even when the maintenance is not a scheduled inspection. The compressor inlet (and screen) area and first stage blades are inspected more thoroughly and more often than was done previously.

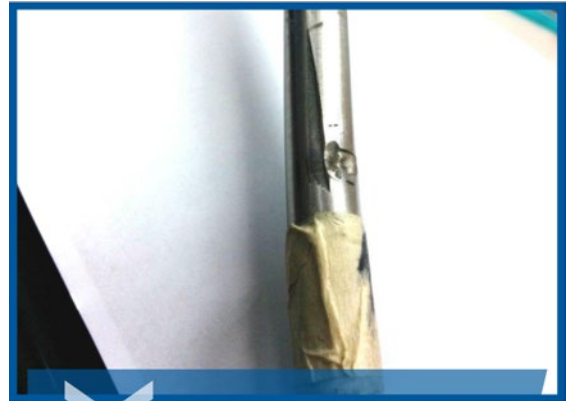
The engine had been in the field for 4 years, the elapsed time in this (improper) configuration is not known.

Due to the wrong configuration, the tube is excessively fretted.

Integrated drive generator (IDG) oil line with fretting wear marks.

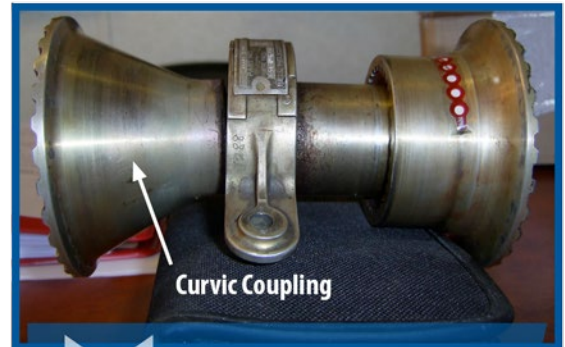
The pilot noticed a slight yaw as he was touching down. He also noticed that when applying collective to take off, there was no response from the pedals. The aircraft was shut down and as it was winding down, a loud grinding noise was heard coming from the back of the helicopter. The pilot observed the tail rotor was not turning even though the main rotor was still winding down. The origin of the noise was isolated to the tail rotor drive shaft coupling under the engine exhaust stack. When the main rotor was turned by hand, the forward end of the coupling was turning but not the aft end. The coupling suffered a complete failure and all tail rotor drive was lost.

The Drive Coupling Assembly is assembled incorrectly and demonstrates a misalignment by the downward appearance of the curvic coupling. For a correct assembly, the curvic coupling should appear square to the coupling shaft.

The coupling failure was the result of an excessive misalignment causing extensive wear to the mating splines between the rear curvic coupling and the coupling shaft. The misalignment of the coupling was due to incorrect assembly of the coupling at the last lubrication and inspection interval. It is suspected that the arrangement and location of the required washers were not correct and subsequently created the misalignment.

The manufacturer's maintenance manual or component overhaul written instructions and associated diagrams must not be substituted for similar exploded view diagrams found in places such as the illustrated parts catalogue. Although the diagrams may appear correct, this is not always the case.

The coupling assembly (hangar assembly) was replaced with a serviceable one and the aircraft returned to service with no further issues. The cause for the coupling failure is still under investigation.

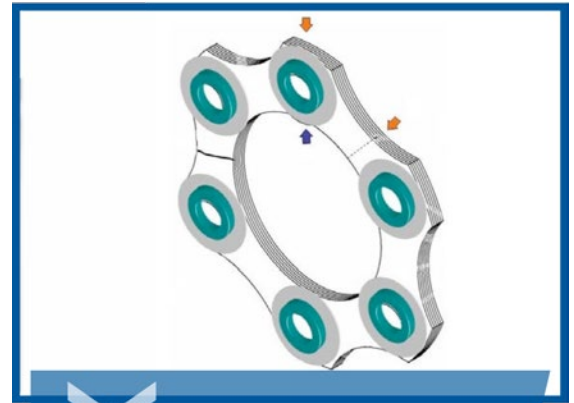
During a post flight inspection of the forward flex coupling between the engine and transmission, cracks were found on the drive shaft side of the coupling. While removing the flex coupling, three of the bolts that attached the coupling to the belt drive pulley were found slightly loose. The drive shaft bolts were all still tight and all six bolts had cotter pins installed.

Common areas where cracks may develop in the Flex Coupling as a result of bolt torque loss.

A loss of torque generally results in fretting and initiation of cracks in the bolt holes. Airbus Helicopters published Service Letters 1140-65-92 and 1826-63-07 to mitigate the frequency of this problem and associated down time. Remain vigilant while inspecting this critical area.

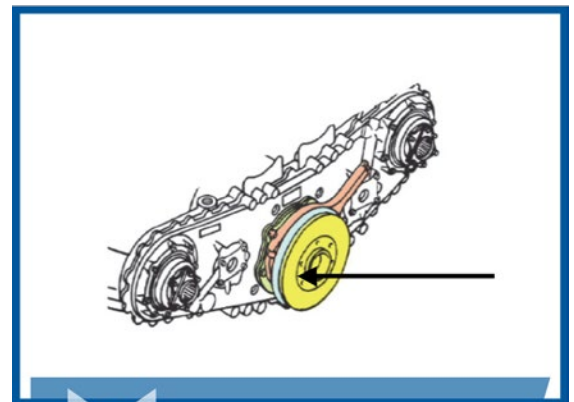
During an unrelated and unscheduled maintenance check, the output flange was found to be loose (total loss of tightness). The bevel gearbox was removed, inspected and reinstalled. Service Bulletin AS355-63.00.27 was completed with a new flange, Sta-Lock nut and securing washer installed. The aircraft had only flown 66.6 hours total time.

Drawing depicting the location of the loose rear output flange.

"Total loss of tightness" is the term Airbus Helicopters has given to the in flight vibrations and loss rotor brake efficiencies that have been reported as Service Difficulties. As a result of the reports, Airbus Helicopters has introduced a new flange and new securing washer to prevent loss of tightness of the Sta-Lock nut on the main gearbox rear output. MOD 077231 was introduced to prevent the loss of tightness via recommended Service Bulletin AS355-63.00.27.

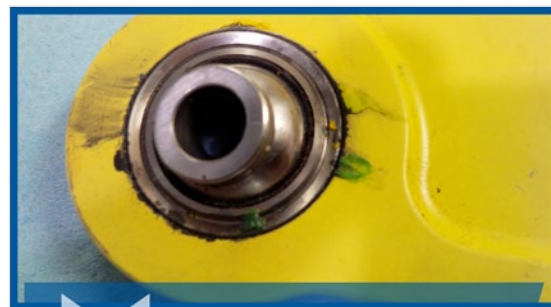
A bearing was noticed to be rotating inside the housing. The part was removed and found that the bearing was improperly staked. The part was replaced with a new part.

Black fretting dust around a bearing outer race as indication of movement between the bearing outer race and its sleeve or the sleeve and parent metal of the component.

An improper roll stake on a flight control bearing could occur at manufacturing or during replacement in the field, either could lead to a catastrophic failure. In the past, Bell Helicopter has acknowledged faulty manufacturing processes. To mitigate the associated risk, Bell issued Alert Bulletins for the affected models. In addition, Bell also published General Operational Safety Notice GEN-OSN-09-38. Transport Canada Civil Aviation would like to remind all affected Bell operators to continue to perform thorough daily and scheduled maintenance inspections to recognize the early signs of a failing roll stake.

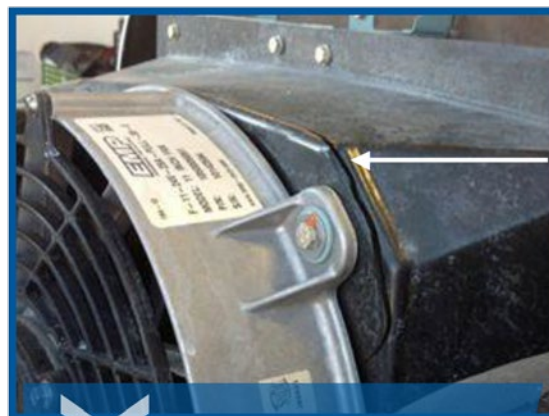
During disassembly of the aircraft for painting, the oil cooler inlet air duct was found cracked. The same discrepancy was found on additional aircraft, the damaged parts were replaced with serviceable units.

Example of the crack and general area for cracks to occur on the oil cooler hopper.

Airbus Helicopters has introduced a daily inspection by means of Emergency Alert Service Bulletin EC130 05A020 and EASA has issued emergency Airworthiness Directive 2014-0229-E with a repetitive 10 hour or 7 day inspection.

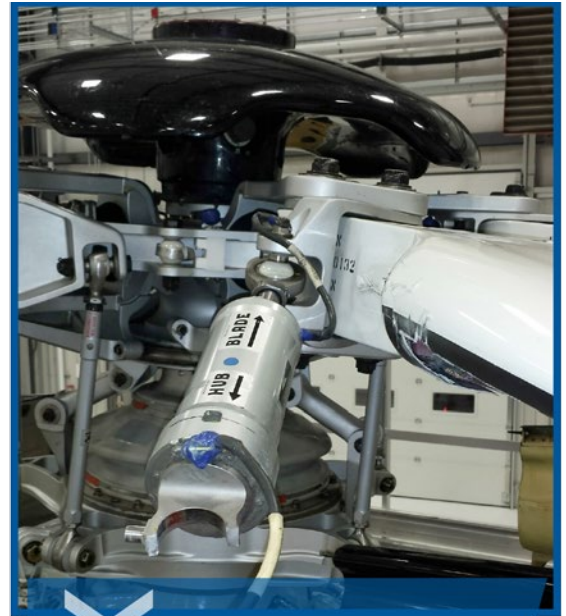
During cruise flight, the aircrew felt an abnormal vibration come on all of a sudden. They reduced airspeed, lowered landing gear and landed the helicopter back at base. Upon inspection, after the aircraft had shut down, one of the main rotor dampers was found hanging from one end. The bore of the inboard end of the damper which retains the spherical bearing had failed.

Main Rotor Damper Part Number: 3G6220V01352, Time Since New: 586.0 hours.

The main rotor damper hanging from the main rotor head with failed damper. The damage to the main rotor blade is also visible in this picture.

In situations like this, take every opportunity possible between flights to visually inspect the specified area. AgustaWestland has been made aware of this latest service difficulty for further analysis.

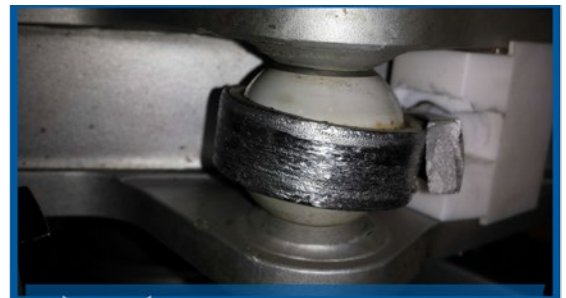
The cause of the main rotor damper failure was a severely spalled spherical bearing. AgustaWestland has published mandatory bulletin BT AW 139-410 to address the failure of the damper with a visual inspection at specified intervals.

The failed spherical bearing and evidence of spalling on the outer surface.

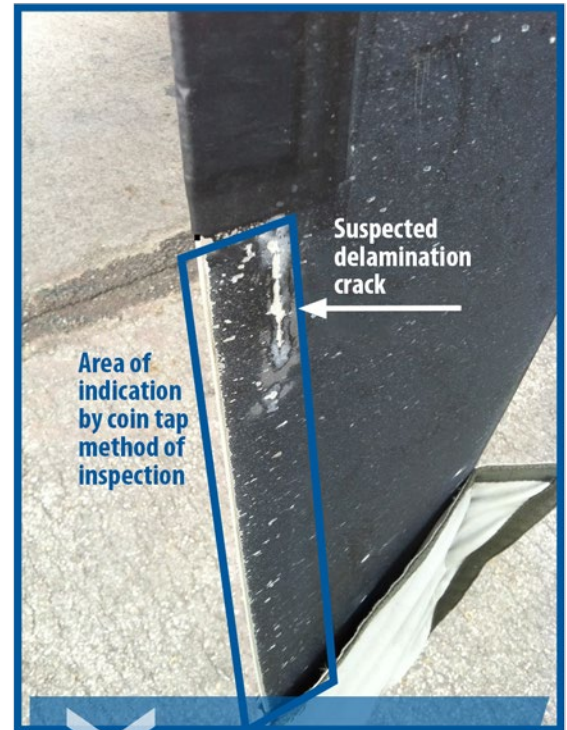
During a scheduled 300 hour coin tap test on the propeller, a significant portion of the leading edge of one of the propeller blades was found delaminated. This was found by interpreting the sound during the test. The leading edge just outboard of the de-ice boot also showed visible cracking. The airworthiness limitations were researched and an approved Hartzell dealer was contacted to further discuss the problem. He indicated that there are operators who have had similar issues. The discussion resulted in grounding the aeroplane and the propeller being sent for repair.

Propeller blade with area of suspected delamination highlighted.
