Transport  
Canada

# Feedback

Canadian Aviation Service Difficulty Reports

TP 6980E  
(2/2013)

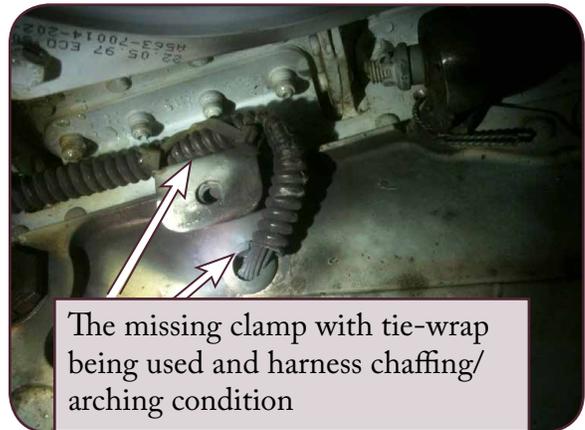
At arrival, it was noted that circuit breaker (C/B) 2LW on the cabin overhead panel was out. When the C/B was reset for troubleshooting, significant sparking was noted at the forward right (R1) passenger/crew door. The sparks were concentrated near the main interior door operating handle.

When the trim was removed from the door, it was noted that the main wire bundle for the door was completely burnt and had arced at one location. It appeared that a grommet was adrift and had split open, allowing a chaffing condition of the harness on the door structure.

Also noted was a missing clamp where a tie-wrap was used to secure the harness, inducing a misalignment condition and eventual harness failure.

The grommet and wires were replaced and a clamp was installed, making the aeroplane serviceable.

*Correct installation of any part or assembly of an aeroplane is essential for its continued airworthiness and safety of flight. ✖*

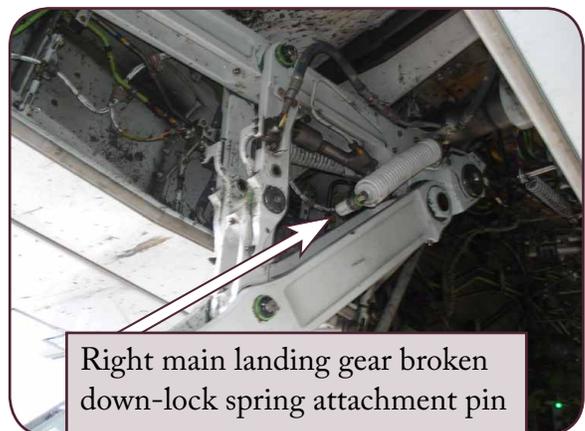
During a standard walk-around, the pilot reported that the right hand main landing gear had a loose spring hanging. Upon further investigation it was noted that the right hand down-lock spring attachment pin had sheered and the forward spring assembly had come loose.

The pin was replaced and the aeroplane was returned to service.

*The importance of the walk-around inspection from both the flight crew and maintenance engineer is an essential task prior to any flight. ✖*

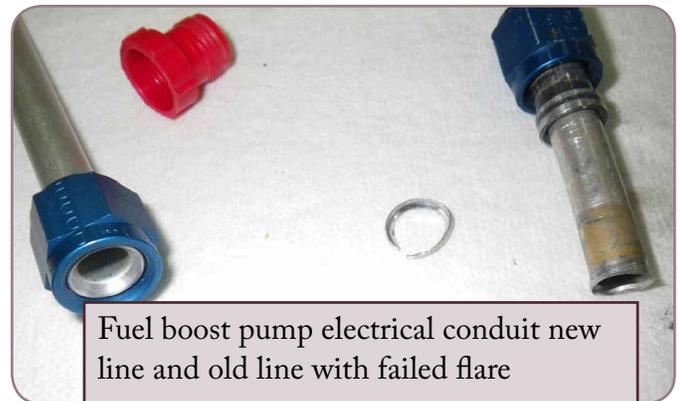
The centre fuel tank was fueled to maximum capacity at 2270 kg (5005 pounds). The aeroplane was parked in the hangar and fuel was noted to be dripping from the left-hand aft face of the main landing gear wheel well forward bulkhead just to the left of the aeroplane centerline. Further investigation revealed the leak was coming through the left boost pump electrical connector backshell.

The fuel was entering the wiring conduit because of a cracked flare at the left fuel boost pump canister.

*It is suspected that from past boost-pump canister changes, the electrical conduit B-nut was over-torqued, causing the eventual failure of the conduits flare end.*

Fuel boost pump electrical conduit new line and old line with failed flare

The aeroplane was removed from service and power lockout procedures were immediately carried out. The tube assembly was replaced and all appropriate leak checks were completed, returning the aeroplane back to service.

*Transport Canada Civil Aviation is advising all owners, operators and maintainers to reference the Aircraft Maintenance Manual for all required torque values with special consideration when working electrical fuel conduit lines. ✖*

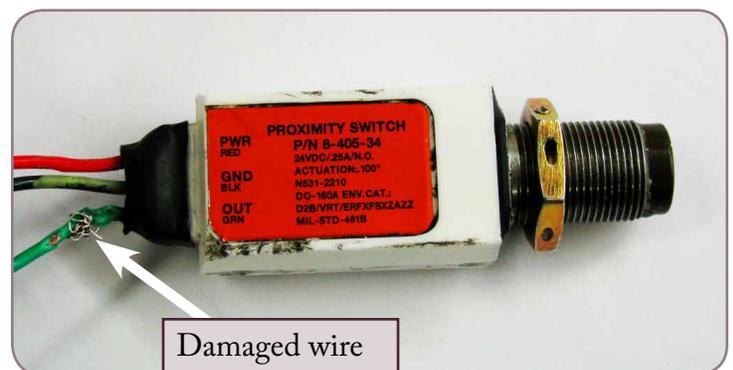
Troubleshooting found the main cabin door (MCD) handle proximity sensor (PS1MB) had a frayed and damaged wire from interference with the MCD handle linkage.

*The normal installation and wiring support requires the wires to be bent back 180 degrees against the sensor body and ty-wrapped in place to provide clearance from the inner door linkage mechanisms. It appears that the wires under the ty-wrap migrated back resulting in contact with the handle linkage, causing the damage to the wire.*

Damaged wire

The proximity sensor was replaced and the aeroplane was made serviceable.

*Transport Canada Civil Aviation (TCCA) is advising all maintenance personnel to adhere to all standard wiring practices and maintenance manual instructions. ✖*

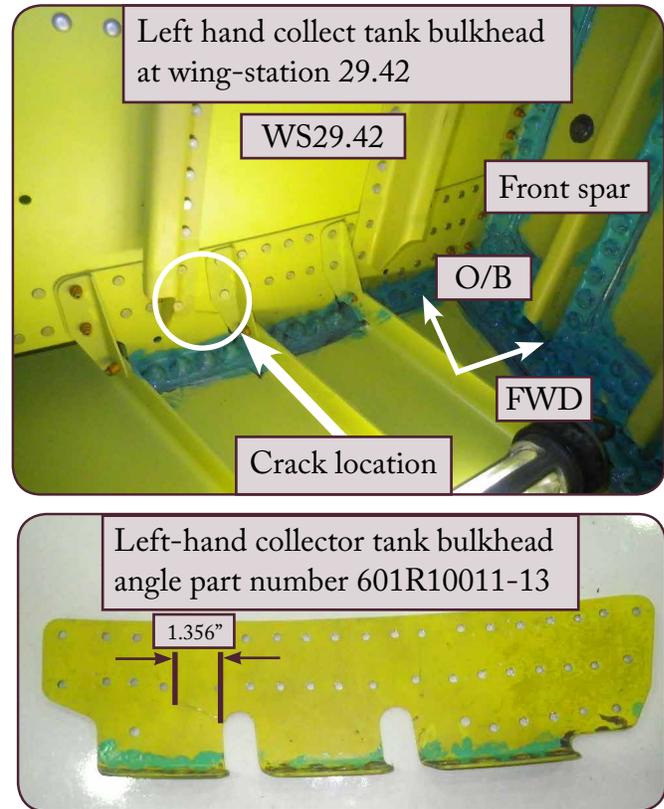
The maintenance technician was performing a internal zonal inspection of the centre wing section as per task card #RJ2-57-900-320 when he found cracks emanating from one of the two relief stringer cutouts for the web of the support angle at both sides of wing station 29.42.

New parts were fabricated and heat treated as per Structural Repair Manual (SRM) 51 10 06 section 3D and corrosion protection reapplied as per SRM 51 25 00 and 51 25 16.

*Transport Canada Civil Aviation (TCCA) is advising all CRJ 100/200 operators to pay close attention to this area in reference to the above mentioned task card for probable crack propagation. ✖*

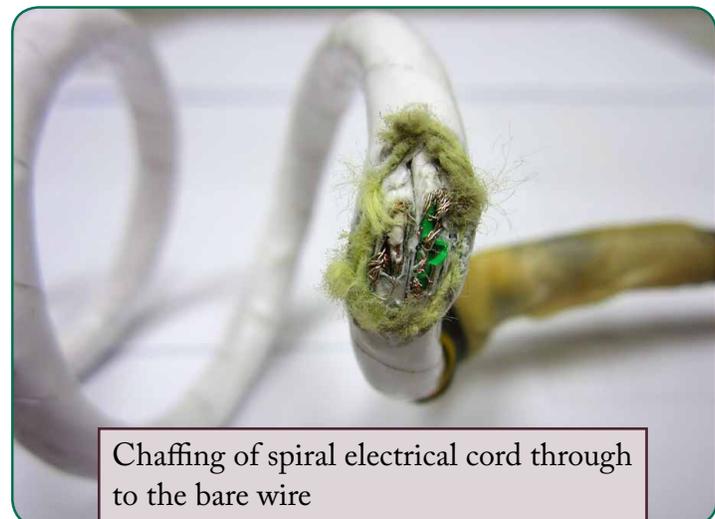
The outer harness insulation was worn through and were repaired or replaced as required making the aeroplane serviceable.

*Wire harness chafing such as described in this service difficulty can cause intermittent system failures that can be difficult to trouble-shoot and correct. ✖*

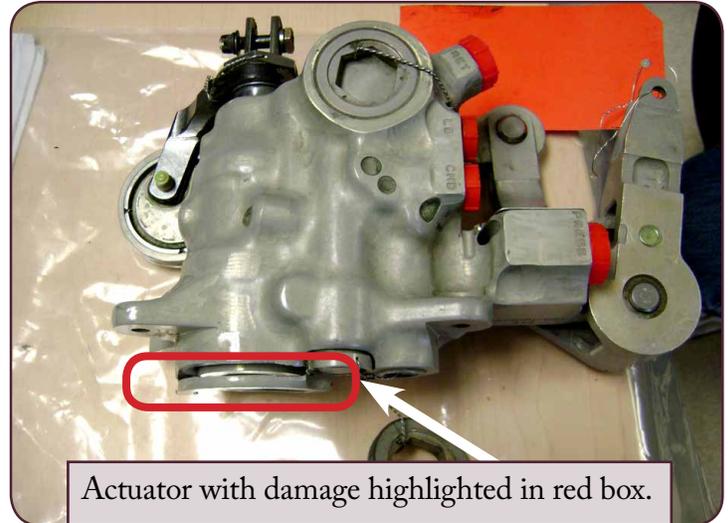
The pilot noticed during taxi for take-off that the right hand outboard spoiler was not deployed. Upon inspection, hydraulic fluid was found to be leaking from the right hand out board wing. Further investigation revealed a loss of hydraulic fluid at a rate of 1 qt per 10 min of engine operation. Maintenance found the spoiler actuator broken and resulting damage to the mounting bracket at the rear spar. (Actuator damage – threaded portion of end cap cracked 270 degree of circumference)

*This could be a possible area of concern as the fleet ages. ✖*

Actuator with damage highlighted in red box.

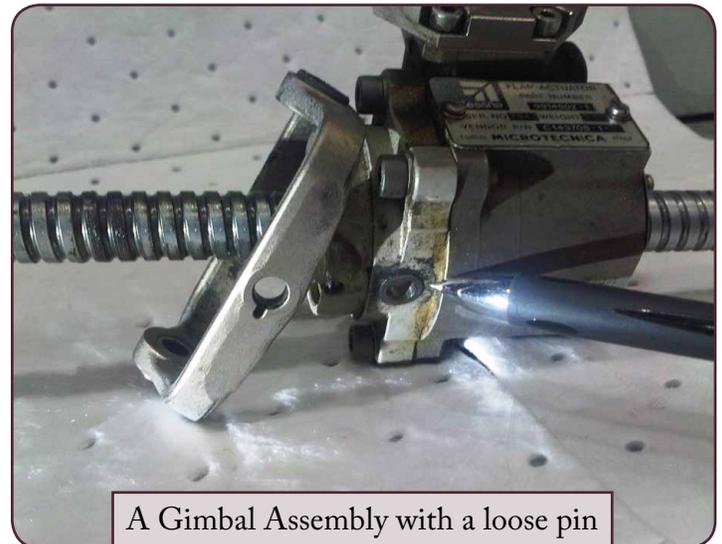
During a walk-around inspection, it was noted that the left-hand inboard flap segment had an excessive amount of fore and aft movement. Further investigation revealed that the flap actuator gimbal assembly that provides the flap actuator to airframe mounting interface was loose at the flap actuator body.

Upon removal, it was evident the two gimbal retaining pins that hold the gimbal assembly to the actuator body were not properly in place. The lower retaining pin was missing entirely and the upper pin had migrated enough that it was no longer engaged into the flap actuator body. These retaining pins are supposed to be held in place by snap rings; however both snap rings were missing. This led to a condition whereby the flap actuator was no longer secured to the trailing edge of the wing, and was only held in position by the Teleflex cable that operates the flap actuator.

A Gimbal Assembly with a loose pin

This created a potential for the inboard flap segment to jam or to come entirely free from the aeroplane.

*It is recommended that operators pay particular attention to this area. Flap assemblies are subjected to significant airloads during flight conditions. ✖*

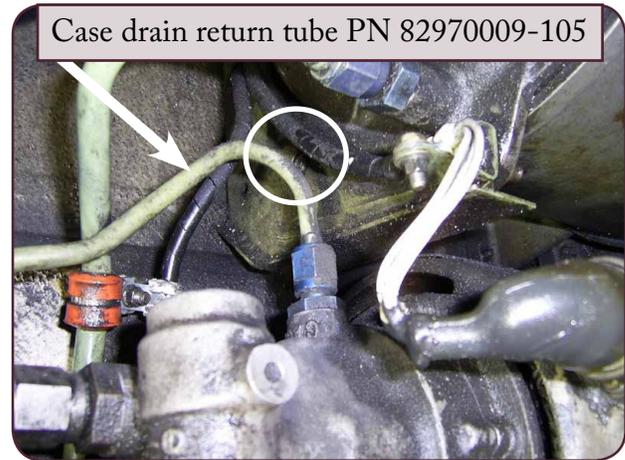
During descent, the flight crew observed a rapid pressure drop of the #1 hydraulic system which directly affected wing flaps, inboard roll spoilers, normal brakes and anti-skid functionality. An emergency was declared and the aeroplane landed without further incident.

*This is a good reminder to all maintenance personnel to inspect for signs of chafing and fouling conditions at every opportunity when in these confined areas.*

*In this case, an emergency landing was the result of a fouling condition. ✖*

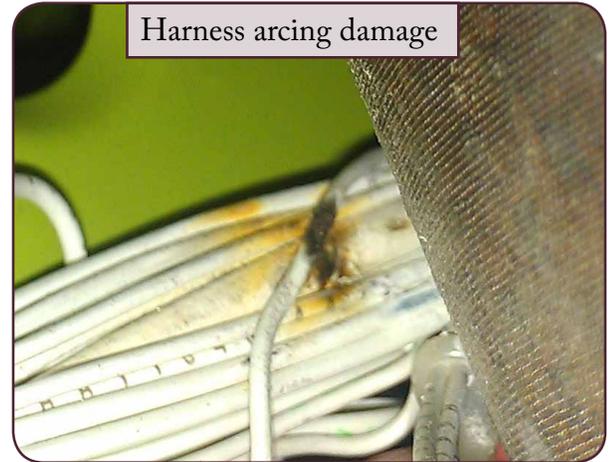
During the pilot walk around, the baggage light circuit breaker (C/B) was noted as “popped” or out. After a reset the C/B immediately popped. Maintenance removed the baggage panels in order to inspect a suspected wiring harness run and with the ceiling panels down, the maintenance technician noted a flash when the light switch was turned on.

Further inspection found two wires chafed through the insulation by the auxiliary power unit (APU) intake duct.

The wires were repaired and the clamp holding the bundle was adjusted for better clearance and the aeroplane was released for service.

*Proper harness support and protection to prevent occurrences as stated is essential for the safe continued operation of all aeroplanes. ✖*

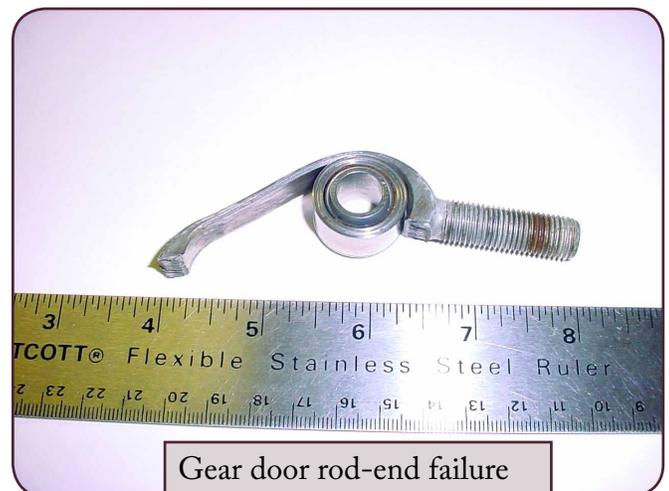
During gear retraction and extension, the pilot heard a loud bang. The aeroplane landed without incident and maintenance found the right-hand forward gear door rod-end broken.

The rod-end assembly was replaced and the aeroplane was made serviceable.

*Transport Canada Civil Aviation (TCCA) is advising all Mitsubishi MU-2B60 owners, operators and maintainers to pay close attention to the main landing gear door rod-ends for possible signs of cracks. ✖*

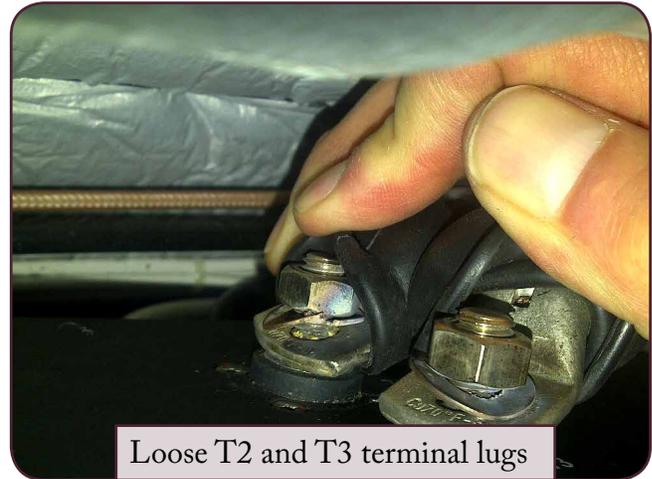
A defect was recorded where the battery assist function was inoperative (secondary start) which was rectified by the replacement of the left-hand power junction box (LHPJB). A few days later a defect was recorded: “generator 1 bus crew advisory status CAS message, unable to clear”. While conducting troubleshooting with the external power on, the battery 1 voltage drained down below 20 volts. During further troubleshooting it was confirmed that the battery 1 generally would not charge with external power connected and would continue to discharge, with the exception of a few instances when battery 1 would receive a partial charge (approximately 27 volts from a 28.5 external power unit). During engine runs, it was also confirmed that the secondary start sequence was not functioning. Additionally there was no load sharing when generator 1 or generator 2 was turned off line where it was suspected that the bus tie was not closing.

Extensive trouble shooting was carried out with no faults found. The left-hand power junction box was again replaced with nil fix. While removing the right-hand power junction box for replacement, the two rear connections at Terminal 2 and Terminal 3 were found to be significantly loose and arcing on the lugs.

*It is suspected that due to the finding where both terminal attachments were loose, previous maintenance work in this area was performed where the error was induced. ✖*

The lugs were tightened and the system was tested serviceable. The right-hand junction box was replaced due to terminal lug damage.

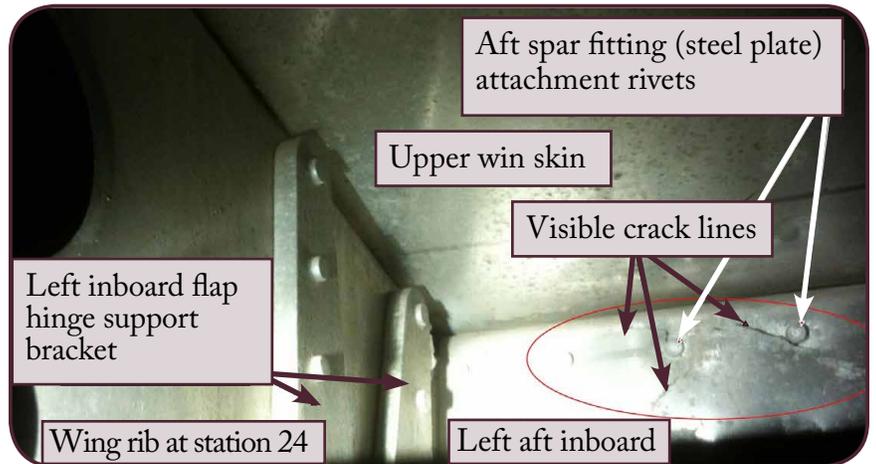
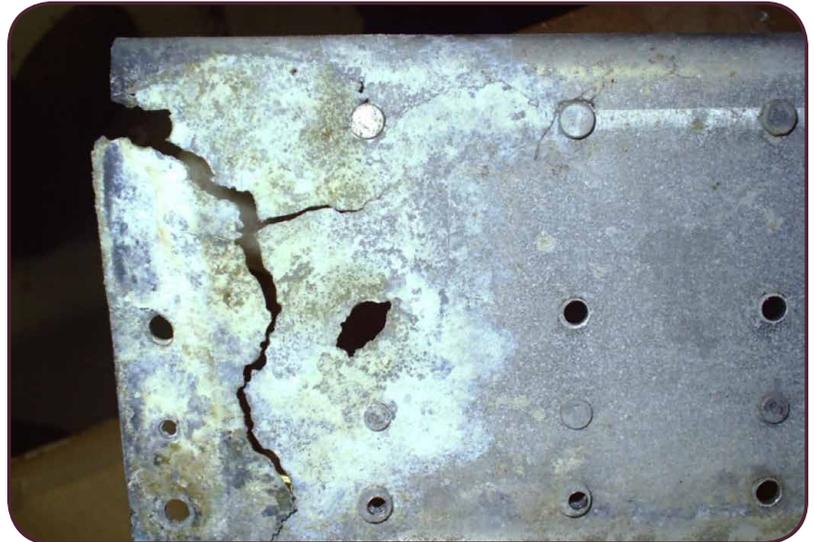
A visual inspection of the wing rear spar attachment fitting (using light and mirror) (Wing Rib Station 24) revealed evidence of corrosion. This area is very difficult to inspect (no inspection panel), thus a video camera was needed to facilitate a more detailed inspection.

Subsequently, a detailed inspection using the camera revealed cracks on the steel aft spar plate attachment fitting, part number (P/N) 66762-000, located on the aft wing spar. Severe, dissimilar metal related corrosion was also found between the rear wing spar and the spar plate attachment fitting.

An earlier Service Difficulty Report reported similar corrosion in this same area. It appears that the aluminum spar and steel attachment fitting were assembled during manufacturing process without corrosion preventive protection. Initially, some metal flaking was visible, but upon disassembly; it was found that over 50% of the aft left-hand spar fitting was degraded by corrosion.

*Transport Canada Civil Aviation (TCCA) highly recommended that owner/operators comply with Piper Service Bulletin (SB) 977 (applicable to PA-28/PA-32, PA-34 & PA-44 series) and carry out a one-time inspection and other recommended corrective action. The installation of these access panels to the rear floorboards will then allow maintenance personnel to conduct a thorough corrosion related inspection of this important area. Additionally, TCCA recommend that operators also comply with the inspection procedures outlined in Piper SB 789A.*

*In the interim, it is recommended that maintenance personnel use a video camera or a small borescope to access this area to carry out these inspections. ✖*

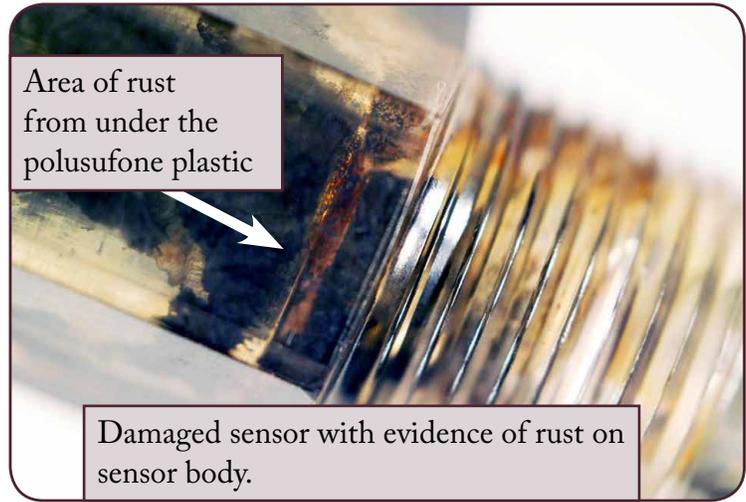
Investigation found that a water level sensor was the cause of the smoke. The unit was sent for testing with the following results:

*The lab report suggests that a crack was likely caused by an over torque situation probably during installation of the unit. Water from the tank was able to penetrate the sensor body and cause the failure of the device.*

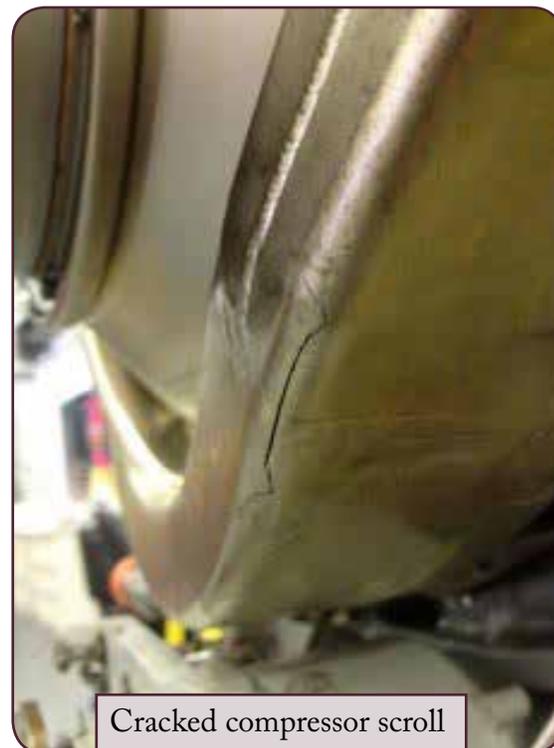
An approximately 10 cm (4 inch) vertical crack was found on the left forward side of the engine compressor scroll during a scheduled daily inspection. The engine was completely replaced. The compressor was sent for overhaul. The scroll was a thin-wall type and will be exchanged for a thick wall version.

*Cracks are common with the thin wall compressor scroll. The cracks in this area are easy to detect and if large enough will cause an increased turbine temperature and likely a degradation of performance. Operators are reminded to be aware of this potential. ✖*

Cracked compressor scroll

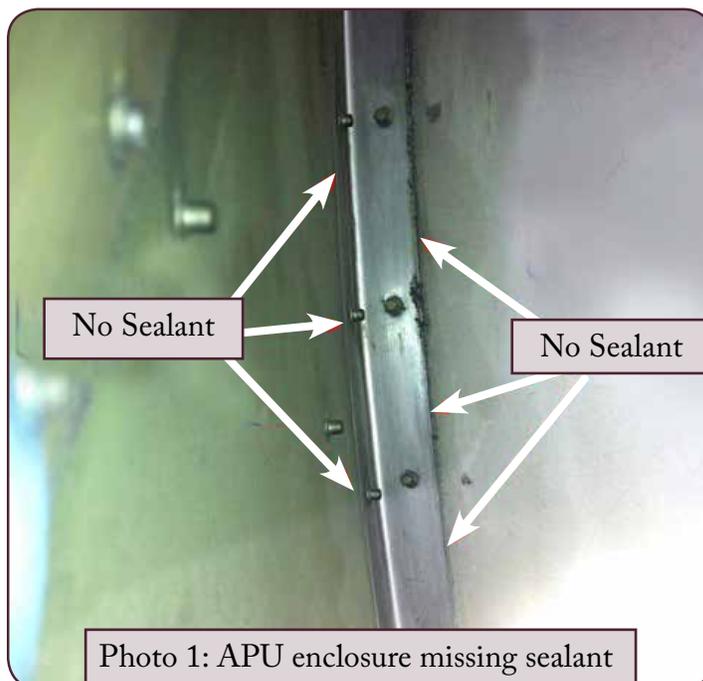
Photo 1: APU enclosure missing sealant

An inspection indicated that sealant inside the APU compartment was missing at the seams and at the APU mount to firewall interface. This resulted in lower pressure within the APU enclosure and may have resulted in reduced APU eductor efficiency. This caused the APU exhaust gases to be sucked into the APU enclosure tripping the fire loops.

Sealant was applied to the missing areas and the aeroplane flown with the APU running. Checked serviceable.

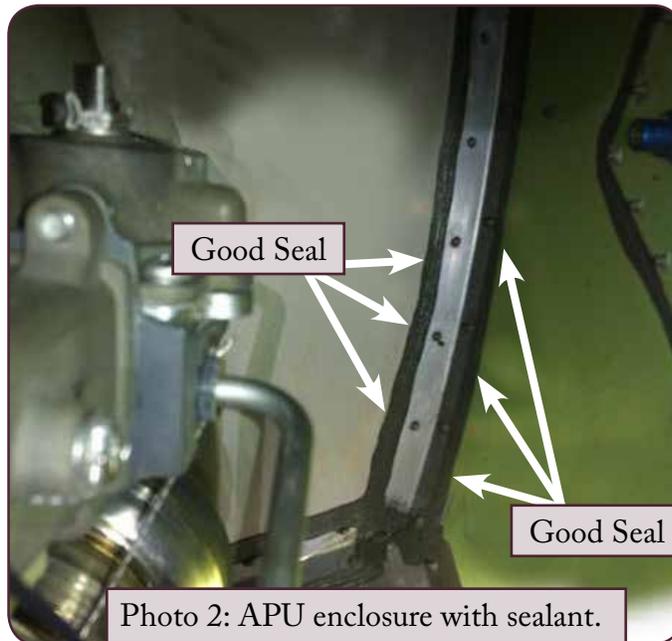
Photo 2: APU enclosure with sealant.

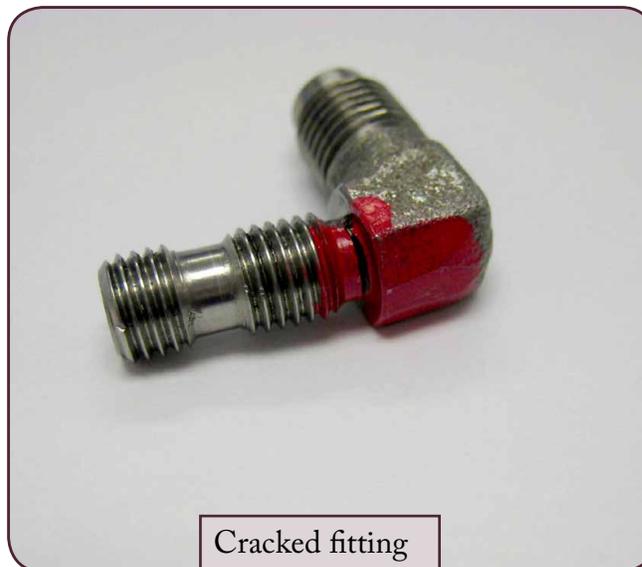
During the daily inspection, it was noted that oil was leaking out of the left engine cowling. Upon investigation, a fitting on the left engine propeller governor was found cracked. The fitting was replaced and the aeroplane was returned to service.

*Oil leaks can sometimes be an indicator of major problems. What may appear to be a minor leak can actually be an indicator of an impending failure which can lead to an in flight shutdown. ✖*

Cracked fitting

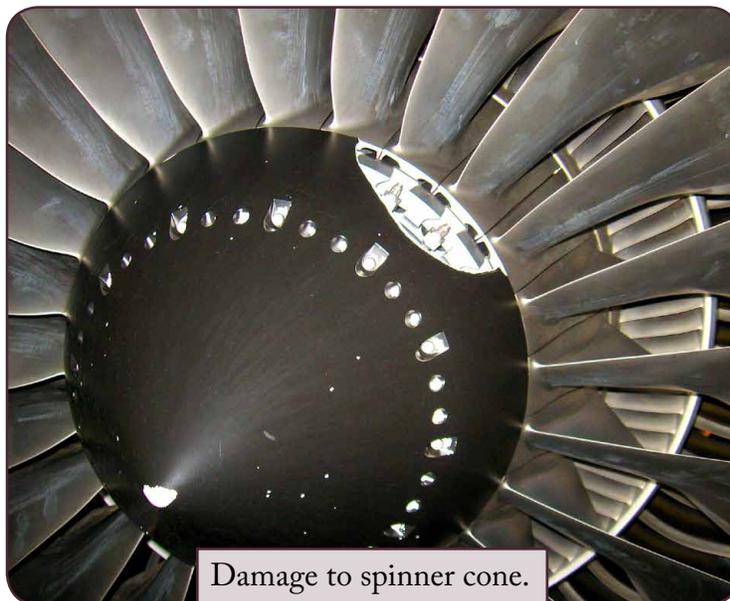
While at flight level 320, the crew reported high engine vibrations on the number 2 engine. They reduced power on the engine to idle to reduce/stop the engine vibrations. They declared a pan pan emergency and returned to departure airport where they landed overweight by approx 3000-4000k. After landing, the crew inspected the engine and found damage to several fan blades due to a missing segment of the engine nose cone.

*This issue may have been caused by pre-existing cracks prior to re-work in accordance with service bulletins 72-0159 and 72-0186. Maintainers are urged to become familiar with the contents of these bulletins. ✖*

Damage to spinner cone.

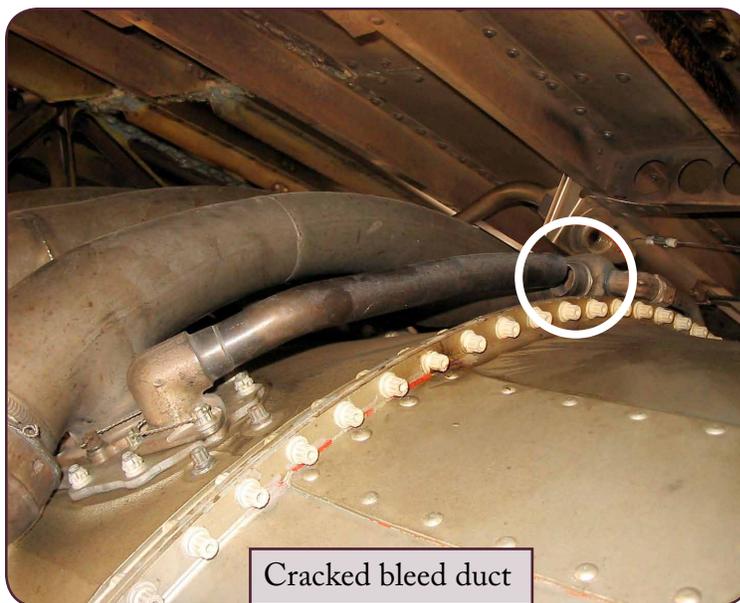
After takeoff, climbing through 6000 feet #2 engine fire warning activated. Crew followed the check list and returned with #2 engine shut down. Inspection of the engine found no evidence of fire however a ruptured bleed air duct was discovered. The duct was repaired and the aeroplane returned to service.

*As aeroplanes age, special attention must be given (during inspections) to components that are subjected to high heat and vibration loads. ✖*

Cracked bleed duct
