Issue 1/2014

Canadian Aviation Service Difficulty Reports

TP 6980E
(1/2014)

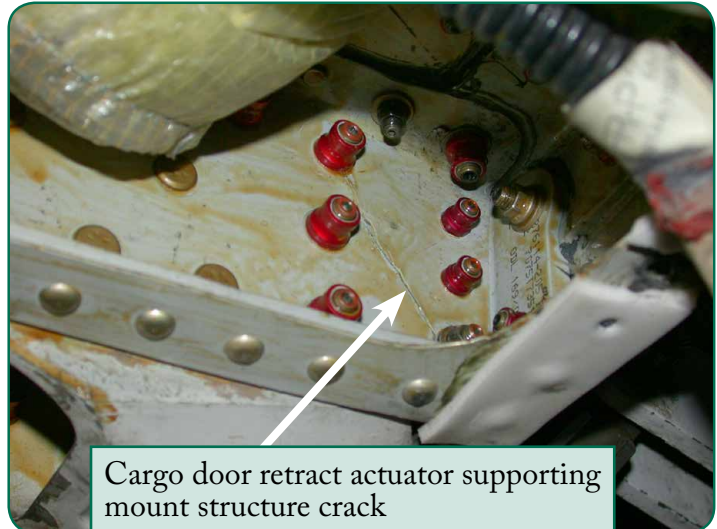
When the cargo door interior panel was opened, a crack was found emanating from the retract actuator frame mount attachment point.

Through discussions with Aerospatiale Continuing Airworthiness engineering, it was determined that this condition does not impose a detrimental effect to flight safety and the repair is covered by the Structural Repair Manual (SRM) 52-31-00.

Cargo door retract actuator supporting mount structure crack

The frame was repaired and the aeroplane was made serviceable.

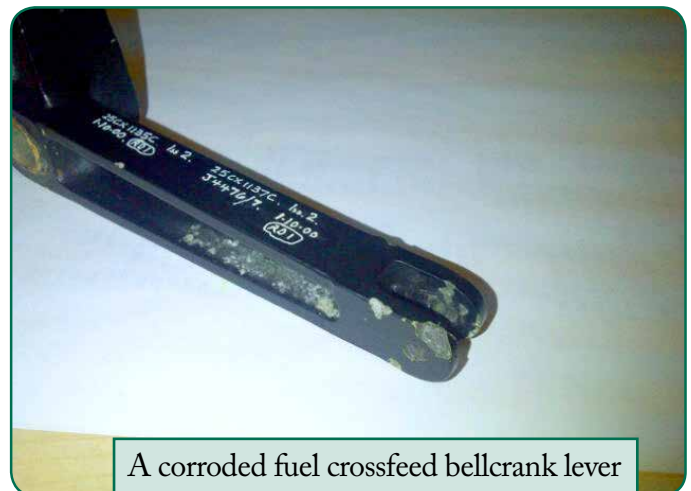
During a routine heavy maintenance 48 month inspection for corrosion, maintenance found the fuel crossfeed bellcrank lever severely pitted and corroded beyond acceptable repair limits.

A corroded fuel crossfeed bellcrank lever

The bellcrank lever was replaced with a new part in accordance with the Aircraft Maintenance Manual (AMM) 28-20-00.

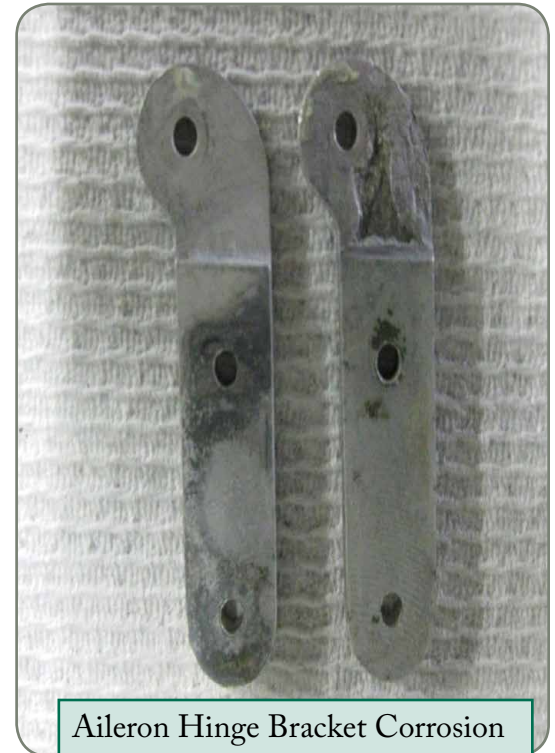
During removal of the right hand aileron for painting, the Aircraft Maintenance Engineer discovered severe corrosion on the inside hinge that reduced the bracket thickness to about 60%-70% of the original manufactured thickness. Corrosion was also found on the left-hand aileron hinge bracket.

Consequently, all 4 hinge brackets were replaced on the right-hand and left-hand ailerons.

TCCA recommend that owners/operators comply with the FAA corrosion related recommendations contained within these SAIB(s):

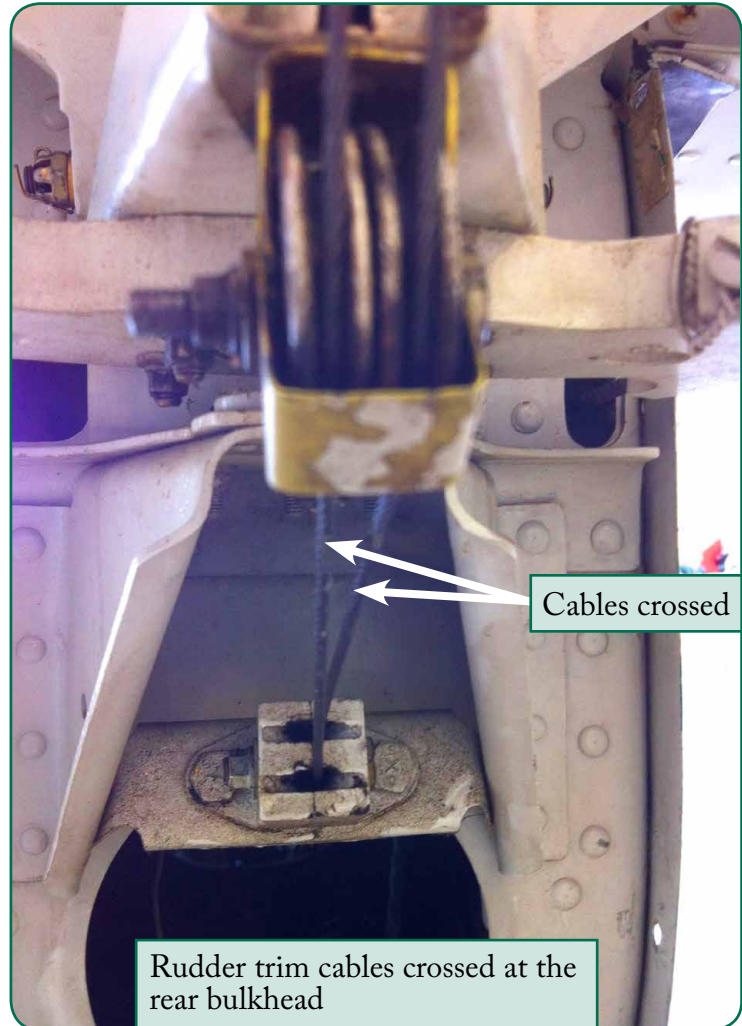
During cruise flight, the pilot attempted to centre the ball in the “Turn and Bank Indicator” by applying rudder trim, however the effect was opposite to normal (turned trim wheel left but the right rudder trim was noted to move). Soon afterwards, the pilot landed and maintenance personnel later confirmed that the rudder trim system was operating in reverse.

During these last 6 years, both flight crews and maintenance personnel had missed this potentially dangerous flight control error. Proper rudder control input would be critical during an engine failure in order to assist flying with asymmetrical thrust, especially in the fire suppression role/low altitude role that this particular aircraft is engaged in.

These types of flight control errors would not have occurred if personnel following the maintenance instructions subsequently conducted dual independent inspections.

Alarming, these types of occurrences continue to occur on both the rudder and elevator trim systems and have resulted in fatal occurrences. It is strongly recommended that dual inspections be carried out as well as conducting visual checks on the actual flight tab position to ensure it corresponds correctly with the cockpit indicated positions. ✖

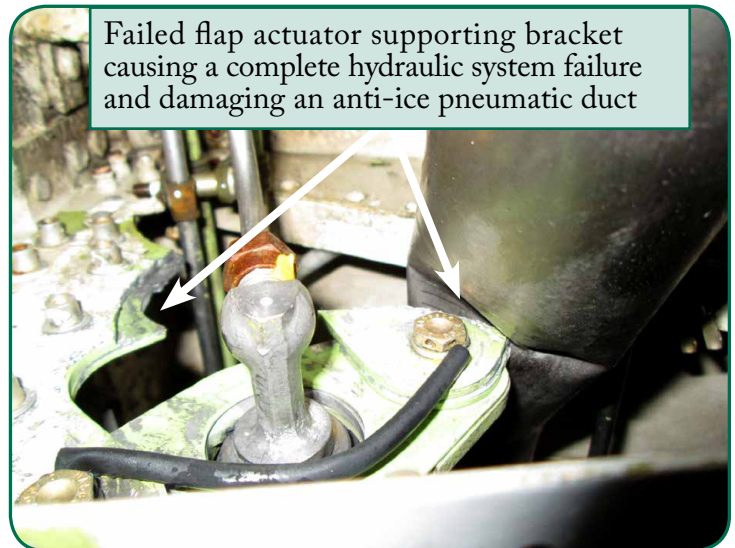
Upon selecting flaps down on approach, the crew noticed a hydraulic system low pressure light and corresponding loss of quantity. The crew declared an emergency and landed without incident. Maintenance discovered the #2 slat actuator had broken from its upper mount and moved aft, shearing a hydraulic line which caused the loss of the hydraulic system and damaging an anti-ice pneumatic duct.

Upon review of the Web Service Difficulty Reporting System (WSDRS) database, additional occurrences were noted where Boeing Service Bulletin (SB) 727-57-0130 has been released to strengthen the slat actuator mount bracket. ✖

The flap actuator supporting mount was repaired, the hydraulic line and pneumatic duct replaced and the hydraulic system re-serviced, making the aeroplane serviceable.

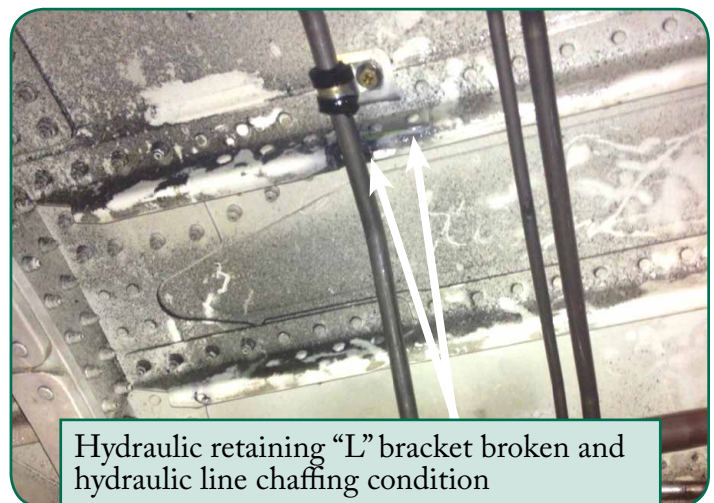
Maintenance investigation found a chaffed hydraulic line in the aft equipment bay that caused the loss of the hydraulic fluid. The line had chaffed against stringer #7 due to a broken retaining "L" bracket.

The hydraulic line and "L" bracket were replaced and the damage to the stringer was repaired making the aeroplane serviceable.

When performing service checks and walkarounds, it's important to inspect for the serviceable condition of hydraulic line retaining brackets and clamps. ✖

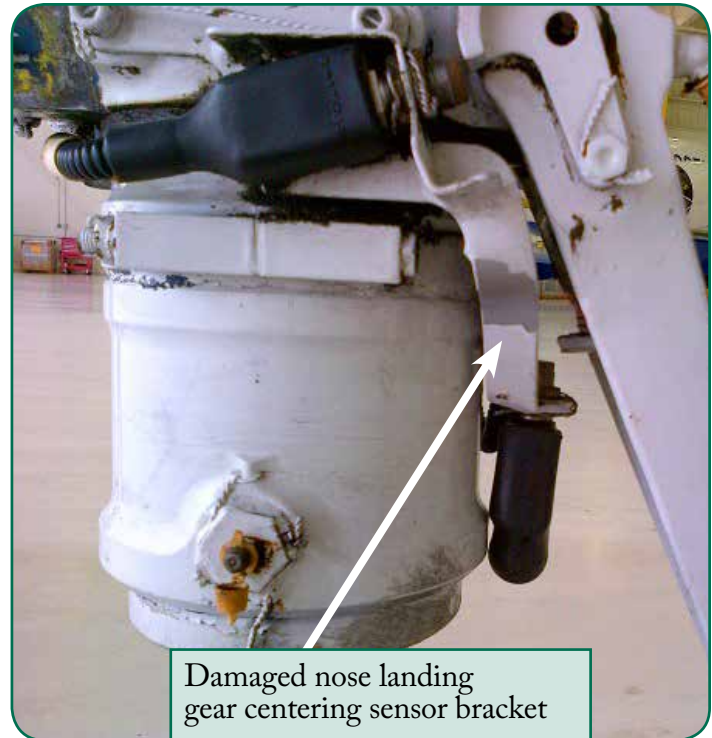
As stated by the operator, Bombardier Advisory Wire 600T-2171 has been issued identifying the possible scenario where damage to the NLG when using a towbarless tug can occur.

Damaged nose landing gear centering sensor bracket

The NLG centering sensor bracket was replaced and the aeroplane was returned to service.

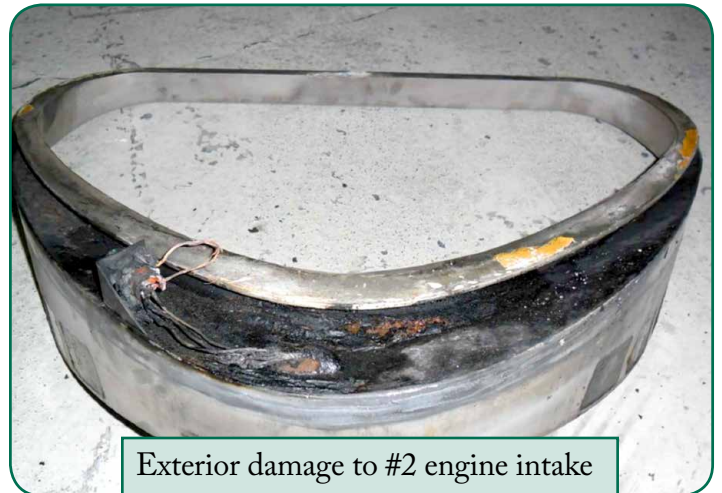
An investigation by line maintenance personnel revealed that the engine intake adaptor heater was severely damaged from a significant overheat event during operation. Soot evidence in the engine area indicates possible flames were generated; however the crew received no cockpit fire indication advisories. Evidence of soot damage was also found in the area of the electrical connector area for the heater.

Investigation by the manufacturer (Zodiac Aerospace) of the engine inlet adaptor heater revealed that during manufacturing process, the heating element is difficult to place with the casting and as a result it can cause overheating during the manufacturing process or in the field. In the interim, it is recommended that maintainers routinely inspect for any visible damage to the engine inlet area and associated electrical connectors. ✖

The failed intake adaptor heater was quarantined and has been sent to the manufacturer for further analysis.

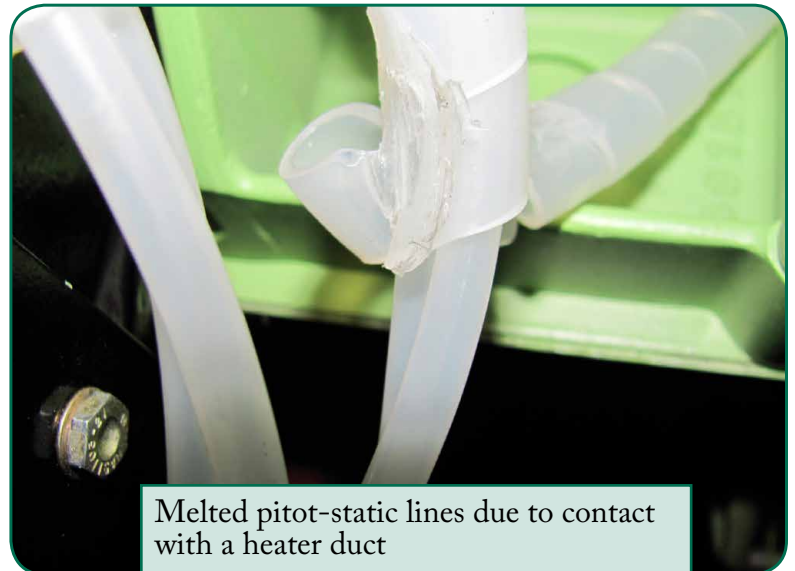
The flight crew reported to maintenance that the captain's airspeed indicator was reading up to 40 knots lower than the co-pilot's airspeed in flight. Maintenance performed a pitot static leak check and visual inspection of the aeroplane revealing that both the captain's pitot and static plastic lines were melted from contacting a cockpit under-floor heater duct.

The pitot and static plastic lines were routed adjacent to a heater duct, causing the contact and eventual melting of the pitot-static lines.

Melted pitot-static lines due to contact with a heater duct

The affected pitot-static lines were replaced and precaution was taken to relocate the replacement lines at a suitable distance away from the heater ducts, making the aeroplane serviceable.

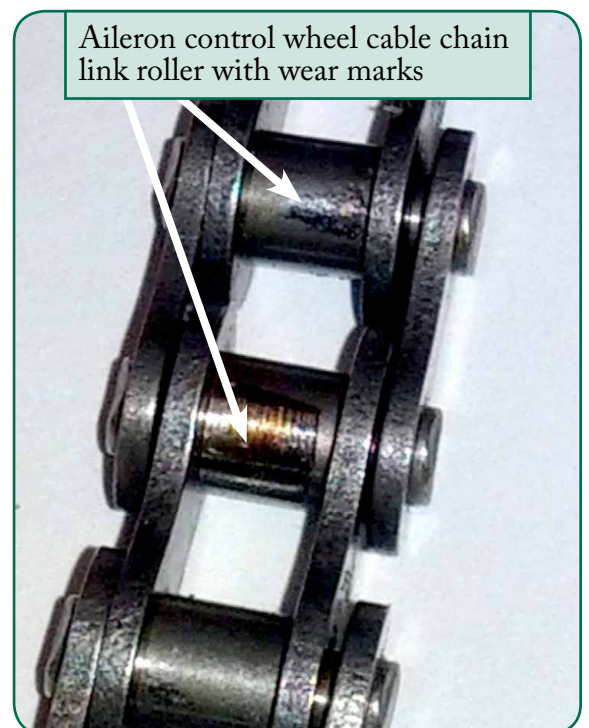
Further investigation found that the chain was binding at the control wheel sprocket area within the control column. The chain looked dry (no lube), its link rollers worn and showed evidence of wear at the link joints. There was also evidence of the chain contacting the insides of the control columns housing (slight loss of metal and primer).

understood that the aileron control wheel jam was caused by a combination of a lack of lubrication and excessive wear on the chain link rollers. With the excessive wear of the chain and a control wheel roll input applied, the chain would have a tendency to ride up the control wheel sprocket teeth and bind through contact with the inside wall of the control column housing.

The chain was replaced and lubed, making the aeroplane serviceable.

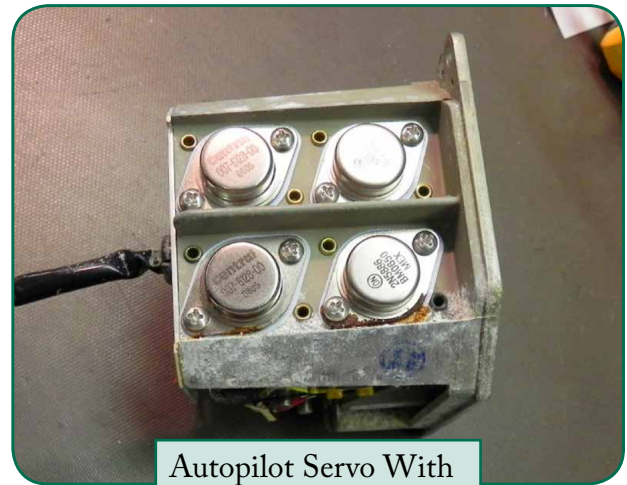
The subject aeroplane was brought to an avionics repair shop with an autopilot snag. It was determined that the pitch servo had sustained water damage that resulted in corrosion and an intermittent short on the clutch engage wire. This in turn caused the failure of a transistor. To rectify the problem, the autopilot computer was repaired and the pitch servo was replaced. The aeroplane is equipped with amphibious floats and has drainage holes in the bottom fuselage.

Corrosion in float aeroplanes is an ongoing concern. Avionics components are also subject to corrosion internally and must be considered when conducting inspections. ✖

Autopilot Servo With Corroded Transistor

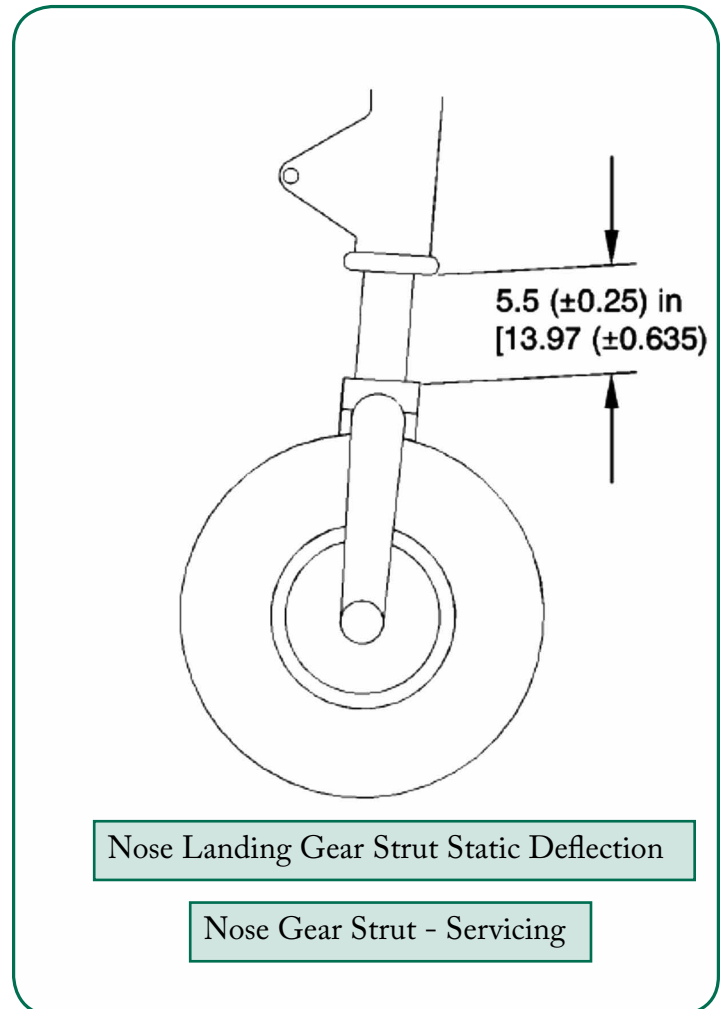
Maintenance inspection found the nose landing gear (NLG) oleo was flat which prevented the internal NLG strut centering cam mechanism from aligning the NLG wheel prior to touch-down.

The NLG showed no indication of hydraulic fluid leakage where it was confirmed that the nitrogen gas charge was underserviced, causing the NLG wheel misalignment.

The attached figure represents the required oleo extension when referencing the "Alternate method" AMM servicing procedure.

Recently, Learjet issued Service Bulletin SB 60-11-4 which provides the installation of a service instructions name plate on the NLG strut that defines the AMM "Preferred Method" servicing procedures. ✖

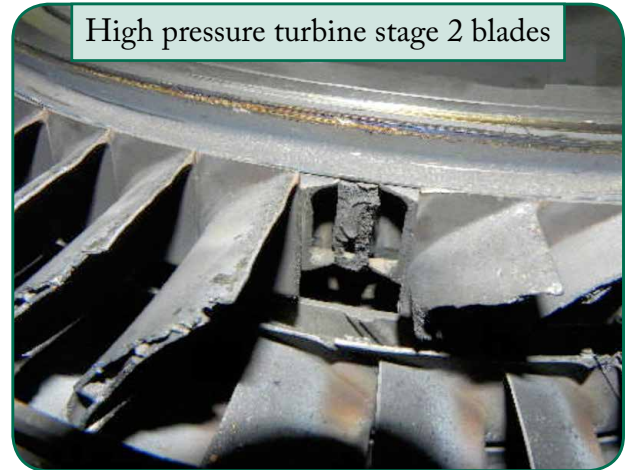
While climbing through 8000 feet, flight crew heard a loud noise followed by a yaw to the right. Right engine parameters indicated the engine was spooling down. Flight crew secured the engine, declared an emergency, turned back and landed without further incident. Initial inspection of the engine by local maintenance revealed no damage to the fan blades however there was significant damage to the turbines.

Engine teardown revealed the failure was caused by high pressure turbine blade release. This is a known problem for CF34 engines and is caused by corrosion under the blade platform. Service Bulletins 72-0228 and 72-0242 introduce re-designed blades that address this issue. ✖

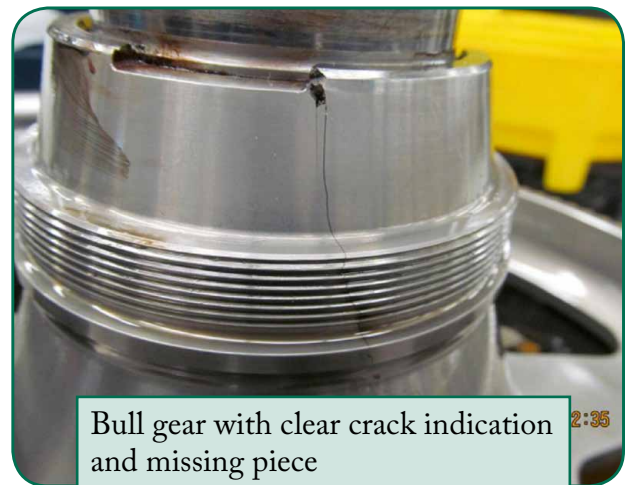
At disassembly of the reduction gear box module (for a light overhaul due to metal in oil), three cracks were noted in the 2nd stage spur gear shaft wall. The cracks were originating from the n° 15 bearing mating face and propagating forward. The cracks were adjacent to each other approximately 1.52 mm (0.060") apart. There was material breakout at the tooling slot corner. The separated piece of material was picked by the magnetic chip detector in-field. The missing piece is approximately 1.52 mm (0.060") wide, 2.54 mm (0.100") long and 1.27 mm (0.050") deep.

Metal found in oil systems and chip detector indication is an indicator of engine wear or distress. This can be a precursor to catastrophic failure. These conditions must be investigated further to determine the source. Manufacturer's instructions regarding metal in oil found in maintenance manuals, Service Bulletins (SB's) and Service Information Letters (SIL's) should always be followed. ✖

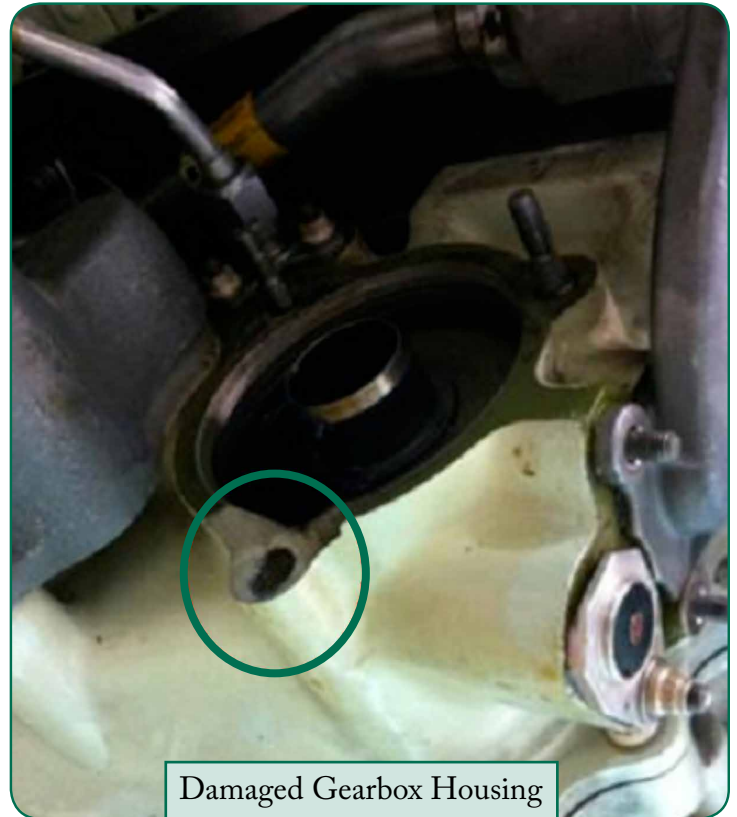
During a visual inspection of the engine gearbox, it was noted that the oil filter housing assembly lower mounting stud ear was cracked. The corrective action taken was to replace the aft gearbox housing case.

Transport Canada Civil Aviation would like to raise awareness of this defect to operators of TFE731 engines. Due to the location of the stud (six o'clock position) and the length of the housing, the possibility of accidental damage is high. The cause in this case is not known; however it could have been the result of corrosion (or casting inclusion), a past over torque or perhaps an accidental overload or impact damage during installation or shipping. Whatever the case, maintainers are urged to be cautious when working on complex systems and always follow manufacturers instruction. ✖

Damaged Gearbox Housing

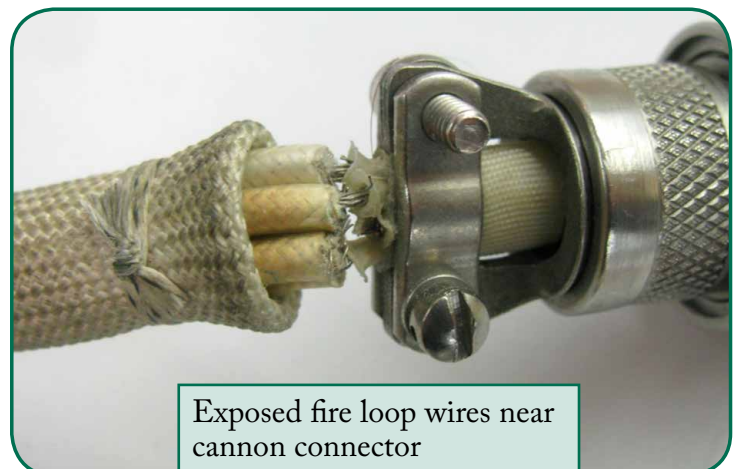
During routine maintenance, the left hand jet pipe loop "A" was found unserviceable. Troubleshooting found that the engine fire detection wiring harness was broken at the pylon connector. The fire detection and fire protection wiring harnesses were replaced. This defect, if unnoticed, might have resulted in an in-flight engine shutdown due to a false engine fire or jet pipe overheat warning.

Exposed fire loop wires near cannon connector

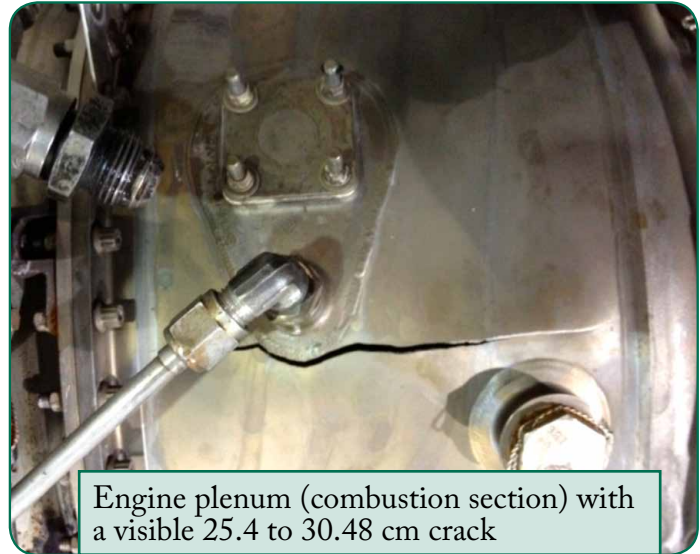
A detailed visual inspection confirmed a large 25.4 to 30.48 cm (10 to 12 inch) long crack in the combustion liner. The engine was removed and replaced.

The plenums on these engines are operated 'on condition'. The type certificate holder (Honeywell) has issued Service Bulletin 72-2178 (Combustion Section –inspect combustion case assembly) that recommends it be accomplished at each scheduled fuel nozzle inspection and/or replacement. Transport Canada Civil Aviation recommends that operators familiarize themselves and comply with this service bulletin. ✖

Engine plenum (combustion section) with a visible 25.4 to 30.48 cm crack

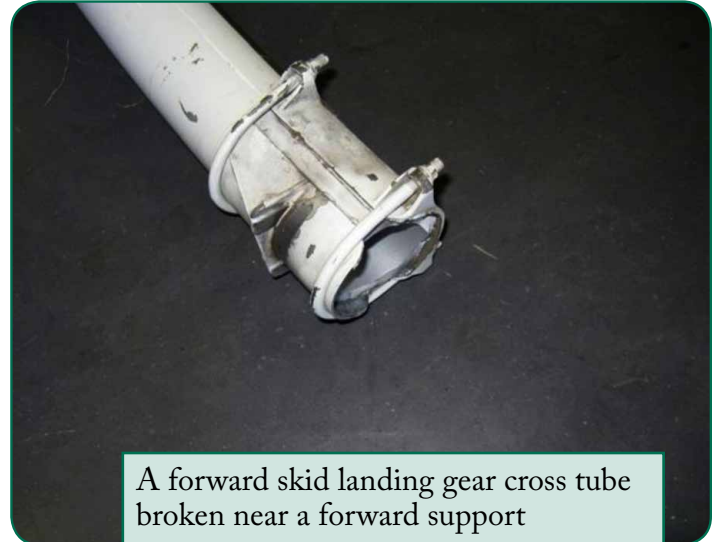
The pilot landed at a forest service lookout tower and heard a bang. He thought he had hit a rock. On landing at a local airstrip, the helicopter sat in an unusual attitude. The forward skid landing gear cross tube was found broken near a forward support.

This cross tube is the subject of recurring Bell Helicopter Alert Service Bulletin (ASB) 212-09-132. The ASB requires a detailed inspection every 7 days. The Federal Aviation Administration (FAA) and the manufacturer have been informed and an investigation is ongoing to determine if the ASB inspection interval requirements are sufficient. ✖

A forward skid landing gear cross tube broken near a forward support

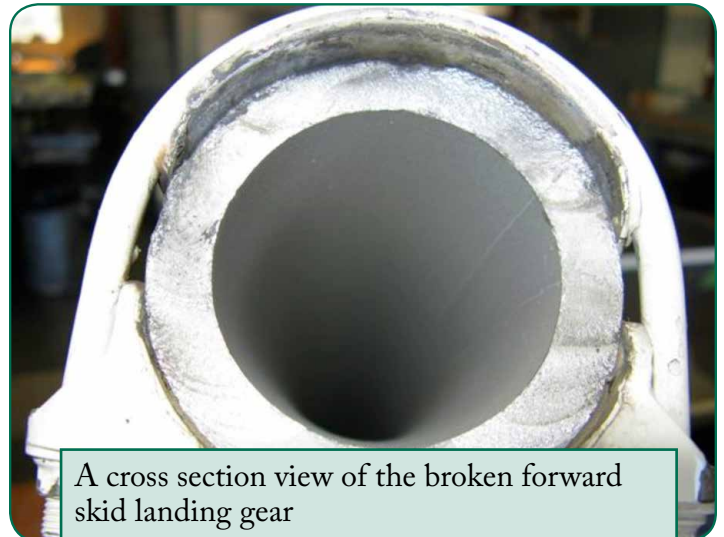
A cross section view of the broken forward skid landing gear

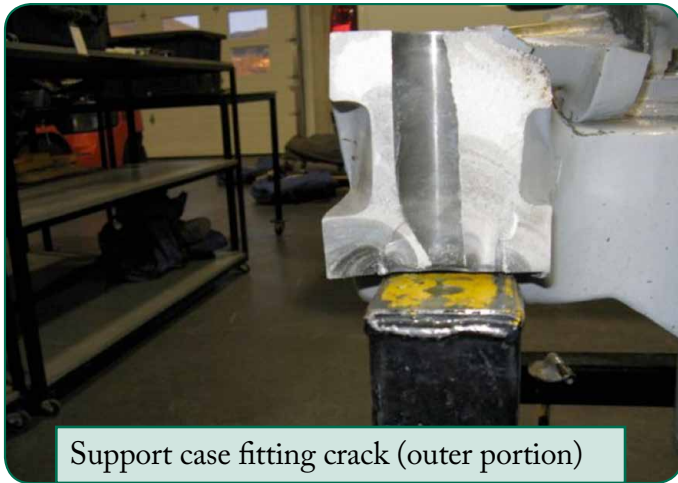
During a routine daily aircraft inspection, an Aircraft Maintenance Engineer (AME) was inspecting the main transmission and noticed the support case was cracked on the left hand side by the airframe attachment bolt. The transmission was removed and it was found that the support case leg was broken with the crack originating from one of the small bushing attachment screws.

Support case fitting crack (outer portion)

The Original Equipment Manufacturer (OEM) is currently investigating this issue. In the interim, Transport Canada Civil Aviation recommends maintenance personnel to remain vigilant while inspecting this area of the transmission. ✖

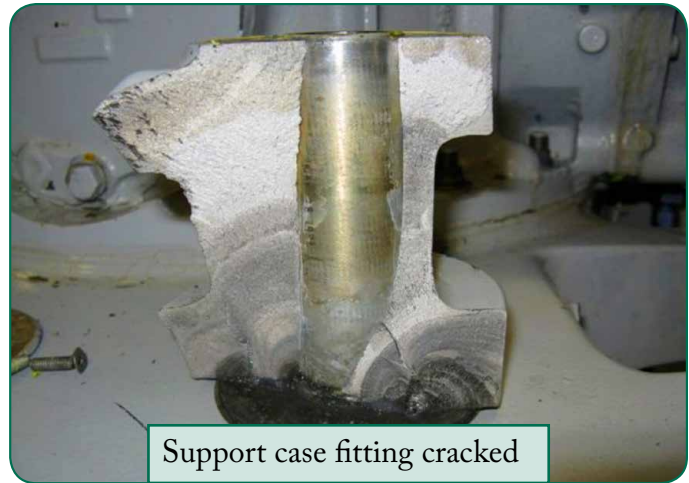
Support case fitting cracked

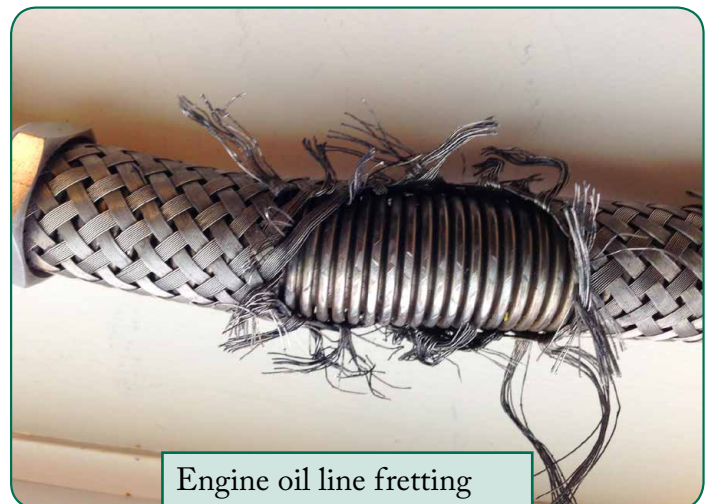
The engine was removed from the aircraft due to a service inspection required for Bell helicopter Alert Service Bulletin (ASB) 407-13-99RA. During that time it was found that oil line part number (P/N) 70-037A0910-000 was seeping black oxide out of its internal portion. After further inspection, the steel braids were found cut.

Engine oil line fretting

Transport Canada Civil Aviation reminds maintainers of the importance of keeping adequate clearance on all hydraulic, fuel and electrical lines to prevent fretting. This defect was discovered before a potential catastrophic occurrence could have occurred. ✖

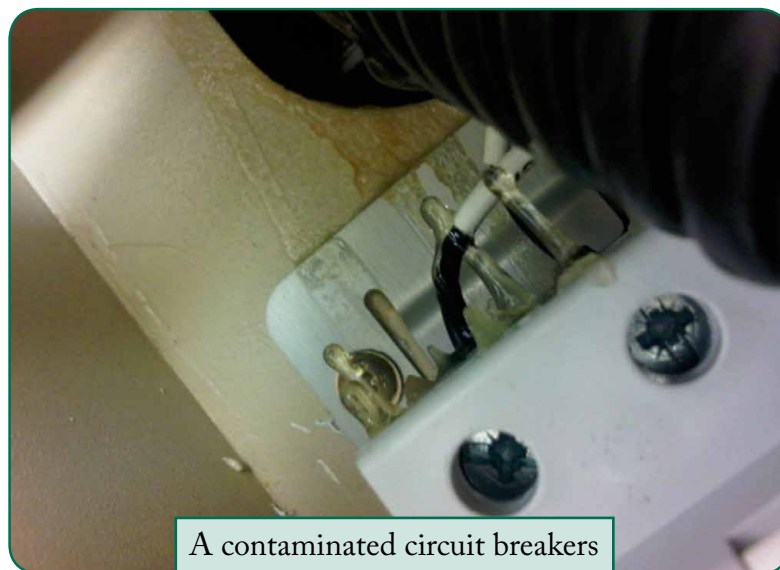
It was found that the soap dispenser had been leaking on to the circuit breaker of the forward lavatory power outlets. The circuit breaker has open terminals on the top allowing the liquid soap to make contact and create a short. Troubleshooting showed that the soap dispenser bottle had not been properly tightened and that the circuit breaker had no protection against leaks. The circuit breaker is located directly below the bottle.

The circuit breaker required replacement due to contamination and possible internal damage/short and the soap dispenser bottle was properly installed.
