SHIP SAFETY BULLETIN

Bulletin No.: 12/2007
RDIMS No.: 3655911
Date: 2007-12-04
Y - M - D

Subject: **Adequacy of Single Cross-bar Type Hatch Covers**

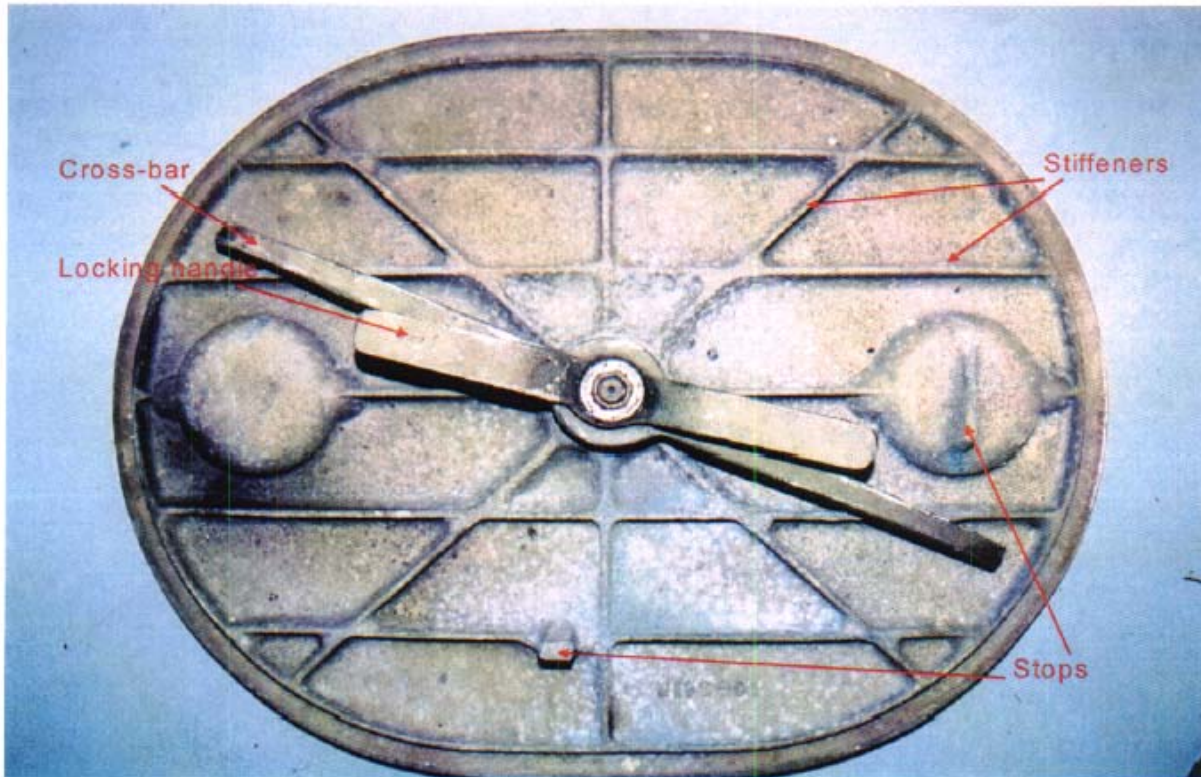
Photograph 1 – View of underside of manhole cover assembly.

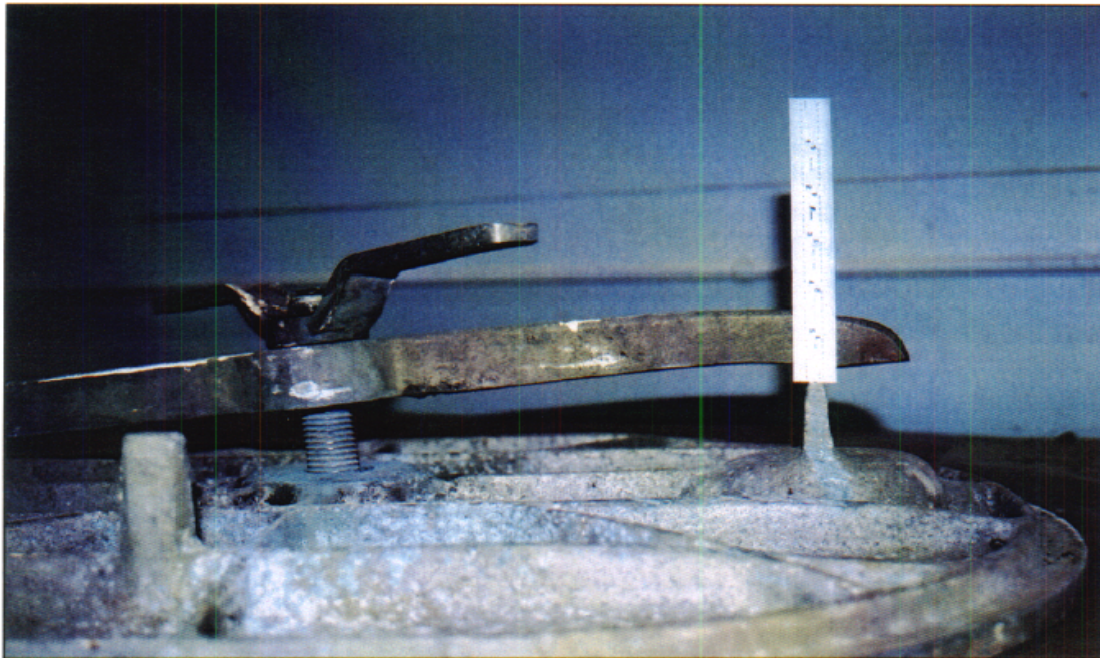
In addition, the short lever arm of the handle makes it difficult to apply sufficient torque to tighten the hatch cover. In conjunction with the tubular nature of the O-ring, this creates a situation where the cross bar can lose its initial tension. However, caution should be taken not to over tighten, as damage to the cover and/or centre pin could occur. Furthermore, short cross bar stops, an excessive length of the spindle and too much clearance between the spindle head and cover could allow the cross bar to slip past the stops leaving the operator unaware that the hatch is not adequately secured.

Photograph 2 – The cross bar is about 12mm above the ‘higher’ stop. It can now rotate behind the stops and the operator will be unaware that this has happened.

- a) to inspect the hatches for material defects;
- b) to contact the manufacturer for any operation and maintenance instructions and conduct the recommended maintenance;
- c) to insure that their operation will maintain watertight integrity in all conditions of operation; and
- d) to demonstrate to all crew members the correct operation of the hatch and to point out potential problems with its operation and maintenance.

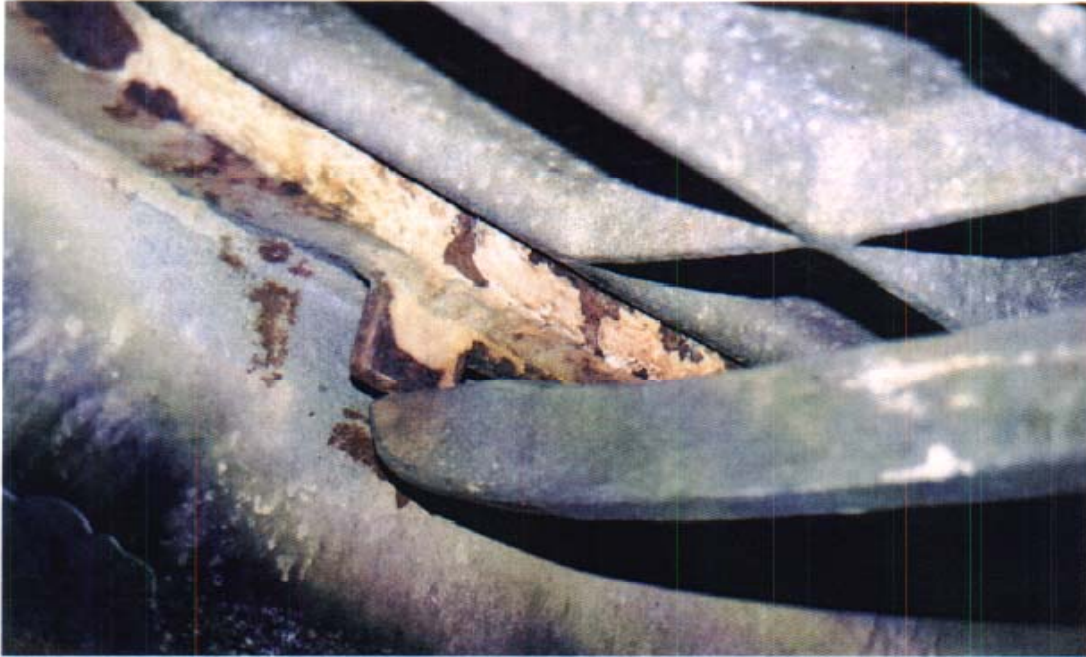
When the operator is securing the hatch from the topside, it is not possible to confirm that the cross bar (on the underside) is correctly seated on the two bearing pieces. *See photographs 1 through 4- attached.* Consequently, failure to correctly fasten the hatch means the hatch is either not secured at all or only partially secured. In either instance the cover may be dislodged allowing leakage and/or down flooding.

Photograph 3 – The cross bar was tightened by the operator from his position on deck and outside the compartment. He was completely unaware that it had come to rest on top of the wedge piece.

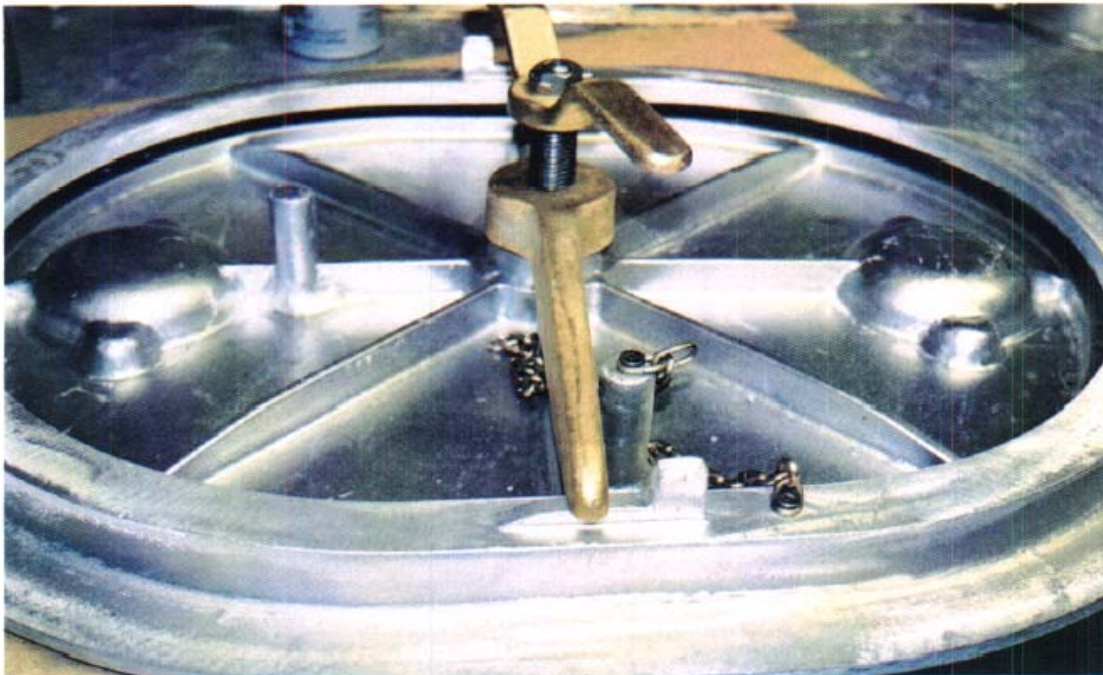
Photograph 4 – Position of 'stop' does not allow cross bar to sit over flat part of wedge piece.
