TP 13412 E

SCHOOL BUS COLLISION SUMMARY CANADA 1989-1997

Bill Gardner and Sandie Ste Marie

July 1999

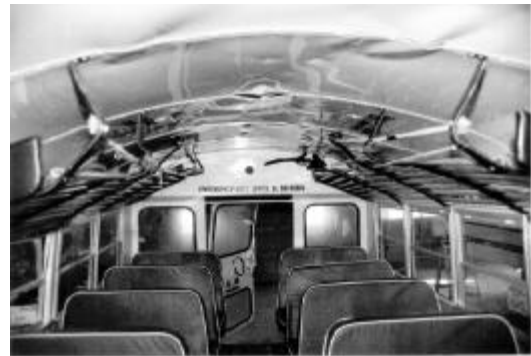
One type of collision merits special mention. It is possible for school children to be transported in vehicles which do not meet the school bus standards. These buses are often used to transport school sports teams to events either during or after school hours. In two cases not included in the tables, students were injured in buses which did not meet the standards. Injuries were definitely increased by the presence of overhead racks which would not meet the requirements for head protection.

Non-complying bus

The provincial/territorial authorities and school boards should be encouraged not to use vehicles that do not meet the safety standards for school buses in order to transport children.

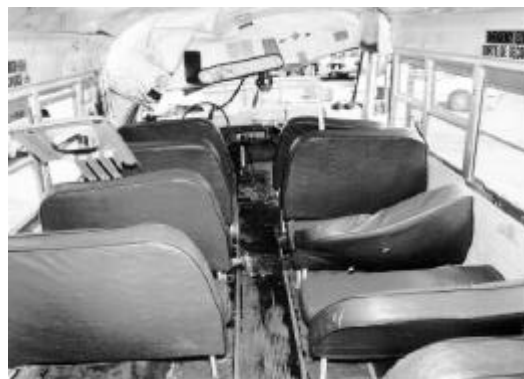
In another case, a school bus entered a ditch on its left side and was in the process of rolling onto its roof when it struck an earth ridge with the roof. The bus rotated about the front of the roof and completed a pitch pole revolution, striking the ground violently with the rear bumper. Due to the complex and violent dynamics of the collision, the 17- and 18-year-old students would be thrown upward and forward and then forced violently down and across toward the rear of the bus. The major damage to the interior of the bus consisted of deformation to the seat backs on the rear right side.

Deformation to seat backs

The collision resulted in a moderate laceration to the back of one student, and a broken collar

bone to another, plus several minor injuries to the 15 students involved. Considering the complex and violent dynamics of the collision, the injuries were neither frequent nor severe. The occupant compartment functioned well in preventing injuries but the injuries which did occur may have been prevented had seat belts been present.

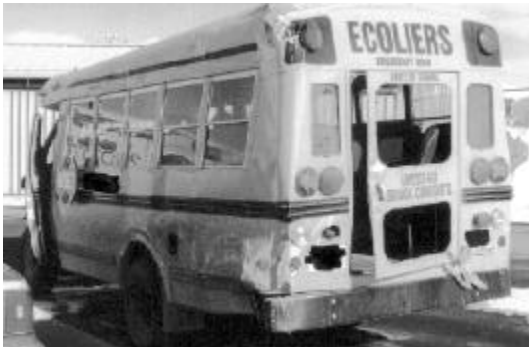
In the only case of occupant ejection, a child was thrown onto the roadway when a school bus was impacted in the side by an ambulance and the rear emergency exit came open.

Emergency exit opened

The child suffered critical, non-fatal head injuries from impact with the roadway. She would not have been ejected had she worn a seat belt.

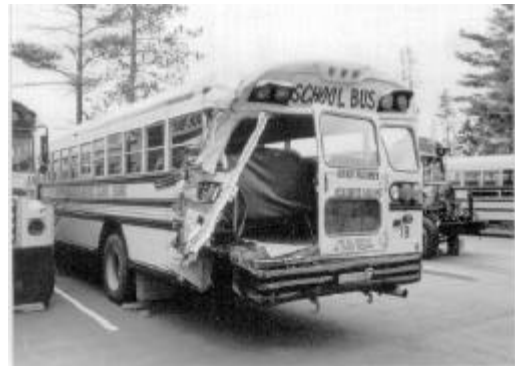
It is possible that seat belts could, by limiting the motion of a child when an object intrudes into the bus, cause injury. In one case the occupied rear seat was pushed into the seat in front by an intruding tractor-trailer.

The child was trapped but uninjured. This illustrates why seat belts, if installed, must be attached to the seats of the bus, and not the floor.

Bus struck by tractor-trailer

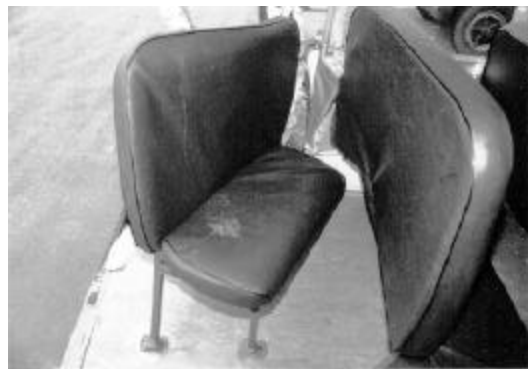
Forward deformation of bus seats

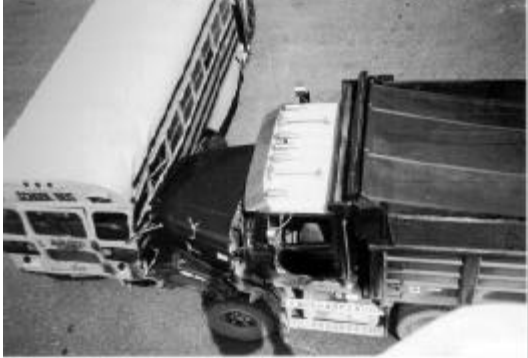
Intrusion was the cause of two fatalities. The head of one child suffered direct contact with the intruding hood of a loaded gravel truck.

Bus struck by gravel truck

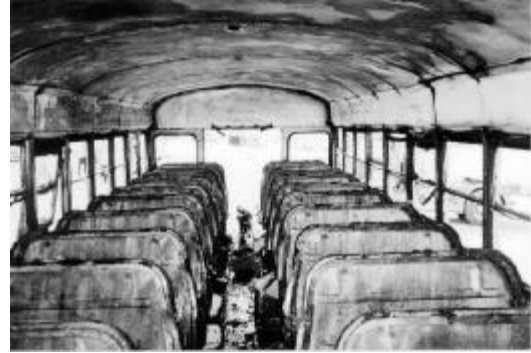
Fire was a factor in two cases. In one, a school bus hit a passenger car and a fuel fire resulted. The driver opened the front door but, on seeing the fire, had the children leave through the rear emergency exit. Both doors were left open, allowing the flames to enter and travel the length of the bus above the seats. The interior of the bus was engulfed in flame within the six minutes that it took the fire department to respond.

Seats burned from the top

All of the seat backs and part of the cushions burned after being ignited from the top. The quick exit of the children prevented injury.

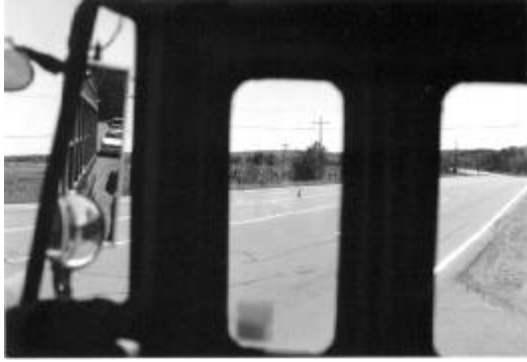
In one collision, through poor choice of route, a school bus was attempting to cross four lanes of traffic when it was hit on the side by a gravel truck.

Poor visibility

It was determined that the bus driver would have had difficulty seeing the approaching truck due to the arrangement of the window frames and mirrors on the right side of the bus. Two other collisions were attributed to right side visibility.

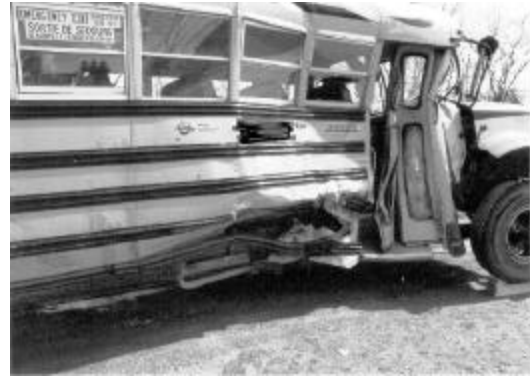
In two cases, school buses were struck very hard in the area of the fuel tank without loss of fuel.

Fuel tank impact

The fuel integrity standard appears to be effective in protecting non-pressurized fuel tanks. The fact that two children died in a propane fire indicate that the design of this type of fuel system bears consideration. Of concern is the fact that in one case the seat covering material burned from the top down in approximately six minutes when ignited by a flame above the seats. The requirements for fire resistant seat covering should be re-examined.

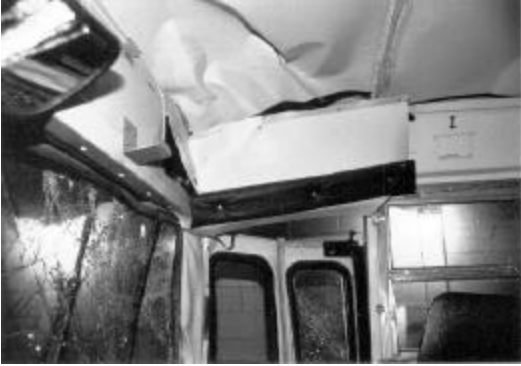
There were no children ejected through any of the bus body joints nor were any injured by separated joints. In one case, however, a body joint separated above the entrance door and presented a sharp edge.

Joint separation

The location of the separation was not considered to be covered by the standard because it was in a maintenance area. Perhaps this exemption should be reconsidered.

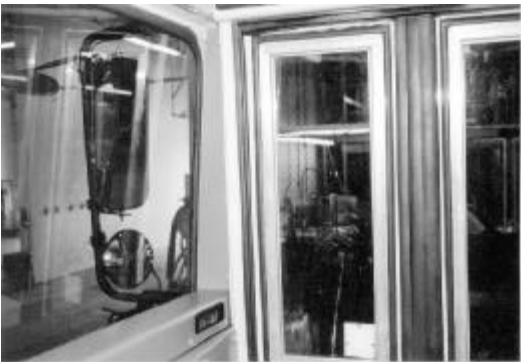
The visibility standards came into question in two cases where the bus was impacted by a truck approaching from the right side. A recent modification to the design of one type of new bus reduces the width of the front vertical structure considerably with the result that the right side visibility is greatly improved.

Improved visibility

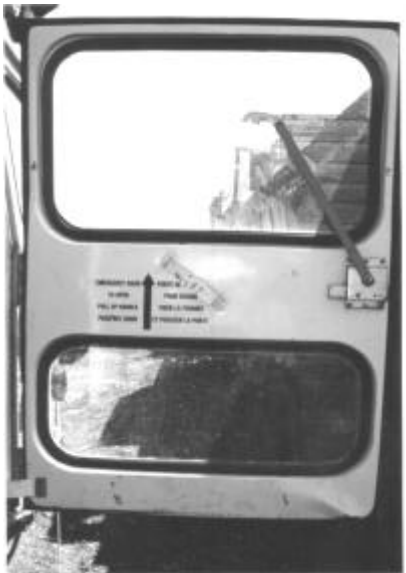
case of ejection through the rear emergency exit is being investigated to ensure that current requirements are adequate. In this case the large windows in the rear exit came free of the rubber molding and openings were provided which were sufficiently large that a child could easily have been ejected. The child was, in fact, ejected through the door, not the window, but there is still room for concern over a trend to larger windows in rear exits.

Larger windows

The latch requirements are being reviewed.
