Transport
Canada

TP 185E
Issue 1/2011

AVIATION SAFETY LETTER

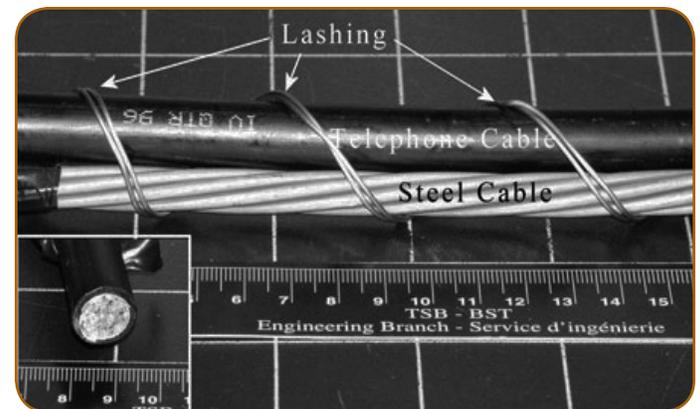
Photo 1: Cable specimen from occurrence site

The cable consists of a telephone cable covered with black protective sheathing lashed to a steel cable (see Photo 1). The cable did not break on impact.

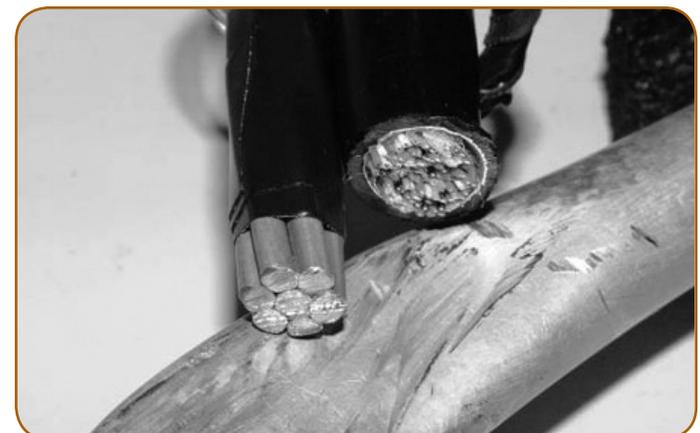
Photo 2: Cable markings on crankcase vent tube

Examination of the aircraft determined that the propeller was being driven by the engine when the cowlings departed the aircraft and continuity of the flight controls was confirmed. Impact marks and material transfer from the telephone cable were noted on the engine crankcase vent line. The impact marks on the vent line had the same spacing and width as the wires of the steel cable that support the telephone cable (see Photo 2).

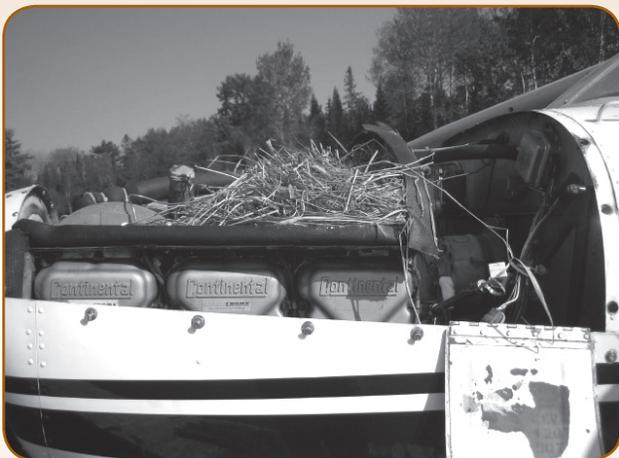
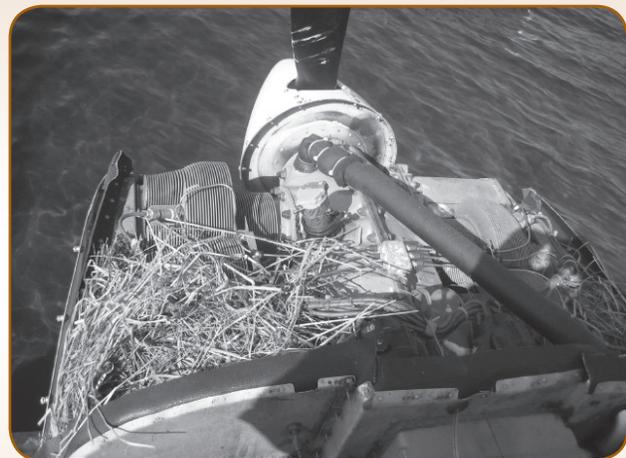
Reminder to Always Do a Thorough Preflight Visual Inspection

From time to time, we get excellent photos that need little commentary. Thank you to Neil Ayers and Dan Ferguson, from Northern Ontario, who provided these undisputable proofs that a thorough preflight visual inspection will save the day.

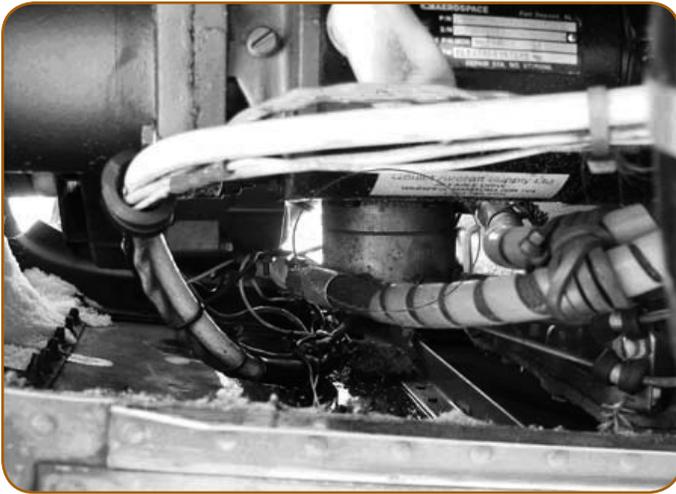
Photo 1: Fuel distributor valve installation in the lower front engine area

During examination of the aircraft at the accident site, a restriction or blockage was found in the fuel supply to both Lycoming IO-540-B1A5 engines. The left engine had a partial blockage with no fuel supply to the forward cylinder nozzles; the right engine had a complete blockage with no fuel supply to any of the cylinder nozzles. The blockage was determined to be within the fuel distributor valve(s) because fuel pressure was present upstream of the valves (see Photo 1). The location of the fuel distributor valve on the Lycoming IO-540-B1A5 engine, in conjunction with the Aero Commander 500B engine cowling configuration, exposes the valve directly to the cooling blast of the outside air.

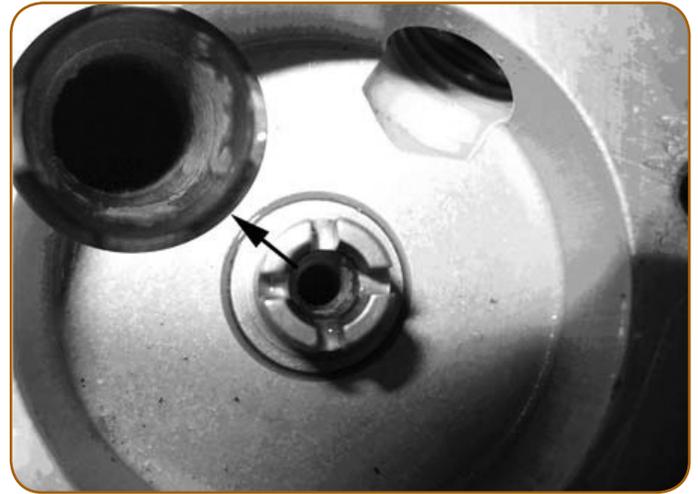
Photo 2: Ice on main metering well

The right engine fuel distributor valve was removed and examined. Ice was found adhering to the internal main metering well surface (see Photo 2). Ice formed from super-cooled water droplets was also found adhering to the servo bleed screen and fully covering and blocking the return-to-tank bleed orifice (see Photos 3 and 4).

1. Suspended water in the fuel system precipitated out of solution and froze in the fuel distributor valve. This blocked the fuel supply to the fuel nozzles and led to the loss of engine power.
2. The aircraft was being operated without a fuel additive icing inhibitor. Use of such an additive would have inhibited ice formation in the aircraft's

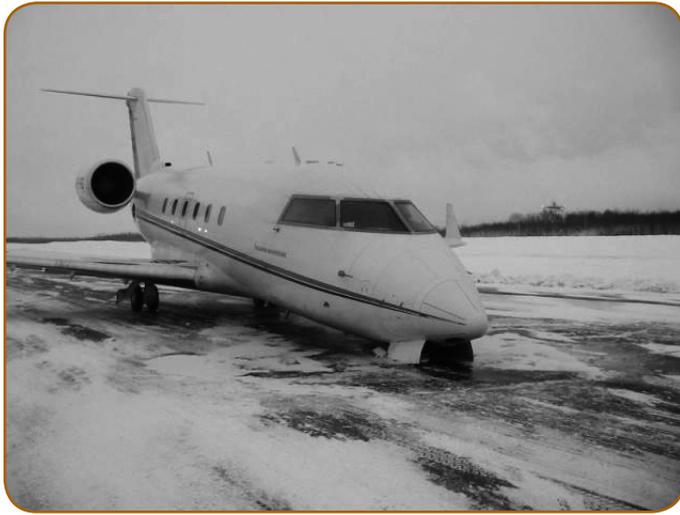
On March 20, 2008, a Challenger CL-600-2A12 was conducting an IFR flight from the Bonaventure Airport, Que., to the Québec/Jean Lesage International Airport, Que. During the approach, the nose gear failed to extend. The flight crew did a low fly-pass, and the tower controller and an aircraft maintenance engineer (AME) confirmed the nose gear anomaly. The flight crew went through the checklist and prepared the six passengers for a landing with the nose gear retracted. At 06:43 Eastern Daylight Time (EDT), the aircraft landed on its nose. Damage was limited to the nose-landing-gear doors and the nose-landing-gear well structure. There were no injuries.

1. The oleo pneumatic shock absorber (oleo strut) was found to be compressed due to a loss of nitrogen. As a result, the nose landing gear was released from the landing gear uplock latch, which allowed the wheel assembly to pivot and become jammed in the well.
2. The right deflector remained jammed in the nose landing gear well, preventing extension of the landing gear.

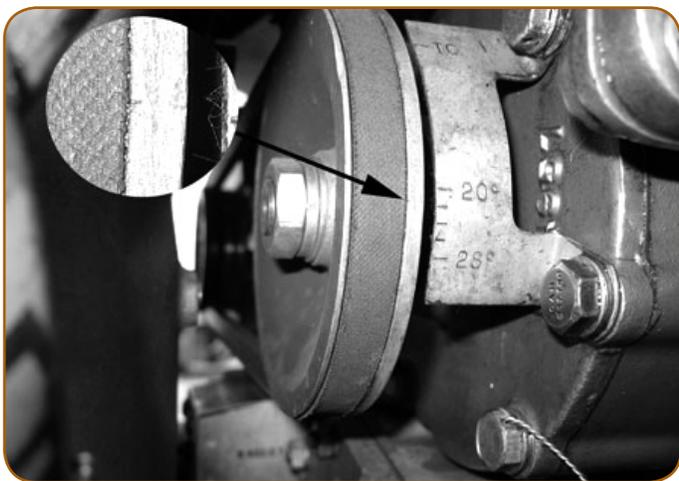
Photo 1: Mistaken timing mark with debris removed

As the engineer rotated the propeller to align the timing marks, the first mark that came into view on the alternator drive pulley was a scratch that had snagged debris from the engine washing (see Photo 1). The scratch, with the embedded debris, looked similar in appearance to the correct timing mark (see Photo 2). The engineer was not able to discern the red paint colouring to cross-reference the mark and chose the scratch as the timing mark of reference. The correct timing mark was out of view on the opposite side of the pulley. The engineer installed the magnetos using the scratch with the embedded debris as the reference point.
