Learn from the mistakes of others; you'll not live long enough to make them all yourself . . . **Issue 2/2004**

When Things Aren't...

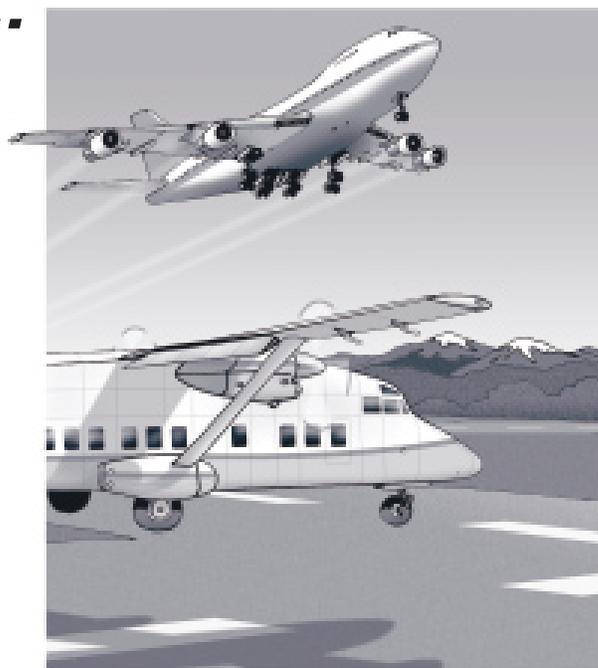
Artist's impression of the risk of collision.

As soon as the pilots observed that they were clear of the departing traffic, they turned toward Runway 12 again and landed the aircraft without further incident. The Shorts had crossed the Runway 26R departure path 0.5 NM in front of and about 100 ft below the take-off profile of the departing 747. There was no indication that the crew of the 747 saw the other aircraft.

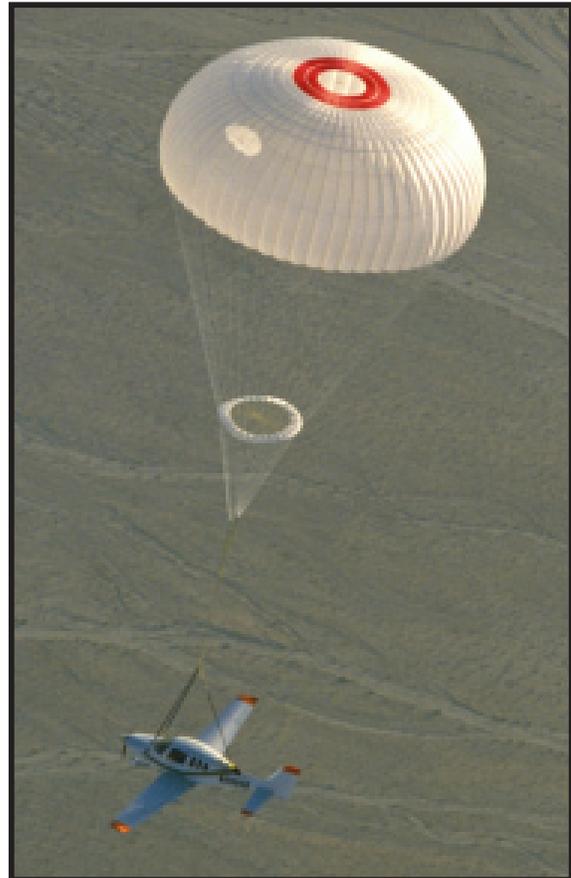
The very small and lightweight parachute is located in a special canister close to the aircraft or ultralight aircraft's center of gravity. It is propelled out of the canister by a solid fuel rocket motor and deploys at various speeds, depending on the height of the aircraft, to preclude any structural failure of the canopy. The pilot manually deploys the system by pulling a handle. Flying small aircraft is no ordinary undertaking and has to be taken seriously as it is most unforgiving of mistakes. In the eventuality of a structural failure or if a downdraft, wind shear or any atmospheric conditions prevent you from maintaining control of your aircraft at low or high altitude and a crash is imminent, isn't it great to know that you can count on such an emergency system to save you from severe injuries and allow you to continue to enjoy life again?

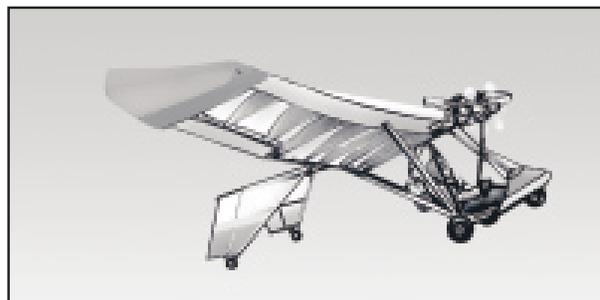
Stalls can be prevented. The warning sign is usually an unmistakable buffet or shaking of the airplane. The buffeting is the result of the airflow separating from the top of the wing. It can occur very quickly depending on the angle of attack, angle of bank and the gross weight of the aircraft. It needs your immediate attention. To recover from the stall, reduce the angle of attack by gently lowering the nose of the airplane with the elevator control. Once the angle of attack is less than its critical angle, the air molecules will flow smoothly over the top of the wing again and the production of lift will resume. It's as easy as that. Remember that you must apply all available power to accelerate the airplane and help reduce the angle of attack. You then have to return the aircraft to the desired attitude and watch that you don't stall again. When you exceed the critical angle of attack, the aircraft wings lose all lift and if your altitude is too low for a recovery, you will fall uncontrollably to the ground. The critical angle of

attack is usually close to 18°. When you are flying at or close to this angle, the air molecules racing over the top of the wing cannot provide a uniform, high-velocity, laminated airflow, and the wing stalls.

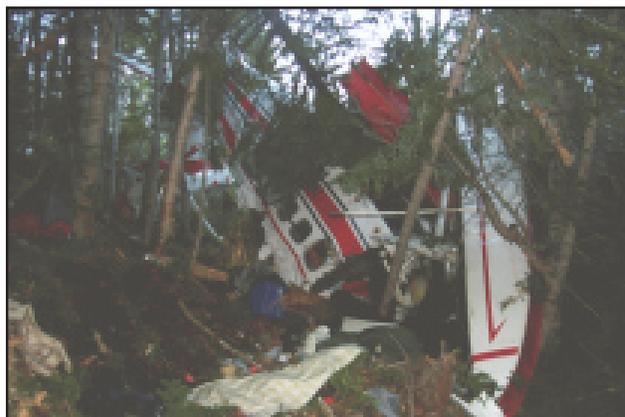
The aircraft cut a 460-ft-long swath through the trees along a constant left curve. At first, only the treetops were involved, but the aircraft quickly dropped, cutting the trees progressively closer to the ground. The aircraft's speed fell and the left wing tore off. The take-off weight was within prescribed limits, and the aircraft was equipped and maintained in accordance with existing regulations. The TSB determined that the engine was producing high power. The continuity of the control cables could still be established—despite the separation of the left wing—because the cables did not break.

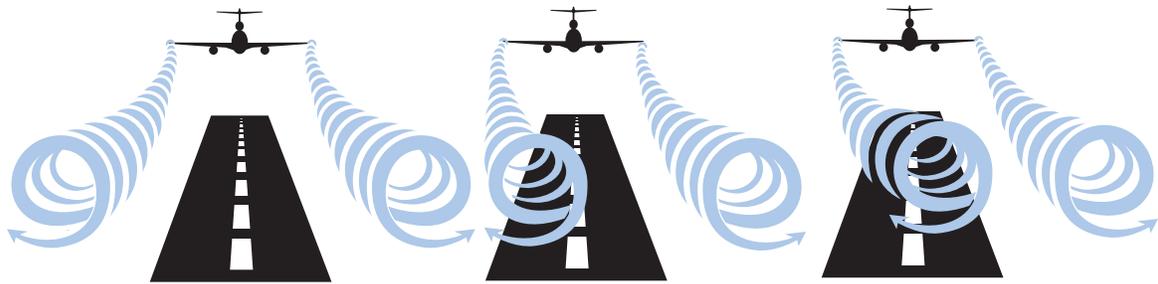
Headwinds
less than 10 kt

Light Crosswind
less than 5 kt

So, you see, the area of hazard is not necessarily aligned with the flight path of the aircraft ahead.

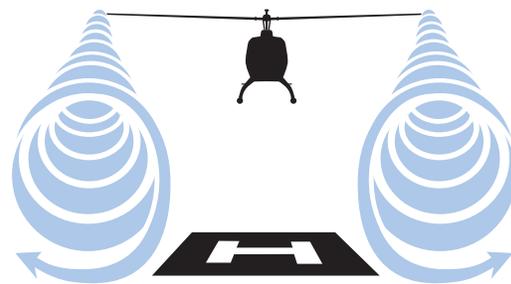
Keep a sharp lookout at all times, and listen to the radio as a guide for traffic movement. Helicopters are hard to spot, but they operate almost anywhere, and they generate vortices more violent than those of a fixed-wing aircraft of comparable weight.
