TP 185E
Issue 1/2017

AVIATION SAFETY LETTER

Emergency Locator Transmitter (ELT): Using
Hook-and-Loop Fasteners

TSB Final Report Summaries

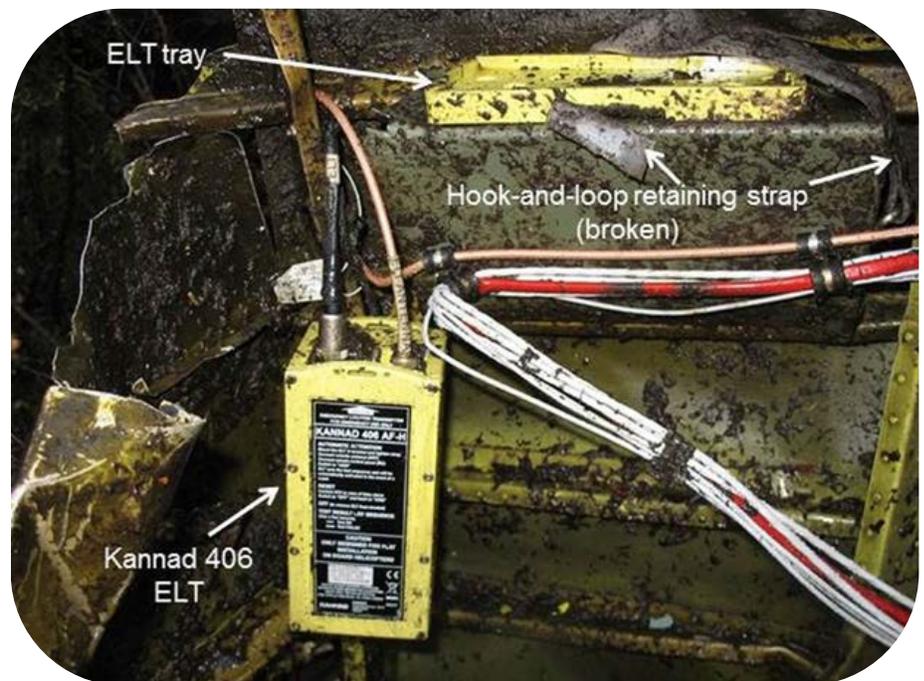
406 MHz automatic fixed helicopter emergency locator transmitter (ELT) hanging by its wires

In 2013, when a rotor-wing helicopter collided with terrain near Moosonee, Ont., hook-and-loop installations were brought up again. In the Transportation Safety Board of Canada (TSB) [report](#), it was noted that the hook-and-loop strap was broken during impact (see [photo](#)).

As a result, the TSB, echoing their American counterparts, determined that hook-and-loop fasteners were insufficient to withstand real world crash scenarios. The TSB recommended that TC prohibit the use of hook-and-loop fasteners as a means of securing an ELT to an airframe.

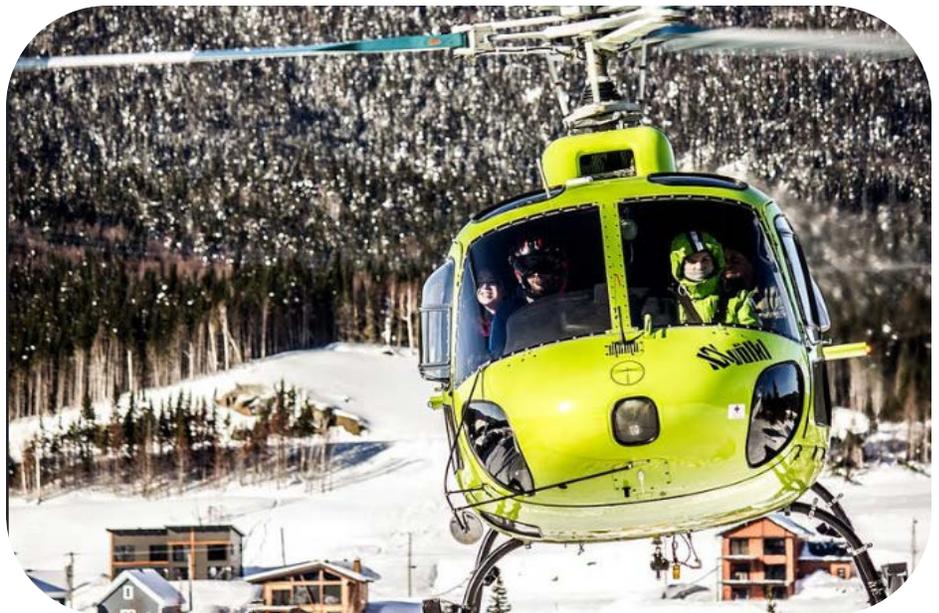
When conducting takeoffs in conditions conducive to recirculating snow, apply enough power to get the snow blowing while keeping enough weight on the aircraft to prevent it from moving. Leave the power on as long as necessary to get good visual references. This could take up to a minute to accomplish.

Once good references are established, use a towering take-off technique (altitude over airspeed) to stay out of the recirculating snow during the remainder of the departure procedure.

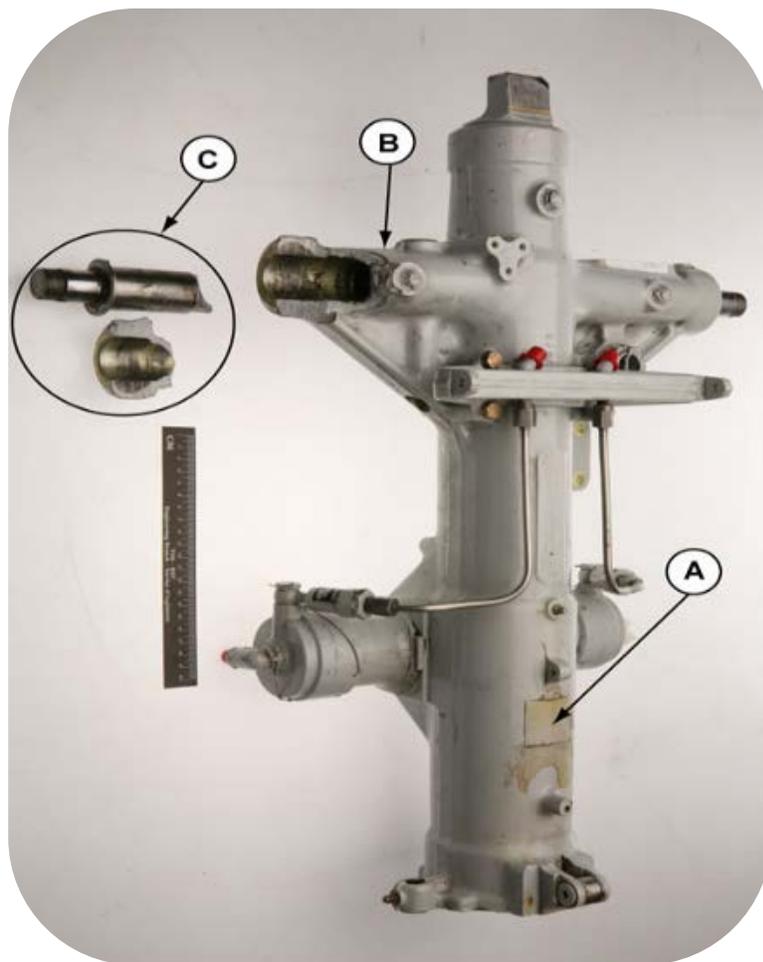
Top nose gear assembly

A—Oleo strut housing assembly

B—Strut housing trunnion link arm

C—Damaged right steel trunnion assembly with bushing

An Embraer EMB-110P1 aircraft was on a training flight with two pilots on board. At approximately 11:30 EDT, while landing on Runway 13 at Cochrane, Ont., the nose landing gear partially collapsed during the landing roll. The aircraft veered to the right and briefly exited the edge of the runway. The left brake was applied to prevent a complete runway excursion and directional control was regained; the aircraft was manoeuvred back onto the runway where it was brought to a stop. The aircraft received substantial damage to the nose section, and the right propeller was damaged when it struck a runway edge light. There were no injuries to either of the pilots.

The nose landing gear was overhauled in Australia on January 11, 2007. The time since new on the Authorized Release Certificate from the maintenance organization was marked "Unknown," which indicated that the maintenance organization may not have been provided with this information when the nose gear was shipped to them for overhaul.

From the time the nose landing gear was overhauled to this date, there were no maintenance arrangements between Transport Canada and the Australian civil aviation authority. Therefore, the Authorized Release Certificate that the maintenance organization used to certify the work performed on the nose landing gear did not meet the requirements of subsections 571.11(3) and 571.08(1) of the *Canadian Aviation Regulations* (CARs). The nose landing gear should not have been installed on the aircraft.

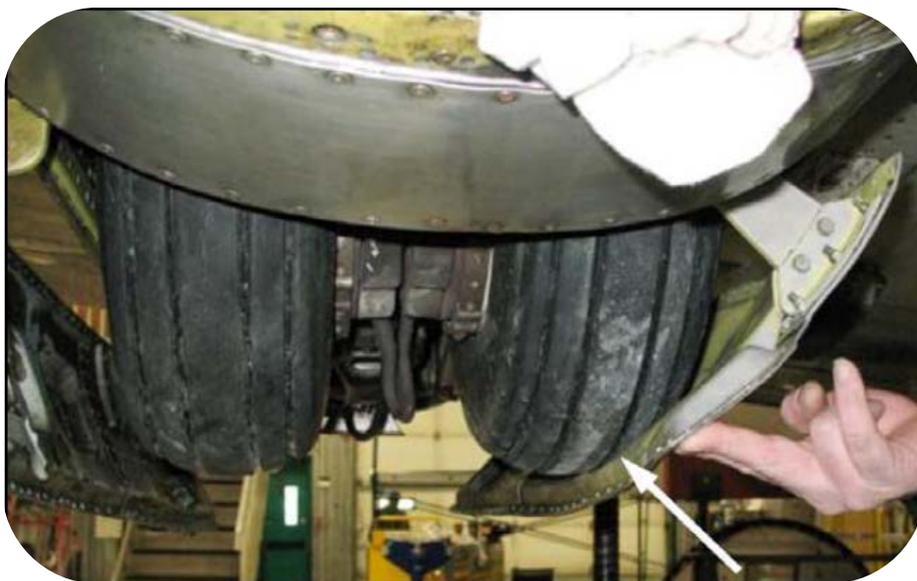
Area of tire-to-gear-door interference

The Swearingen SA226-TC Metro II was inbound for Winnipeg/James Armstrong Richardson International Airport from St. Theresa Point, Man., with two crew members and eight passengers on board. On final approach into Winnipeg, the landing gear was selected down, but the right main gear did not extend. The crew carried out a missed approach, declared an emergency, and entered a holding pattern to attempt gear extension. The right main gear could not be extended by either the normal or emergency methods. The crew elected to conduct a gear-up landing into wind on Runway 18 with aircraft rescue and firefighting (ARFF) personnel standing by. Over the threshold of Runway 18, prior to touchdown, the crew shut down both engines and feathered both propellers. The aircraft came to a gradual stop on its belly on the centreline of the runway at 12:09 CST. The aircraft was evacuated with no injuries reported. The aircraft sustained substantial damage to its propellers, flaps, and aft belly area.

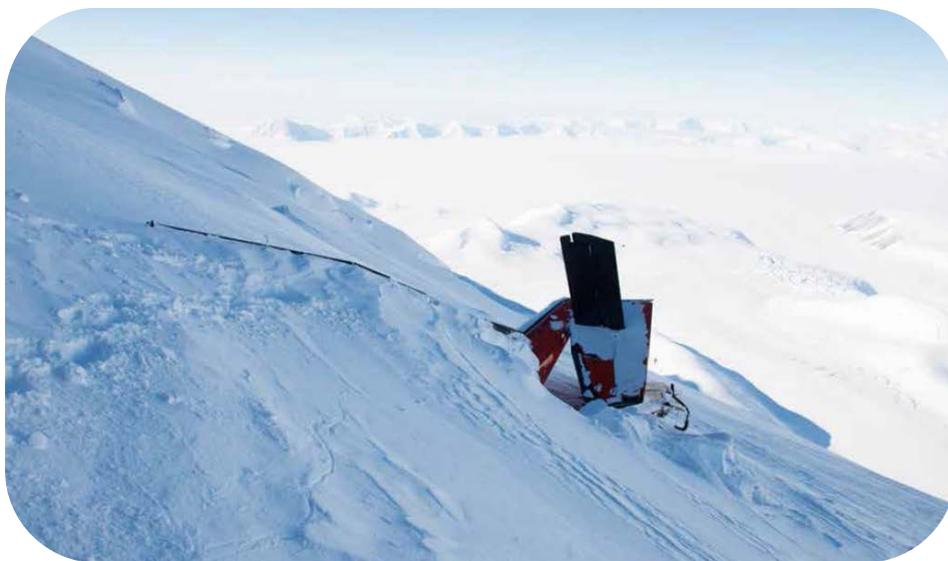
Wreckage of the occurrence site, looking southeast

The Twin Otter de Havilland DHC-6-300 departed South Pole Station, Antarctica, at 0523Z on January 23, 2013, for a visual flight rules (VFR) repositioning flight to Terra Nova Bay, Antarctica, with a crew of three on board. The aircraft failed to make its last radio check-in scheduled at 0827Z, and the flight was considered overdue. An emergency locator transmitter (ELT) signal was detected in the vicinity of Mount Elizabeth, Antarctica, and a search and rescue (SAR) effort was initiated. Extreme weather conditions hampered the SAR operation, preventing the SAR team from accessing the site for two days. Once on site, it was determined that the aircraft had impacted terrain and that the crew members had not survived. Adverse weather, high altitude and the condition of the aircraft prevented the recovery of the crew and comprehensive examination of the aircraft. There were no indications of fire on the limited portions of the aircraft that were visible. The accident occurred during daylight hours.

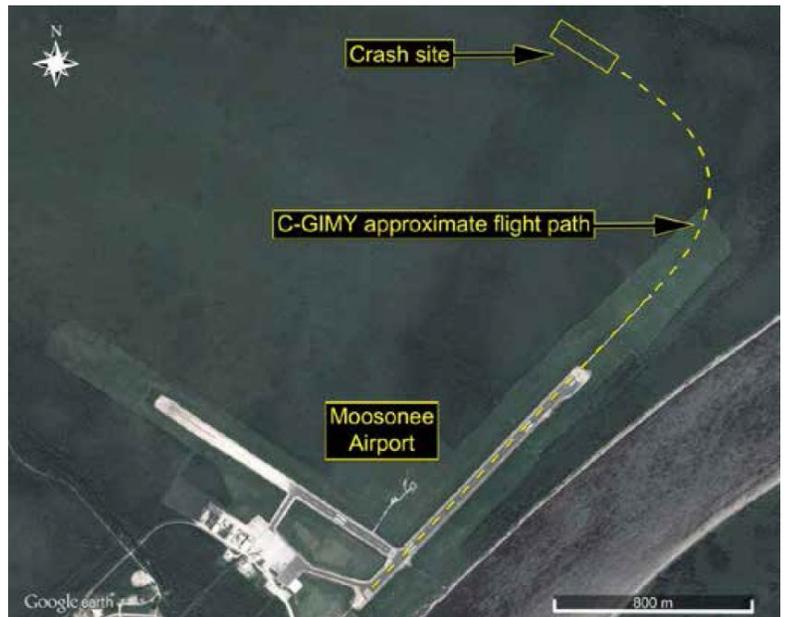
Approximate flight path of the occurrence helicopter

On May 31, 2013, at approximately 00:11 EDT, a Sikorsky S-76A helicopter departed at night from Runway 06 at Moosonee Airport, Ont., on a visual flight rules (VFR) flight to Attawapiskat Airport, Ont., with two pilots and two paramedics on board. As the helicopter climbed through 300 ft above ground level (AGL) toward its planned cruising altitude of 1000 ft above sea level (ASL), the pilot flying commenced a left-hand turn toward Attawapiskat Airport, approximately 119 NM northwest of Moosonee Airport. Twenty-three seconds later, the helicopter impacted trees and then struck the ground in an area of dense bush and swampy terrain. The aircraft was destroyed by impact forces and the ensuing post-crash fire. The helicopter's satellite tracking system reported a takeoff message and then went inactive. The search-and-rescue (SAR) satellite system did not detect a signal from the emergency locator transmitter (ELT). At approximately 05:43, a SAR aircraft located the crash site approximately 1 NM northeast of Runway 06 and deployed SAR technicians. There were no survivors. △
