Ferrari Befix High Back Booster Seats – Shoulder Belt Guide Routing Instruction
 Revisions

Manufacturer:	Team Tex Rue du Claret 38230 Charvieu-Chavagneux France www.nania.com										
Importer and Distributor:	5514 KM Corporation (Car Seat Group) 201 Wicksteed Avenue, Suite 2 Toronto, ON M4G 0B1 www.5514km.ca www.csg-canada.com										
Consumer Contact:	Local calls: 416-422-4515 Toll-free: 1-855-422-4515 Email: info@csg-canada.com										
Model, Model Number and Dates of Manufacture Affected:	Ferrari Befix High Back Booster Seat (F4000C) Manufactured on:

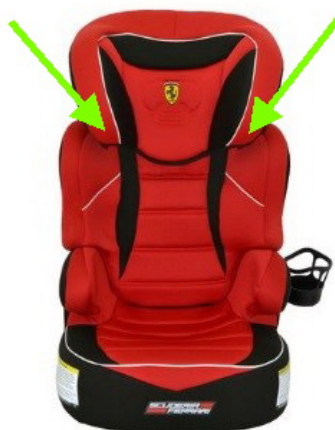
Figure 1. Location of the Shoulder Belt Guides

5514 KM Corporation and Transport Canada wish to inform the public about the availability of revised instructions for certain Ferrari Befix high back booster seats. These booster seats were available in two different shoulder belt guide configurations, either with a simple U-shaped slot or with a Z-shaped slot. The shoulder belt guides are located on the underside of the booster seat’s head support and help to properly position the vehicle shoulder belt across the child occupant’s chest and collarbone.

It is possible that the labels affixed to, and the English and French instruction manuals provided with the booster seats did not outline the proper shoulder belt guide configuration. Without the correct instructions, it may be possible to have the vehicle shoulder belt routed incorrectly, preventing the belt from sliding freely in the guide. The revised instructions clarify the correct routing of the vehicle shoulder belt through the shoulder belt guide. Transport Canada’s defect investigations program identified this issue after receiving a consumer complaint.
