TP 185E
Issue 1/2006

AVIATION SAFETY LETTER

In this Issue...

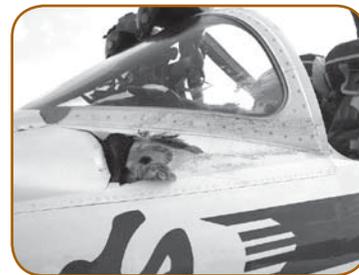
Birdstrike damage on a Snowbirds aircraft

The description above is a true story, as told by the pilot. Terry Johnson was hit in the face by windshield debris and the remains of a lesser scaup—a 1.5-lb diving duck. Terry succeeded in completing a successful landing in his Van's Aircraft RV-6, but the incident could have been much more serious, had Terry been blinded, or had he hit a larger bird such as a Canada goose, at 15 lbs.

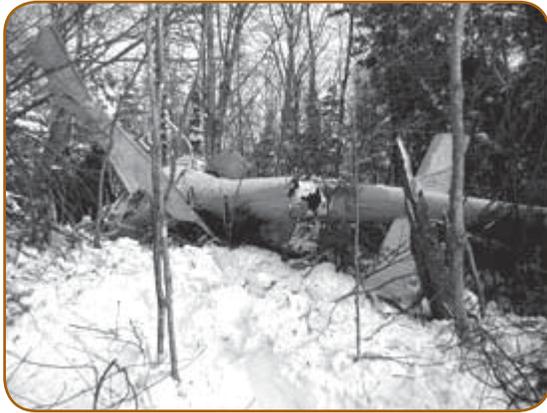
On January 21, 2003, a Eurocopter AS 350 B2 helicopter with the pilot and three passengers on board, departed on a day, visual flight rules (VFR) flight from Sault Ste. Marie, Ont., to conduct a moose survey at a location approximately 45 NM northeast of Sault Ste. Marie. During the survey, at 11:43 Eastern Standard Time (EST), the pilot communicated to the Ministry of Natural Resources ground-based radio operator that the aircraft experienced a hydraulic failure and that he was proceeding to a logging site at Mekatina to land the helicopter. As the helicopter approached the logging site, workers observed the aircraft proceed to the north and enter a left turn. As the helicopter proceeded back towards the logging operation in the left turn, control of the aircraft was lost and it crashed in the rising wooded terrain east of the logging site. The helicopter came to rest in an inverted position. All of the aircraft occupants were fatally injured. There was no post-crash fire.

1. After experiencing a hydraulic system failure, the helicopter departed controlled flight and crashed while manoeuvring for landing. The reason for the departure from controlled flight could not be determined.
2. It is likely that the hydraulic pump drive belt failed in flight, precipitating the hydraulic failure.
3. It is likely that the hydraulic circuit breaker was in the tripped position in flight, rendering the hydraulic CUTOFF and HYD TEST switches inoperative. This would result in hydraulic pressure from the main-rotor servos being depleted asymmetrically.

1. Laboratory examination of the failed hydraulic drive belt and other similar unbroken belts from other aircraft revealed extensive cracking in the same location in all the comparison samples. A problem may exist at that location, creating a stress/strain concentration that results in a consistent and predictable failure.

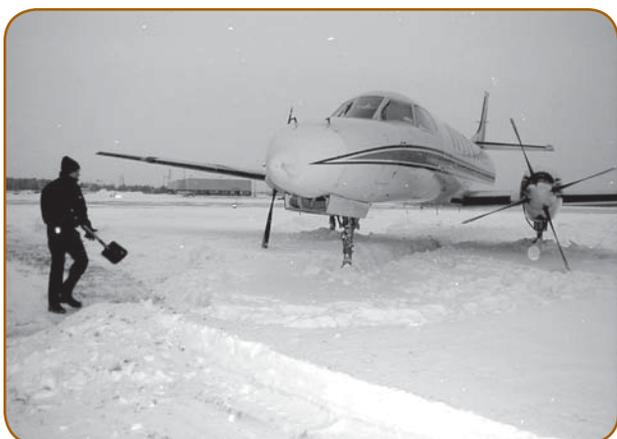
On January 15, 2004, a Fairchild Metro SA227-AC had departed Kenora, Ont., and was landing on Runway 11 at Dryden, Ont., with two pilots and ten passengers on board. During the landing roll, the aircraft went off the left side of the runway into deep snow. The aircraft was not damaged, except for two blown tires on the left main landing gear. The crew and passengers were not injured. The incident occurred during daylight hours at 14:57 Central Standard Time (CST).

1. The aircraft was operating in environmental conditions conducive to snow penetration into the brake assemblies during ground operations at Kenora.
2. The brake assemblies on the left main landing gear froze, preventing the wheels from rotating during the landing roll at Dryden.
3. The first officer's foot position and pressure application on the rudder pedals prevented effective use of differential braking and nosewheel steering to maintain directional control of the aircraft after landing.

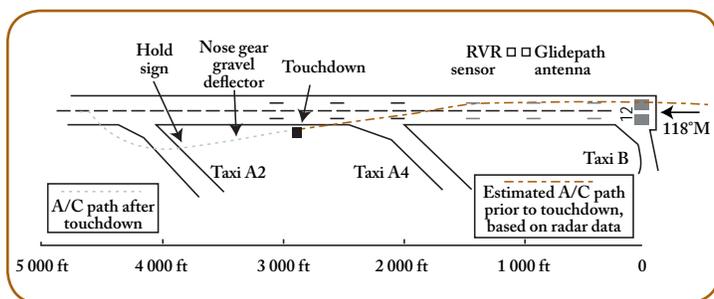
Overhead view of Runway 12 at Edmonton

On February 25, 2004, a Boeing 737-210C was operating from Lupin, Nun., to Edmonton, Alta. The runway visual range (RVR) provided to the flight crew prior to commencing the approach to Runway 12 at Edmonton was 1 200 RVR, with a runway light setting of 5. The crew flew the instrument landing system (ILS) approach in darkness and touched down on the infield to the left of the runway surface, at 05:44 Mountain Standard Time (MST). The aircraft travelled approximately 1 600 ft before returning to the runway. After the aircraft was brought to a full stop, aircraft rescue and firefighting (ARFF) was requested by the flight crew. One runway light, four taxiway lights, and one hold sign were struck by the aircraft. There were no injuries and the passengers deplaned via the rear airstair door.

1. With deteriorating visibility and only runway edge lighting for guidance, the captain was unable to manoeuvre the aircraft to stay within the confines of the runway.

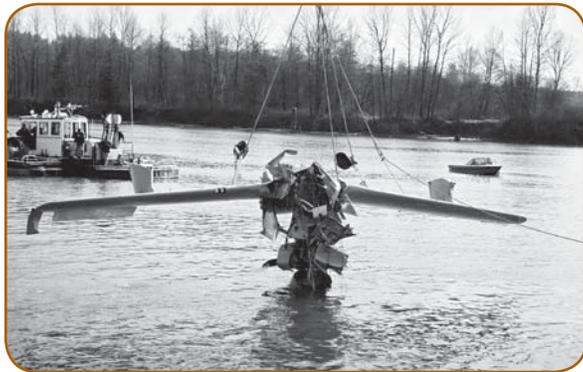
TSB Final Report A04P0041— Collision with Water

On February 29, 2004, a Consolidated Aeronautics, Inc. model LA-4-200 Buccaneer departed Delta Heritage Airpark, B.C., at about 13:10 Pacific Standard Time (PST) for a local VFR flight. The departure was normal and the engine was running smoothly. Some time later, the aircraft conducted a touch-and-go landing on the Fraser River on an easterly heading in Plumper Reach, adjacent to Crescent Island. The aircraft appeared to be descending for another landing when it hit the water in a nose-down, wings-level attitude, with a high vertical speed component. Boaters arrived at the accident site in less than one minute. However, the aircraft had already sunk and there was a little floating debris. Sections of the aircraft were recovered two days later, and the pilot's body was recovered almost three months later.

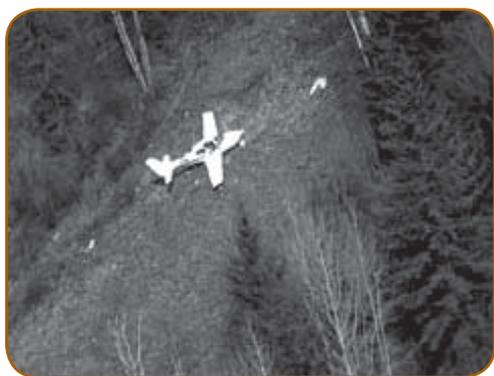
At approximately 21:11 PDT, the aircraft/parachute landed on a steep mountainside on the southern slope of Mount O'Leary, B.C., at the 2 300-ft level. The aircraft sustained substantial damage, but there were no injuries. A search and rescue operation was initiated. The four occupants were found and rescued early the following morning and returned to Kelowna by military helicopter.

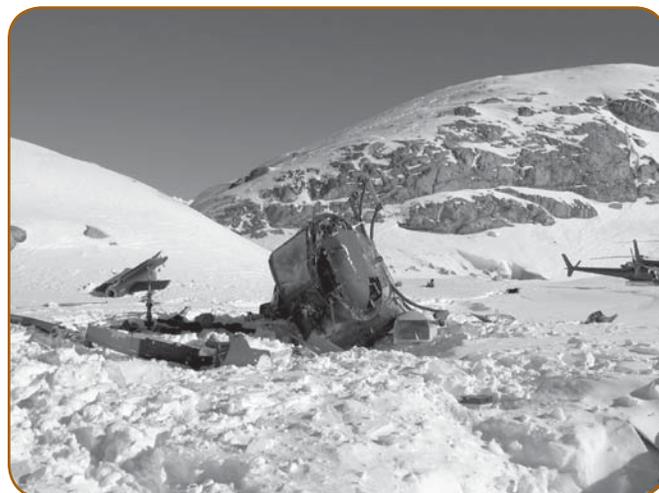
TSB Final Report A05P0032—Settling with Power—Roll-Over

On February 11, 2005, a Bell 212 helicopter was being used in heli-ski operations near Whistler, B.C. After operations on one glacier with two groups of skiers, the guides and the pilot agreed to move to the Spearhead Glacier. The skiers and guides were dropped off at the top of the glacier, and the pilot chose to pick up the skiers near the toe of the glacier. The first group down the glacier comprised 11 skiers. During takeoff from the toe of the glacier with this group, the helicopter began to settle as it turned downwind. The pilot turned it back toward the take-off area, but the helicopter continued to settle with full power applied. The helicopter struck the snow in a level attitude, turned over, and came to rest on its right side. The helicopter was substantially damaged. The main rotor chopped the tail off, the nose was crushed, and the battery was ejected. There was no fire. The passengers and pilot escaped with only minor injuries.

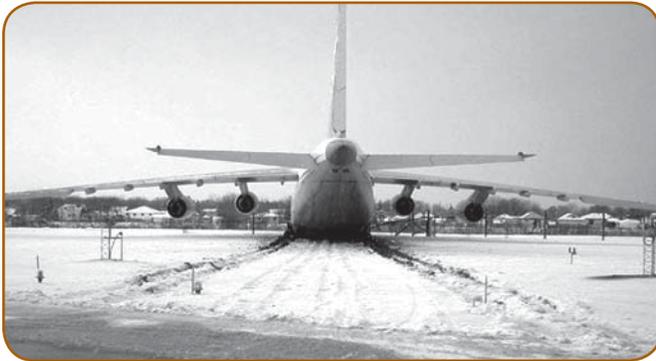
*Antonov 124 overrun at the Windsor, Ont., airport,
18 December 2000*

On 18 December 2000, the crew of an Antonov 124 conducted an instrument landing system (ILS) approach to Runway 25 at the Windsor, Ont., airport. Because of the weather minima on Runway 07, the aircraft was landed with a 4-kt tailwind component. The aircraft was about 20 ft higher, and about 6 kt faster, than recommended when it crossed the threshold of Runway 25. Consequently, the aircraft touched down well beyond the normal touchdown point (3 400 ft from the threshold). The runway was covered with a trace of loose snow, which reduced braking friction and lengthened the landing roll. Finally, the aircraft could not be stopped, and overran approximately 340 ft past the end of the runway. There were no injuries, and the aircraft sustained minor damage. Source: TSB Report Number A0000279.

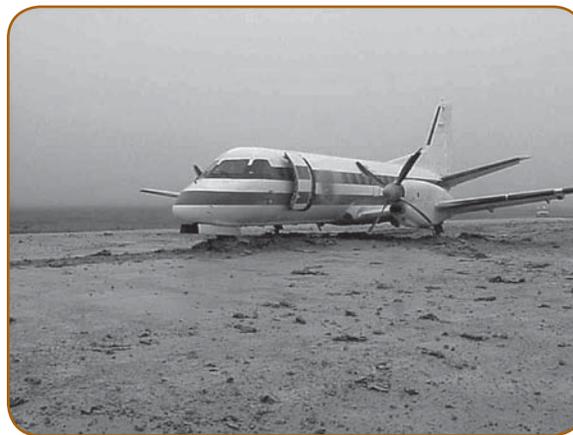
Example of an overrun that didn't become an accident due to a soft arrestor bed.

An interesting technology that is worth mentioning here, is the application of a ground arrestor system, which is located beyond the end of the runway and centred on the extended runway centreline. A ground arrestor system is designed to stop an overrunning aircraft by exerting deceleration forces on its landing gear. Although this technology (as will be explained later) cannot prevent overruns from happening, its application can mean the difference between an accident and a minor incident. Different types of ground arrestor systems for civil application were studied in the United Kingdom in the 1970s, and later in the United States. An example

of a ground arrestor system is the engineered material arresting system (EMAS), which is a so-called soft ground arrestor. A soft ground arrestor system like EMAS deforms under the weight of an aircraft tire that runs over it. As the tires crush the material, the drag forces decelerate the aircraft, bringing it to a safe stop. In recent years, EMAS became popular in the United States at airports that have difficulties complying with the rules on runway safety areas defined by the Federal Aviation Administration (FAA). There have been at least three reported overruns in which EMAS stopped the aircraft. These occurrences took place in the United States with a Saab 340 (May 1999), a MD11 (May 2003), and most recently, with a B747 (January 2005). Clearly, no soft ground arrestor system can prevent overruns from happening; however, it seems evident that such a system can affect the consequences. Other arrestor systems were also studied in the past. Examples are loose gravel, water ponds, and arrestor cables. Application of these systems to commercial airports has been limited. In the unlikely event that you do run out of runway, let us hope that you do not run out of luck!

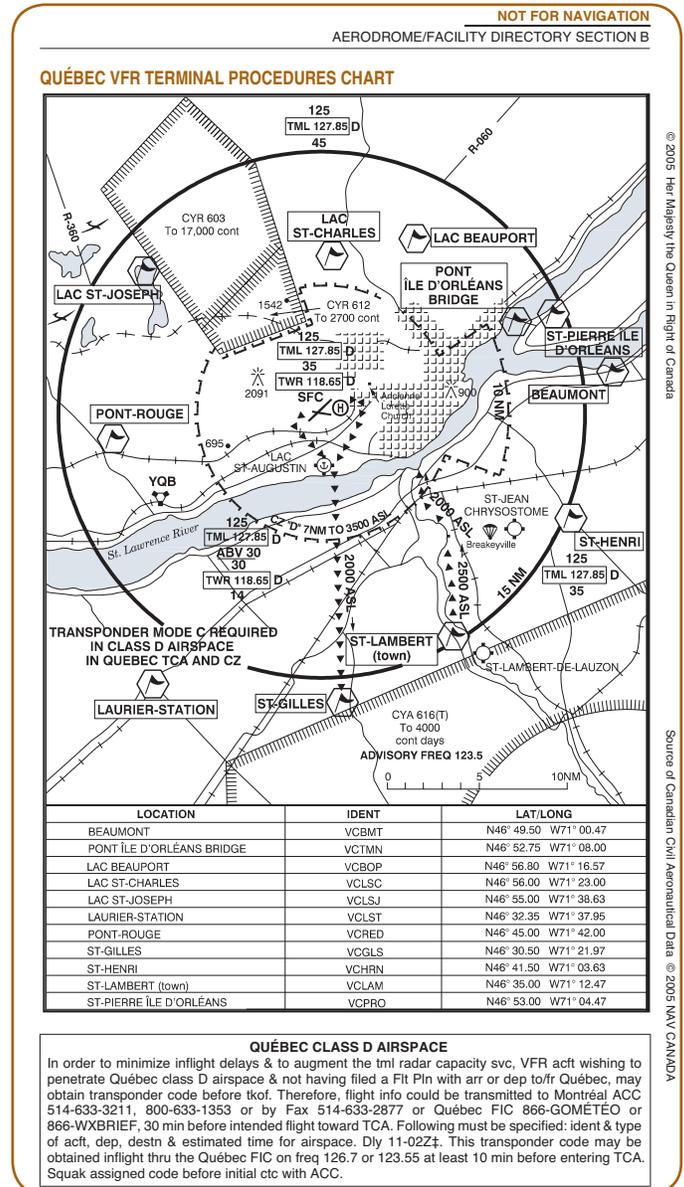
The area of class D airspace around Québec has a complex, stacked shape, that is limited to the north by a restricted area. Arrivals from and departures towards the west are almost in a straight line with the Québec VHF omnidirectional range (YQB VOR), which is also where several airways cross. To the south, there is a training area with heavy traffic.

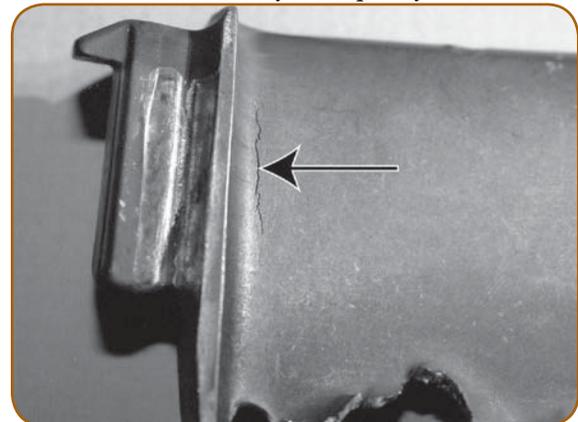
Example of a fatigue crack (arrow) on a compressor blade propagated from multiple origins on both convex and concave sides of the blade indicating cyclic loading in the reverse bending.

Compressor surging is unpredictable, so the only kind of maintenance tasks that can adequately determine the effects of a compressor surge on the physical well-being of an engine, are unscheduled maintenance tasks. Since such tasks should be both applicable and effective, it must therefore be possible to do a comparison between the condition of an engine with no damage, and one that has sustained damage as a result of compressor surge effects. The inspection method would have to be applicable while the engine is installed and would generally include a visual inspection, most of which would entail the use of a borescope. The principal intent would be to inspect as many engine compressor and turbine blades as possible without disturbing the engine interior. Since the causes of some compressor surge events may be attributed to malfunctions of the engine's fuel control unit or of its bleed valves, these items may also qualify for some sort

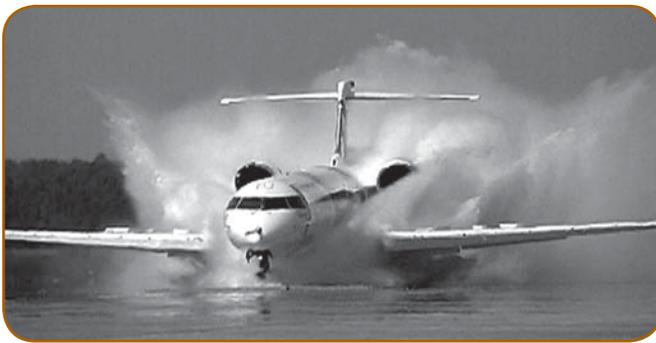
RJ 900 water ingestion test

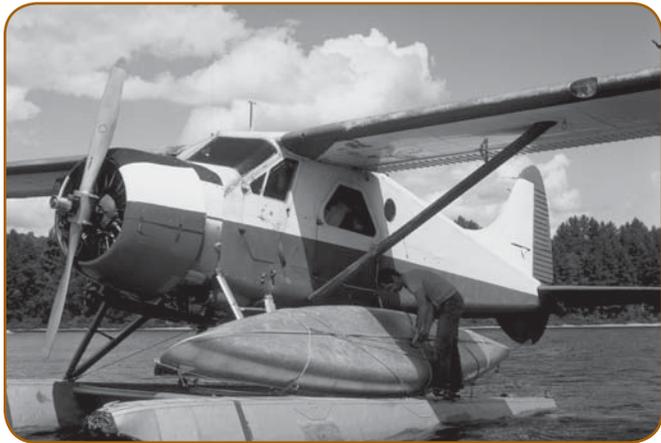
Float plane carrying an external load

Unfortunately, accidents and incidents continue to occur with airplanes carrying external loads. In October 2003, a fatal loss-of-control accident involving a Piper PA-18-150 occurred while carrying moose antlers attached to the aircraft floats. The Transportation Safety Board report (TSB Report A03W0210) for the PA-18-150 accident cites more than 17 accidents that have occurred since 1976, involving external load operations with airplanes. Nine of these accidents involved fatalities.
