ISSUE 2/2020

AVIATION SAFETY LETTER

TP 185E

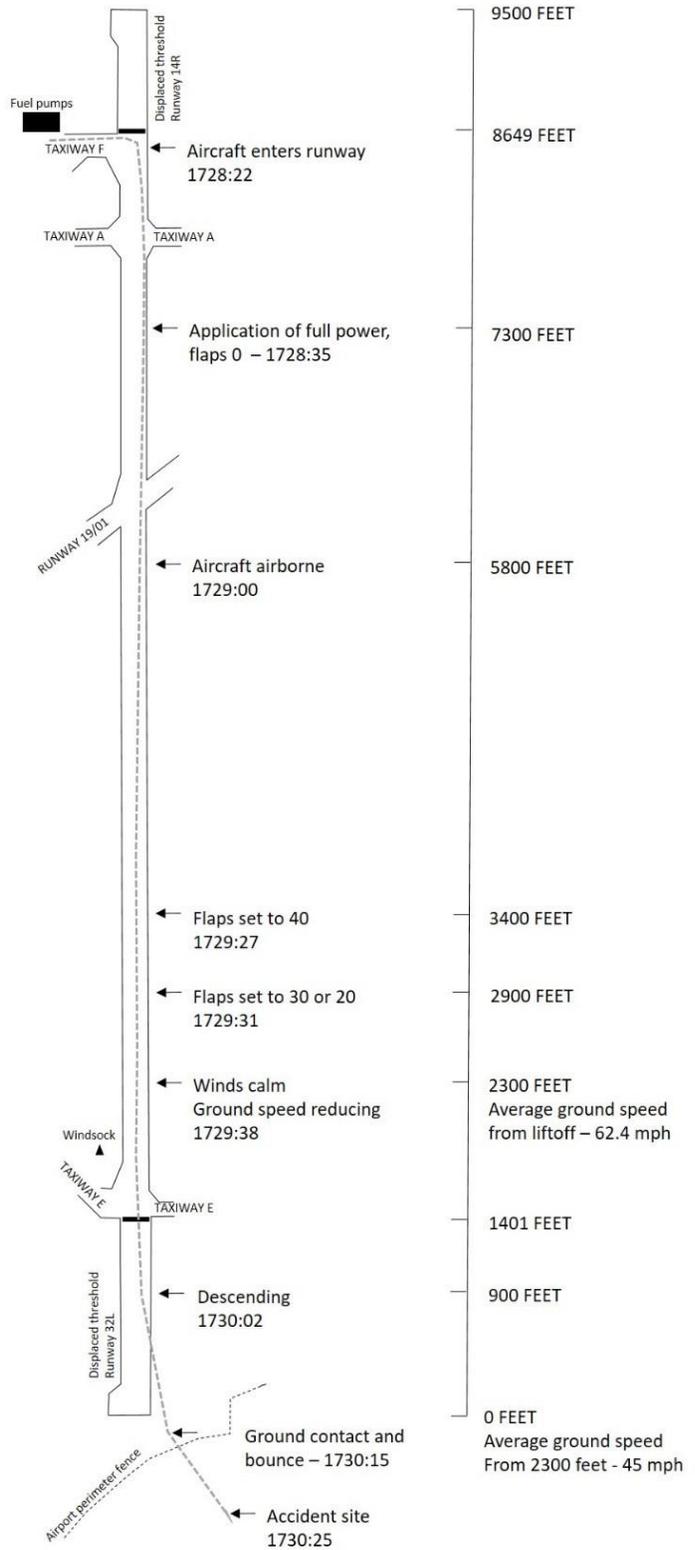
Figure 1. Diagram depicting the occurrence

At 17:30:25, the aircraft crashed into a wooded area and was severely damaged. An on-board video recorder continued to record both audio and video after the aircraft had come to rest. Based on the audio, electric power was still on after the crash because a beeping sound could be heard. A fire erupted 10 seconds after impact and eventually consumed the aircraft. Both occupants were fatally injured. The emergency locator transmitter was activated during the crash sequence.

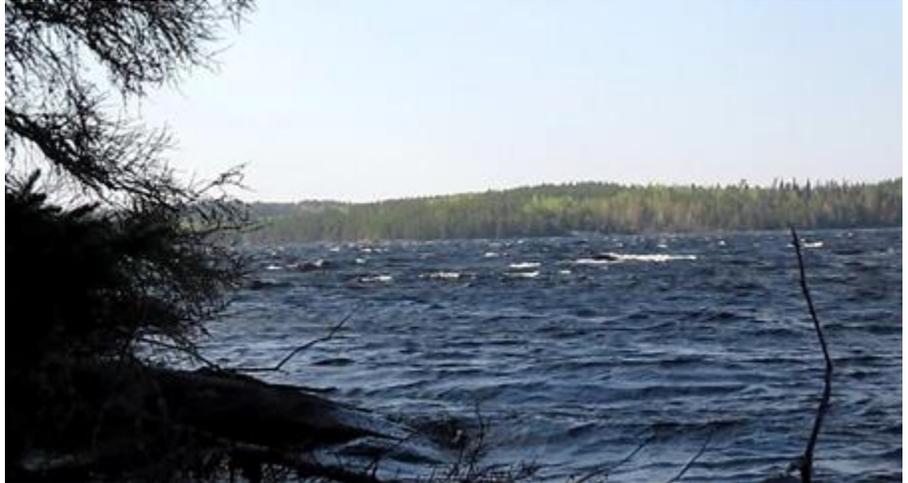
The pilot landed at Domain Lake at approximately 16:00, and taxied to the outpost camp. Subsequently, the pilot and the 1st passenger departed for Optic Lake, leaving the 2nd passenger at the camp. At approximately 17:30, canoeists saw the aircraft land on Optic Lake. As the canoeists continued their journey around the shore of Optic Lake, they experienced difficult paddling conditions due to strong southwesterly winds and high waves (Figure 2).

Figure 2. Choppy water on Optic Lake at 17:11
