Transport
Canada

ISSUE 4/2020

AVIATION **S**AFETY **L**ETTER

TP 185E

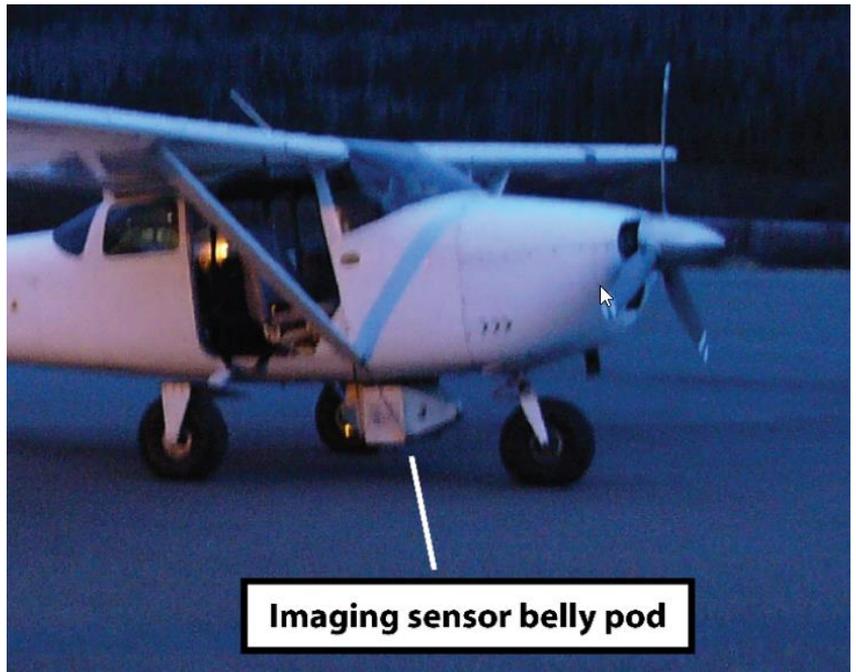
Imaging sensor belly pod

Figure 1. The occurrence aircraft on the morning of the accident with imaging sensor belly pod installed (Source: Precision Vector Aerial Inc., with TSB annotation)

On 01 May 2019, an imaging-sensor-equipped belly pod was installed on the aircraft (Figure 1), as per Supplemental Type Certificate (STC) SA4-662. On 02 and 03 May, flights were conducted to test and calibrate the scanning equipment to detect underground hot spots in areas of previous fire activity.

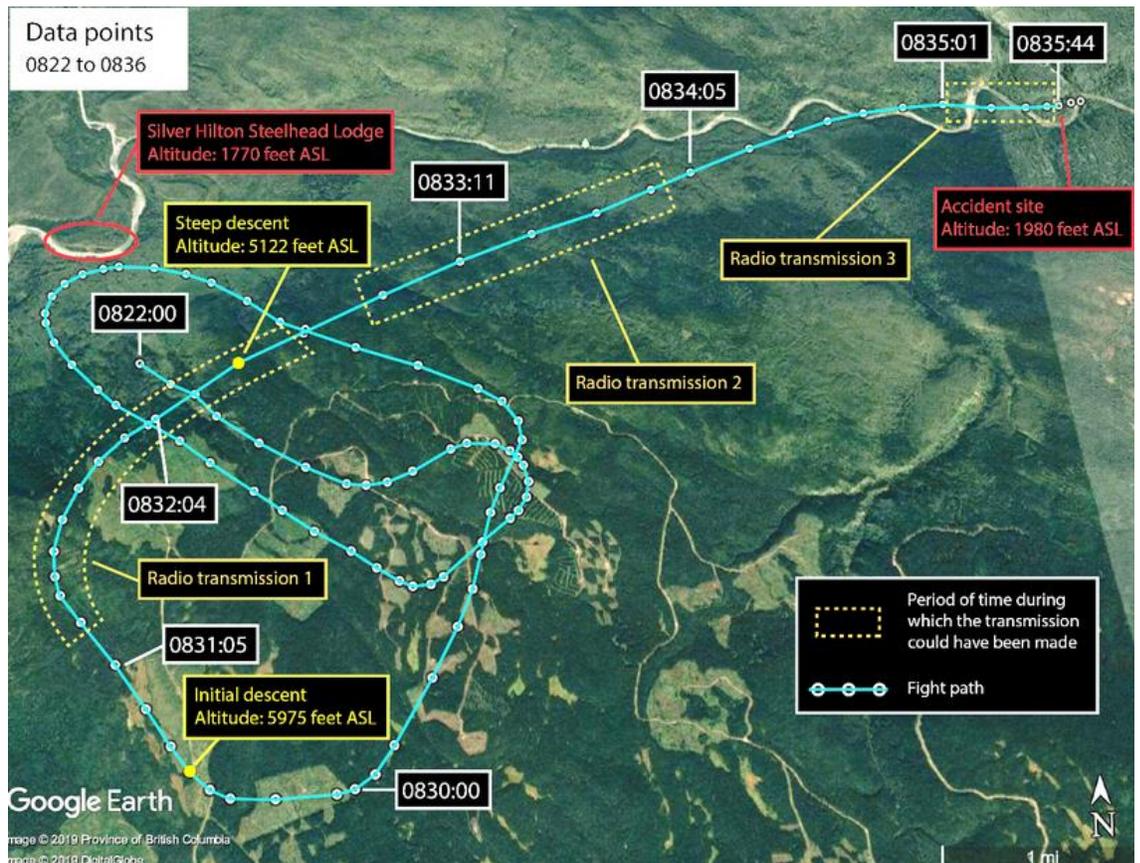
Figure 2. Flight path of the occurrence aircraft (dotted line) with associated events (Source: Google Earth, with TSB annotations)

At 08:32, the pilot advised the Northwest Fire Centre (NWFC) dispatchers that the aircraft would be landing at the Silver Hilton Steelhead Lodge airstrip, which was located approximately 2.5 NM to the northwest (Figure 2, radio transmission 1).

At 08:33, the pilot transmitted a Mayday call to the NWFC dispatchers indicating that the flight would be unable to reach the Silver Hilton Steelhead Lodge airstrip and stated that he would “land 5 miles west” of the airstrip (Figure 2, radio transmission 2).

At 08:35, a final transmission from the pilot was received giving the position of the aircraft (latitude and longitude) and stating that the aircraft would be landing in the trees (Figure 2, radio transmission 3). Less than 1 min later, the aircraft crashed into a forested area adjacent to the Babine River. The 406 MHz ELT activated on impact and transmitted a signal, which was received by the Canadian Mission Control Centre (CMCC). The CMCC then relayed the information to the Joint Rescue Coordination Centre (JRCC) Victoria.

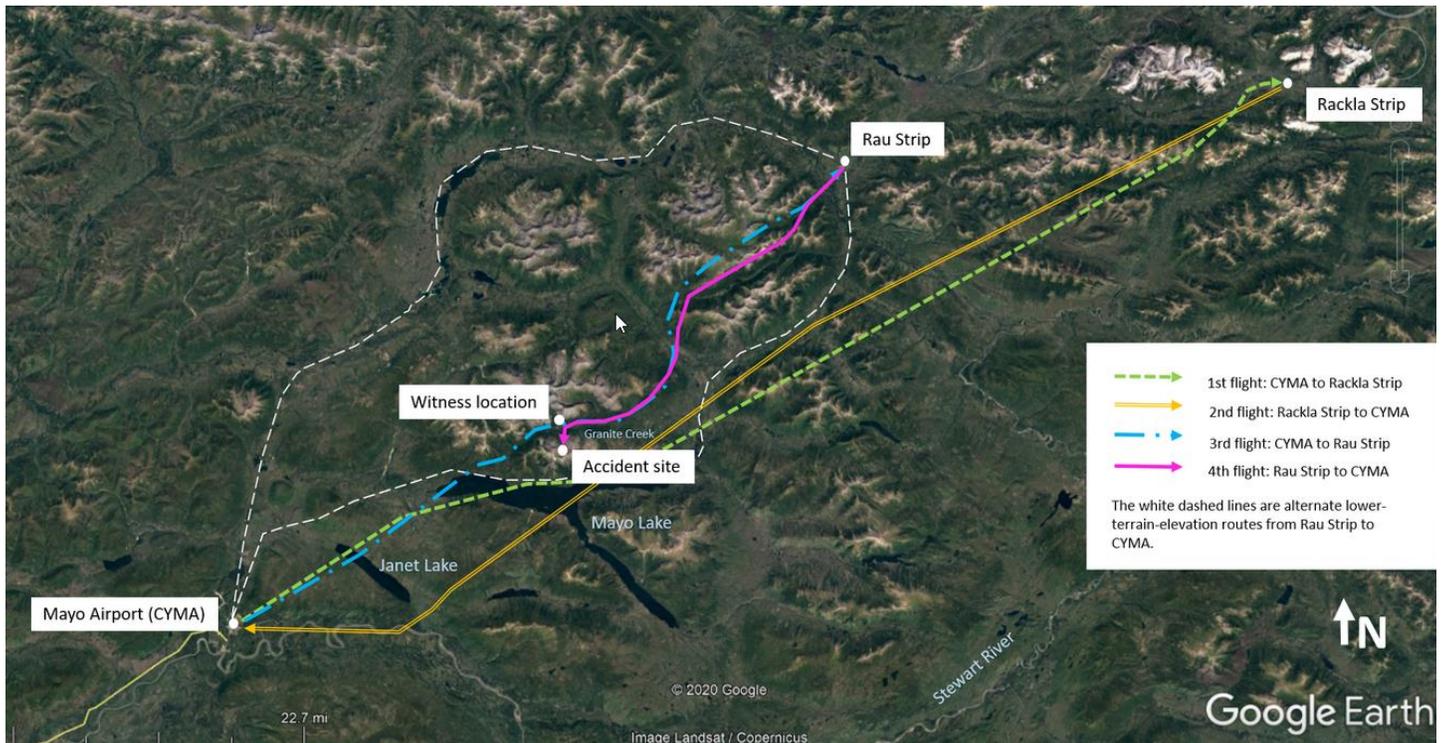
On 6 August 2019, the Cessna 208B Grand Caravan aircraft was scheduled to depart from Mayo Airport (CYMA), Yukon, at 08:30 to conduct four flights under VFR (Figure 1):

Figure 1. Flight path data

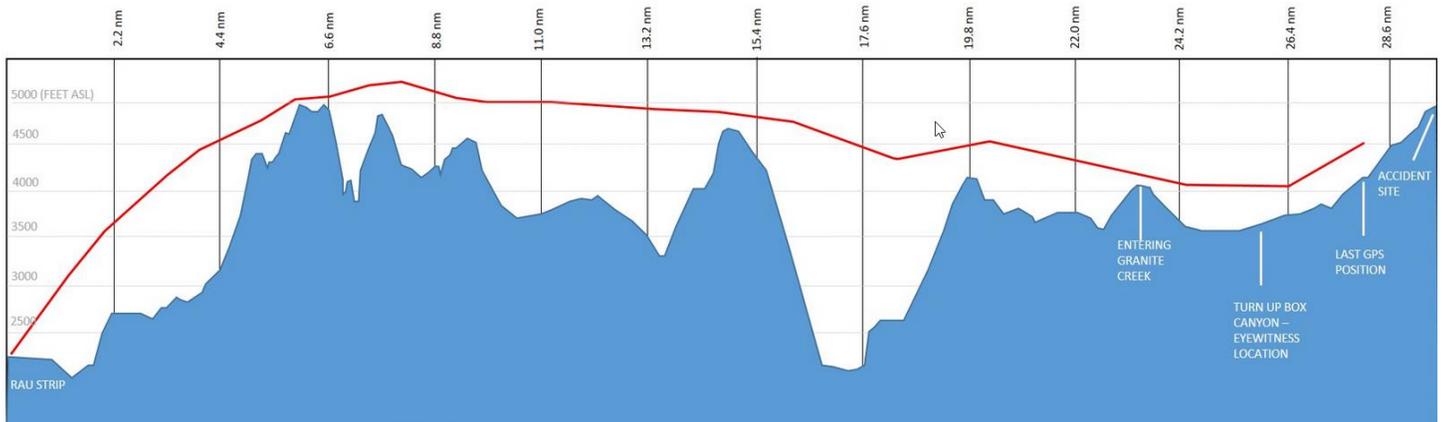
Figure 2. Profile view of accident flight showing GPS altitude (red line) compared to Google Earth terrain elevation

The route of the fourth flight from Rau Strip to CYMA was the reverse of the previous flight. The aircraft entered Granite Creek at 4 300 ft ASL and was flying at a ground speed of 156 knots (kt) (Figure 2). Eyewitnesses at an exploration camp approximately halfway along Granite Creek heard and then observed the aircraft flying at near treetop level. The cloud bases to the west of the exploration camp were at treetop level.

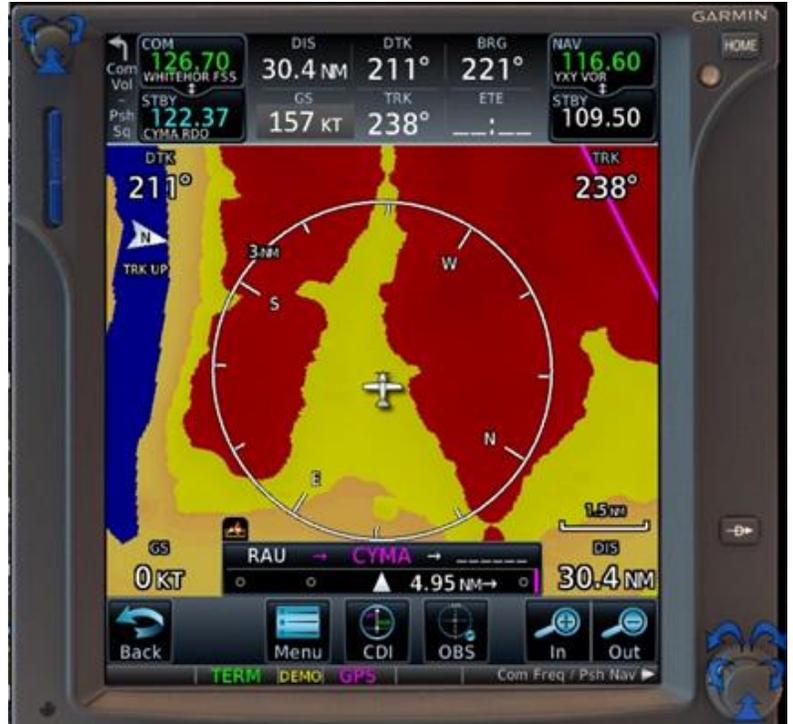
The system displays visual and aural terrain alerts to the pilot in several ways. There are threat location indicators on the display that colour the terrain yellow when the terrain is between 1 000 and 100 ft below the aircraft (Figure 3). This is accompanied by a visual annunciation of TERRAIN on the lower left corner of the display and an accompanying aural message of "terrain ahead; terrain ahead." Terrain is depicted red when the terrain is above the aircraft or less than 100 ft below the aircraft's GPS altitude. This is accompanied by a visual annunciation of PULL-UP and an aural message of "terrain ahead, pull up; terrain ahead, pull up" (Figure 4).

Figure 3. GTN 750 simulator display of terrain depiction based on GPS data entering Granite Creek at 4 000 ft ASL. Magenta line is direct track between Rau Strip and CYMA (Source: Garmin, with TSB annotations)

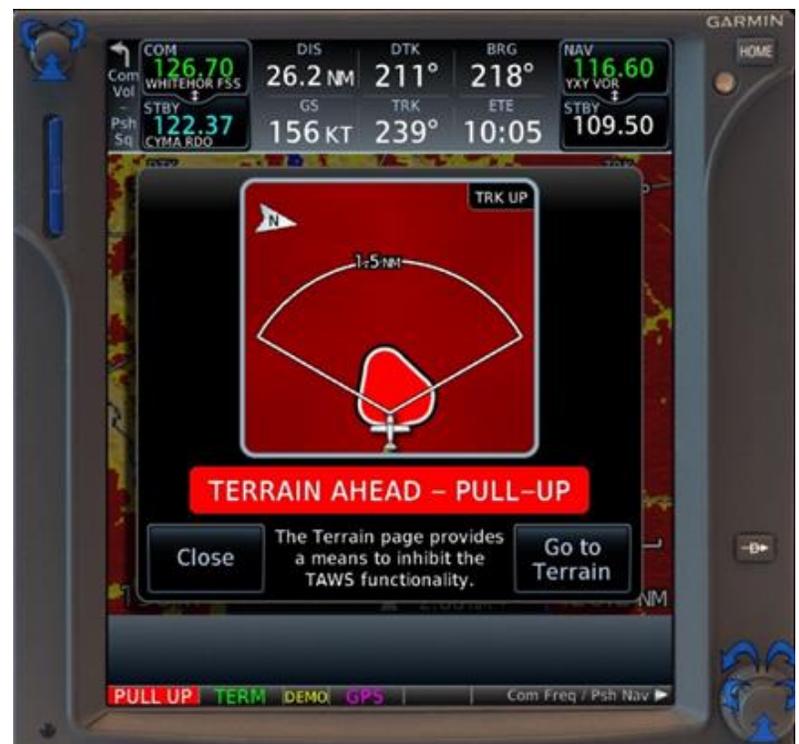
Figure 4. GTN 750 simulator display of terrain warning based on GPS data about 90 s before impact at 4 000 ft ASL (Source: Garmin, with TSB annotations)

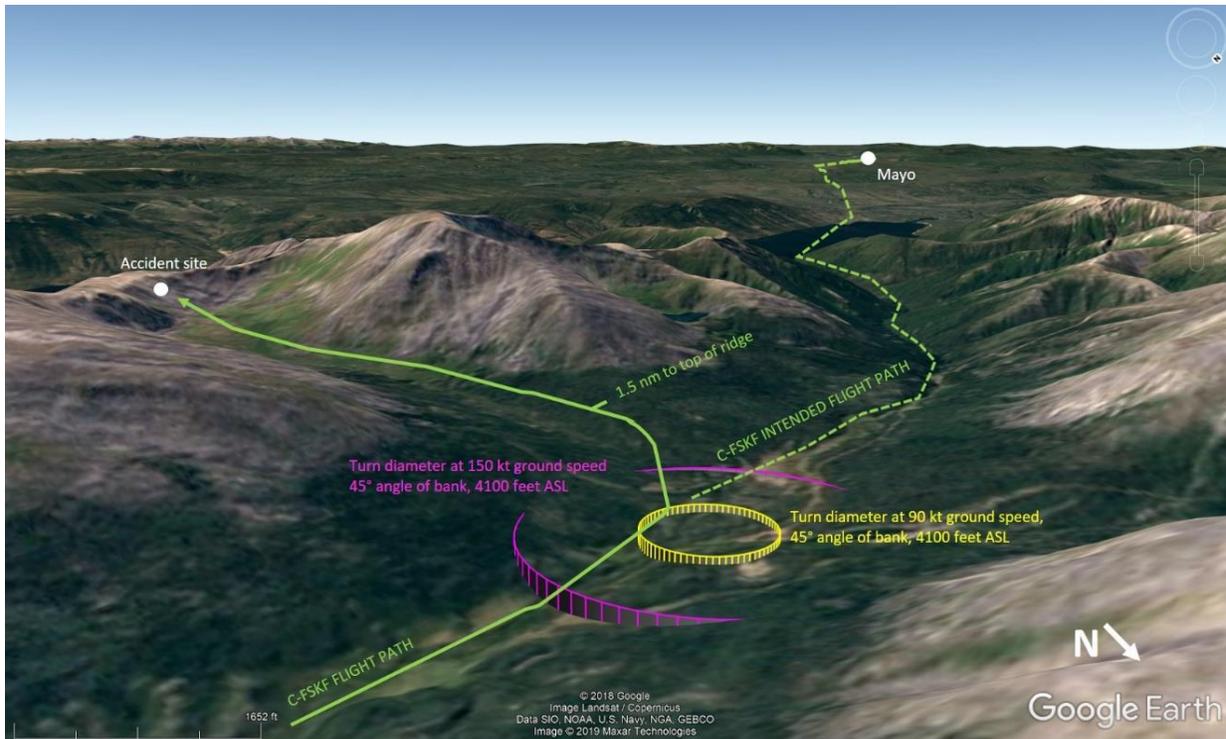
At a constant ground speed of 90 kt, an aircraft would need a turn diameter of 1 441 ft at a 45° angle of bank and 15 s to complete the course reversal (Figure 6).

Figure 6. Comparison of turn diameters at various ground speeds in Granite Creek
(Source: Google Earth, with TSB annotations)

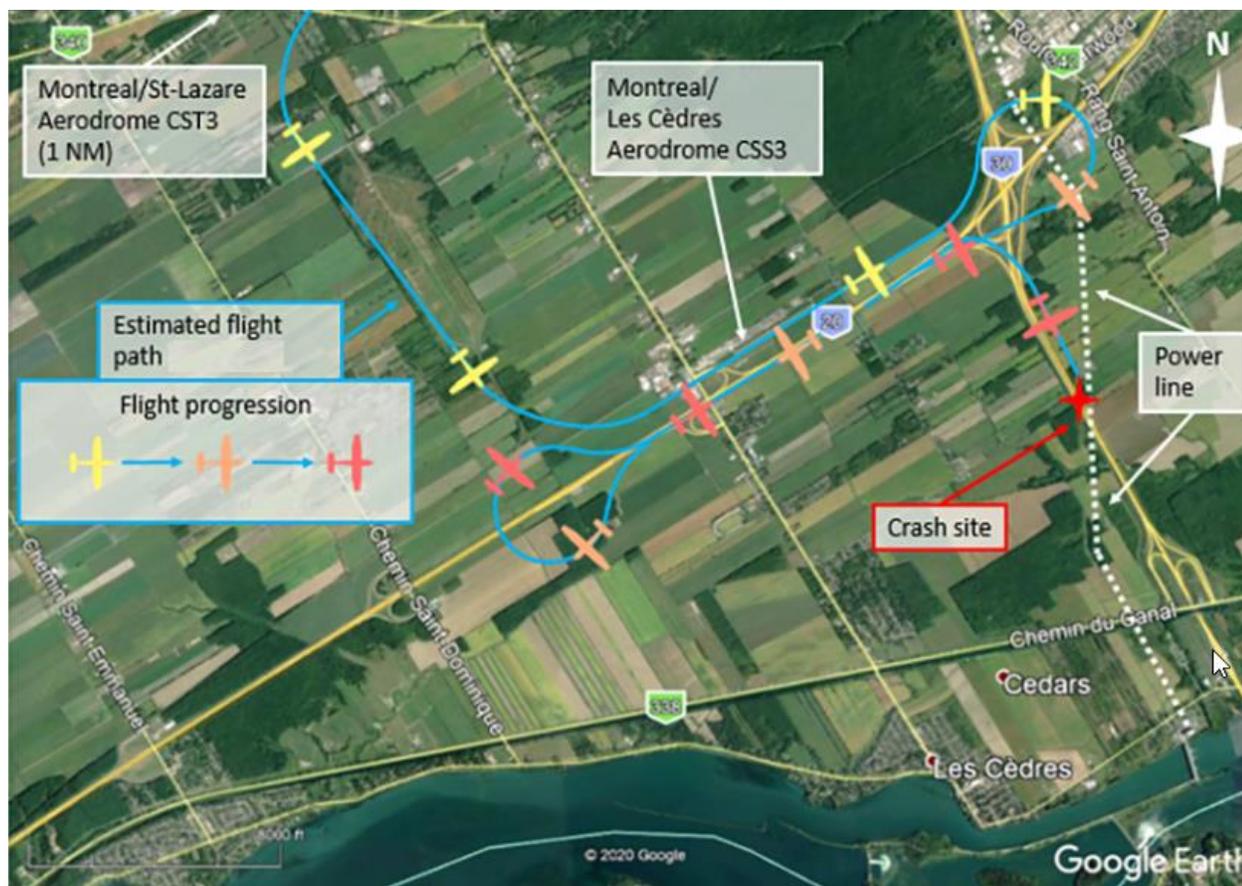
At approximately 18:27 on 17 February 2020, a privately registered Cessna 150M, with a passenger seated on the right and the pilot seated on the left, took off from the Montréal/St-Lazare Aerodrome (CST3), Quebec, for a night flight under visual flight rules (VFR). At approximately 18:30, the aircraft conducted an approach to Runway 07 at the Montréal/Les Cèdres Aerodrome (CSS3), Quebec, followed by a pull-up. The aircraft then conducted a 180-degree turn over the interchange between Highway 20 and Highway 30 and flew westbound over Highway 20 at a very low altitude (Figure 1).

Figure 1. Estimated path of the occurrence aircraft (Source: Google Earth, with TSB annotations)
