ISSUE 2/2022

AVIATION **S**AFETY **L**ETTER

TP 185E

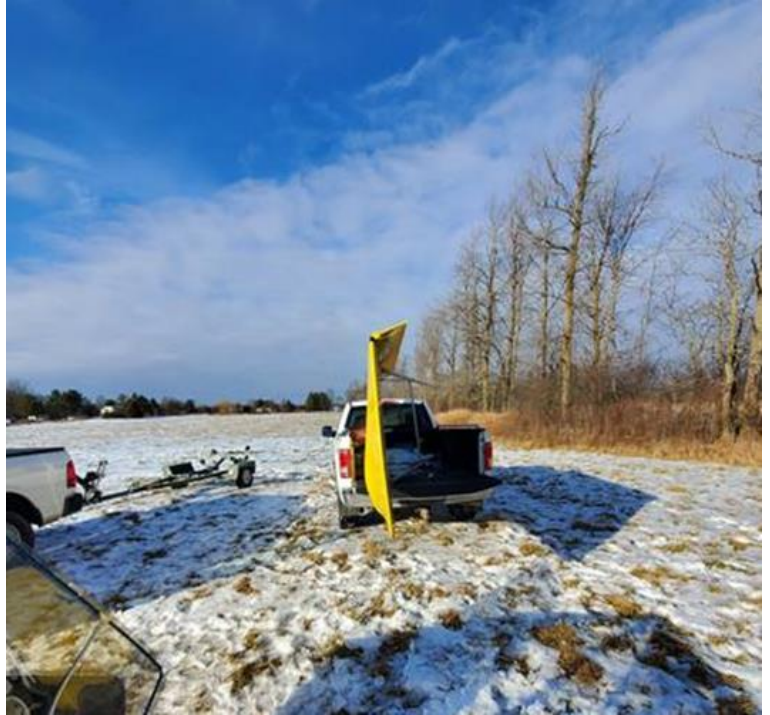
*Credit: Gordon Dyck
Wings are off in the back of pick-up truck*

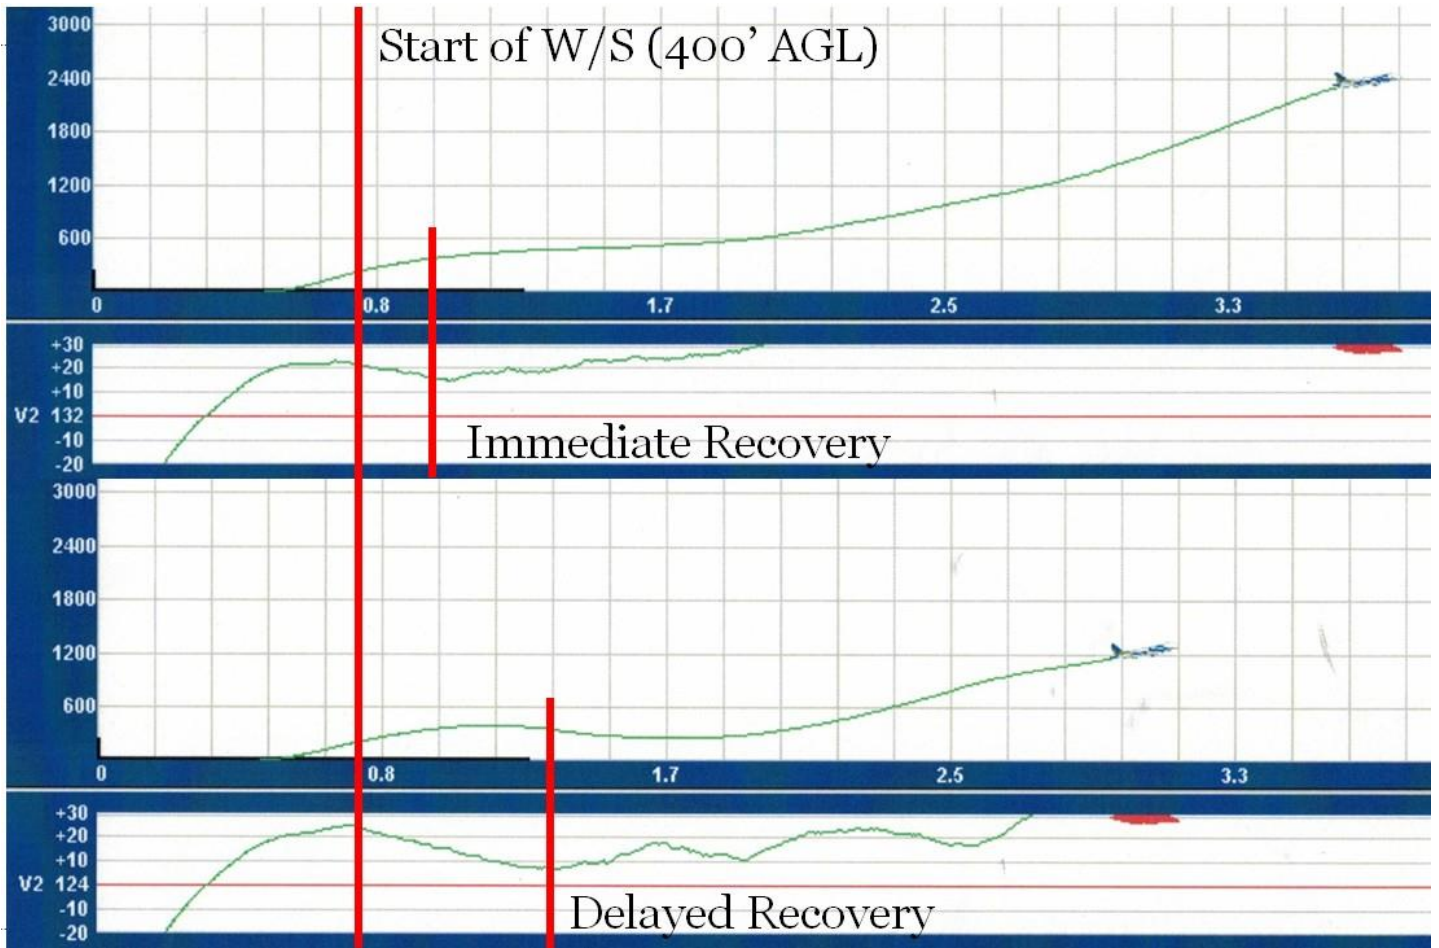
Comparative windshear recoveries

In both cases, the performance decreasing shear started as the aircraft was climbing through 400 ft above ground level (AGL). In the first case, the pilot quickly recognized that the aircraft speed should not be decaying and initiated recovery immediately. In the second case, the pilot waited until speed had decayed to nearly V_2 before initiating recovery—approximately $\frac{1}{2}$ nautical miles (NM) later along the departure path.

It should be noted that the second pilot flew the recovery more effectively; they were much more accurate at maintaining the target speed of V_2 . However, the first pilot, even though they flew at $V_2 + 20$, didn't get a sink

during the manoeuvre like the second pilot did. Why? It may be worth considering the extra energy the aircraft was carrying when the recovery was initiated in Case 1.

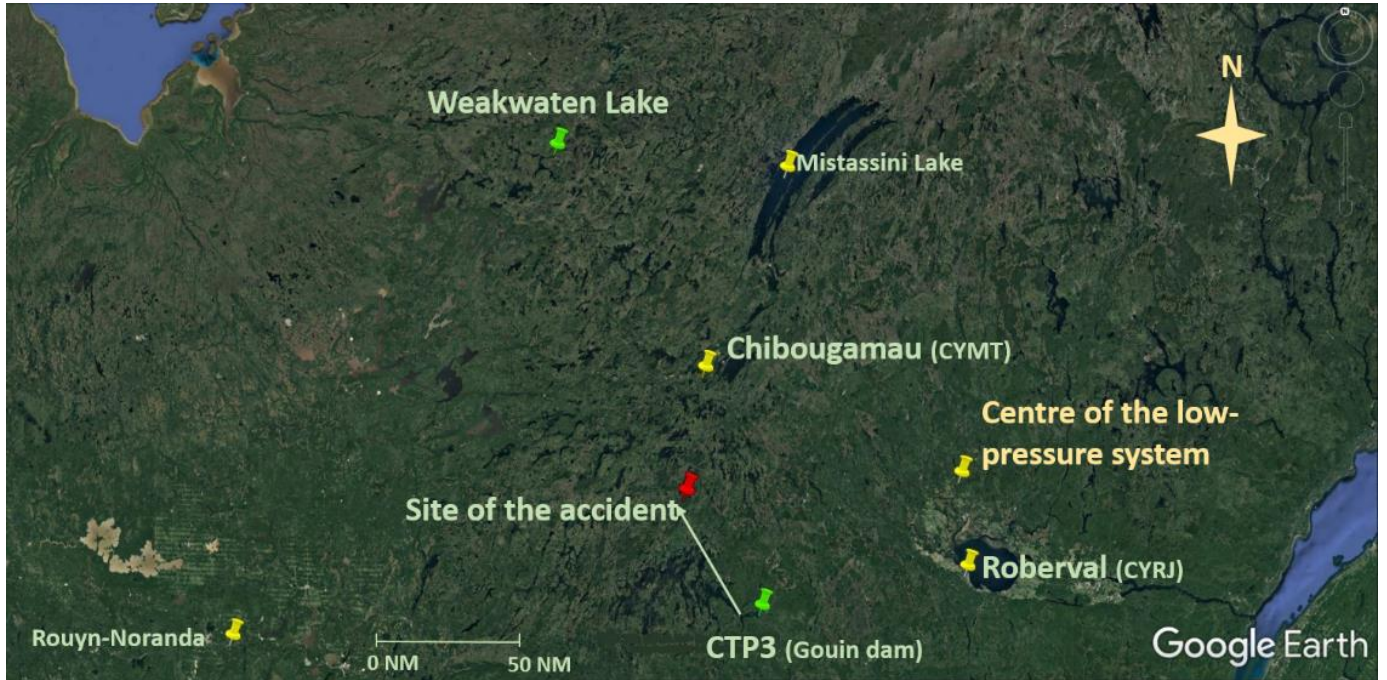
Figure 1. Centre of the low-pressure system in relation to the points of interest in the occurrence (Source: Google Earth, with TSB annotations; map data: Image Landsat/Copernicus, Data SIO, NOAA, U.S. Navy, NGA, GEBCO)

At 1300, the centre of a quasi-stationary low-pressure system was located approximately 37 statute miles (SM) north of the Roberval Airport (CYRJ), Quebec (Figure 1). Areas to the west and northwest of the low-pressure system were influenced by a cloudy return flow strengthened by high humidity, which was 87% at CTP3 and 100% near the site of the accident. Localized areas of mist, drizzle or intermittent rain were also possible in these areas, which could lead to a reduction in visibility and in the height of the cloud ceiling. Between 1300 and 1700, the Chibougamau/Chapais Airport (CYMT), Quebec, located approximately 43 nautical miles (NM) north of the scene of the accident, reported visibility varying between 2½ SM and 9 SM, with a ceiling at 400 ft above ground level (AGL) and intermittent low precipitation.

Between 1300 and 1700, the cloud base was generally between 400 and 1 200 ft AGL in the areas to the west and northwest of the low-pressure system. Given that the elevation at the site of the accident was higher than that of the weather stations providing the data, it is possible that the cloud ceiling was below 400 ft AGL in some places.

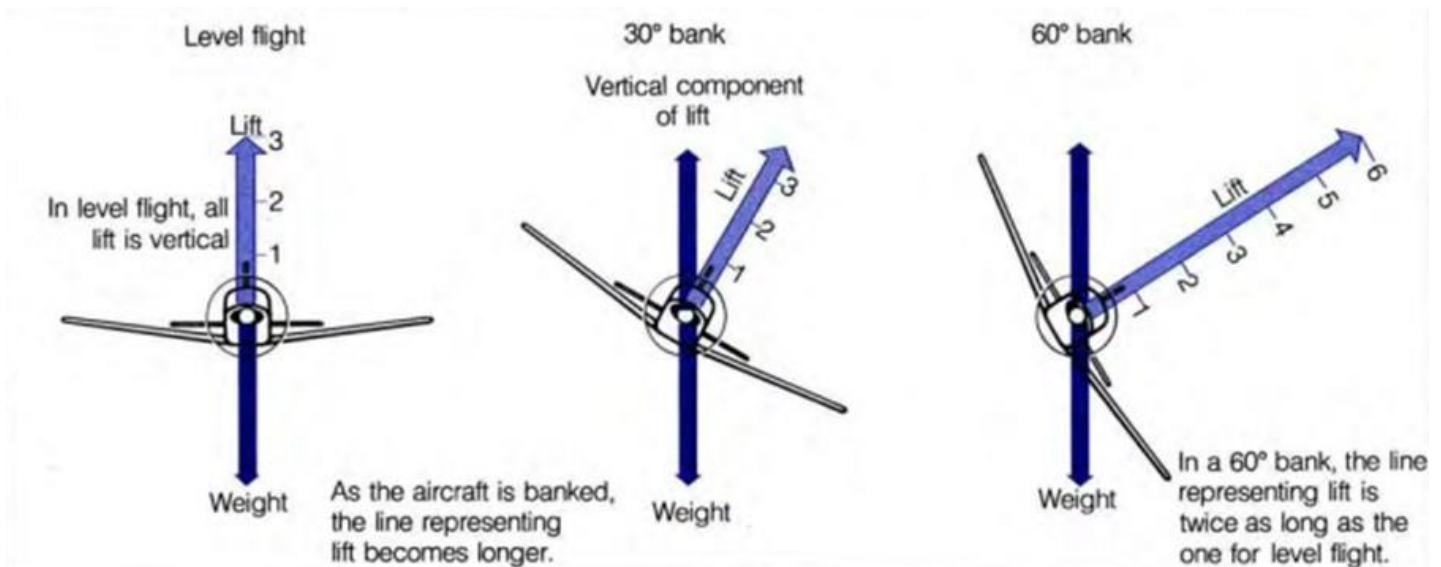
Figure 4. Relationship between lift and angle of bank (Source: Transport Canada, TP 1102E, Flight Training Manual Aeroplane, 4th edition [Revised], p. 63)

During straight and level flight, lift and weight are equal, and the load factor is 1. To maintain level flight when an aircraft is banked, the vertical component of lift must be increased to equal the weight of the aircraft; this is accomplished by increasing the angle of attack of the wing by pulling on the elevator control to maintain altitude (Figure 4).

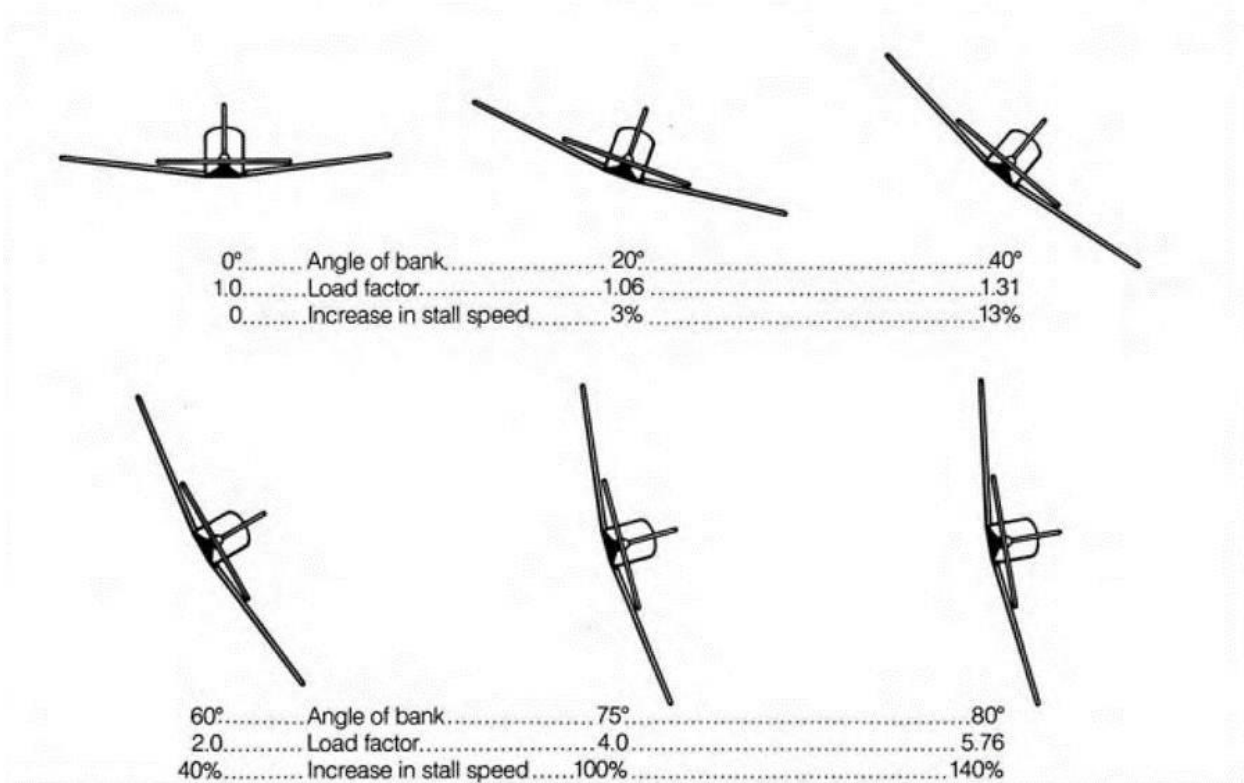
Figure 5. Relationship between angle of bank, load factor, and basic stall speed (Source: Transport Canada, TP 1102E, Flight Training Manual Aeroplane, 4th edition [Revised], p. 63)

Increasing the angle of bank increases the load factor and the aircraft's stalling speed because it causes the aircraft to perform as if it is heavier. At a 60° angle of bank, the load factor is 2, meaning that the aircraft performs as if it is twice as heavy as it would be in level flight. The stall speed is increased by 40% at a 60° angle of bank (Figure 5).

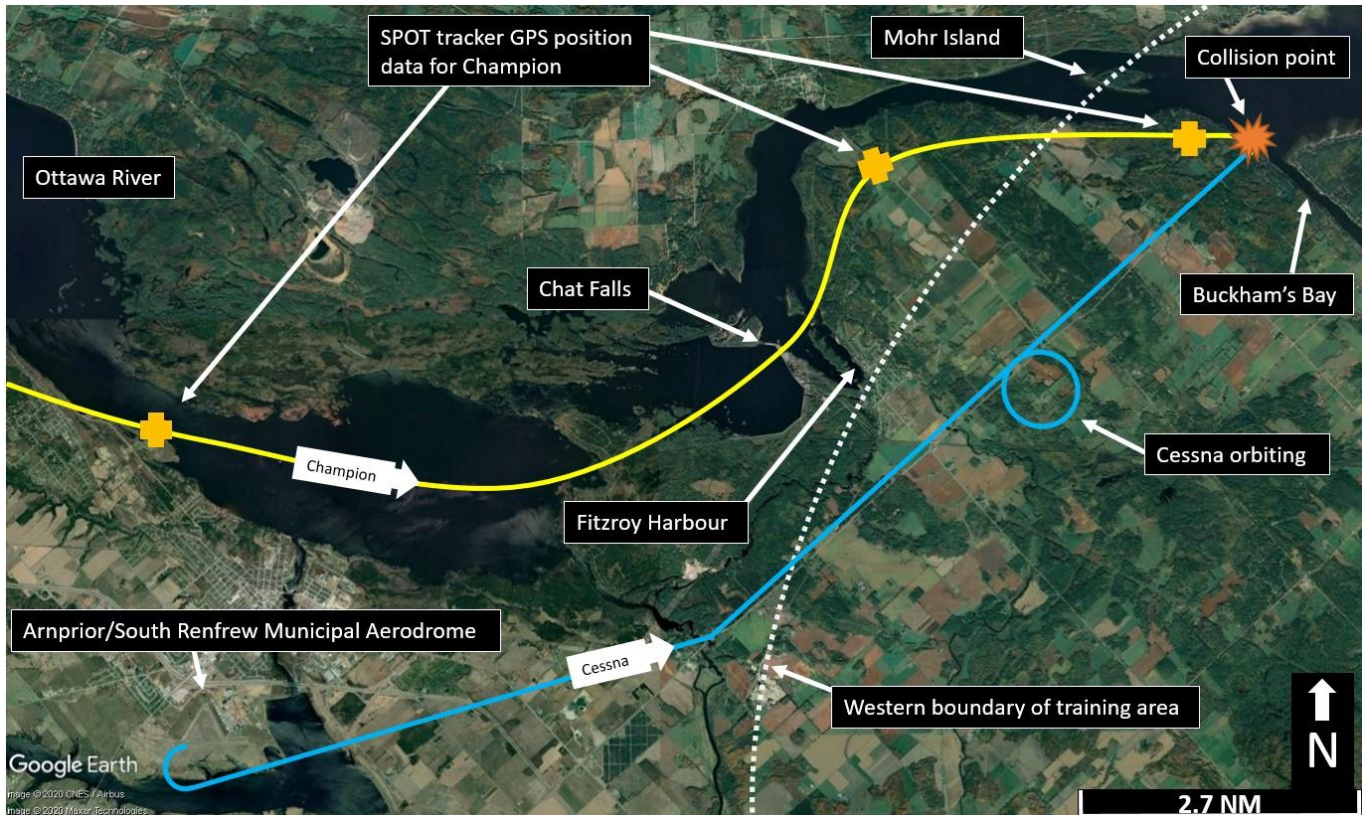
Figure 1. Estimated flight paths of the Champion and the Cessna (Source: Google Earth, with TSB annotations)

At approximately 1446, the two aircraft collided while flying over the Ottawa River near Buckham's Bay, approximately 12 NM east-northeast of CNP3 (Figure 1).
