Issue 1/2012

Canadian Aviation Service Difficulty Reports

TP 6980E
(3/2012)

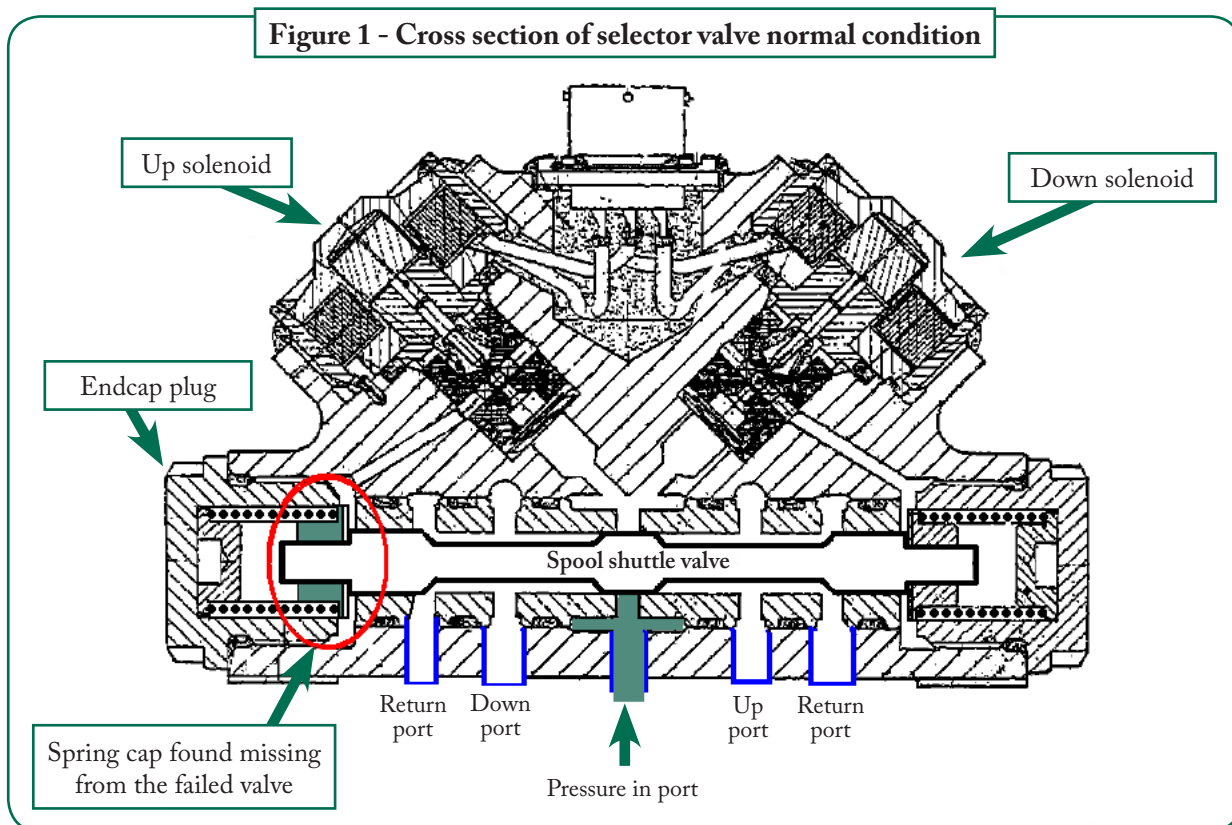
Figure 2 - Cross section of selector valve with the spring cap removed

- the unit failed an internal pressure drop test
- the unit used an unknown type of lockwire for the end-cap plugs
- the lockwire installation was "sloppy" with long pigtailed
- upon the valves disassembly, the spring cap for the spool shuttle valve of the "UP" solenoid side was found missing

It is believed that due to the missing spring cap, the spool shuttle valves last set position was such as to allow the inadvertent direction of hydraulic pressure to the “UP port” or retract side of the three gear retract actuators, portrayed in figure 2.
