Learn from the mistakes of others; you'll not live long enough to make them all yourself . . . **Issue 1/2005**

## Beware of the 180° Turn Back to the Runway...

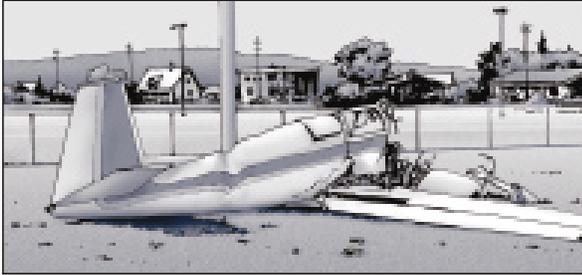
### TSB Final Report A02Q0119—Engine Failure and Loss of Control

On September 2, 2002, a Mooney M20E was to make a flight according to visual flight rules (VFR) from Québec City to Rimouski, Que. The aircraft took off from Runway 30 at 13:46 Eastern Daylight Time (EDT), with the pilot, a flight instructor, and a passenger on board. As the aircraft was climbing through 600 ft above sea level (ASL), the control tower received a radio message from the aircraft, indicating that the engine had failed and an emergency landing would be made. The aircraft was observed in a steep right turn before nosing down and crashing near a baseball field, less than 1 NM north of the end of Runway 30. The aircraft was destroyed on impact but did not catch fire. The three occupants were fatally injured.

The fuel selector on Mooney M20 models A to G can be hard to reach without interfering with the flight controls, thereby adversely affecting the pilot's ability to control the aircraft.

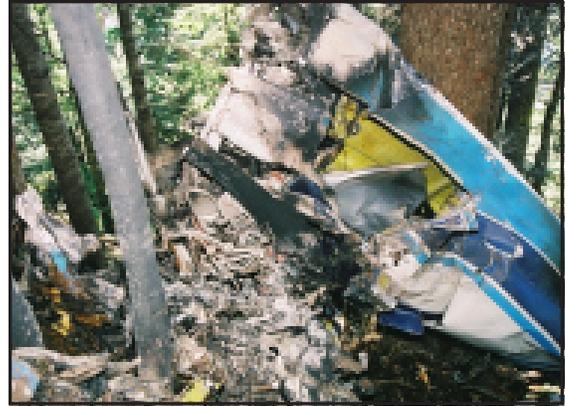
### TSB Final Report A03P0133—Controlled Flight Into Terrain (CFIT)

On May 31, 2003, a Cessna 182 took off from a private airstrip near Chilliwack, B.C., with the pilot and four skydivers on board at approximately 18:40 Pacific Daylight Time (PDT). Two skydivers were released at 3 000 ft and two at 9 000 ft. The aircraft failed to return to the strip. No ELT signal was received. The Rescue Coordination Centre (RCC) at Victoria, B.C., was notified and a search was initiated. The aircraft was found six days later on a northwest-facing slope of the Skagit mountain range, 4 NM from the private airstrip, at an altitude of about 4 600 ft ASL. A fire had broken out on impact and consumed much of the cockpit area and left wing. The aircraft was destroyed. The pilot was fatally injured.

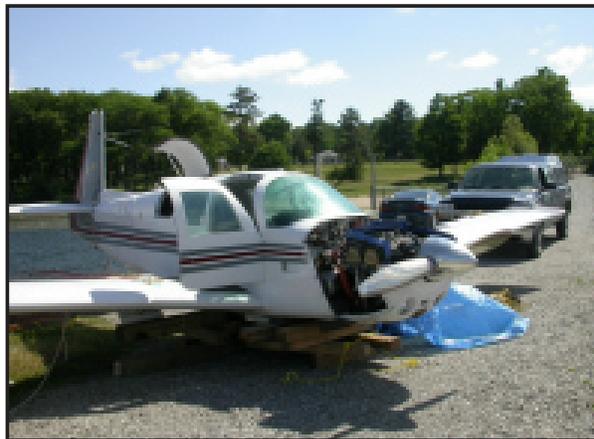
#### **TSB Final Report A0300156—Engine Failure and Forced Landing on Water**

On June 24, 2003, a Mooney M20E aircraft, with only the pilot on board, departed the Midland/Huron Airport, Ont., at 07:15 EDT, on a VFR flight to Charleston, West Virginia. A few minutes after takeoff, the pilot transmitted a distress call to Toronto Buttonville flight service station (FSS), reporting that the engine had lost power and he was diverting to Collingwood airport for an emergency landing. Shortly afterwards, he reported a total loss of engine power and his intention to ditch the aircraft in Georgian Bay. At 07:23 EDT, he reported his position to Toronto Buttonville FSS as 7.5 SM from Collingwood at 3 000 ft ASL, and indicated that the ELT was armed. This was the last radio transmission from the aircraft. The aircraft struck the water shortly thereafter. Two pilots flying in the vicinity heard the distress call. Both pilots volunteered to divert to the last position reported by the Mooney, but their search for the aircraft was unsuccessful. The RCC was notified, and at 09:12 EDT, located the aircraft submerged in 58 ft of water, 5 mi. west-southwest of Wasaga Beach, Ont. Divers were requested, and brought to the site by helicopter. The divers entered the water at 09:32 EDT and examined the aircraft, but could not locate the pilot. Once search and rescue (SAR) personnel departed the site, police divers took over the search for the pilot; his body was found at approximately 19:30 EDT.

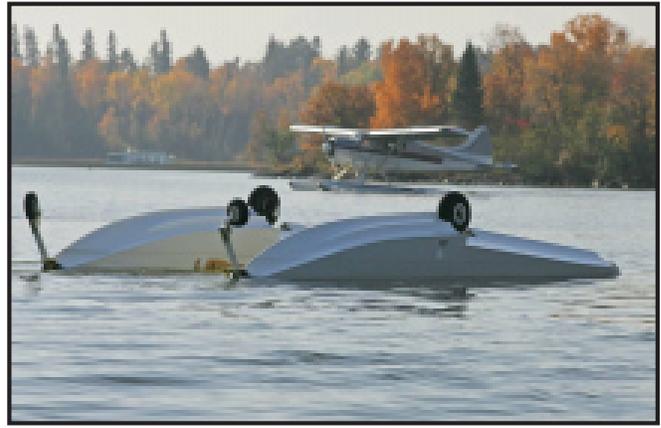
This amphibious float-equipped Cessna A185F was being flown a short distance between water bases. The pilot called the nearest flight information centre (FIC) to advise that the aircraft was on approach and would be landing at destination. The aircraft touched down with the amphibious wheels extended and the aircraft overturned on landing. The uninjured pilot was taken to hospital, examined and subsequently released.

*Why did the pilot forget the wheels you ask? Could the short transit and rushed procedures have had anything to do with it? —Ed. △*
