Transport  
Canada

# Issue 1/2013 **Feedback**

Canadian Aviation Service Difficulty Reports

TP 6980E  
(1/2013)

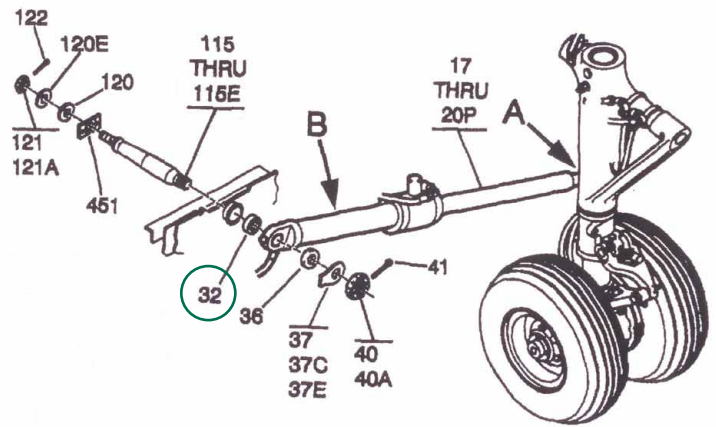
Illustrated Parts Catalogue main landing gear side-stay actuator and attachment hardware.

Cracked conical spacers, Item 32

*Transport Canada Civil Aviation is advising all Learjet 60 and 35A owner, operator and maintainers of this possible condition. ✖*
