TP 185E
Issue 1/2014

AVIATION SAFETY LETTER

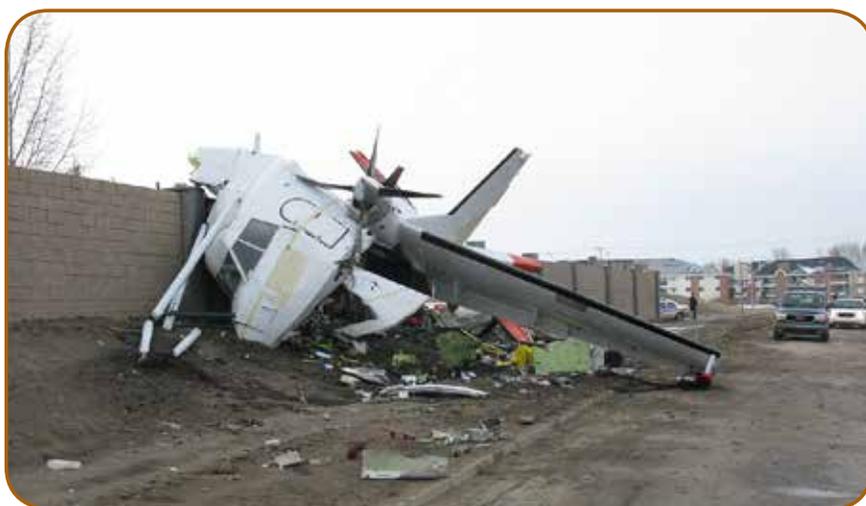
Right engine power loss

The torque sensor had accumulated approximately 6 470 hr since overhaul in 1997. The torque sensor assembly does not have a designated overhaul period and is normally overhauled with the engine. The laboratory analysis indicated that the case hardening of the gear tooth flanks and roots of two spur gears in the torque sensor gear train was below the manufacturer's specification requirements and likely led to the wear of the loaded faces and flanks of the gear teeth. The combined wear of the two gears likely caused an abnormal vibration that produced excessive cyclic loading and eventual fatigue cracking in the tooth roots of the intermediate gear. The intermediate

spur gear subsequently separated into several fragments and caused the loss of power transmission to the high-pressure, engine-driven fuel pump. The immediate result would have been fuel starvation of the engine, flameout and loss of power.
