Transport  
Canada

TP 185E  
Issue 2/2014

# AVIATION SAFETY LETTER

TSB Final Report Summaries

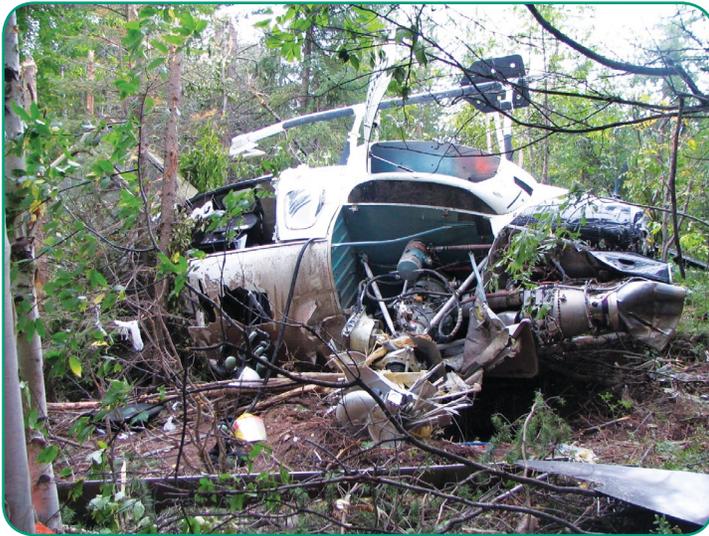
On September 1, 2010, at 15:29 EDT, a Eurocopter AS350 B-2 departed on the 85-NM VFR flight from a worksite to the Hydro-Québec helicopter base near Chibougamau, Que., with the pilot and three passengers on board. Approximately 20 NM northwest of the destination, the pilot deviated from the direct route to make a precautionary landing due to reduced visibility in heavy rain and thunderstorms. On final approach to land, and at approximately 70 ft AGL, the pilot lost all visual reference. The aircraft collided with trees coming to rest on its left side. The pilot and the passenger seated in the front were seriously injured. The two passengers seated in the rear suffered minor injuries. The aircraft sustained substantial damage. There was no post-crash fire. The ELT activated on impact. *The TSB authorized the release of this report on December 12, 2011.*

1. Although the pilot was aware of the passage of a cold front forecast for the time of the return flight, a weather update was not obtained as weather at the worksite was VMC throughout most of the day.
2. The pilot had not anticipated catching up with the line of thunderstorms which had previously passed over the worksite. The decision to deviate and/or land prior to encountering conditions of reduced visibility in heavy rain was made too late.
3. While attempting to execute a landing on a gravel road to wait for the weather to improve, the pilot lost all visual references in conditions of reduced visibility in heavy rain; consequently, the helicopter collided with the trees and ground.

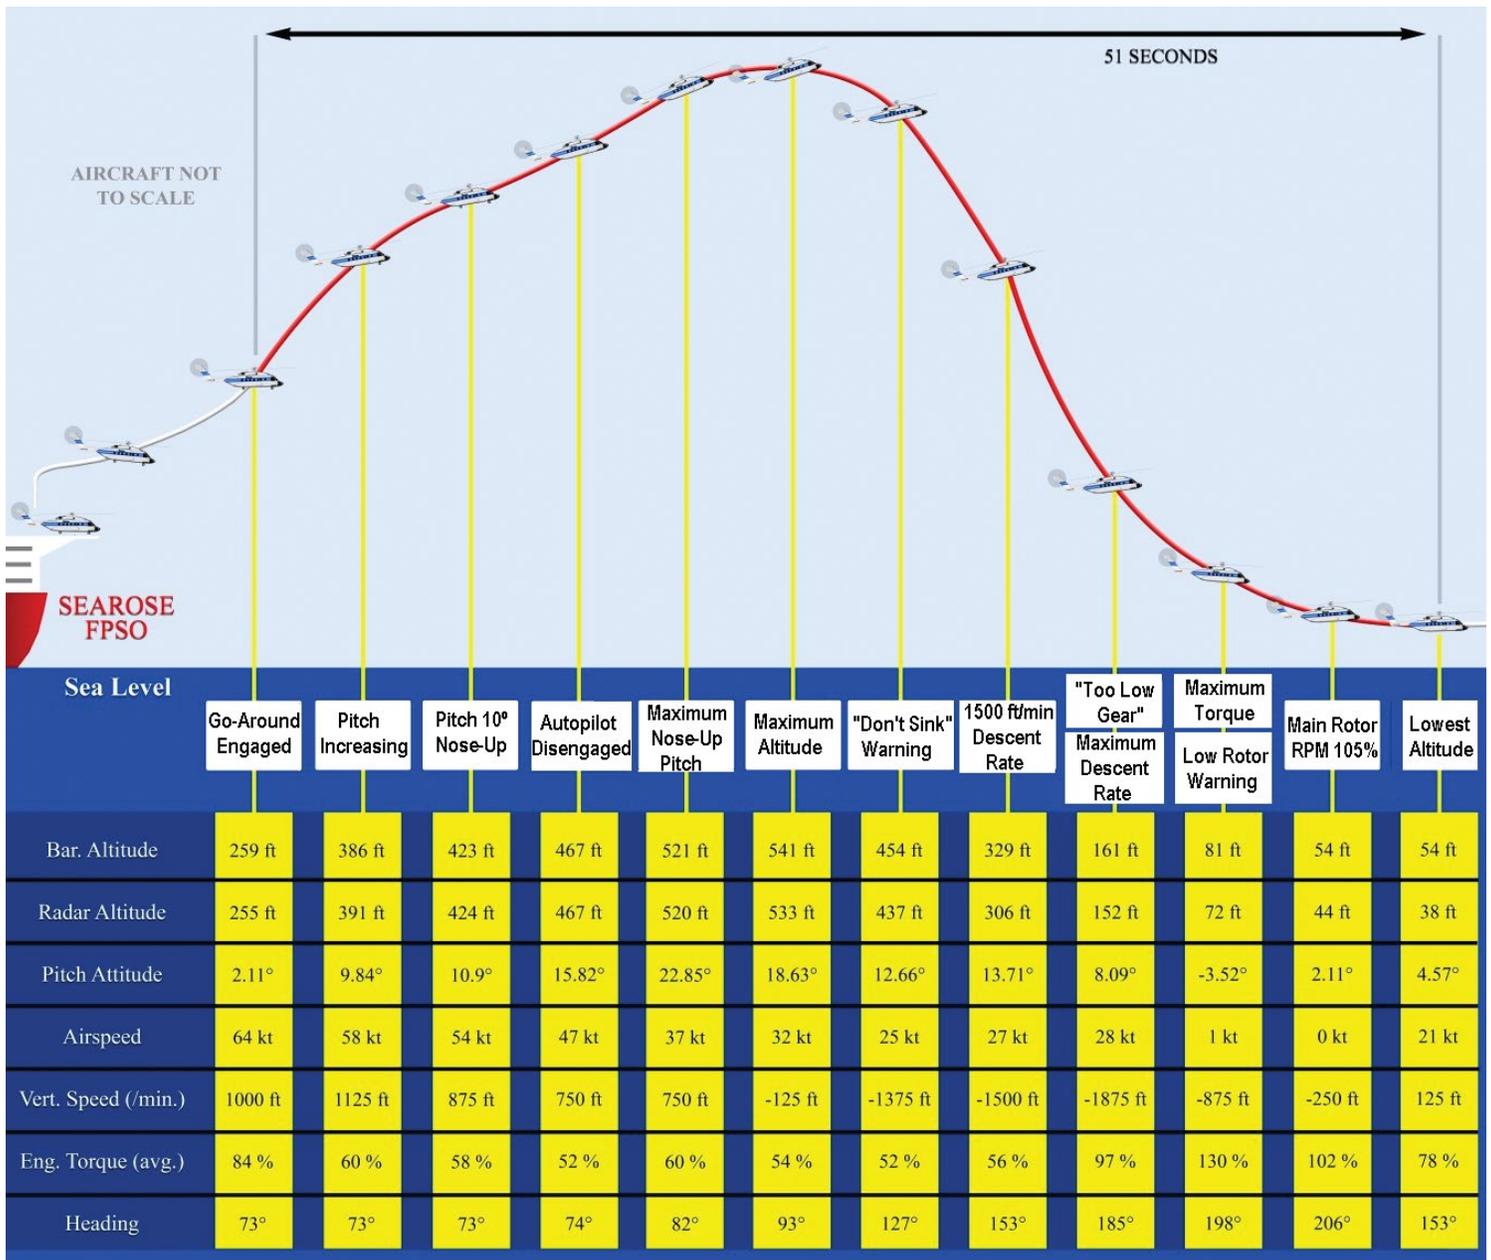
Departure profile (derived from flight data recorder (FDR) data)

1. During the departure procedure, the captain made a large, rapid aft cyclic input just before the cyclic trim button was released and the go-around (GA) mode was engaged, which caused the helicopter to enter a nose-high, decelerating pitch attitude.

3. As the airspeed of the helicopter decreased to within 5 kt of the minimum control speed in IMC ( $V_{MINI}$ ), the captain momentarily pressed the cyclic force trim release button and made an aft cyclic input. This caused the helicopter's airspeed to decrease below  $V_{MINI}$ , and the helicopter to enter a 23° nose-high unusual attitude.

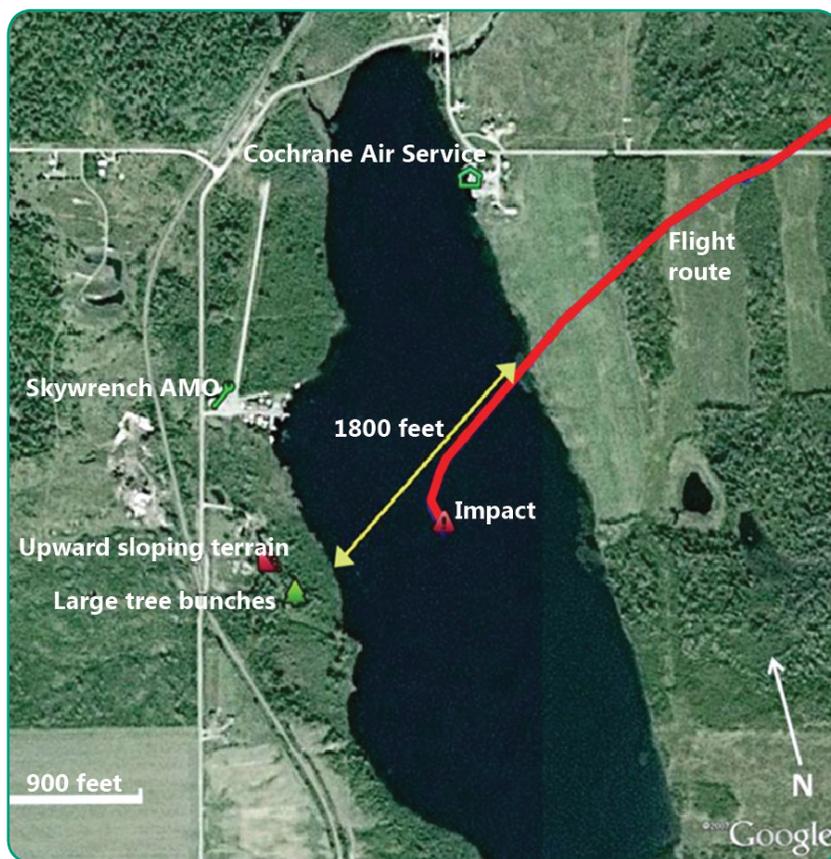
Lillabelle Lake

On May 25, 2012, a de Havilland DHC-2 Mk.1 Beaver floatplane departed Edgar Lake, Ont., with two passengers and 300 lb of cargo on board. The aircraft was destined for the company’s main base located on Lillabelle Lake, Ont., approximately 77 mi. to the south. On arrival, a southwest-bound landing was attempted across the narrow width of the lake, as the winds favoured this direction. The pilot was unable to land the aircraft in the distance available and executed a go-around. At 14:08, EDT, shortly after full power application, the aircraft rolled quickly to the left and struck the water in a partially inverted attitude. The aircraft came to rest on the muddy lake bottom, partially suspended by the undamaged floats. The passenger in the front seat was able to exit the aircraft and was subsequently rescued. The pilot and rear-seat passenger were not able to exit and drowned. The ELT activated on impact. *The TSB authorized the release of this report on September 19, 2013.*

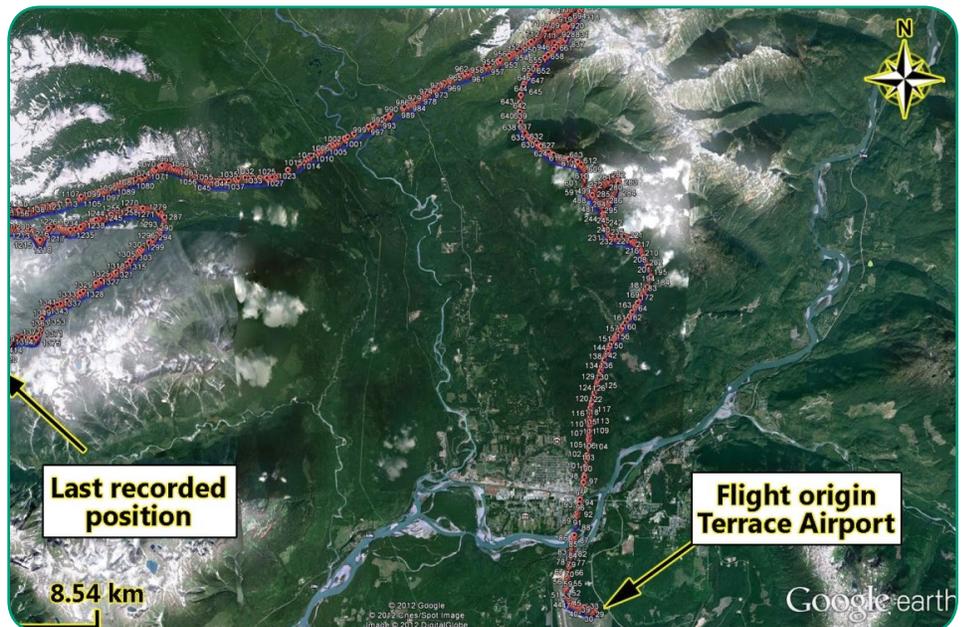
Plot of GPS data from the occurrence flight  
(Image: Google Earth, diagram added by TSB)

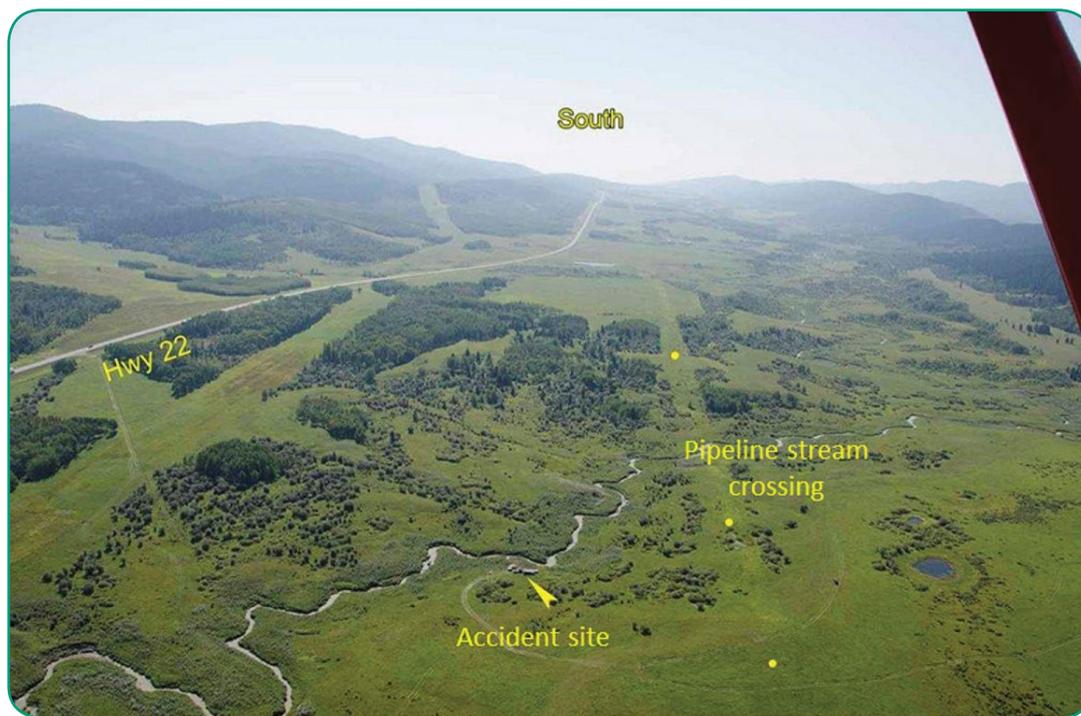
1. The conduct of single-pilot, low-level aerial inspection flights that include additional tasks beyond flying the aircraft, such as photography, increases the risk of loss of control. △

*Aerial photograph of the accident site*
