Transport
Canada

Feedback

Canadian Aviation Service Difficulty Reports

TP 6980E
(4/2013)

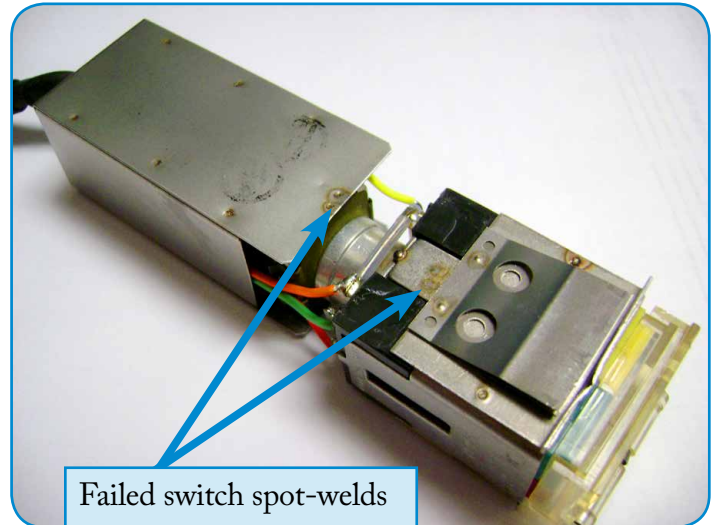
An indication fault as seen here can be as serious as a true engine fire fault. ✖

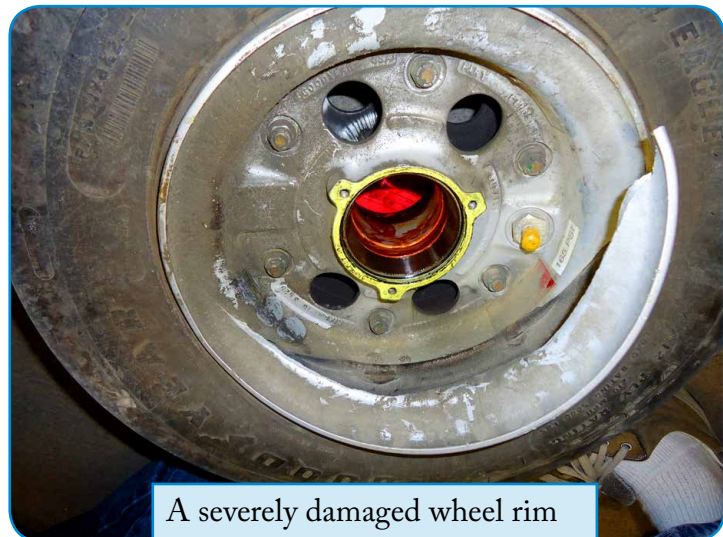
Through discussion with the operator, it has been confirmed that for all tire assembly replacements, the rim halves require an eddy current inspection in the bead seat radius. Reference Learjet aircraft maintenance manual (AMM) 32-42-00. ✖

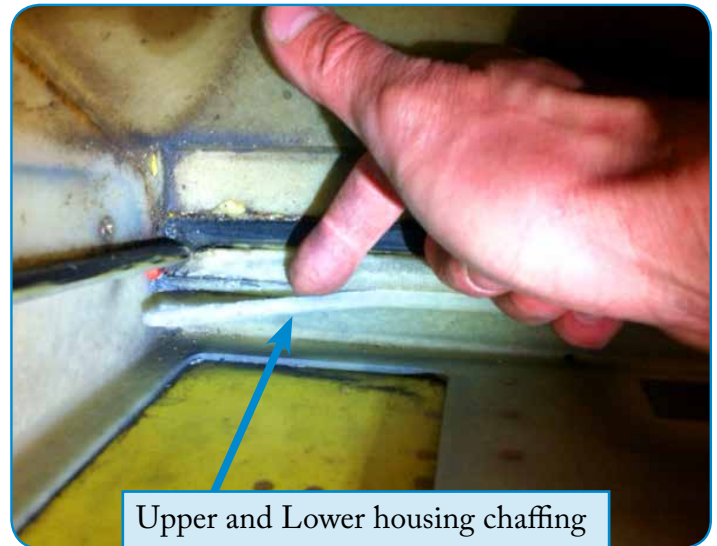
A heads up to maintainers that have this STC installed to pay attention to this area during installation and inspection. ✂

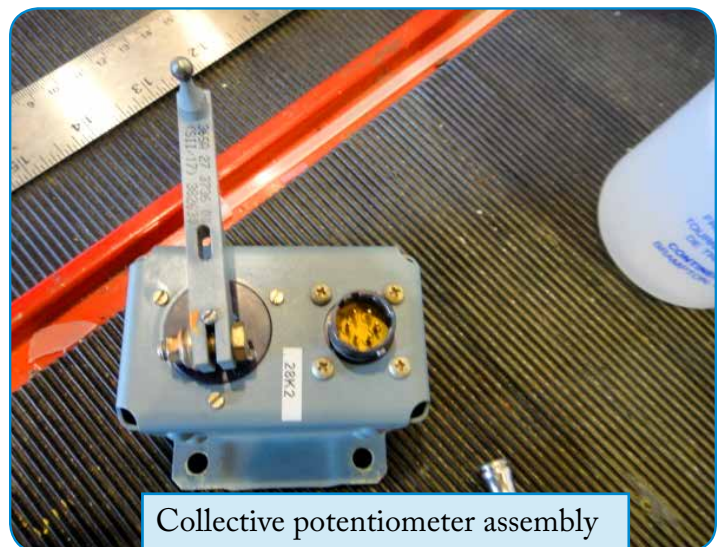
Eurocopter issued Alert Service Bulletin 76.00.18, which introduces a modification to eliminate the potential for a rotor RPM drop in-flight. The modification involves reconditioning the electrical harness that connects the engine computers digital engine control unit (DECU) to the engine anticipator potentiometer, in order to eliminate any over-length and loops from this electrical harness. ✂

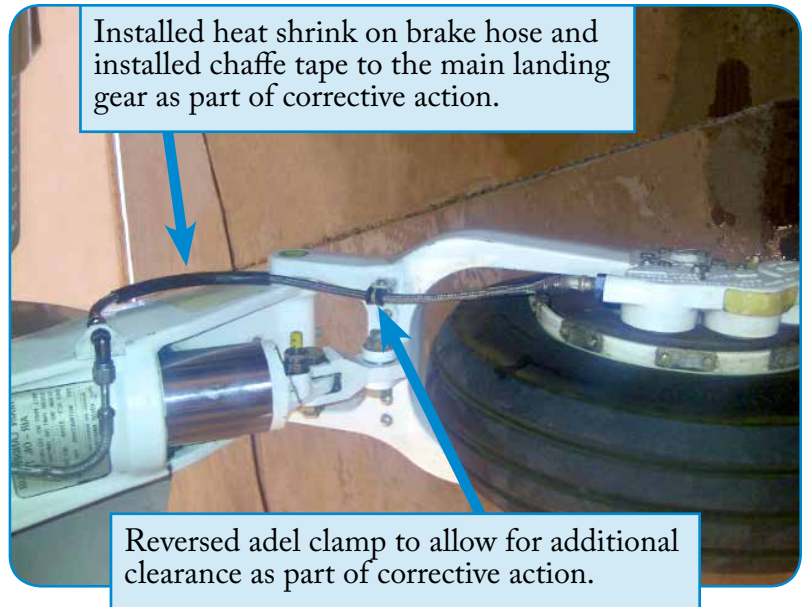
This incident illustrates the importance and vigilance of routing and proper security of hoses and clamps in vital aircraft systems. Failure to do so may have catastrophic consequences. ✖
