ISSUE 1/2021

AVIATION **S**AFETY **L**ETTER

TP 185E

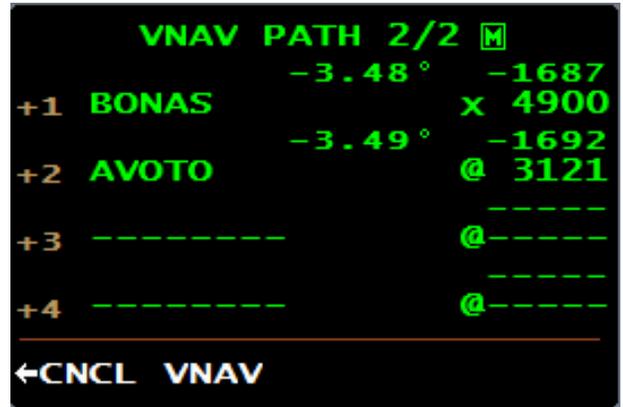
FMS screen

If you are flying a BARO VNAV path (RNP, LNAV/VNAV) with a FMS that does not use temperature compensation, you may expect the following PAPI indications when entering the visual segment of the approach. An additional caution must be observed when flying LNAV *with advisory BARO VNAV. The advisory BARO VNAV is derived from the runway threshold altitude +50 ft and projected back up the approach slope at 3° or the steeper angle required to provide a descent path above all step-down altitudes in the final approach segment. This provides the aircraft with a path to follow in the instrument segment of the approach that will clear all step-down altitudes and obstacles to LNAV minimums. The visual segment of the non-precision approach may require a different descent angle based on the PAPI. Dease Lake, BC, is a good example of this. The FMS has generated a path of 3.49° from BONAS to AVOTO to RWY20.

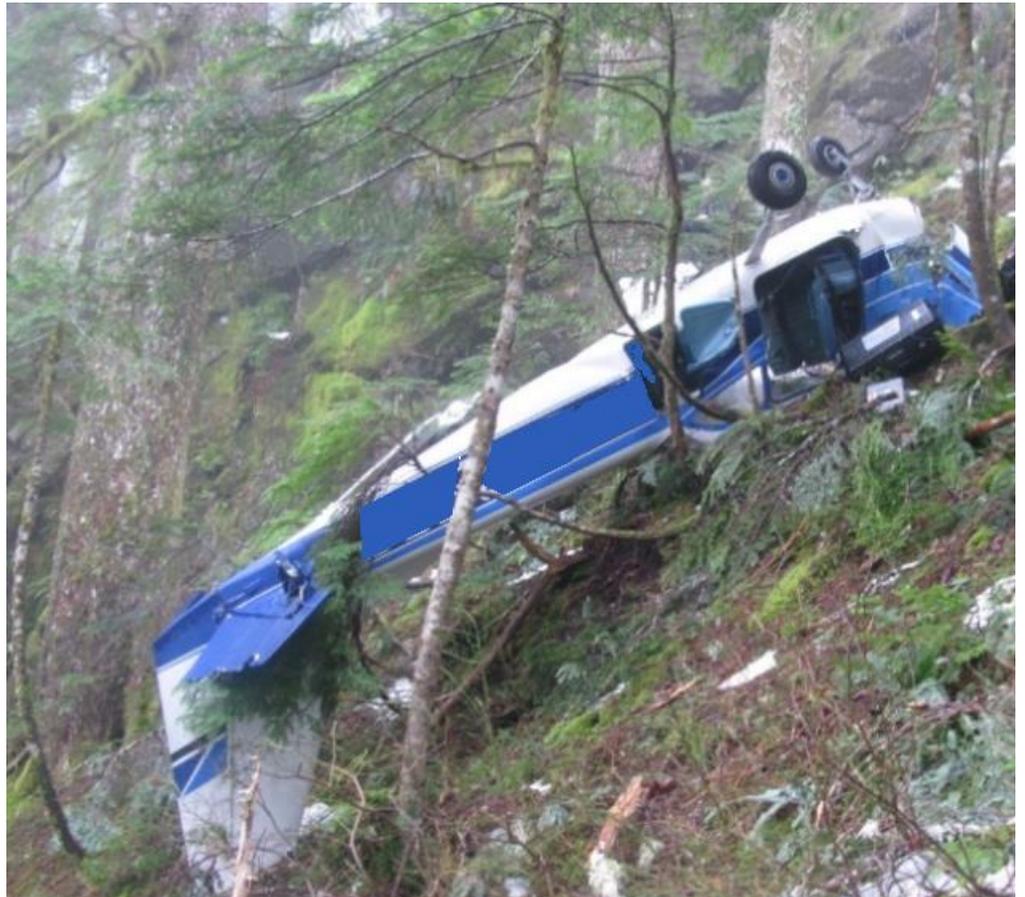
Figure 2. Occurrence site on 12 February 2020, looking west (Source: TSB)

The wreckage was found at approximately 2 600 feet ASL on a steep, densely wooded mountainside, 31 nautical miles (NM) northwest of Tofino/Long Beach Airport (CYAZ), BC. (Figure 2). Few tree tops and tree limbs were broken. The average height of the trees at the occurrence site was approximately 150 feet and those nearest the aircraft had bark scarring on the lower 60 feet, primarily on the sides facing east-southeast; the aircraft's flight path to the occurrence site from CAH3 was from the east-northeast. The scarring is consistent with the NOAA GPS track, which showed the aircraft made a right turn in the last 20 seconds of flight.

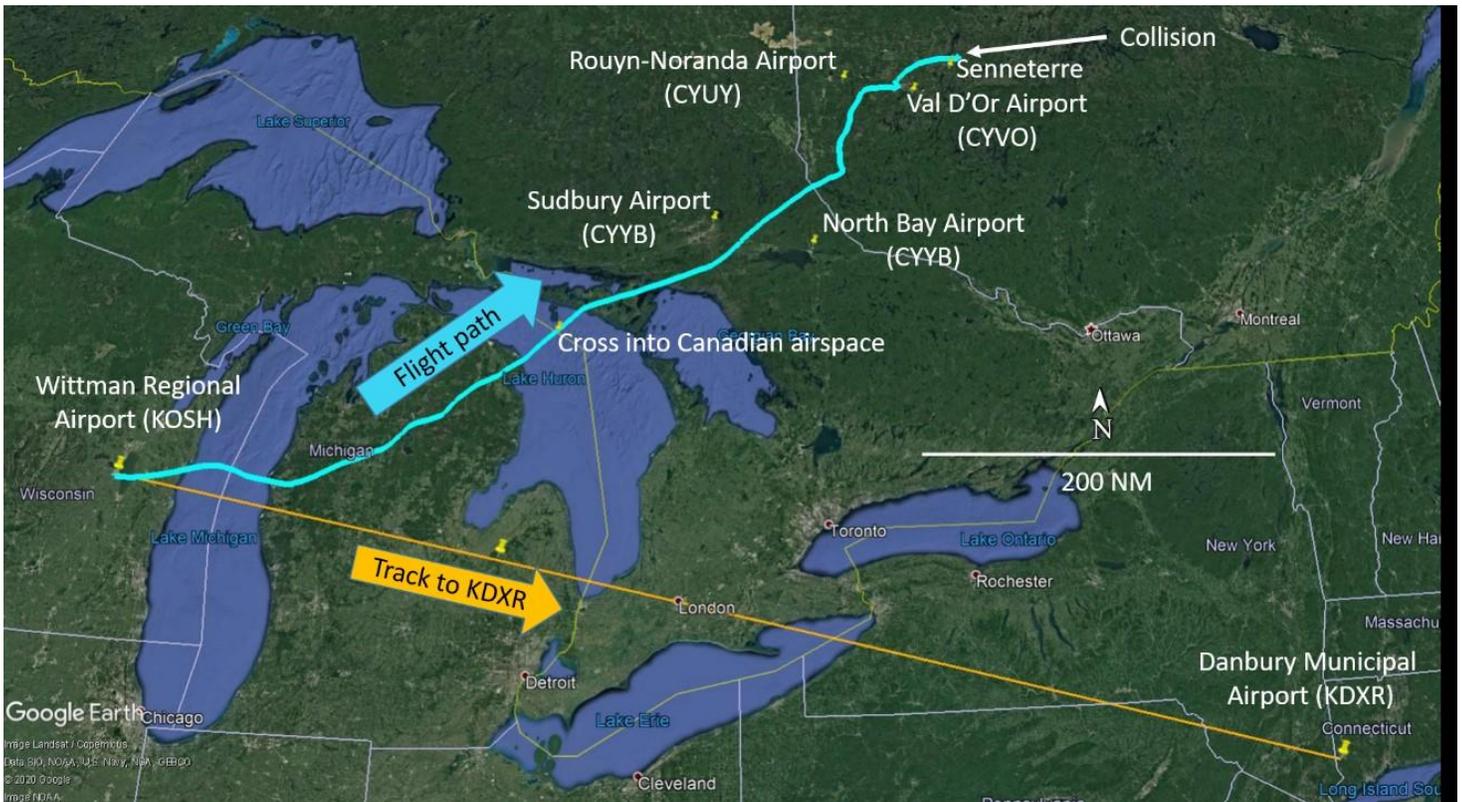
Figure 1. The occurrence aircraft's flight path (green line) and direct track from Wittman Regional Airport to Danbury Municipal Airport (orange line)
(Source: Google Earth, with TSB annotations)

At approximately 19:06, the aircraft flew past Senneterre, Quebec, level at 7 000 feet ASL. Approximately 3 minutes later, the aircraft was in a gradual climb through 7 500 feet ASL. At that point, the aircraft was flying at 160 knots calibrated airspeed (KCAS), on an easterly heading. The aircraft then entered a slow turn to the left at 1.45° per second for approximately 75 seconds, which then increased to 4.36° per second for another 33 seconds. At 19:10 the left turn continued into a descent, and the descending left turn continued until the aircraft reached 7 200 feet ASL.

After turning approximately 250° to the left, the aircraft then immediately entered a climbing right turn and its speed decreased to approximately 100 KCAS while it climbed back to approximately 7 900 feet ASL.

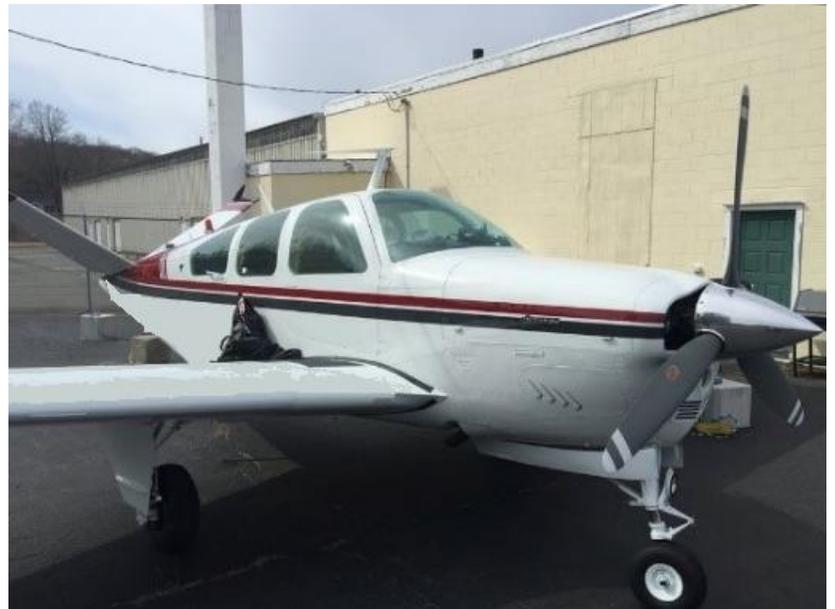
*Figure 2. Occurrence aircraft
(Source: TSB, with permission from third party)*

The model 35 Bonanza is a single-engine, low-wing monoplane with retractable landing gear. A distinguishing feature is its combined elevator and rudder, called a ruddervator, or V-tail. The occurrence aircraft (Figure 2) was a Bonanza V35B model, manufactured in 1980. The occurrence pilot purchased the aircraft in 2001.

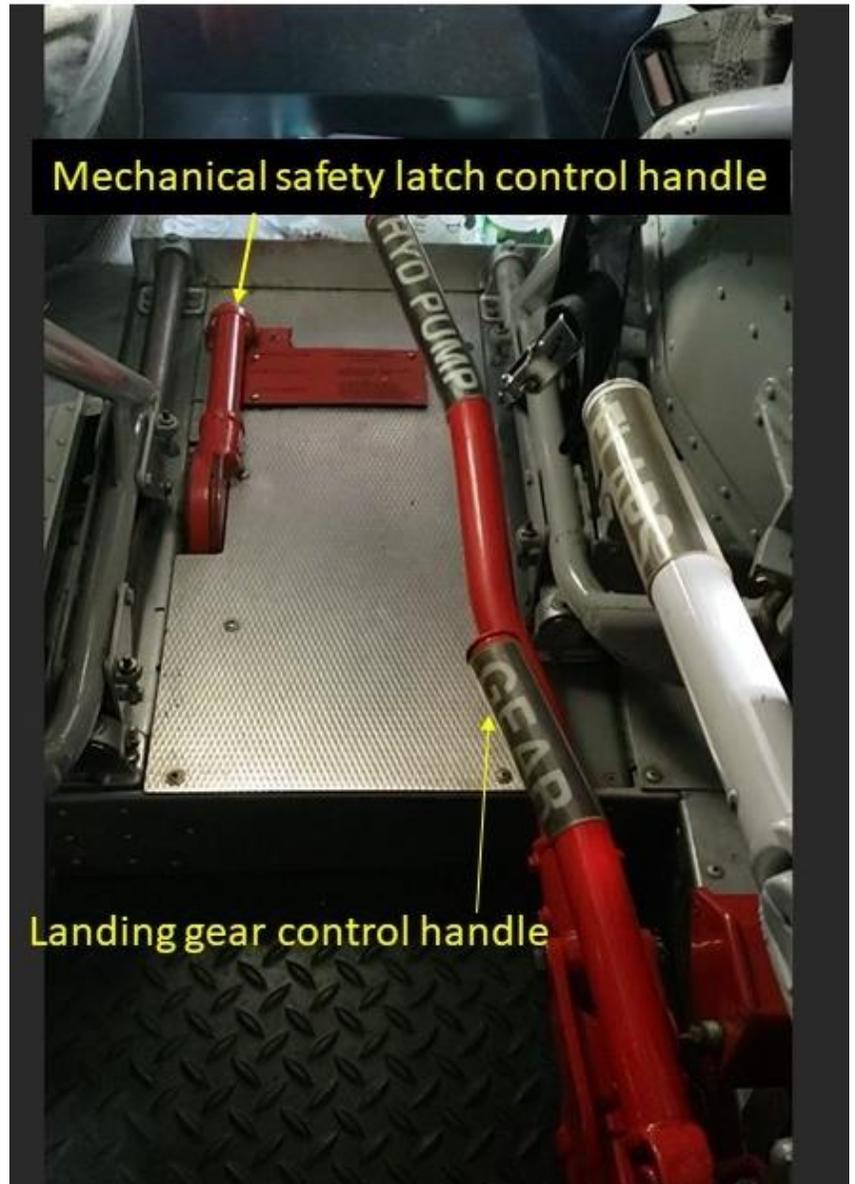
Figure 3. Main landing gear control handle and mechanical safety latch control handle (Source: TSB)

A hydraulic pump is installed on each engine to provide hydraulic system pressure. As long as one engine is operating, hydraulic pressure to operate the main landing-gear system is available. The main landing gear is actuated by means of a 3-position landing gear control handle located behind and to the left of the right seat. A mechanical safety latch control handle provides a backup system to keep the landing gear in the down position if there is a hydraulic failure, and this handle is located on the cockpit floor to the right of the left seat (Figure 3).

The position of the handles can present ergonomic challenges, as some pilots may need to bend over and/or rotate sideways to reach the handles. When the left-seat pilot is tasked with raising the landing gear, they unlatch the mechanical safety latch control handle by pressing down on the handle with their right hand and pushing the safety latch forward with a finger. Next, the left-seat pilot pulls the handle up. He then rotates inboard at the waist to reach back and lift the landing gear control handle with one hand (the right hand).

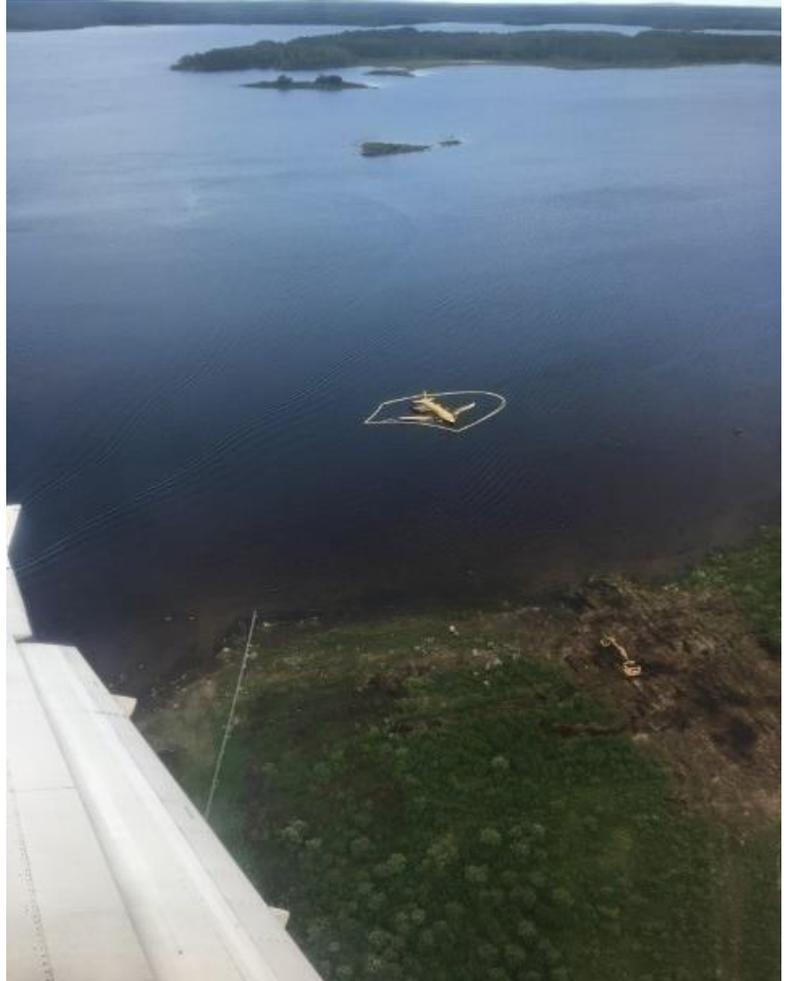
*Figure 5. Occurrence aircraft on Eabamet Lake during recovery
(Source: Pratt & Whitney Canada)*

Investigators attended the scene while the aircraft was partially submerged and conducted an examination of the aircraft (Figure 5). The leading edge of the left wingtip had crush damage consistent with the left wing striking the water (Figure 6).

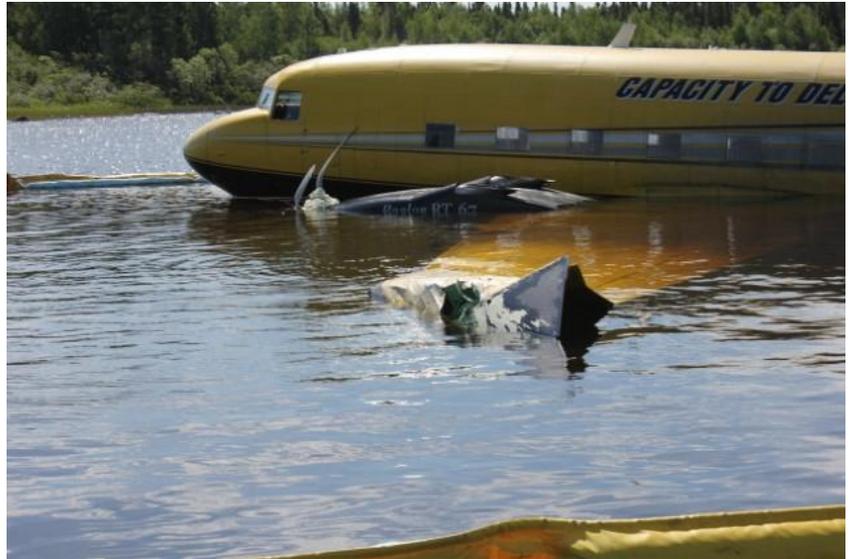
Figure 6. Occurrence aircraft's left wingtip, with crush damage (Source: TSB)
