**ISSUE 2/2021**

# **A**VIATION **S**AFETY **L**ETTER

TP 185E

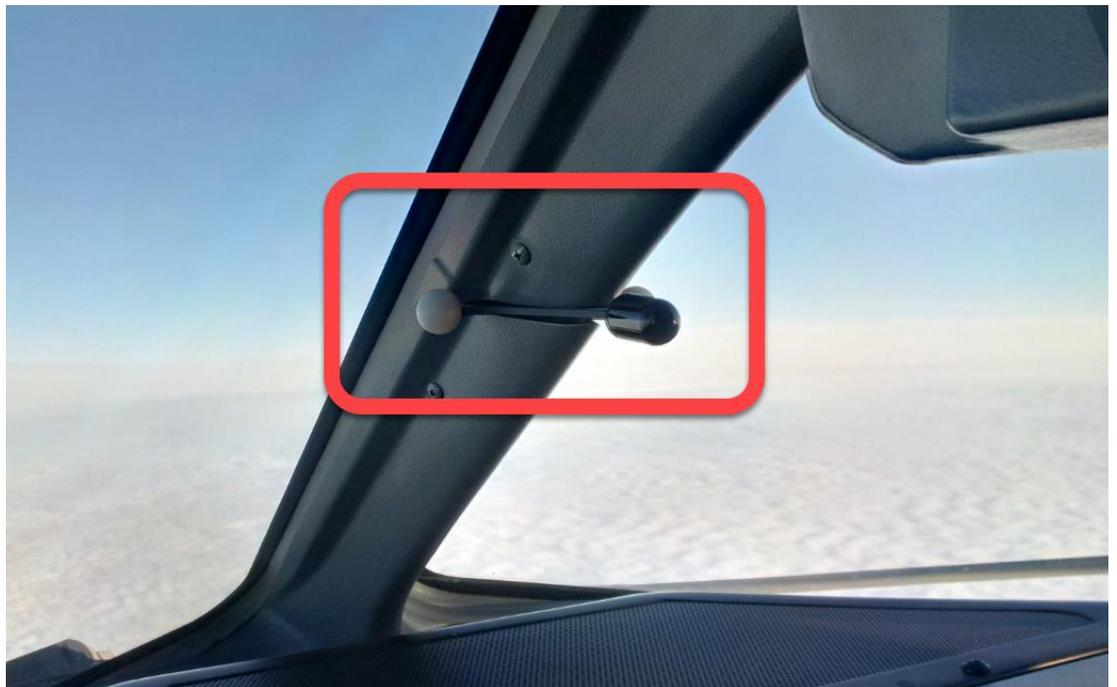
Photo credit: Michael Schuster  
Example of a DERP

First, it's important to know that every aircraft has a DERP built in by aircraft engineers. In transport category aircraft, it's readily available information... the pilot adjusts his or her seat up/down and fore/aft until the alignment "balls" match. Ideally, the aircraft has adjustable rudder pedals that are now moved into position so that the pilot has full range of control.

When sitting in the correct DERP, the pilot has the best view of both the instruments and the outside world. According to the *SAE Dictionary of Aerospace Engineering*, the Design Eye Position is defined as "a point fixed in relation to the aircraft structure at which the midpoint of the pilot's eyes SHOULD be located." The *Aeronautical Information Manual* (Airmanship 4.12) goes on to highlight that the pilot should also be comfortable.

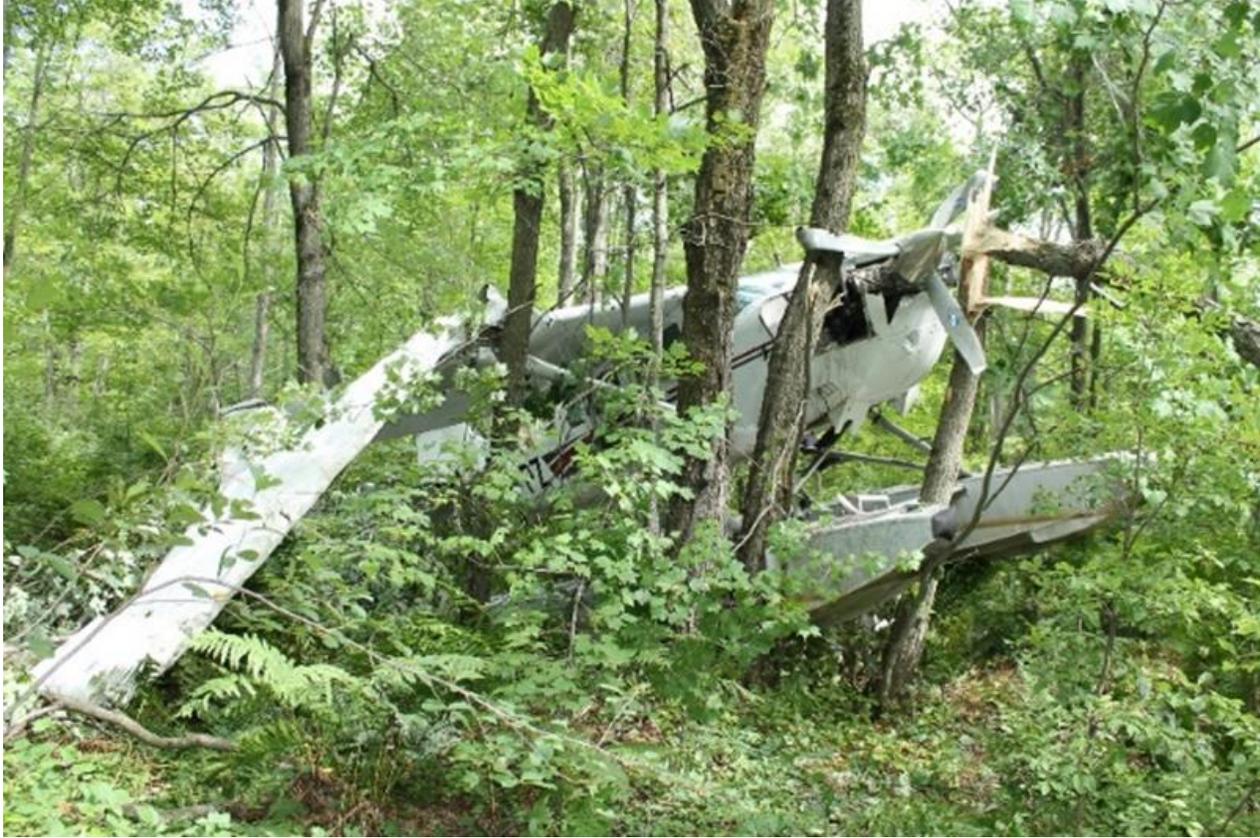
*Figure 2. Occurrence aircraft wreckage (Source: TSB)*

The area surrounding the wreckage, approximately 1 000 ft southeast of the lake, was a woodland with large, deciduous trees. The first signs of an impact with trees could be found approximately 250 ft southeast of the wreckage (Figure 2).

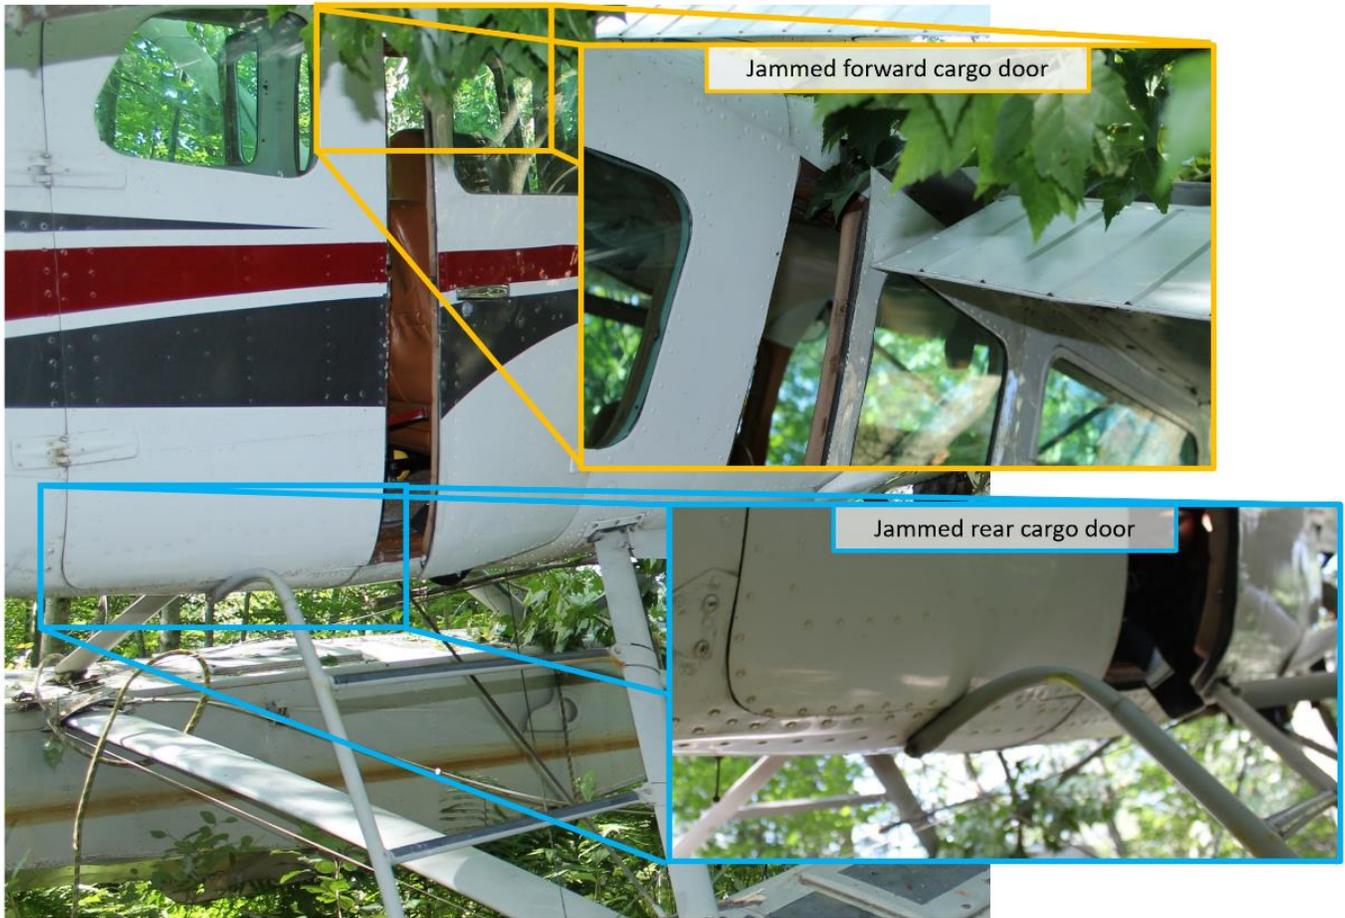
Figure 3. Double cargo door of the occurrence aircraft after the accident (Source: TSB)

The forward cargo door was partially open and jammed because the flaps were down. This issue, specific to the Cessna 206, was identified and analyzed during TSB investigation A18W0129 and resulted in Aviation Safety Advisory A18W0129-D1-A1. The rear cargo door of the occurrence aircraft was closed and the locking lever was in the stowed position. Investigators attempted to open the rear cargo door, but the top of the ladder was bent from the impact and was preventing the rear cargo door from being opened (Figure 3).

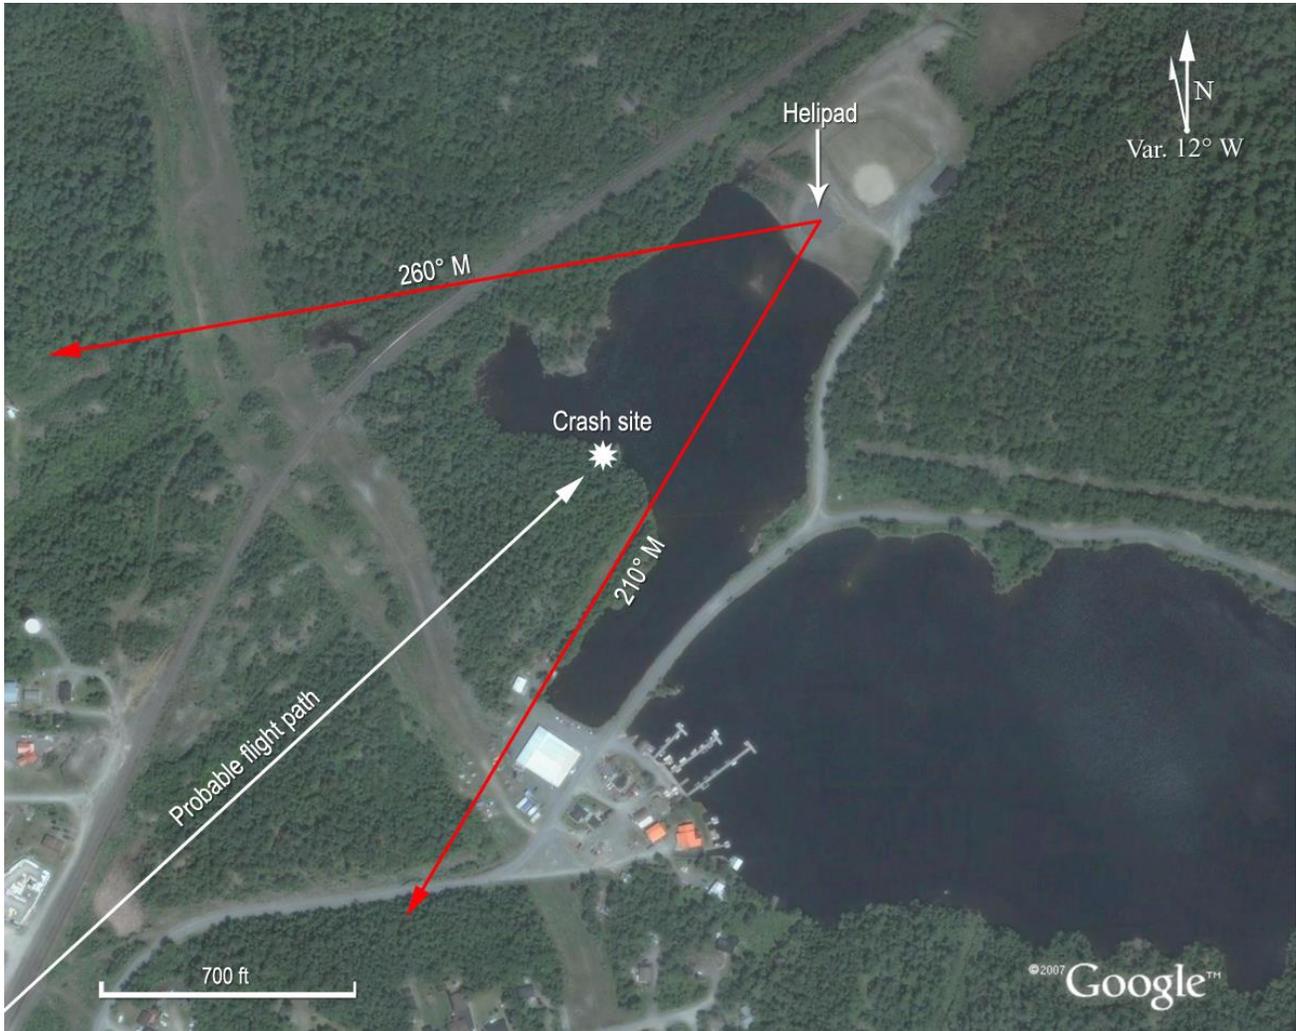
Figure 2. Snake Lake Helipad

The helicopter approached the helipad from the southwest on a heading of approximately 048° M and entered the trees near the edge of the lake approximately 814 ft horizontally from the helipad (see Figure 2—Snake Lake Helipad).

The trees on the approach averaged 40 ft in height. The helicopter impacted trees that were located on the downward slope of the hill, at approximately 70 ft horizontally from the shore where the height of the hill is approximately 10 ft higher than the helipad. As such, the average tree tops were approximately 50 ft higher than the helipad. The descent into the trees was near vertical with very little horizontal momentum and the nose of the helicopter came to rest approximately 15 ft from the shore. During the descent, a tree passed through the left

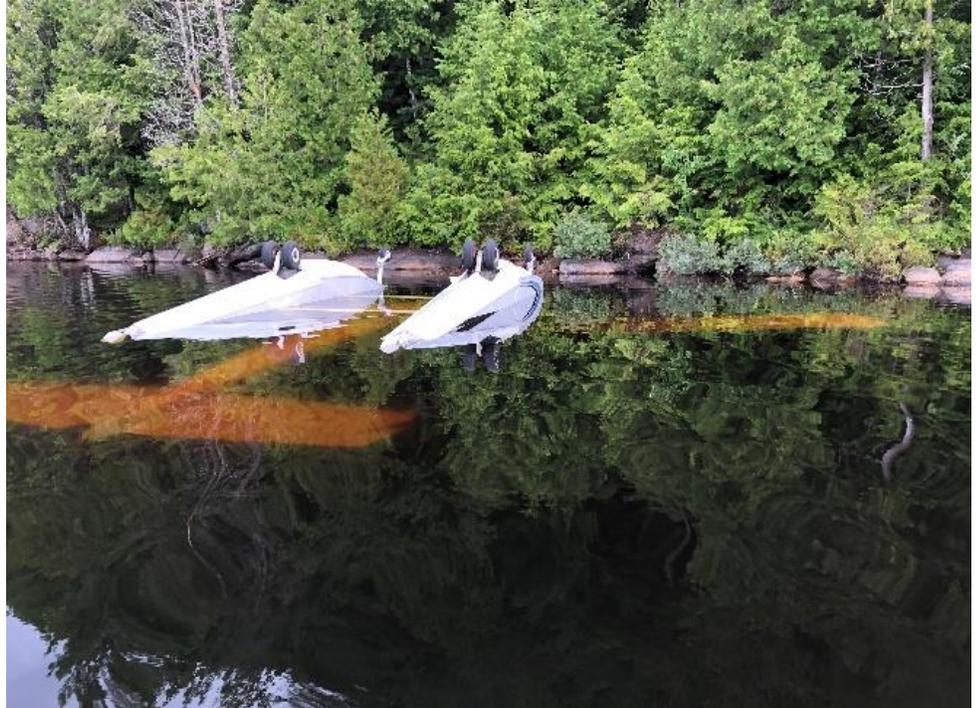
*Figure 1. The occurrence aircraft found the day after the occurrence, tied to the shore (Source: friend of the pilot)*

The aircraft touched down on the surface of the water with the wheels down, causing it to flip over; the aircraft came to rest inverted, the floats above the water keeping it afloat (Figure 1).
