Aviation Safety

Letter

Learn from the mistakes of others; you'll not live long enough to make them all yourself . . . Issue 1/2003

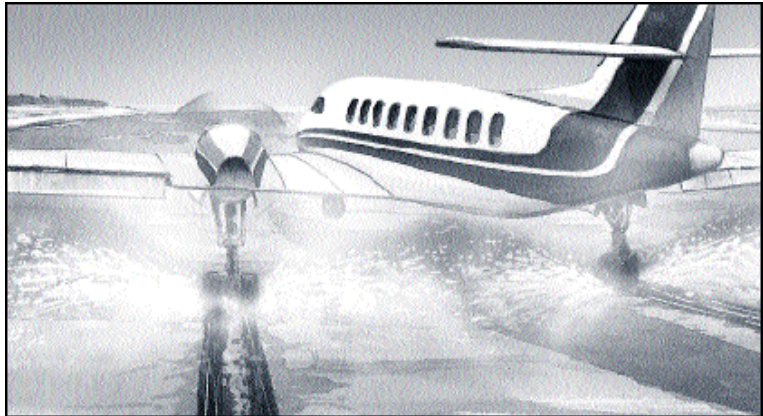
Just a bit of slush can seriously affect aircraft control.

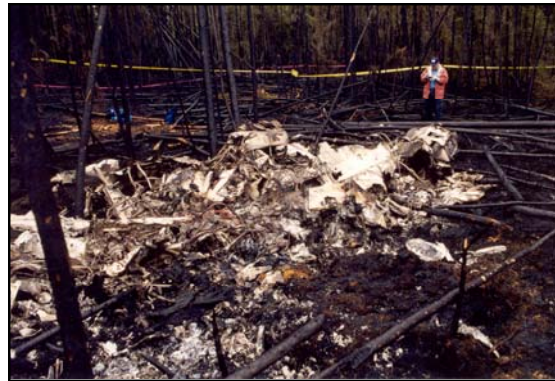
The wreckage was examined on site, to the extent possible, because of destruction by impact and fire. No pre-existing defects could be found. The main wreckage trail was about 100 ft long, preceded by a

40-ft long by 10-ft wide slash through trees at an angle of 42° from horizontal.

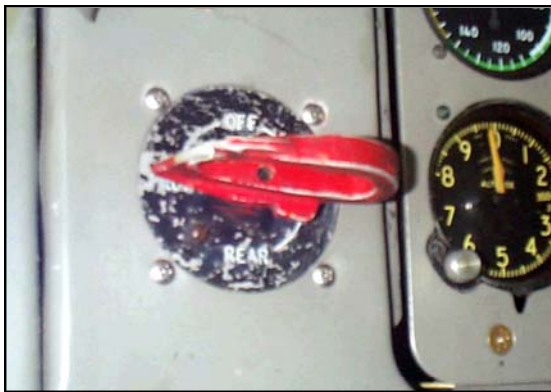
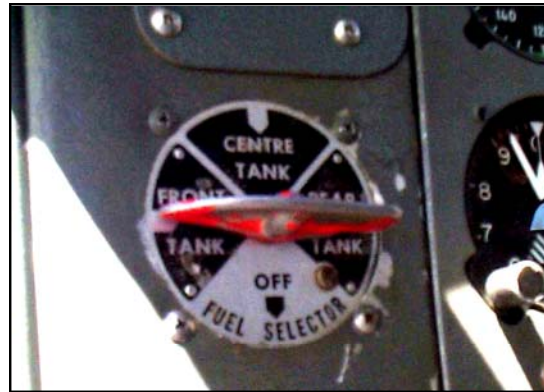
The DHC-2 Beaver has a surprising reversal in its fuel selector control, one that is not mentioned in the Aircraft Flight Manual (AFM). The early models were built with a fuel selector with the "OFF" selection at the 12 o'clock position. This was modified at S/N 1313, to a fuel selector with the "OFF" selection at 6 o'clock, and the centre tank at 12 o'clock.

A modification kit (#2/1303) was offered for earlier aircraft. However, the AFM only illustrates the earlier, pre-mod fuel selector. Additionally, the throttle and propeller controls are also reversed between earlier and later production Beavers. Many operators have a fleet of Beavers with various combinations of fuel selectors and power control configurations, resulting in the potential for confusion.
