Learn from the mistakes of others; you'll not live long enough to make them all yourself . . . **Issue 2/2003**

Overloading Keeps You Down

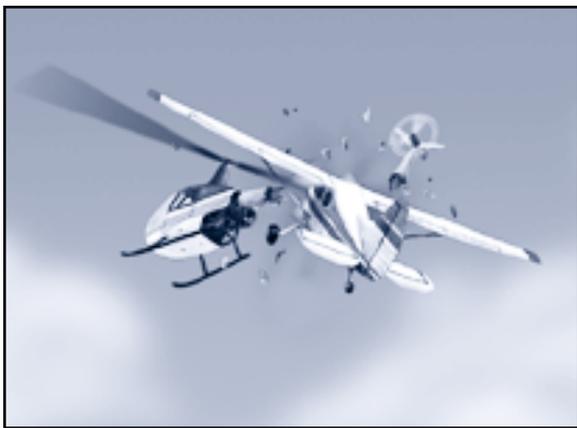
On June 20, 2001, at 20:05 eastern daylight time (EDT), a Robinson R22 helicopter, with only the pilot on board, departed Lindsay, ON, for the Toronto/Buttonville Municipal Airport. At 20:22 EDT, a Cessna 170 took off on Runway 18 from a private grass strip, locally known as Sandford Field, with only one person at the controls, who was never licensed as a pilot. This person planned to conduct one left-hand circuit and landing. At 20:25 EDT, the two aircraft collided in visual meteorological conditions (VMC) at approximately 700 ft AGL. The accident occurred near Uxbridge, over a farmer's field 1 NM south of Sandford Field. The helicopter's tail and the main-rotor system sustained catastrophic damage, rendering the helicopter uncontrollable. The helicopter pitched inverted and plunged to the ground, and the pilot was fatally injured. The C-170 sustained substantial damage; however, the person at the controls was able to control the aircraft and conduct a forced landing in a nearby cornfield.

Findings as to Causes and Contributing Factors—Neither the R22 pilot nor the person at the controls of the C-170 saw the other aircraft in time to avert the collision. The design limitations of both aircraft with respect to pilot visibility, combined with the intercept geometry, contributed to the R22 pilot and the person's failure to see and avoid the other aircraft.

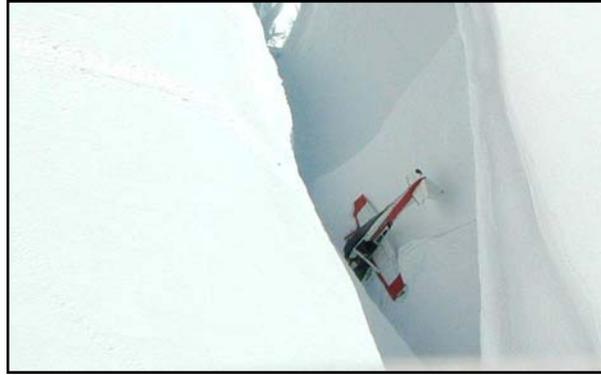
Aerial view of slide path and aircraft at rest in crevasse.

The aircraft eventually came into contact with the lip of an open crevasse, then with a large drift of compacted snow. The propeller and the skis separated from the aircraft and were found at this location. Shortly after contacting this drift, the aircraft nosed over and fell into the next open crevasse. The aircraft came to rest on its back at the bottom of the crevasse, in a nose-

down attitude, at approximately 11 500 ft ASL.

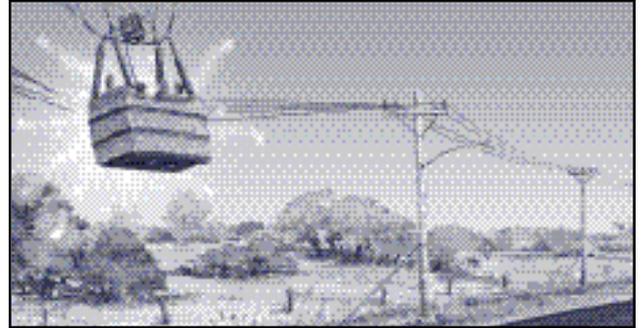
approximately 15 ft, and fell to the ground. The balloon drifted with the wind, and became entangled in the power lines. An electrical arc occurred and the gondola caught fire. There were injuries and one casualty.

The balloon flight manual suggests maintaining at least 100 ft of horizontal separation from power lines for each mile-per-hour wind at the landing site. The location of the initial landing site was close to this requirement; however, when the balloon was walked closer to the power lines, the separation was lost. As winds associated with towering cumulus clouds can be unpredictable, better use of the recovery truck might have averted disaster. 🍷

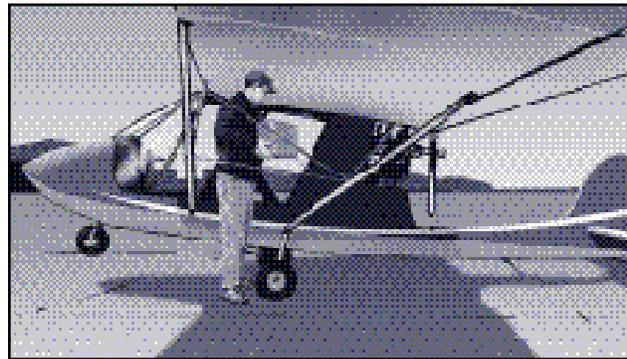
Spring is almost with us, and so too is the hazard of aircraft refuelling. When you refuel your aircraft from a plastic container that is not grounded to the aircraft, it creates a definite fire hazard. Unfortunately, many aircraft have been lost during this seemingly simple process. Aircraft and lawnmower fuel tanks do not share all of the same environmental factors that create this hazardous situation. Nevertheless, the same risk is present when you refuel a lawnmower. The difference is based on the electrostatic potential of the two machines. Given the proper temperature, humidity, barometric pressure, and wind conditions, the aircraft becomes electrically charged because its wing and structure area are exposed to air, which charges them electrostatically. Likewise, the plastic fuel container gets charged when being refuelled. If you do not ground the container to the aircraft structure, or directly to the aircraft fuel tank, with the help of a wire—preferably touching the bottom of the plastic container—and a clamp on the fuel tank before you start dispensing fuel, the difference in electrostatic potential makes the charged electrons race from the aircraft tank to the fuel container at an accelerated rate in order to establish a balance of electron potential between the

two structures. This occurs in microseconds and brings about a source of ignition of the fuel molecules in movement at the surface of the gasoline and the ensuing potential for fire. So be careful, and make sure to ground the aircraft to the ground and ground the fuel container to the aircraft before refuelling. Using a metal fuel container, a metal funnel, bonding wire and a clamp to ground all articles to the aircraft should ensure safe fuel transfer. Equally important is to have at-hand, a fire extinguisher of sufficient size to save your aircraft when refuelling. The value of your life and of your aircraft is worth countless numbers of fire extinguishers. Happy flying!

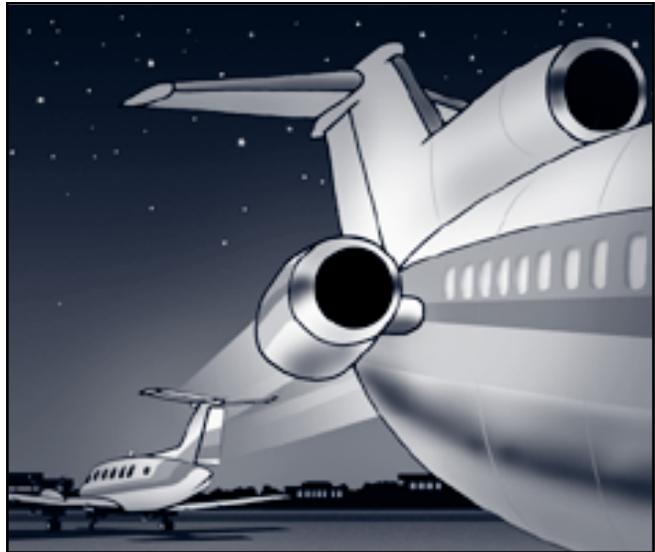
The crew returned a few hours later, and did not notice anything unusual during the walk-around or the pre-flight control checks prior to departure. After an uneventful takeoff, the crew noticed the rudder pedals no longer lined up and the rudder trim could not be adjusted. The crew consulted the pilot operating handbook (POH) and the minimum equipment list (MEL), and called their maintenance department via cell phone. After confirming they had positive directional control, they elected to continue the flight to their home base. Maintenance found considerable internal damage to the rudder system, including cracks in the trim jack housing, sheared rivets at the base of the rudder spar, torn skin on the rudder at the hinge points, and distorted bolt holes in the torque tube.

In discussions between the Transportation Safety Board (TSB), System Safety personnel and the management of both the aircraft operator and the FBO, all agreed that the situation could have been avoided, and had the potential to be an extremely serious event. It was determined that the rudder damage, which occurred during the short night holdover, was most likely caused by the jet blast of the departing 727. Given that most of the damage was internal, it would have been very difficult for the pilot to find it during the walk-around if he didn't know what he was looking for. It also took place during a calm night where external damage was not expected.

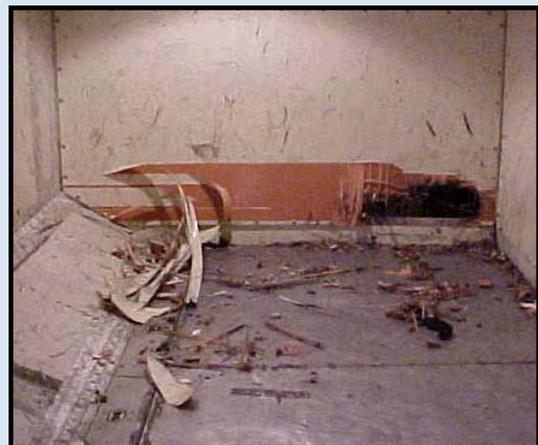
Guess what caused this damage inside this forward bulk compartment of a Boeing 757? A detonation? Wrong. Explosive decompression? Try again. A mad Pit Bull? You got it! A Pit Bull in serious need of TLC escaped from his kennel in the forward bin and decided to chew through reinforced fiberglass, coaxial cables and other wires. The flight reportedly lost TCAS, both ATC transponders and a VHF/VOR receiver. The damage was so serious, it caused the operator to establish a new policy of not accepting animals of any kind with the potential of doing such damage.
