AVIATION SAFETY LETTER

TSB Final Report Summaries

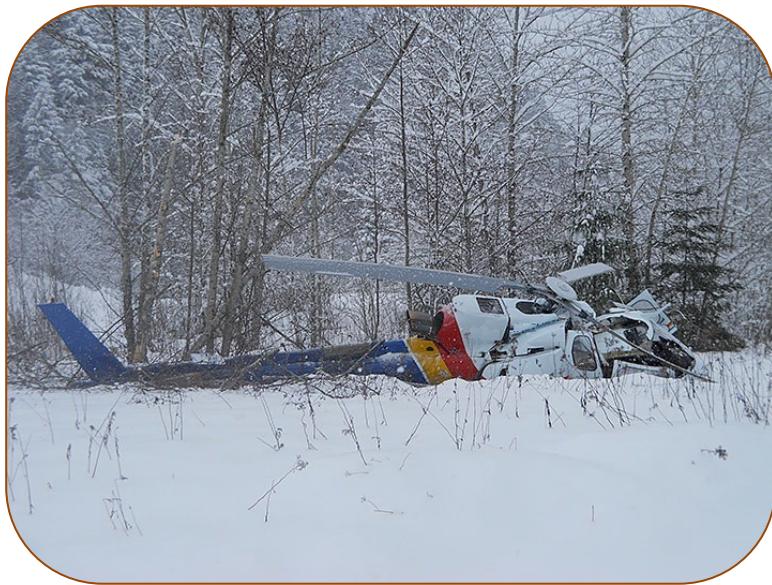
Wreckage

On January 17, 2012, at 13:51 Pacific Standard Time (PST), a Eurocopter AS 350 B3 helicopter with only the pilot on board, took off from an open field near Cultus Lake, B.C., on the outskirts of the city of Chilliwack. The helicopter slowly travelled nearly 260 ft to the north, and then hovered at about 80 ft above ground level (AGL) for approximately 30 s. Suddenly, a distinct noise and a puff of grey/white vapour from the engine area occurred, followed by a rapid loss of rotor revolutions per minute (rpm). The helicopter descended quickly, and within seconds, landed heavily on the snow-covered terrain. Upon impact with the ground, the helicopter fuselage collapsed and the fuel tank ruptured. There was no fire. The helicopter was destroyed, and the pilot was fatally injured. The emergency locator transmitter (ELT) activated and was detected by the search and rescue satellite system. The accident occurred in daylight at an elevation of about 650 ft above sea level (ASL). *The TSB authorized the release of this report on March 12, 2014.*

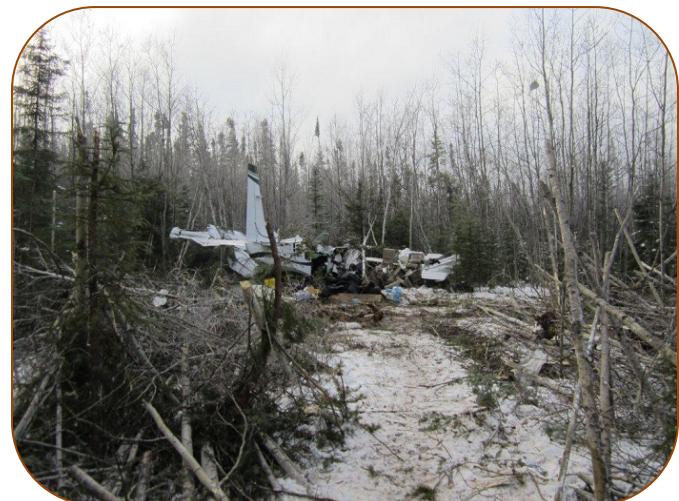
Cessna 208 and crash trail near
Snow Lake Airport, Manitoba

On November 18, 2012, a Cessna 208B departed Runway 21 at Snow Lake Airport (CJE4), Man., en route to Winnipeg, Man., with the pilot and 7 passengers on board. At approximately 0956 Central Standard Time, shortly after take-off, the aircraft descended and struck the terrain in a wooded area approximately 0.9 nautical miles beyond the departure end of the runway. The pilot was fatally injured, and the 7 passengers sustained serious injuries. The aircraft was destroyed by impact forces, and a small fire ensued near the engine. The aircraft's emergency locator transmitter activated. First responders attended the scene, and the injured passengers were taken to area hospitals. The aircraft's fuel cells ruptured, and some of the onboard fuel spilled at the site. *The TSB authorized the release of this report on April 16, 2014.*

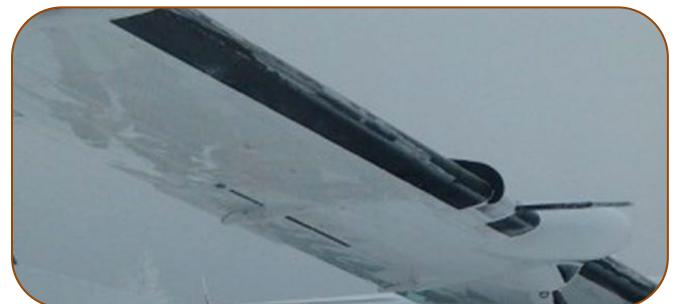
Ice on edge of wing before the accident flight

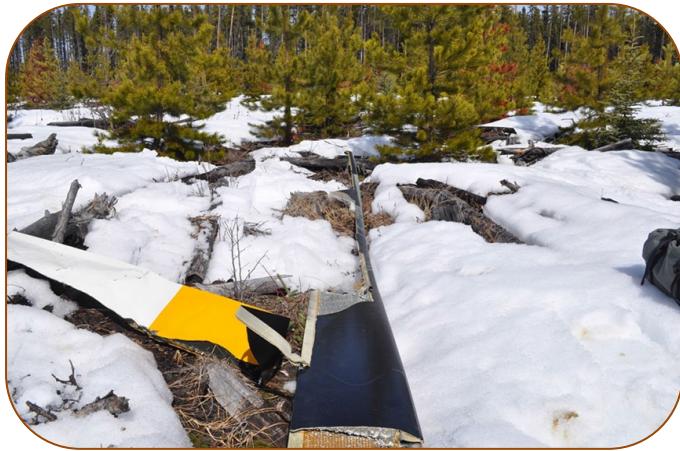
Detached main rotor blade

On January 27, 2013, a Robinson R44 Raven II helicopter was being used to conduct monitoring of well sites southwest of Fox Creek, Alta. At 1311 Mountain Standard Time, the helicopter departed from its base of operations at the Horse Facility gas plant camp for the day's activities. After several flights, including one with a passenger, the helicopter landed at a roadside security gate, dropped off the passenger, and departed at 1735 with only the pilot on board. The helicopter broke up in flight over a wooded area 5 minutes later. The pilot was fatally injured. There was no post-crash fire. Although the emergency locator transmitter activated on impact, no signal was received due to impact damage to the emergency locator transmitter. *The TSB authorized the release of this report on May 21, 2014.*

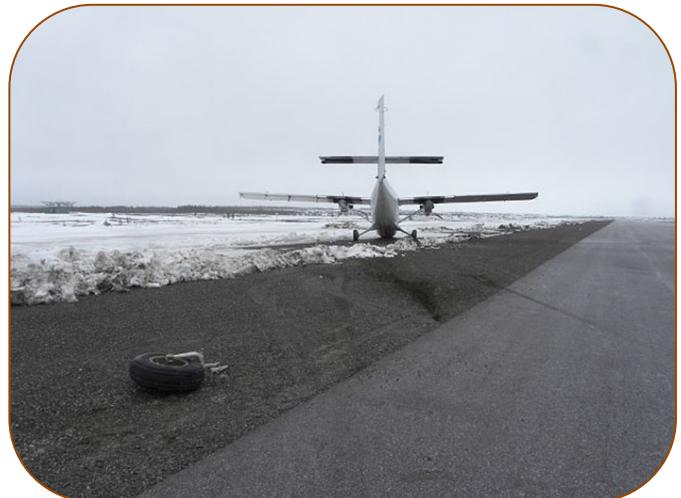
Occurrence aircraft after coming to rest off the side of the runway (Source: RCMP)

On March 27, 2013, a de Havilland DHC-6-300 Twin Otter aircraft was landing at St. Anthony Airport, N.L., with two crew members and eight passengers on board. The aircraft first contacted the runway with the left tire, bounced, and became airborne before touching down hard on the nose wheel. The nose landing gear collapsed, and the aircraft skidded on its nose, coming to rest 96 ft off the north side of Runway 10. There were no injuries. The aircraft was substantially damaged. The 406-MHz emergency locator transmitter (ELT) did not activate. The accident occurred at 12:53 Newfoundland Daylight Time (NDT). *The TSB authorized the release of this report on April 16, 2014. △*
