TP 185E
Issue 1/2007

AVIATION SAFETY LETTER

The Adverse Aerodynamic Effects of Inflight Icing on Airplane Operation

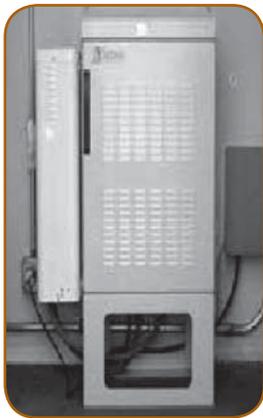
An ADS-B installation is the size of a filing cabinet

ADS-B ground stations receive signals from appropriately equipped aircraft to report their GPS-derived position,

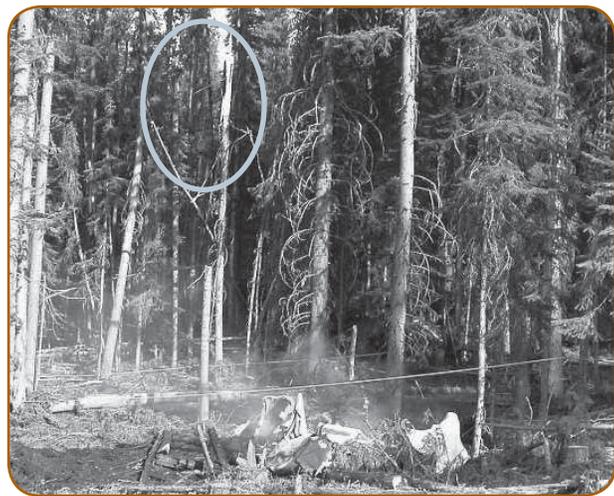
Circle indicates where the bucket got caught

On August 17, 2003, a Bell 204B helicopter was involved in forest fire suppression at Bonaparte Lake, B.C. At about 11:05 Pacific Daylight Time (PDT), the helicopter departed a staging site, eastbound, slinging an empty water bucket on a 100-ft longline. Shortly after takeoff, the helicopter emitted a high-pitched, oscillating sound. The flight path and behaviour of the helicopter were normal as it went out of view over some trees. Immediately thereafter, there was a pronounced slap sound of the main rotor blade, followed by sounds of impact with the trees. The helicopter struck the ground just short of a small clearing adjacent to a fire road, about 0.25 NM southeast of the staging site. A post-impact fire ensued, which destroyed the helicopter. The main driveshaft assembly remained attached to the engine and transmission input quill assembly. The water bucket was found in a tree, detached from the longline, on the approach to the accident site. The longline was wrapped around another tree and lay in a direct line to the helicopter. The pilot was fatally injured.

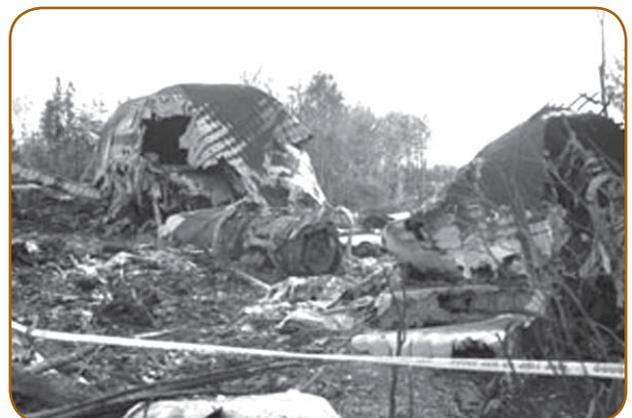
TSB Final Report A04H0004—Reduced Power at Takeoff and Collision with Terrain

On October 14, 2004, a Boeing 747-244SF was being operated as a non-scheduled international cargo flight from Halifax, N.S., to Zaragoza, Spain. At about 0654 coordinated universal time (UTC), 3:54 Atlantic Daylight Time (ADT), the aircraft attempted to take off from Runway 24 at the Halifax International Airport. The aircraft overshot the end of the runway for a distance of 825 ft, became airborne for 325 ft, and then struck an earthen berm. The aircraft's tail section broke away from the fuselage and the aircraft remained in the air for another 1 200 ft before it struck terrain and burst into flames. The aircraft was destroyed by impact forces and a severe post-crash fire. All seven crew members suffered fatal injuries.

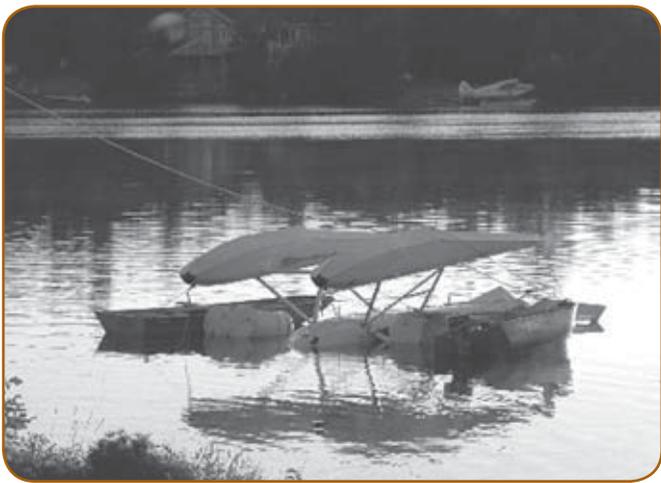
At approximately 10:50 EDT, the aircraft cartwheeled on the lake, travelling in a northwesterly direction and adjacent to the north shore of the eastern section of the lake. The aircraft came to rest inverted in the lake with most of the aircraft visible. It floated approximately 500 ft east, then came to rest on the bottom of the lake, with only the bottom of the floats visible. Some local residents attempted a rescue, but they were unable to get the pilot out of the aircraft. The pilot had manoeuvred himself into the right seat, but he was unable to exit the aircraft, and drowned.
