# AVIATION SAFETY LETTER

The SMS Approach to Dangerous Goods in a 705 World

COPA Corner—Electrical Fires Do Happen

Fuel Tank Safety and Electrical Wiring Interconnection Systems—  
Considerations for Transport Airplane Modification and Repair Designs

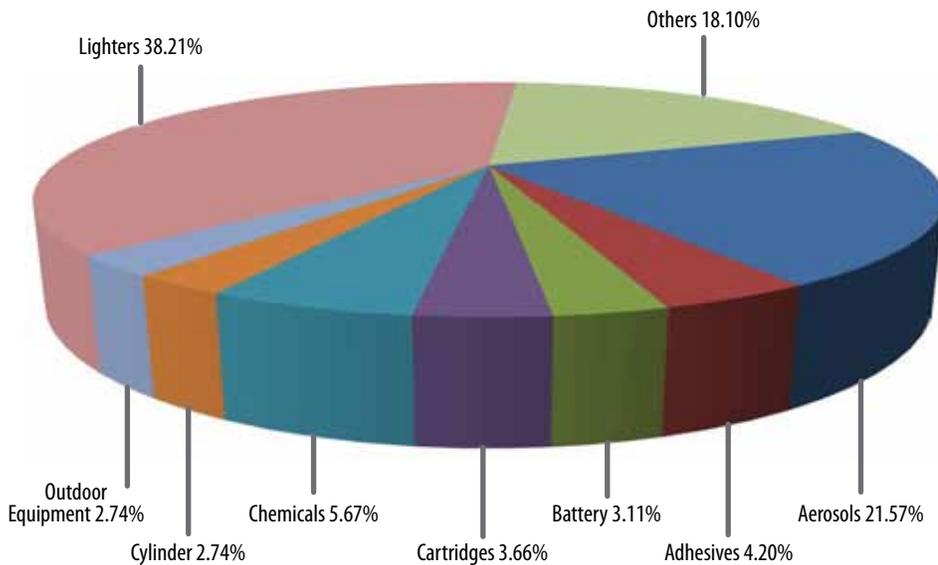
Figure 1: Proportion of dangerous goods in articles intercepted in passenger or crew baggage in the last 12 months

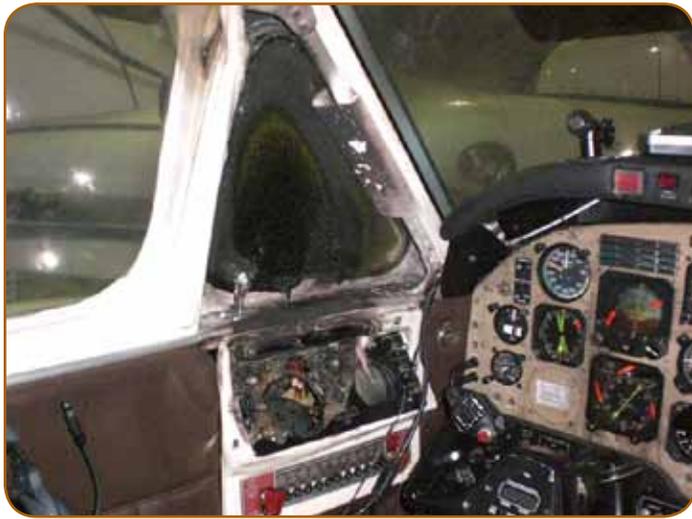
Damage caused by fire in the cockpit of a King Air 100.

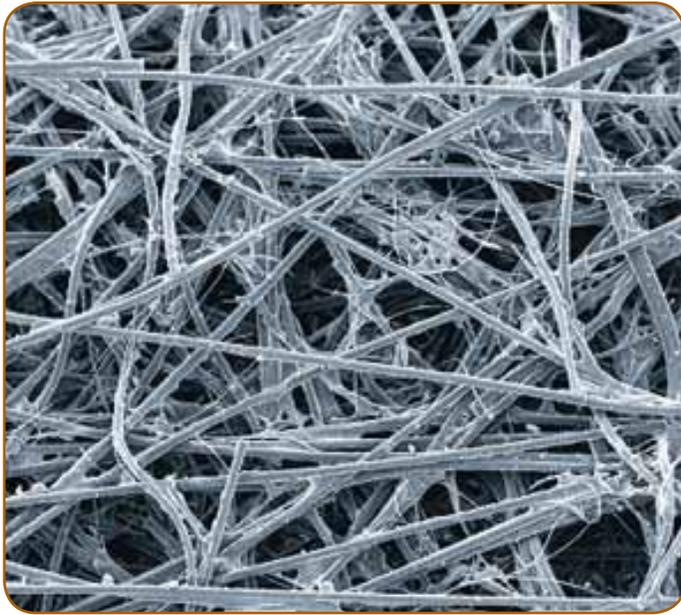
*The tight weave of the dry media traps particles by sieving the dust contaminants.*

Dry media filters can be either a cellulose or synthetic media. The tight weave of the media traps particles by sieving the dust contaminants. The pleated style of the media maximizes the surface area of the filter providing the engine maximum area to breathe. Most GA original equipment manufacturers (OEM) use a dry media pleated filter on their equipment. The dry media pleated filters are designed to offer long life, approximately 500 flight hours or three years of service, and they can be cleaned up to five times before replacing them. Cleaning can be initially performed by using compressed air to expel any dust and particulate that has been trapped in the filter pleats. Once all of the dust and particulate has been blown away, you should hold the filter up to a light source and inspect the condition of the media for deterioration. If the media is in satisfactory condition, further cleaning can be accomplished by washing the filter in a solution of water and general purpose low-suds detergent. After washing, the filter should be dried and once again inspected for contamination and general condition. The following steps can be used as a guide when servicing the dry media filter:

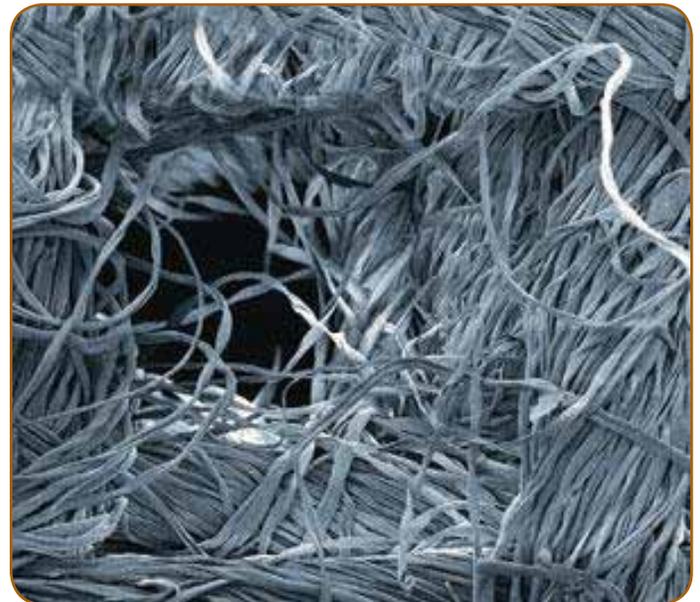
*Wet media, as its name implies, is a type of media that requires a tacky oil to be applied to a substrate to act as the dust trapping agents.*

3. Apply the cleaner to clean side of filter.
4. Apply the cleaner to dirty side of filter.
5. Let the cleaner soak for 10 min.
6. Rinse with water.
7. Dry the filter without accelerated drying methods.
8. Re-oil the filter substrate.
9. Let sit for approximately 20 min and check for oil coverage.
10. Re-oil any areas of the filter that were initially missed.
11. Continue steps 5 through 7 until a uniform colour covers the entire filter media.

The cleaning procedures for this type of filter are recommended every calendar year or every 100 flight hr, and can be cleaned up to 25 times or a maximum of 2 500 flight hr.

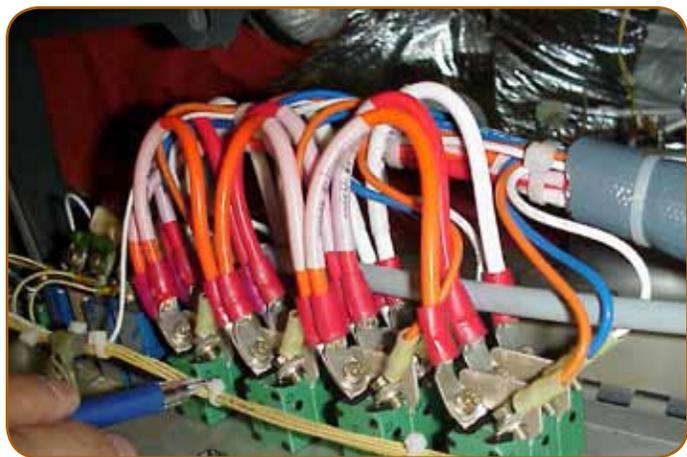
*Electrical wiring interconnection systems (EWIS)*

The EZAP is an analytical procedure that identifies the physical and environmental conditions in each zone of an airplane, analyzes the effects of these conditions on EWIS, and assesses the possibilities for smoke and fire. From EZAP analysis, maintenance tasks can be developed to detect EWIS degradation issues, prevent ignition sources and minimize possibilities for combustion by minimizing accumulation of combustible materials. The resulting EWIS EZAP ICAs are to be presented in

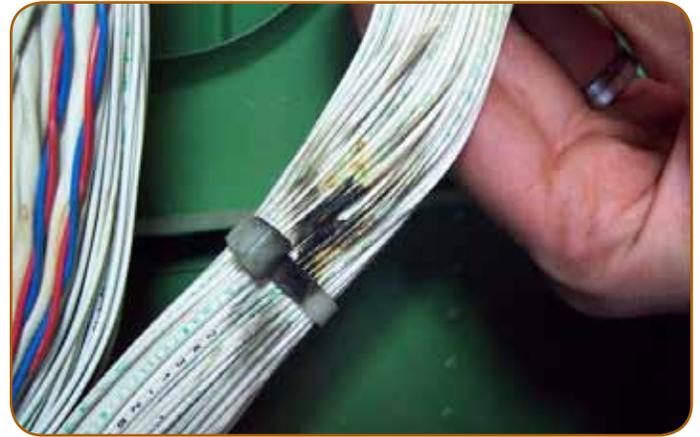
*Wire chaffing issue*

- current maintenance practices did not adequately address wiring components;
- wiring inspection criteria were too general;
- maintenance instructions did not describe unacceptable conditions in enough detail; and
- airplane wiring needed to be considered as a discrete system and given the same level of scrutiny as other airplane systems.

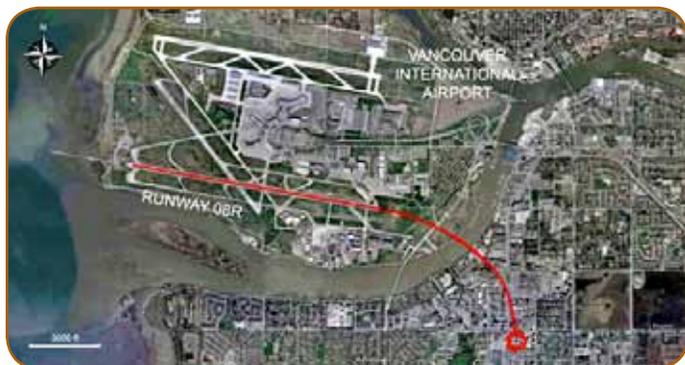
*Aircraft flight path*

On October 19, 2007, at 16:02 PDT, a Piper PA-34-200 Seneca was cleared for takeoff from Runway 08 Right at the Vancouver International Airport destined for Pitt Meadows Regional Airport. The flight was operating under VFR with only the pilot on board. Shortly after takeoff, communications and radar contact were lost. The aircraft collided with a 15-storey residential building in Richmond, about 1.5 NM east-southeast of the departure end of Runway 08R. The pilot was fatally injured. There was no post-impact fire. The aircraft entered a suite occupied by two people; one received serious non-life-threatening injuries, the other received minor injuries. Structural damage to the building was minimal, but there was extensive water damage from the fire suppression system. As a result, hundreds of people were displaced from their homes for extended periods. There were no other reported injuries.

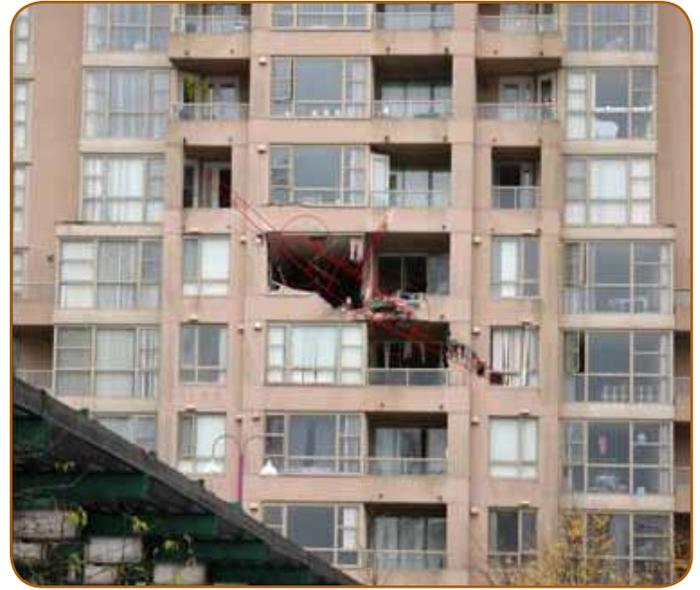
*Impact damage*

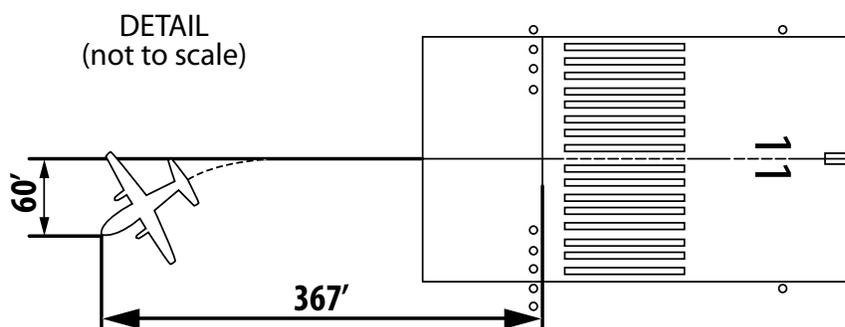
*Aircraft final position 60' from centreline and 367' past runway threshold*

On January 4, 2008, a Jetstream 3212 was landing at Fort Smith (CYSM), N.W.T., following an IFR flight from Edmonton, Alta. While landing on Runway 29, at 15:02 MST, the aircraft rolled off the end of the runway and stopped 367 ft from the threshold and 60 ft to the left of the runway centreline. There was about 18 in. of snow in the overrun area. Damage was limited to the number two propeller. There were no injuries to the 2 pilots and 16 passengers.

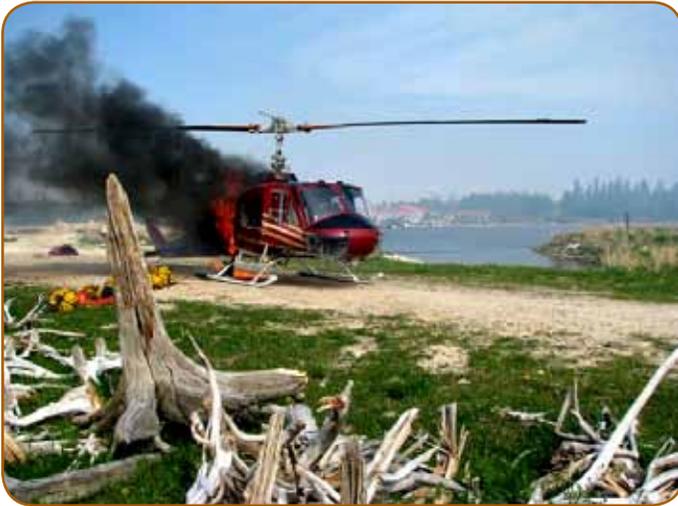
*Helicopter showing fire emanating from the engine area*

100 m away. The pilot landed the helicopter, shut off the engine, fuel, and electrics, and the crew quickly exited. Flames emanated from the right side of the engine cowling area, the fire spread quickly, and within minutes the helicopter was completely engulfed. The community fire truck was called and arrived within five minutes of the occurrence. The crewmembers were not injured, but the helicopter was completely destroyed. The accident occurred during daylight hours at 17:27 CDT.

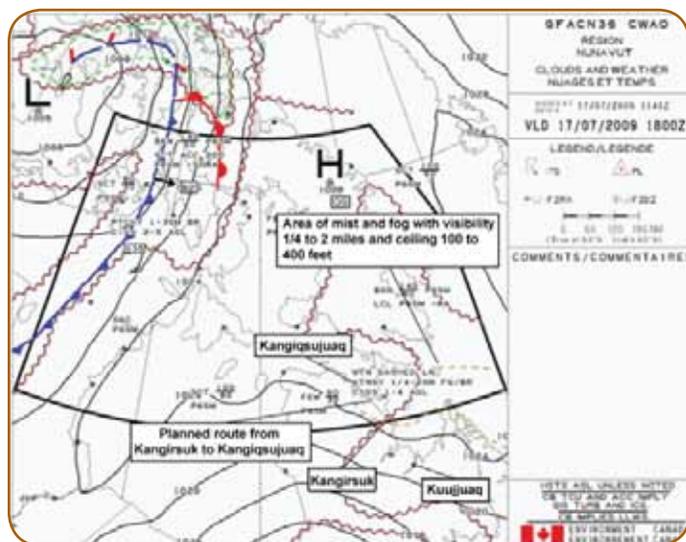
*This is the GFA available prior to takeoff from Kuujuaq, Que.*

For an undetermined reason, the pilot did not call the flight information centre (FIC) at Québec to request a printout of the graphic area forecast (GFA). Because the pilot could have obtained weather information from the Internet, it cannot be stated without a doubt that he did not check the GFA before going to the airport. However, if he had done so, especially being an airline pilot, he would have easily seen that the GFA for the region called for visibilities of ¼ SM to 2 SM in mist/fog and ceilings of 100 to 200 ft between Kangirsuk and Kangiqsujuaq in the coastal area and over the Hudson Strait. Also, by analyzing the GFA he would have seen that the mist was clearing over the land to the west of the shoreline. Given his qualifications, the route he elected to fly and the diversion route he chose, it is unlikely that the pilot checked the GFA on the Internet.

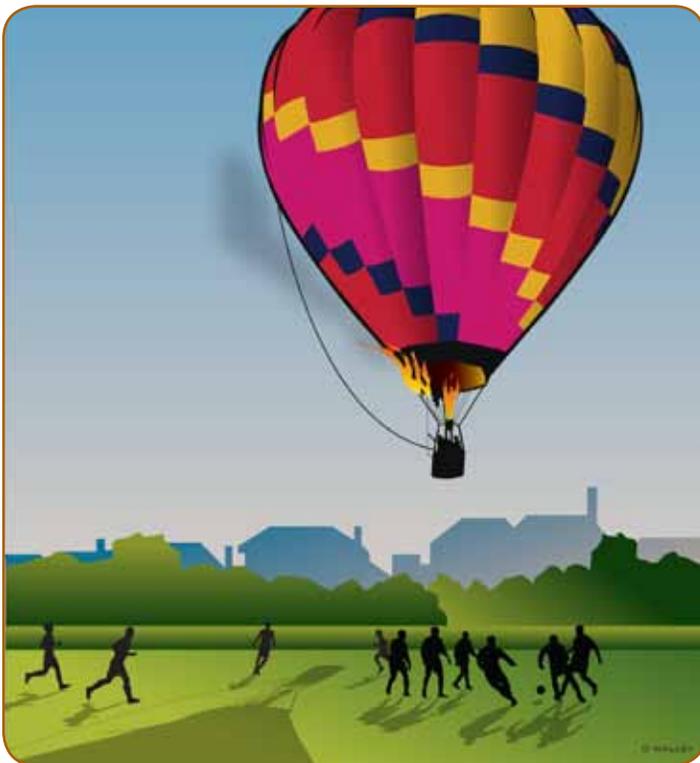
Artist impression of occurrence as the balloon came to land near a soccer field

On July 14, 2010, a hot air balloon launched at approximately 19:25 EDT from Carleton University, Ottawa, Ont., for a local flight. On board were the pilot and 12 passengers. While over the city at approximately 700 ft AGL, the balloon encountered turbulence. The pilot initiated a descent with the intention of executing a precautionary landing. The balloon's rate of descent increased unexpectedly, and the pilot had to light all 3 burners to arrest the descent. During this time the lower portion of the balloon's envelope collapsed into the path of the burner flame. Some of the lower envelope panels caught fire, but self-extinguished once the flame was removed. The balloon's basket struck the tops of some trees, and then the balloon climbed to approximately 1 000 ft AGL. The pilot then executed another descent to land. The balloon struck trees during the landing, and subsequently came to rest in a residential area of Ottawa at about 20:00 EDT.

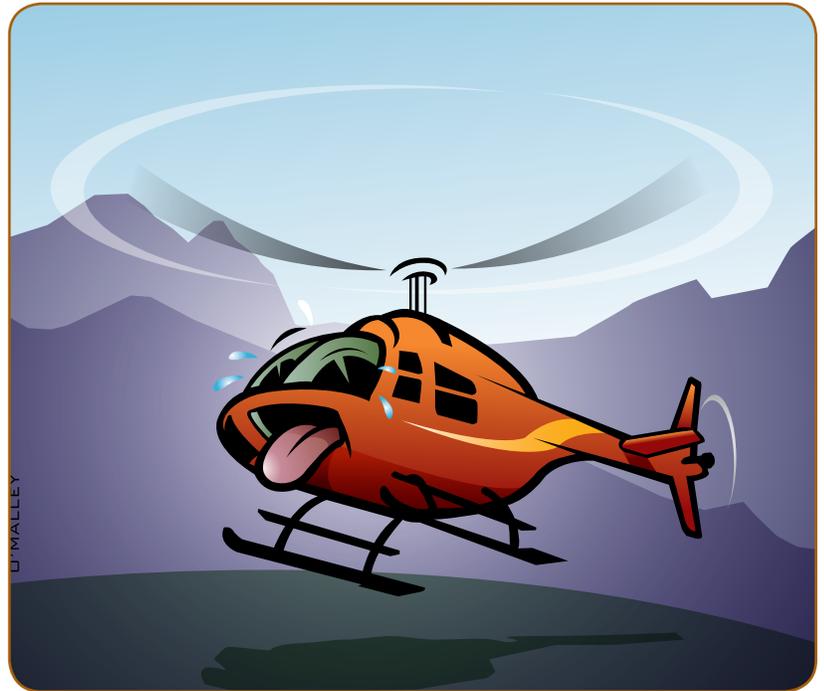
To validate my point, I calculated the length of time required to vertically climb 100 ft at specific weights and using the power required to hover OGE. (My calculations were derived by considering the difference between the weight of the helicopter and the thrust required to maintain an OGE hover.) My calculations showed that when operating as close to 50 ft below the OGE limits, it can take up to 20 sec to vertically climb 100 ft. It is reasonable to characterize this sort of performance as sluggish at best, and perhaps dangerous at worst. By reducing the gross weight to 100 lbs less than the OGE hover ceiling weight, I found that the situation improves considerably, and when it is reduced by 200 lbs, the time required to climb 100 ft is half that of a 50-pound reduction. Therefore, the advantages of operating at 200 lbs below the OGE hover ceiling when conducting OGE operations are several:

- the helicopter is subject to reduced power demands;
- pilot work load is reduced;
- the time spent in the shaded area of the height-velocity diagram is reduced;
- the effects of humidity on density altitude and OGE operations are to some extent mitigated;
- the critical relative wind azimuth area on the OGE hover ceiling chart will almost certainly be avoided;
- the pilot's power margin is greater and manoeuvrability is enhanced; and
- some admittedly small savings in flying time may be achieved in some cases.

I will use the performance of a common single-engine turbine helicopter as an example. The charts for the OGE hover ceiling for this type, as with any other type of helicopter, are published in its flight manual. These ceilings are predicated on density altitude (DA) in otherwise standard atmospheric conditions in which the humidity is zero percent<sup>1</sup>. If the pilot is operating at those limits, any attempt to manoeuvre with any application of power, engine and/or transmission limits will likely be exceeded. If operations under these conditions are to be practically and safely carried out, in my opinion gross weight should be less than the maximum specified by the OGE hover ceiling charts to allow the pilot a margin of power for manoeuvrability.

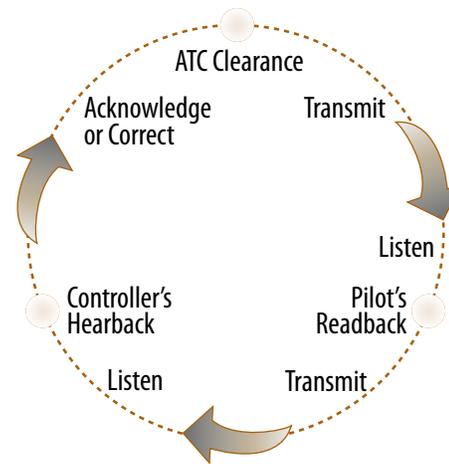
### **The pilot/controller communication loop**

The pilot/controller communication loop constitutes a confirmation/correction process that ensures the integrity of communications. Strict adherence to this closed loop constitutes a line of defence against communication errors. Readback/Hearback errors may result in an event such as: operational deviation; airborne conflict; less than required separation; runway incursion; near midair-collision, etc.
